UNDERWATER BRIDGE INSPECTION REPORT

STRUCTURE NO. 14523

RED RIVER OF THE NORTH

DISTRICT 4 - CLAY COUNTY, FARGO, ND / MOORHEAD, MN

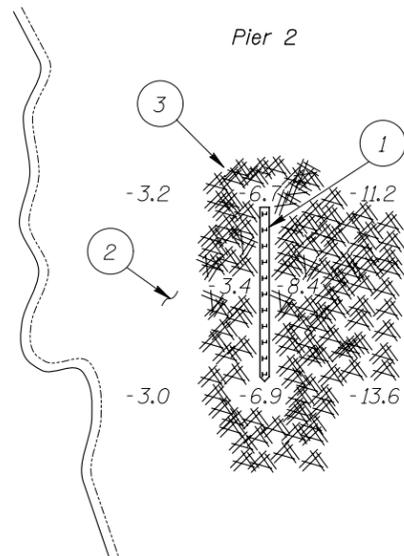
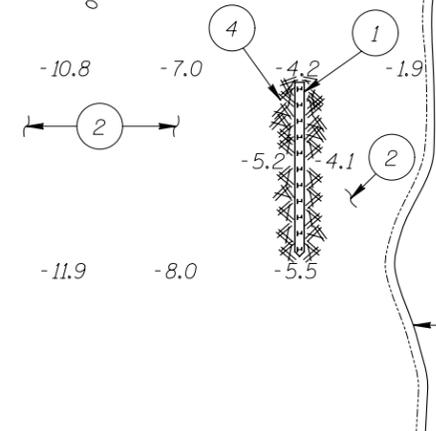
SOUNDING PLAN

- 1 Overall, the concrete was smooth and sound with random minor areas of poor consolidation with 1/4 inch maximum penetration.
- 2 The channel bottom consisted of soft clay with a probe rod penetration up to 1.5 feet and random 12-inch-diameter cobbles.
- 3 A heavy accumulation of timber debris consisting of 2-foot-diameter or smaller logs and branches was observed around the entire perimeter of Pier 2 extending from the channel bottom to 5 feet above the waterline. The debris extended 20 feet off the upstream nose, 10 feet off the downstream nose, 30 feet off the East face, and 10 feet off the West face.
- 4 A light accumulation of timber debris consisting of 6-inch-diameter and smaller limbs and branches was observed around the entire perimeter of Pier 3 extending from the channel bottom to 1 foot above the waterline. The debris extended 3 feet out from all faces and noses.
