UNDERWATER BRIDGE INSPECTION REPORT

STRUCTURE NO. 4237

BUFFALO RIVER

MINNESOTA DEPARTMENT OF TRANSPORTATION  
UNDERWATER BRIDGE INSPECTION

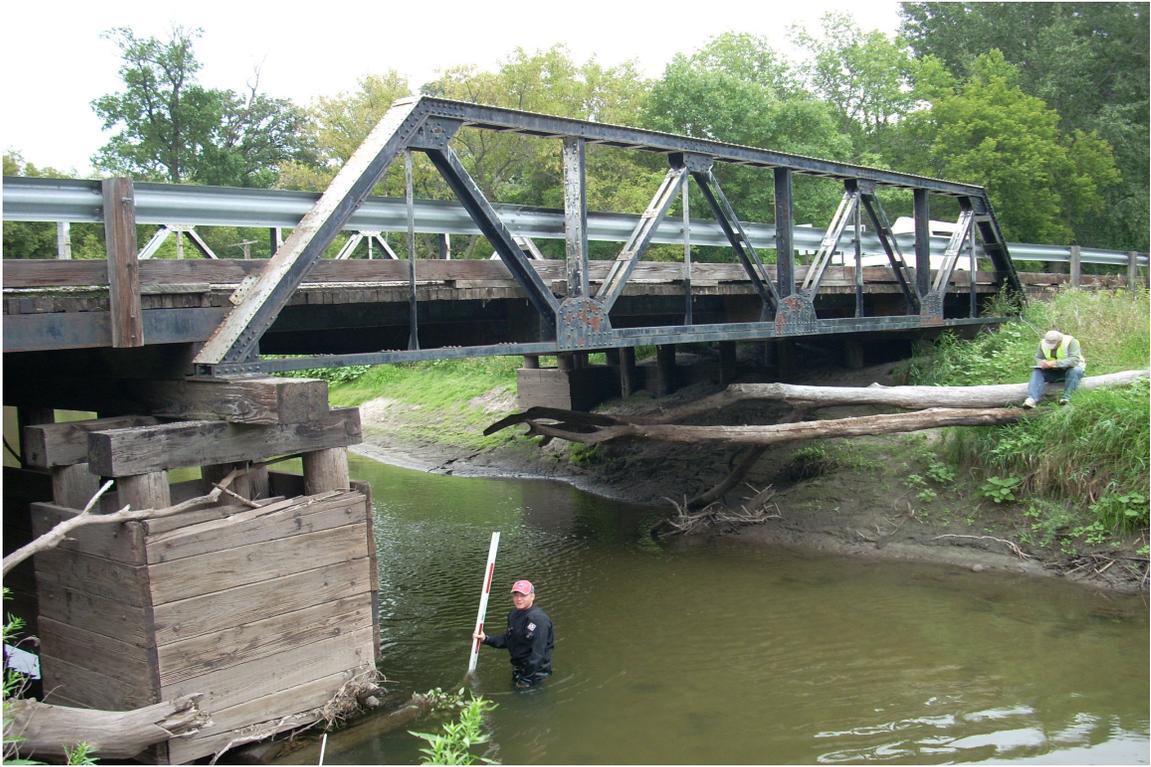
Photograph 1. Overall View of the Structure, Looking Northwest.

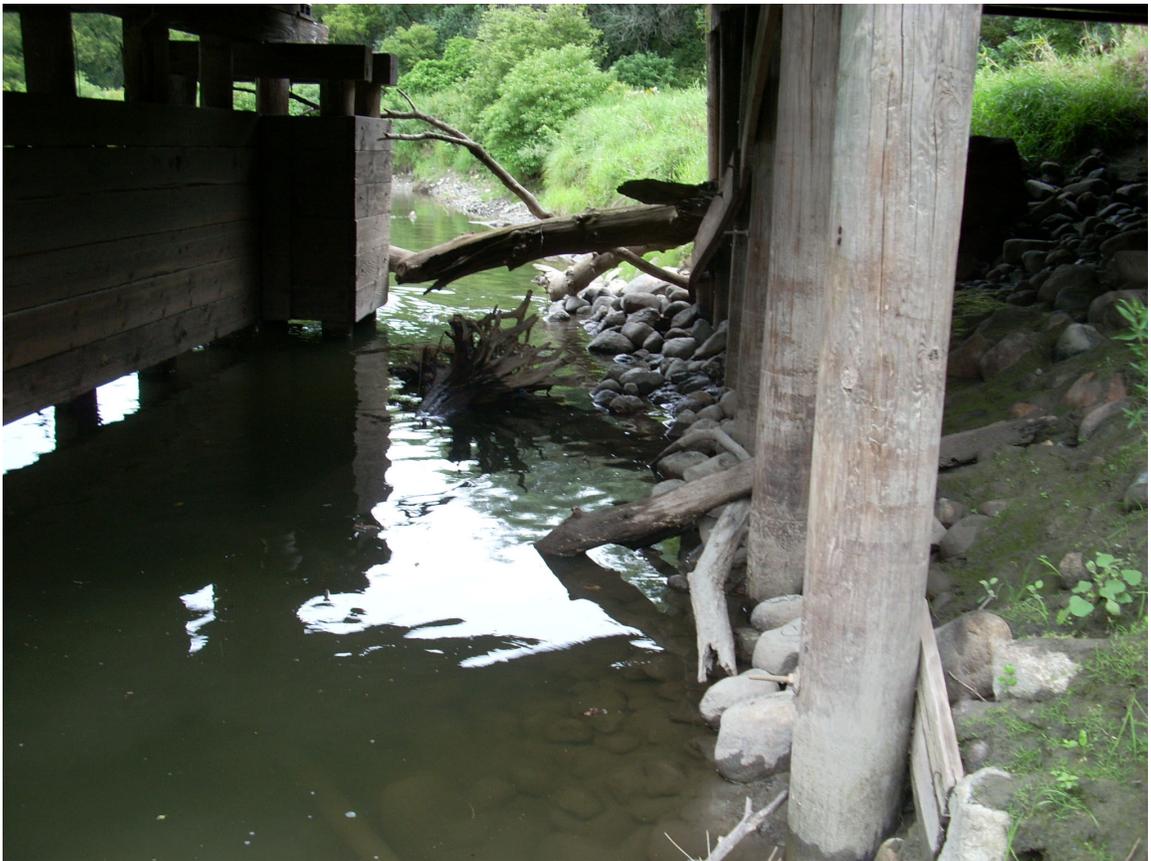
Photograph 2. View of Pier 1 and South Shoreline, Looking East.

- 1 The channel bottom consisted of silt with a maximum probe rod penetration of 1.5 feet.
- 2 The south shoreline was protected with riprap up to 1 foot in diameter.

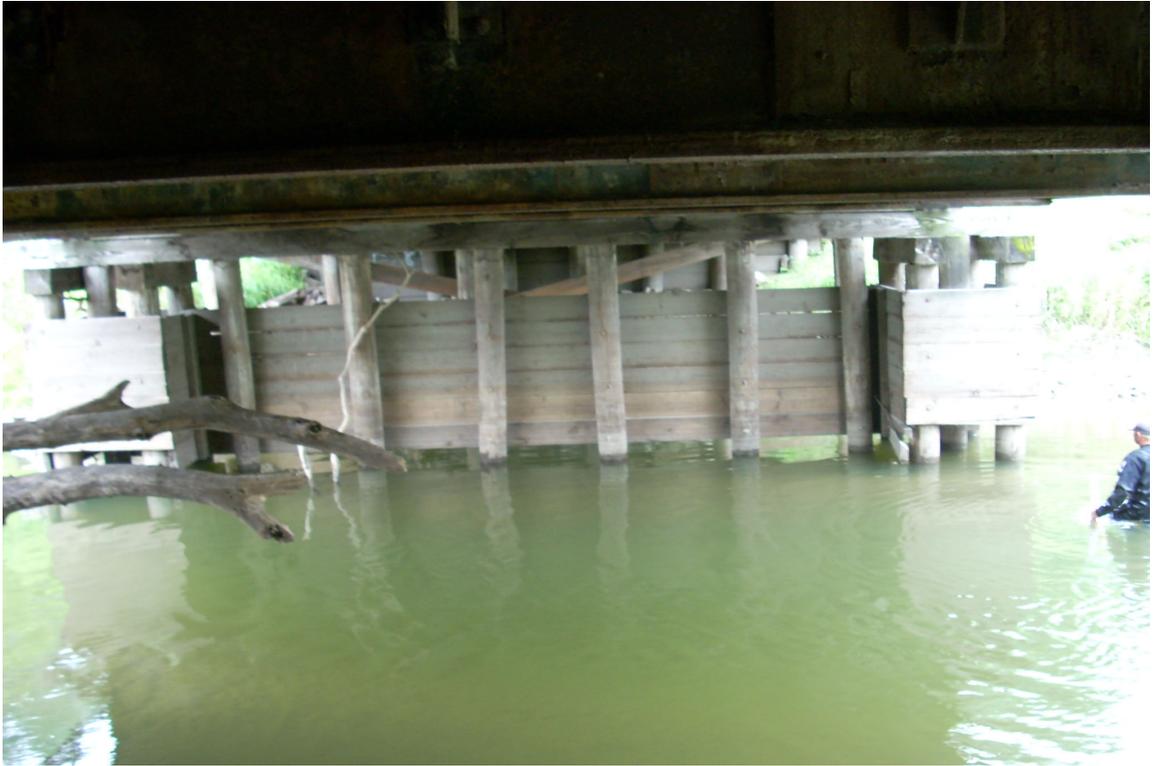
Photograph 3. View of Pier 2, Looking South.

- 3 The timber piles, caps and bracing of Piers 1 and 2 were lightly weathered with checks up to 1/8 inch wide. Awl penetrations into the timber were between 1/4 and 1/2 inch. The galvanized steel connection hardware exhibited light surface corrosion with no appreciable loss of section. There were two broken and one missing horizontal timbers at the upstream and two broke and two missing horizontal timbers at the downstream truss support elements of Pier 2.

- 4 A moderate accumulation of timber debris, consisting of logs up to 18 inches in diameter, was observed along the entire south face, around the upstream nose, and along the north face to the upstream 1/4 point of Pier 2. The debris extended from the channel bottom to 2 feet above the waterline, and extended up to 3 feet from the upstream nose, up to 4 feet from the north face, and from the south face to Pier 1.

- (A) Remove timber debris accumulated at Pier 2 and on the north shoreline upstream of bridge.

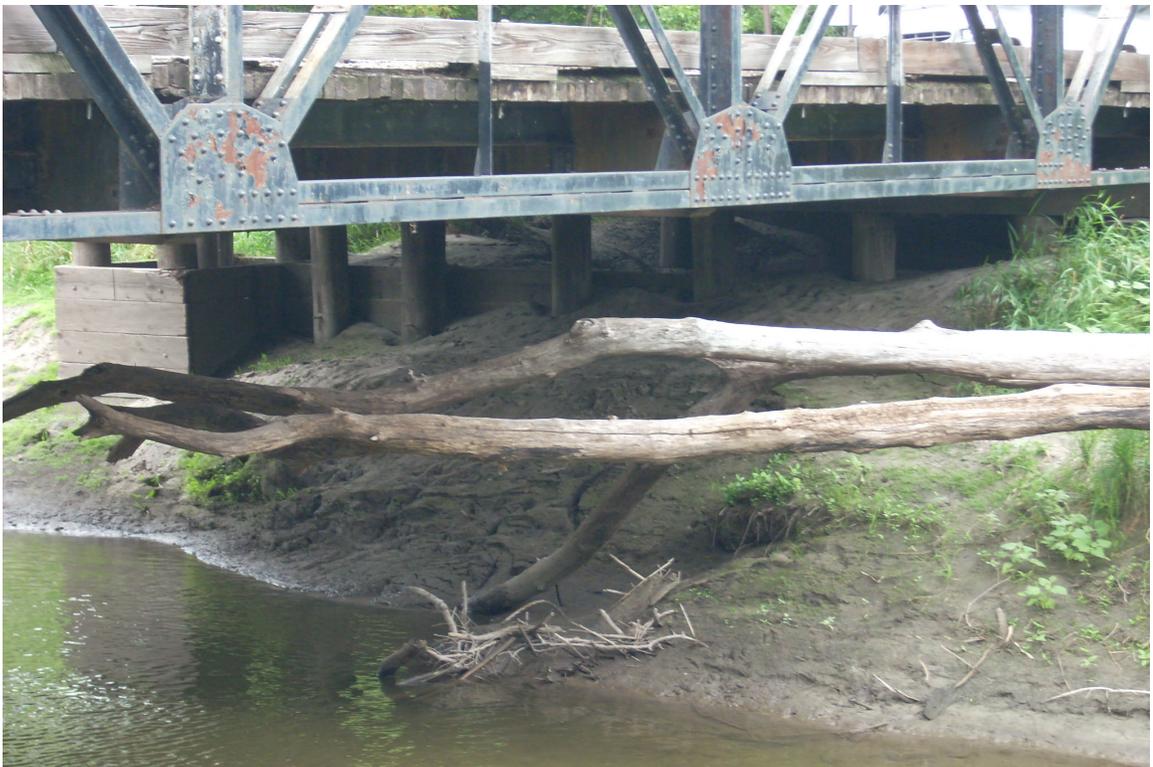
Photograph 4. View of Heavy Timber Debris at North Shoreline upstream of Pier 3, Looking Northwest.

- 5 A heavy accumulation of timber debris was on the north shoreline upstream of the bridge.
