UNDERWATER BRIDGE INSPECTION REPORT

STRUCTURE NO. 92453
CSAH NO. 15
OVER THE
SOUTH BRANCH OF THE BUFFALO RIVER
DISTRICT 4 - CLAY COUNTY

PREPARED FOR THE
MINNESOTA DEPARTMENT OF TRANSPORTATION
BY
COLLINS ENGINEERS, INC.
JOB NO. 5221 (CEI 53)

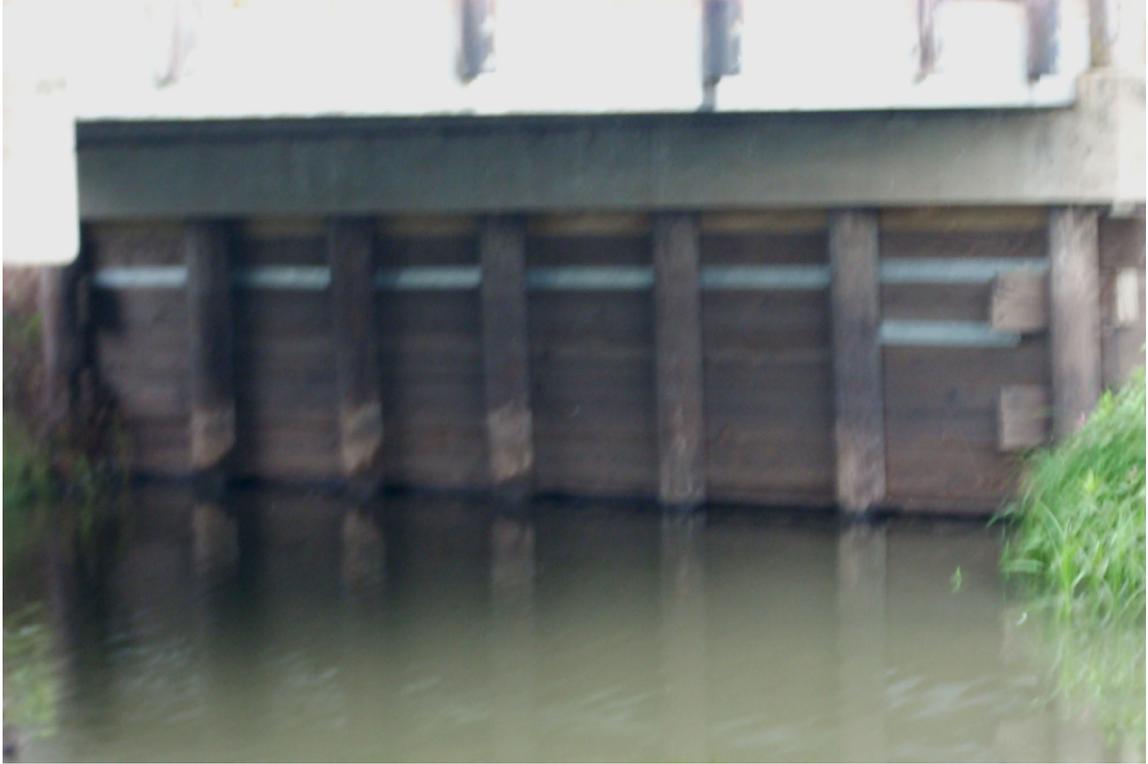
Photograph 1. View of North Abutment, Looking Northwest.

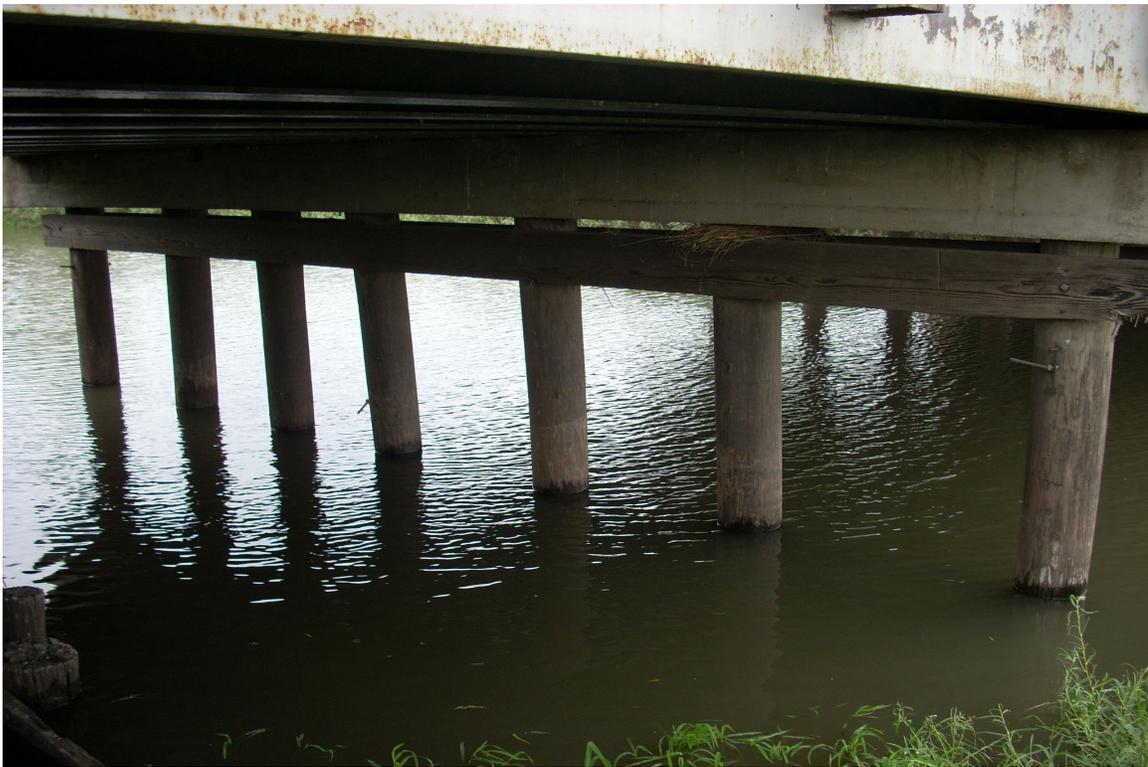
Photograph 2. View of Pier 1, Looking Northwest.

| UNIT REFERENCE NO. | UNIT DESCRIPTION | MAXIMUM DEPTH OF WATER | SUBSTRUCTURE | | | | | CHANNEL | | | | | GENERAL | | | | | | |
|---|---|---|---|---|---|---|---|---|---|---|---|---|---|---|---|---|---|---|---|
| | Pier 1 | 3.1' | 7 | N | N | 9 | 5 | 5 | 8 | N | N | 7 | 7 | N | N | 7 | N | N | N |

- (A) Repair missing and/or broken timber bracing at Piers 1 and 2 to re-establish the lateral stability of the structures.

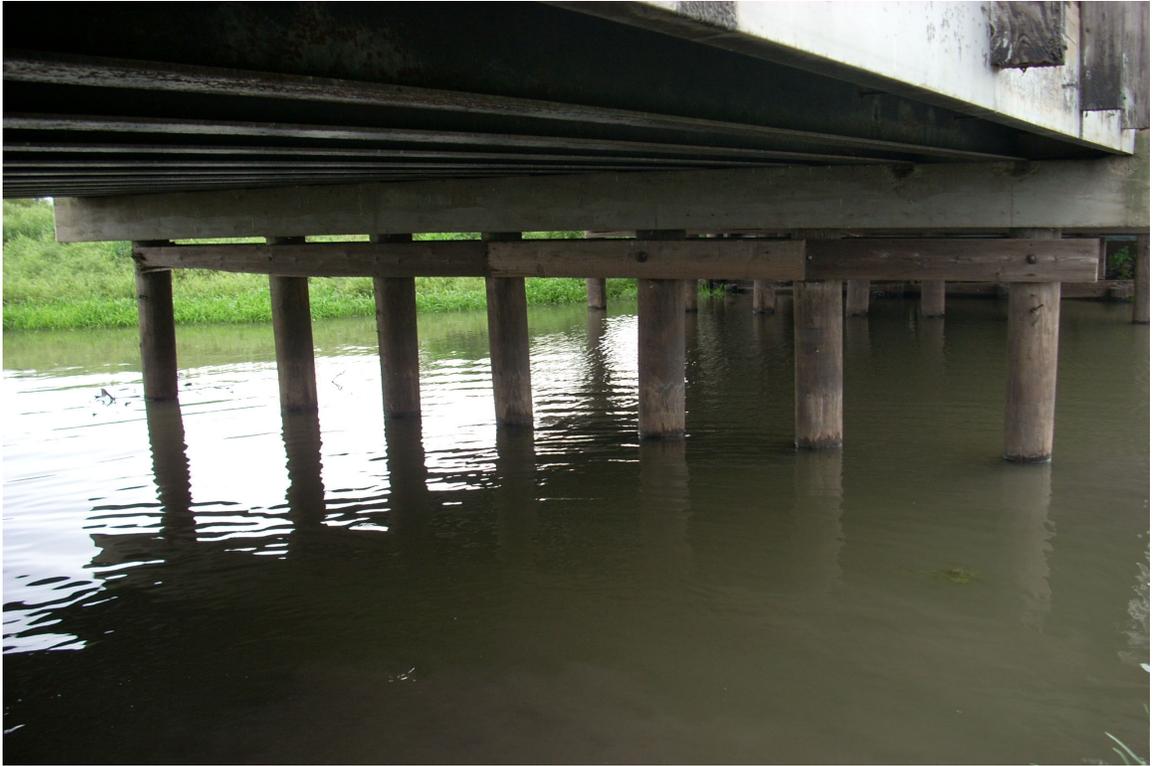
Photograph 3. View of Pier 2, Looking Southeast.

| UNIT REFERENCE NO. | UNIT DESCRIPTION | MAXIMUM DEPTH OF WATER | SUBSTRUCTURE | | | | | CHANNEL | | | | | GENERAL | | | | | | |
|---|---|---|---|---|---|---|---|---|---|---|---|---|---|---|---|---|---|---|---|
| | Pier 2 | 3.7' | 7 | N | N | 9 | 5 | 5 | 8 | N | N | N | 8 | N | N | 7 | N | N | N |

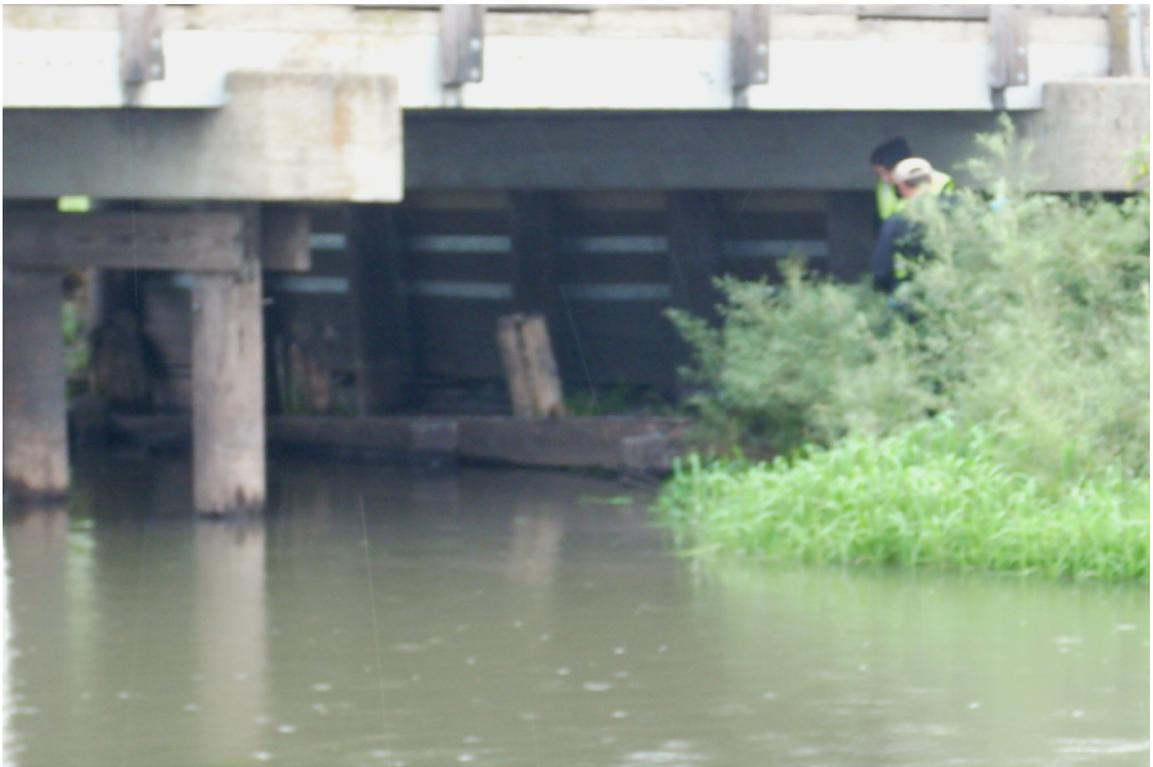
Photograph 4. View of South Abutment, Looking Southeast

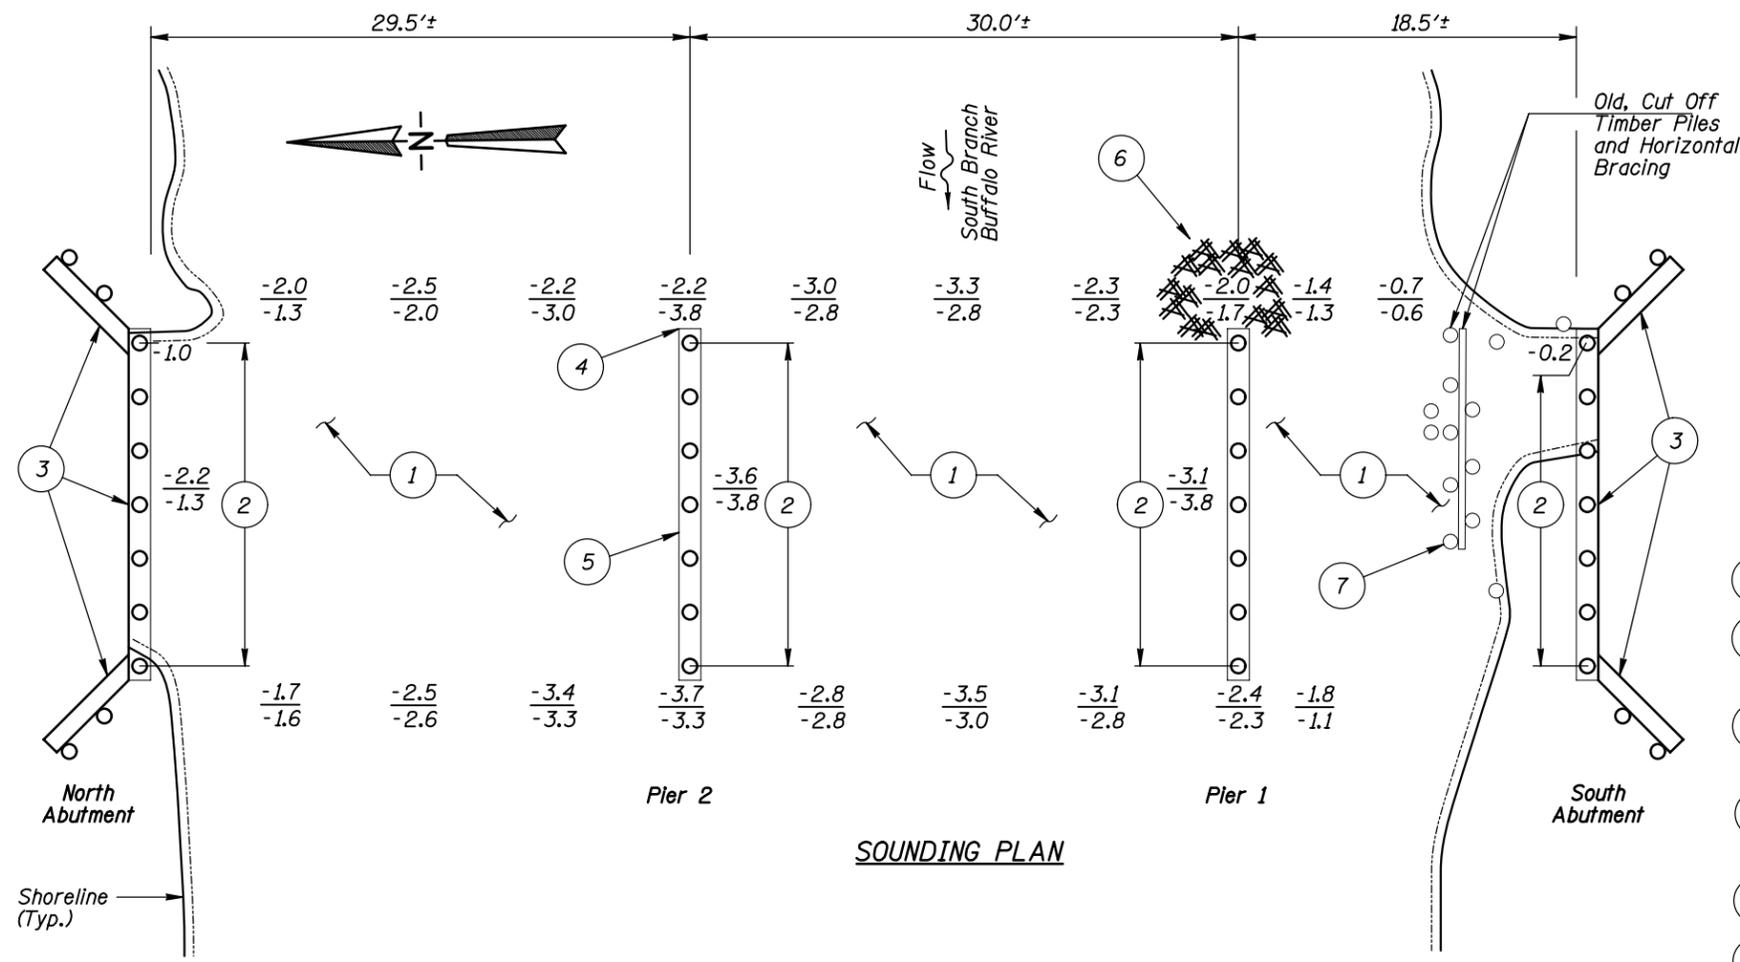
| INSPECTION AND SOUNDING PLAN | | |

- INSPECTION NOTES:**
- 1 The channel bottom consisted of silty clay with up to 12 inches of probe rod penetration.
 - 2 The timber piles exhibited vertical checking with a typical width of 1/8 and a maximum width of 1/4 inch.

- 3 The gaps between the timber planking along the backwall and wingwalls have been repaired with metal strips to halt backfill loss.
 - 4 The horizontal timber brace directly below the pier cap was broken and no longer engaged at the upstream pile at Piers 1 and 2 on both north and south sides.

- 5 The diagonal timber bracing at Piers 1 and 2 was completely missing.
 - 6 A light accumulation of timber debris consisting of 4 inch diameter and smaller limbs and branches of Pier 1 extending from channel bottom to waterline with a radius of 5 feet off the upstream pile.

- 7 Cut off timber piles were observed at 8 feet North of the South Abutment from channel bottom to 3 feet above the waterline and 2 feet North of Pier 1 from channel bottom to 1 foot below the waterline.
