UNDERWATER BRIDGE INSPECTION REPORT

STRUCTURE NO. L0885
TWP NO. 970
OVER THE
OTTER TAIL RIVER
DISTRICT 4 - OTTER TAIL COUNTY

PREPARED FOR THE
MINNESOTA DEPARTMENT OF TRANSPORTATION
BY
COLLINS ENGINEERS, INC.
JOB NO. 5221 (CEI 64)

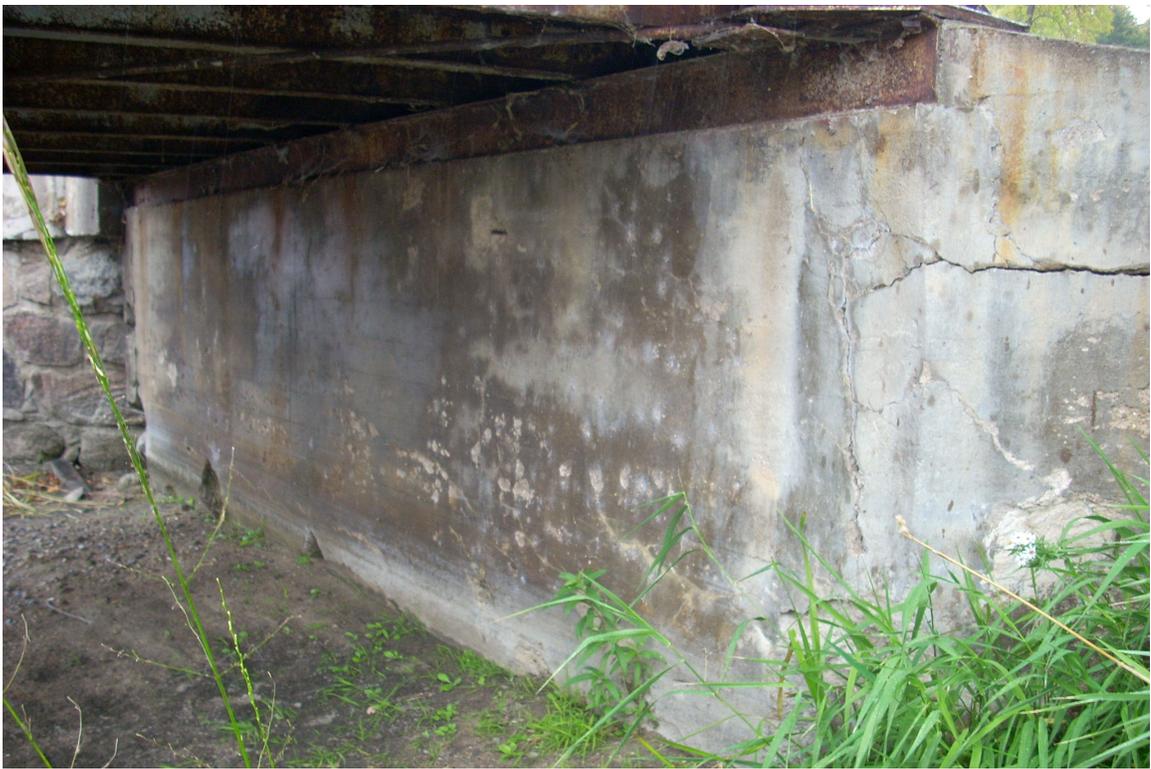
- (D) The East Abutment breastwall exhibited vertical cracking up to 1/2 inch wide and three spalled areas with some exposed reinforcing steel. The spalls were each no larger than 3 square feet in area and located near the ground line.
- (E) A horizontal crack with a maximum width of 3/4 inch extended the full length of the South Wingwall of the East Abutment at 4.5 feet above the ground line.

Photograph 2. View of East Abutment, Looking Northeast.

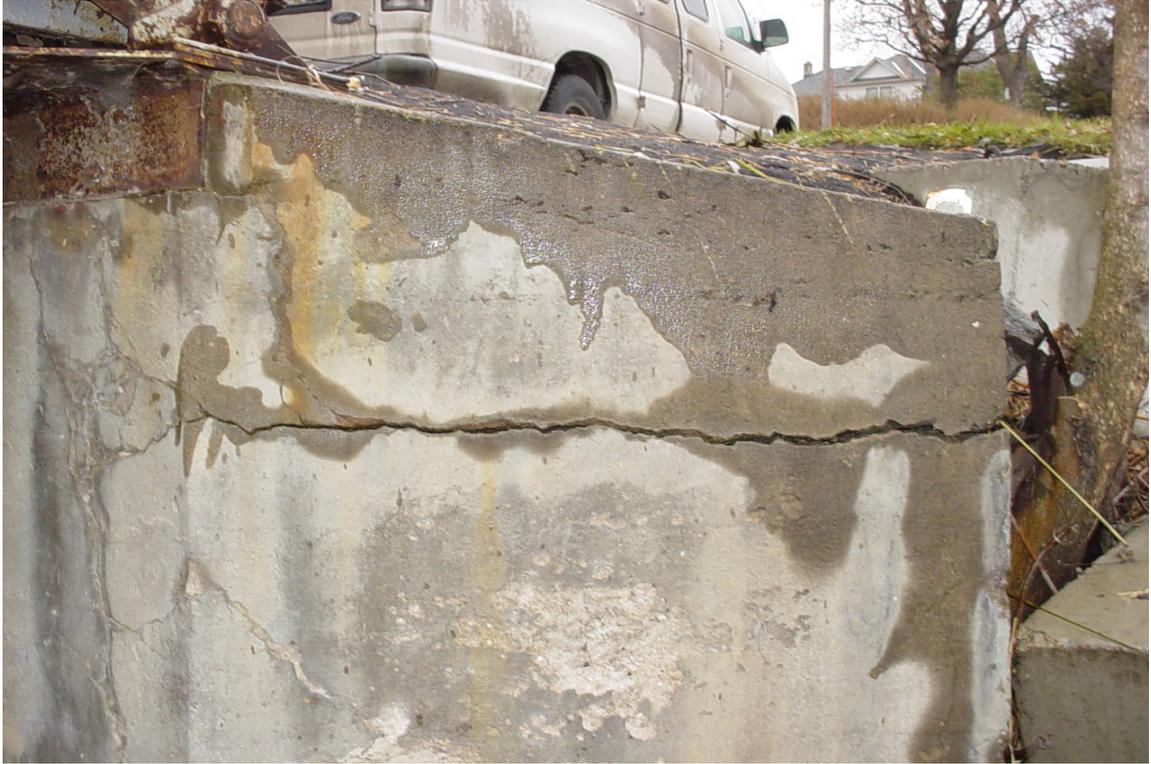
Photograph 3. View of Horizontal Crack in Southeast Wingwall, Looking East.

- 10 A horizontal crack, 3/4 inch maximum width, extended the length of wingwall 4.5 feet above the groundline.

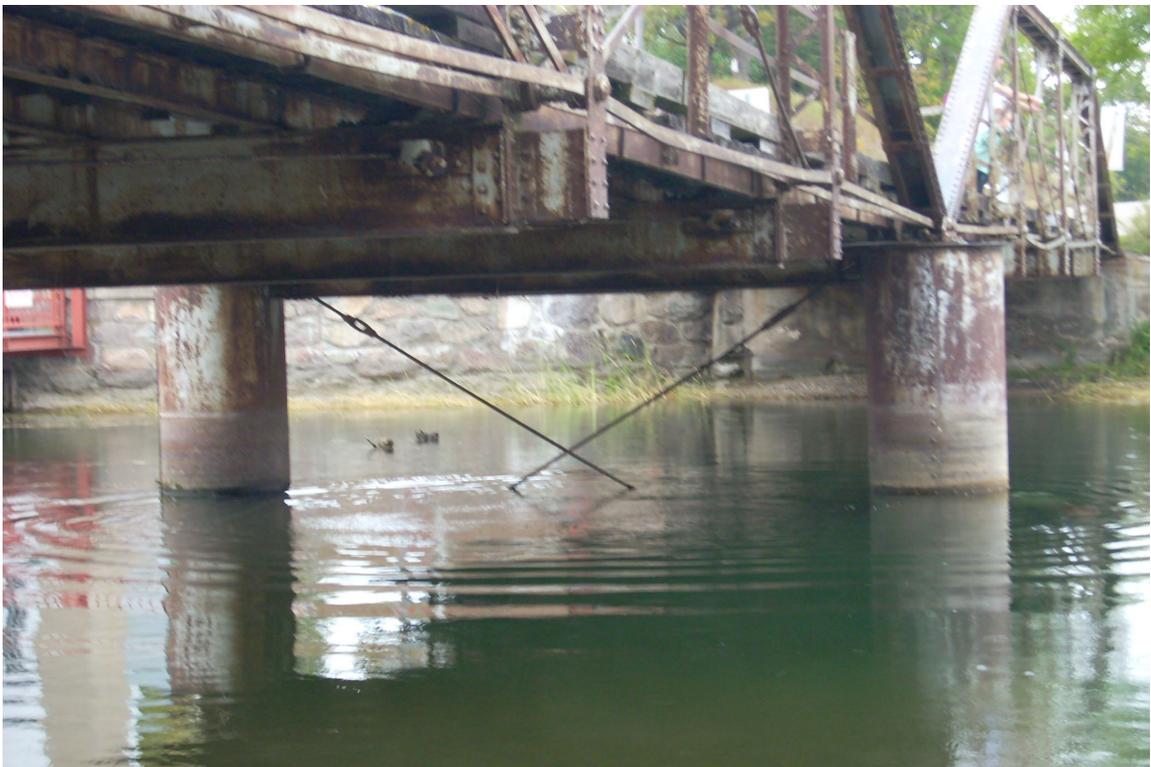
- (A) The south caisson of the Center Pier had a rivet missing below water, causing a 1/4-inch-wide by 1-foot-long gap in the steel caisson shell. Additionally, one steel cross brace between the two caissons was bent out-of-plane. It was also observed that the Center Pier has overall settled noticeably towards the north.
- (B) The Center Pier caissons exhibited 100 percent coating failure and minor surface corrosion from 1 foot above the waterline to the channel bottom.
- (C) The West Abutment breastwall exhibited random vertical hairline to 1/16 inch wide cracking and widespread moderate to heavy scaling with some exposed reinforcing steel.

Photograph 4. View of the Center Pier, Looking Northeast.

- 9 Both caissons of the Center Pier exhibited 100 percent of coating failure and minor surface corrosion from 1 foot above the waterline to the channel bottom. Overall, the Center Pier also exhibited a detectable differential settlement to the north.

- (A) It is recommended that the bridge remain closed to vehicular traffic. Monitor the settlement rate of the Center Pier during future inspections, preferably at a minimum interval of one (1) year during above water inspections. If settlement is continuing and is adversely affecting the stability of the structure, measures to stabilize the bridge may be warranted.
- (B) Reinspect the submerged substructure units underwater at the normal maximum recommended (NBIS) interval of five (5) years; unless the above water inspection reveals significant changes that would warrant an earlier underwater inspection.

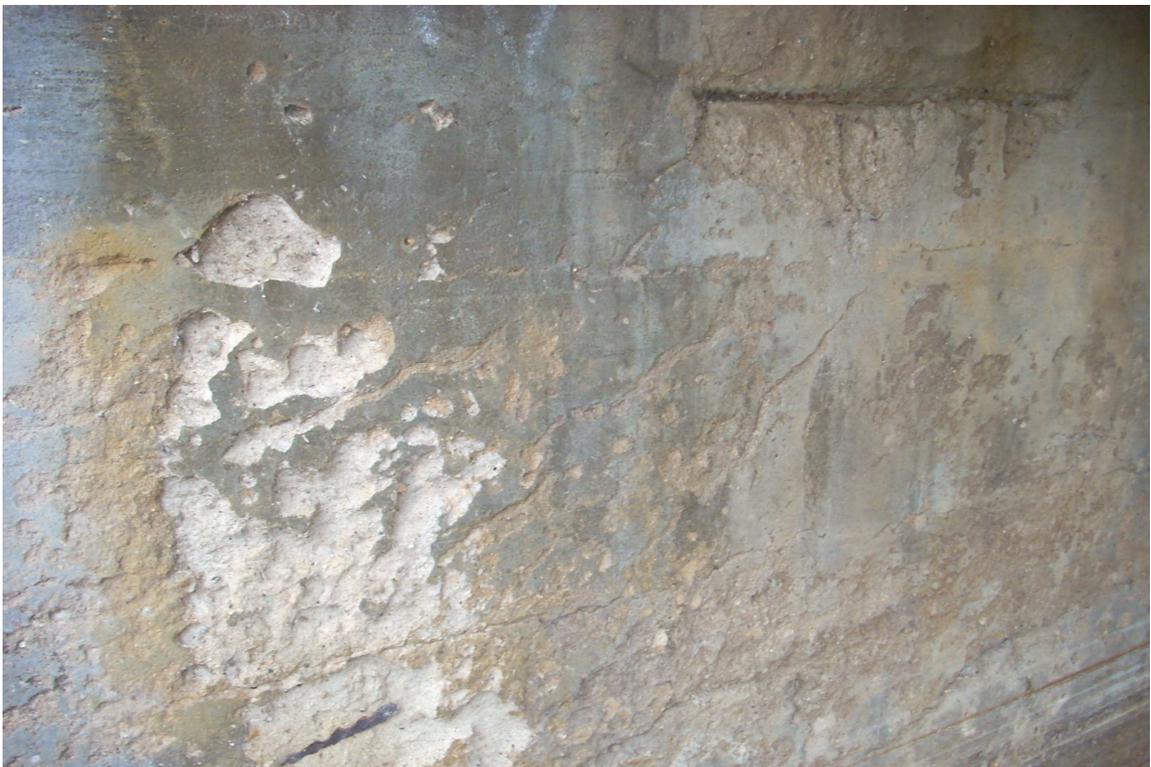
Photograph 6. View of Scaling and Exposed Rebar at the south corner of the West Abutment, Looking Northwest.

- 1 The channel bottom material consisted of sandy gravel and scattered 12 inch diameter riprap with 1 to 4 inches of probe rod penetration.
- 2 Approximately 50 percent of the abutment breastwall was covered with 1 inch deep scaling with some areas of exposed reinforcing steel.

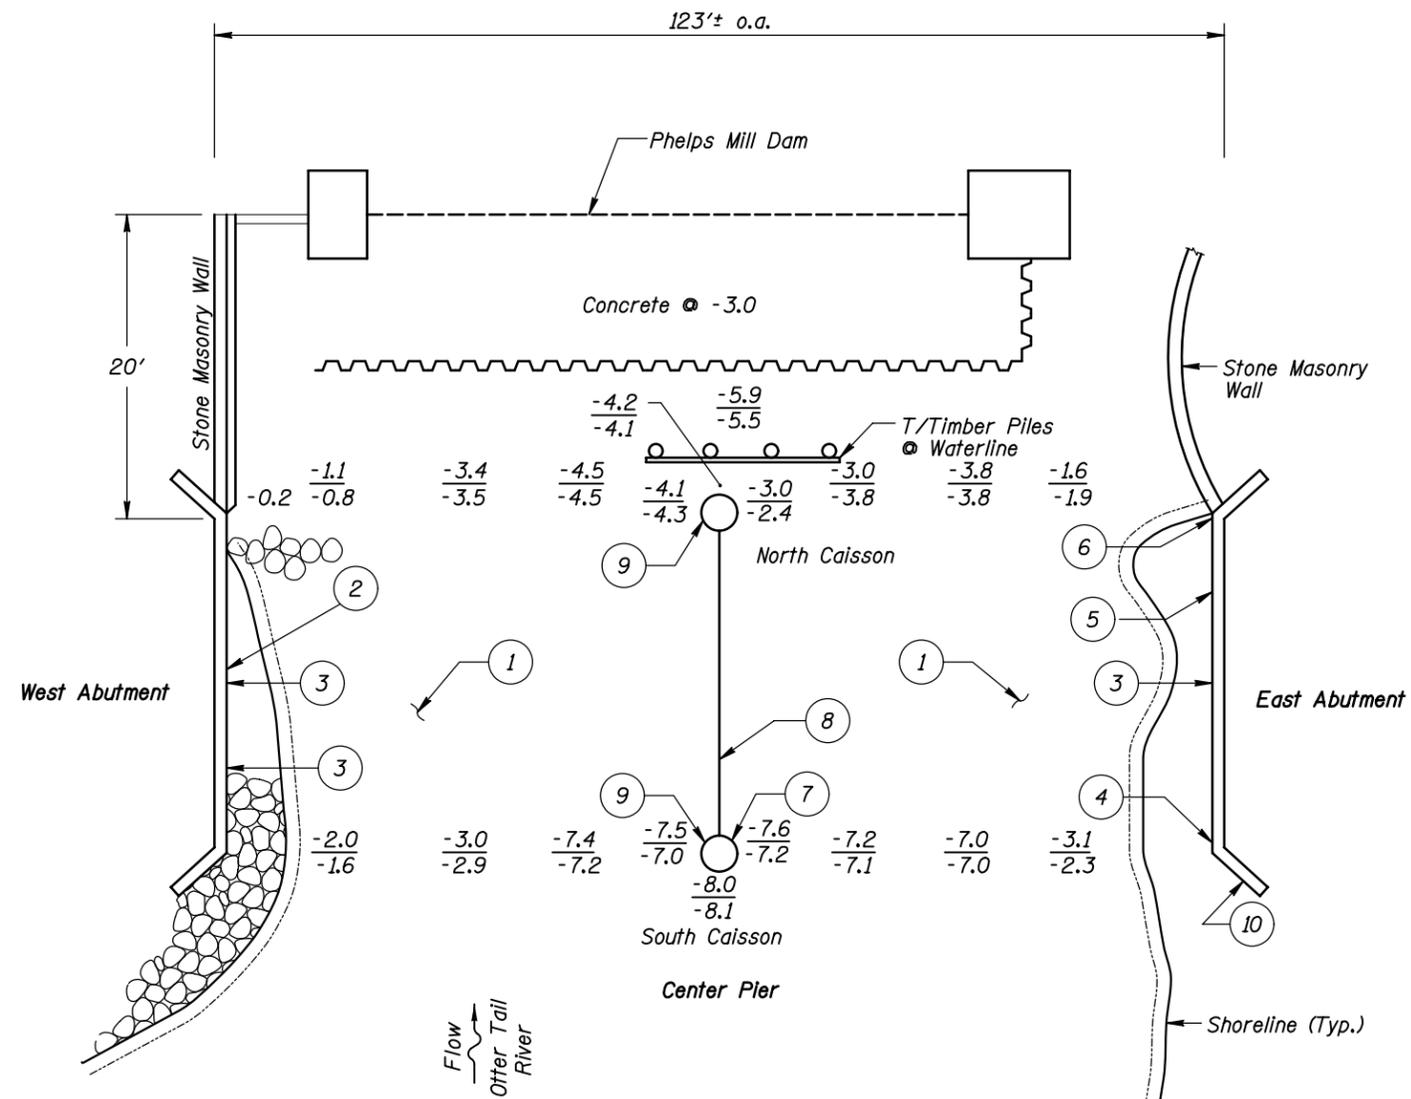
INSPECTION AND SOUNDING PLAN

- 3 Vertical crack, hairline to 1/16 inch wide, was present extending the full abutment height.
- 4 Vertical crack, 1/2 maximum width, was present extending the full abutment height. In addition, a spall, 1.5 feet wide by 2 feet high with 3 inches of penetration was present at the groundline.

- 5 Vertical crack, 1/16 inch maximum width, was present extending the full abutment height. In addition, a 10 inch diameter spall with 2 inches of penetration was present at the groundline.

- 6 Vertical crack, 1/2 inch maximum width, was present extending the full abutment height. Two spalls with exposed reinforcing steel were also present. One spall was 1.5 feet high by 1.5 feet wide with 6 inches of penetration and was at the groundline. The other spall was 0.5 feet high by 1 foot wide with 2 inches of penetration and was 2.5 feet above the groundline.

- 7 Missing rivet at 11.5 feet below the top of the caisson, causing a 1/4 inch wide by 1 foot long gap in the steel caisson shell.
- 8 Cross bracing extending from the top of the south caisson to the bottom of the north caisson exhibited a minor vertical bend/distortion.
