UNDERWATER BRIDGE INSPECTION REPORT

STRUCTURE NO. L7352
TWP NO. 140
OVER THE
RABBIT RIVER
DISTRICT 4 - WILKIN COUNTY

PREPARED FOR THE
MINNESOTA DEPARTMENT OF TRANSPORTATION
BY
COLLINS ENGINEERS, INC.
JOB NO. 5221 (CEI 59)

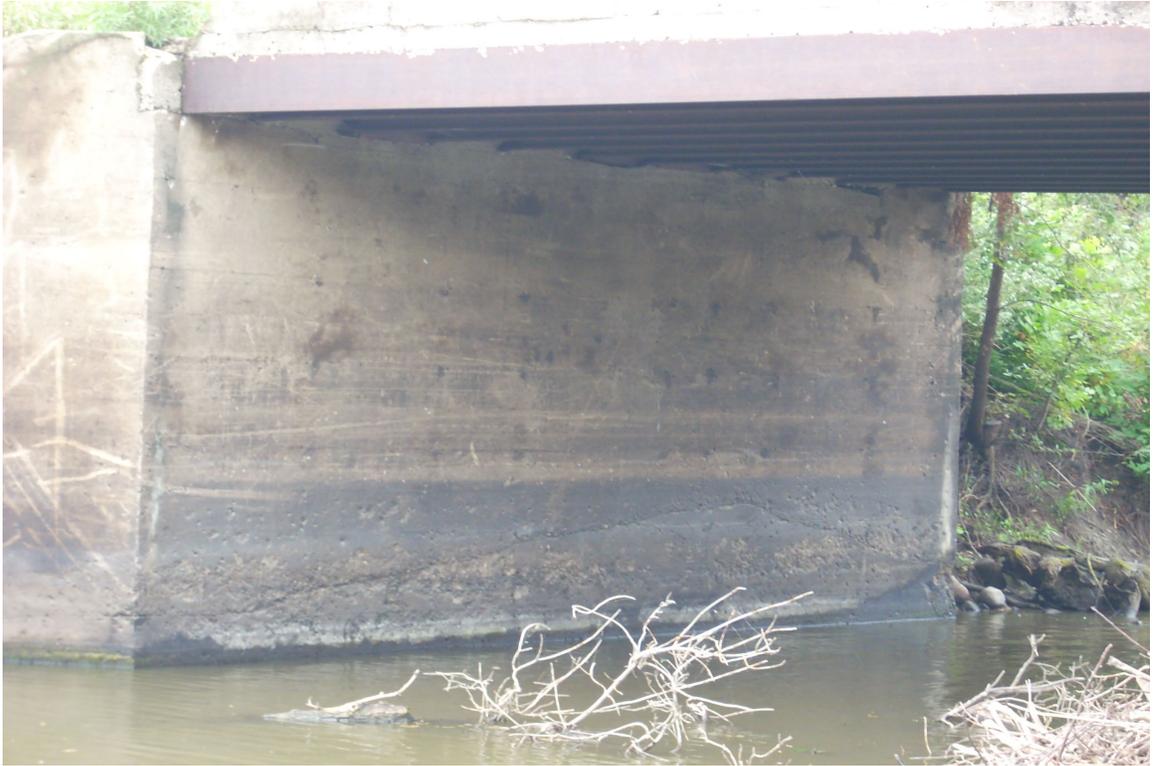
Photograph 1. View of South abutment, Looking Southwest.

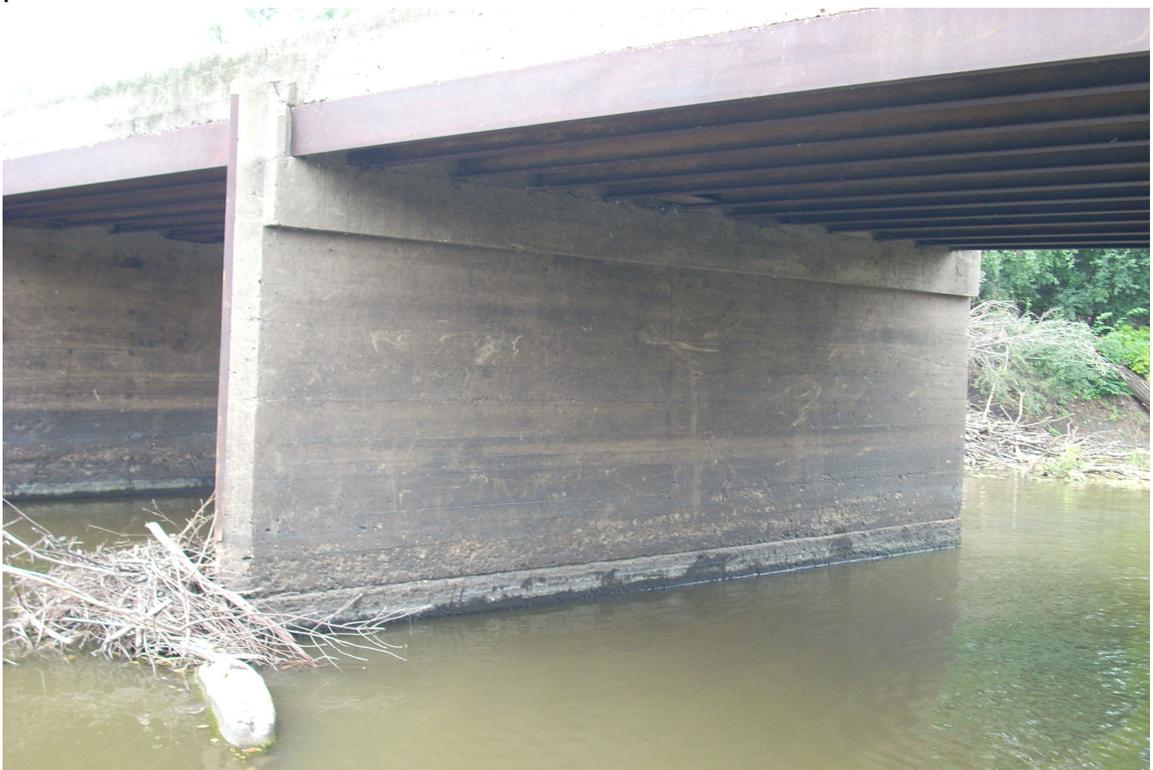
- (D) A construction joint, 3 inches below the waterline, exhibited random areas of section loss along both faces of Pier 1 with a maximum penetration of 1 inch.

- (E) An area of section loss, 6 inches in diameter with 1 inch of penetration, was observed at 2 feet above the waterline on the North abutment.
- (F) The top of the footing was exposed along the north face of Pier 1 with up to 4 inches of vertical face detected.

Photograph 2. View of Pier 1, Looking Southwest.

(B) Because no information about the footings was available, monitor the extent of the local scour and footing exposure at the pier and both abutments during future inspections. If scour conditions and footing exposure increase, a scour evaluation, which has presently not been made, and/or countermeasures may be warranted.

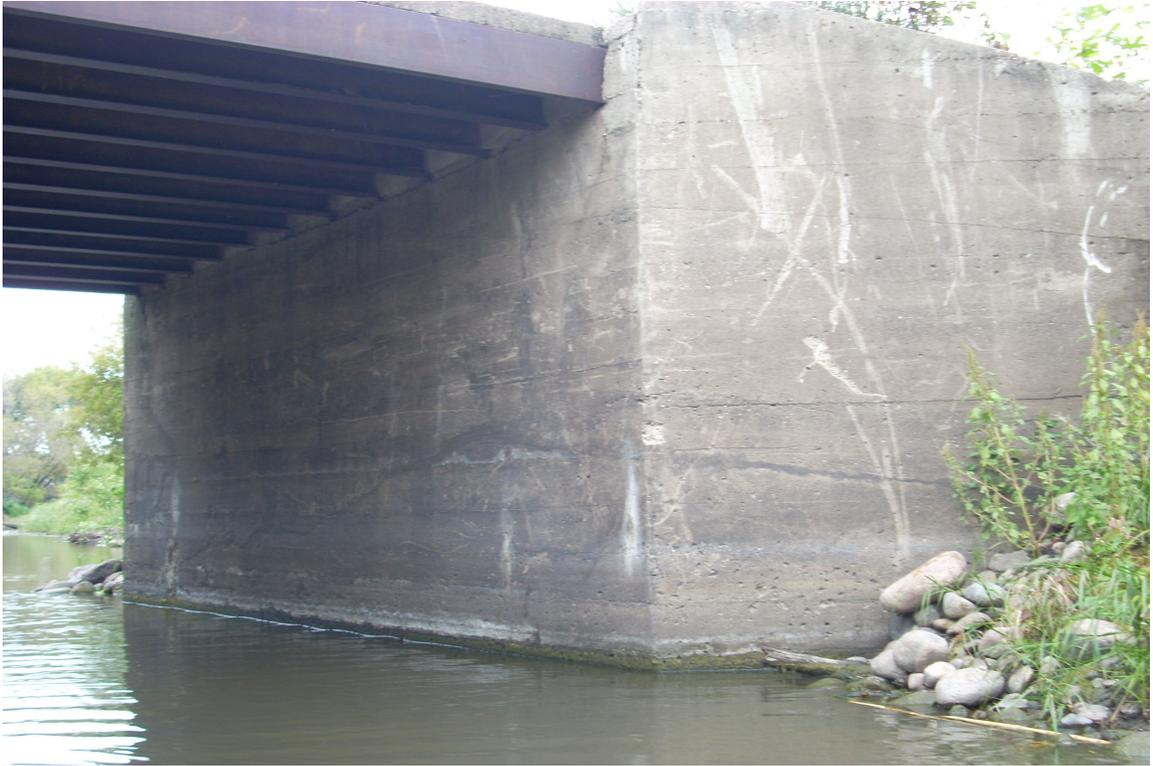
(F) The top of the footing was exposed along the North Abutment with no vertical face exposure detected.

Photograph 3. View of North Abutment, Looking Northwest.

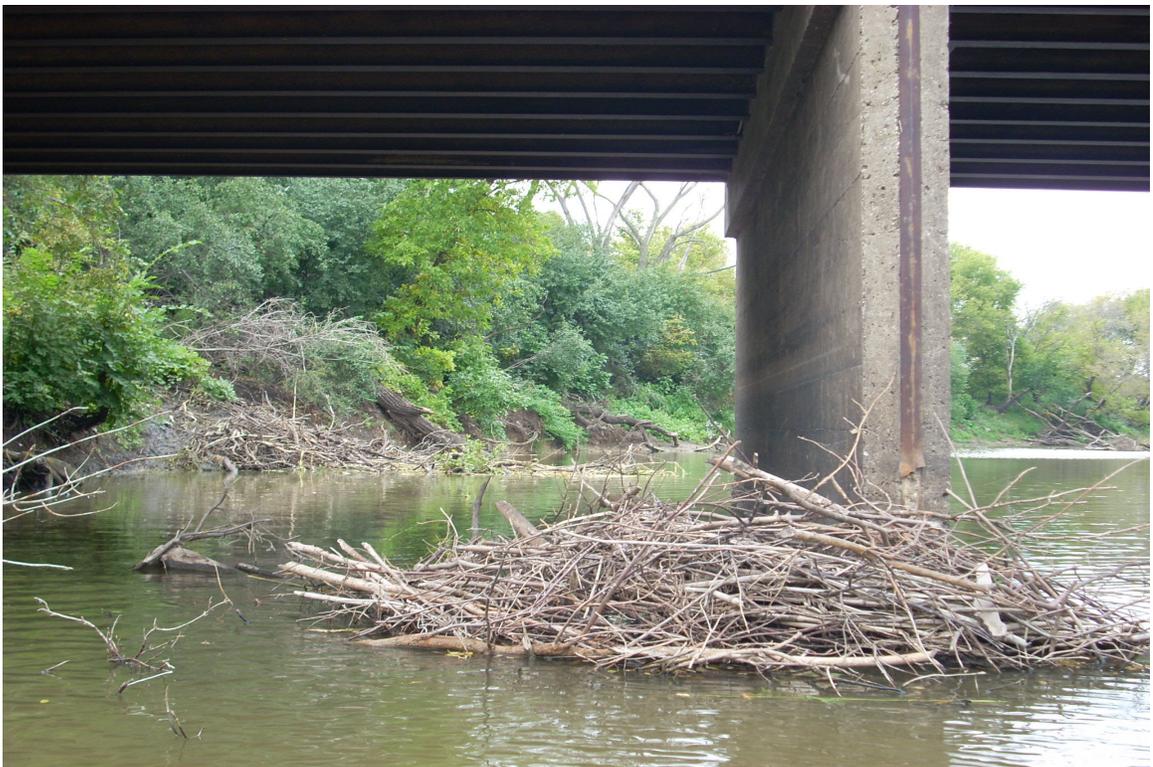
- (B) A 2.5-foot-diameter tree and a heavy accumulation of timber debris extended from the north embankment to midway between Pier 1 and the South Abutment along the upstream fascia of the bridge.

Photograph 4. View of Pier 1 and Timber Debris, Looking West.

(A) Remove the large tree and heavy accumulations of timber debris extending along the upstream fascia to eliminate the potential for continued accumulation and adverse affects on the bridge.

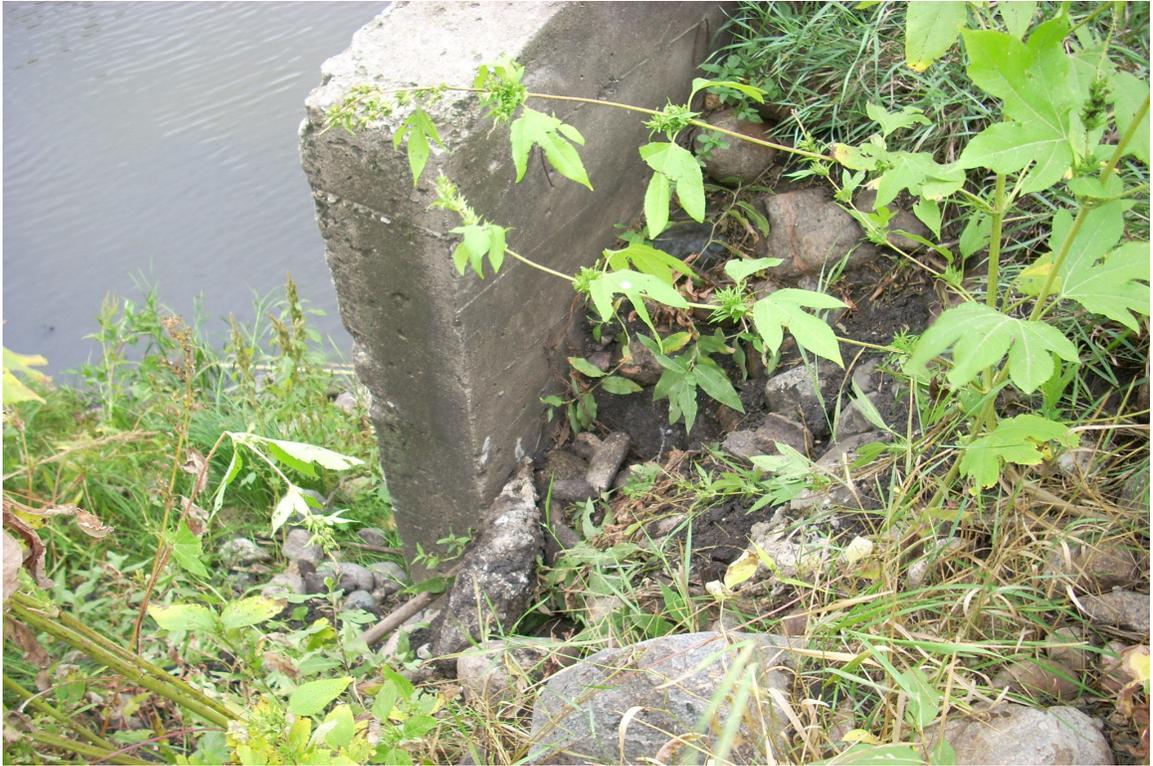
(G) The backfill behind each abutment wingwall was missing due to erosion making the area steeply sloped.

Photograph 5 View of Northeast Wingwall, Looking down at Erosion.

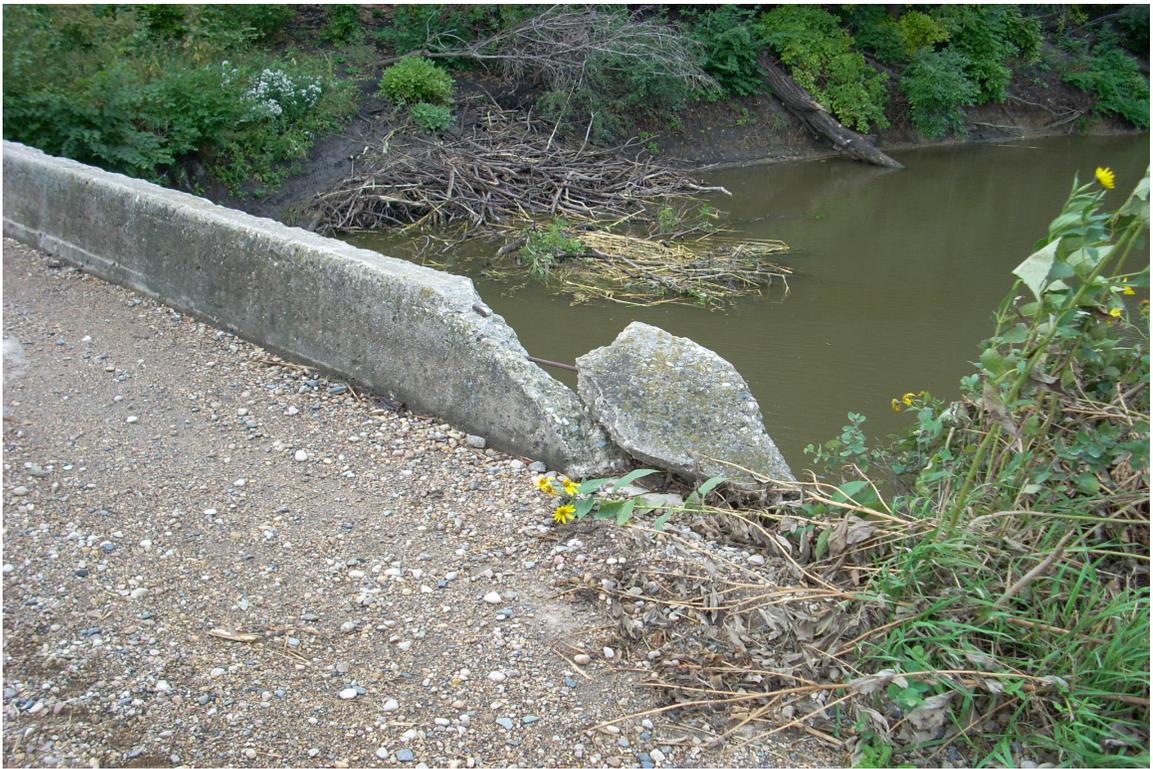
Photograph 6. View of Southwest Corner of Deck, Looking Southwest

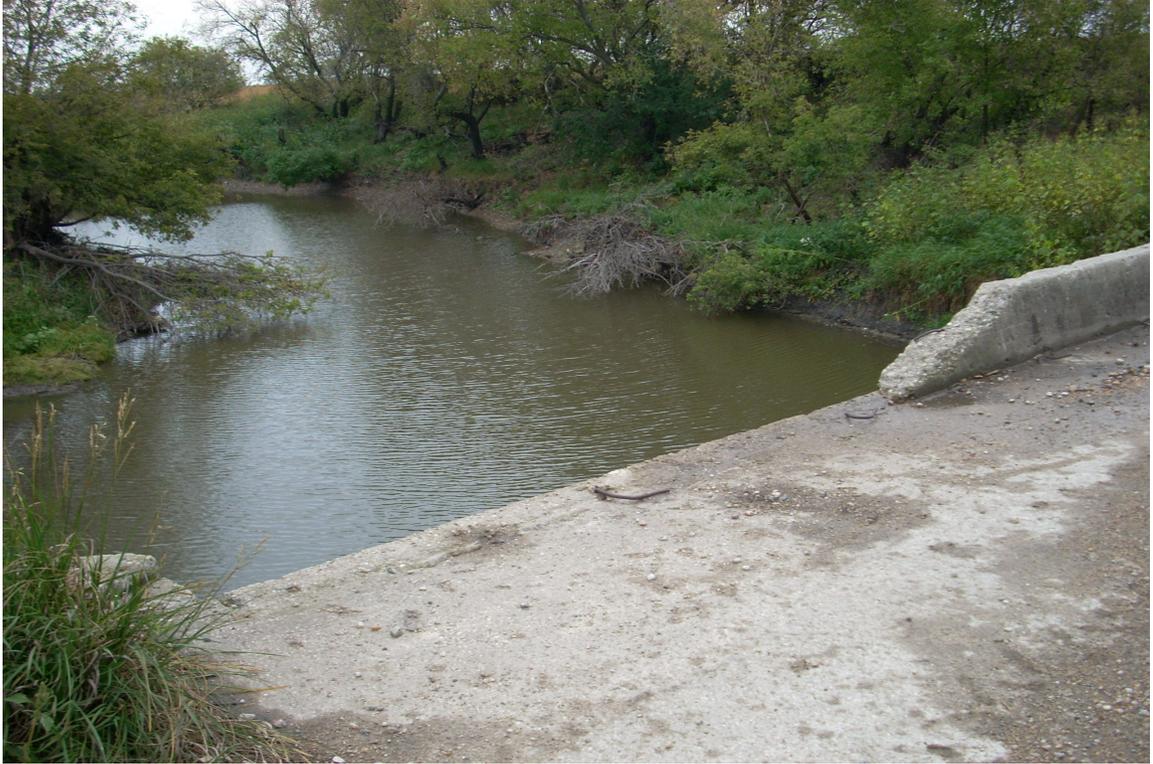
Photograph 7. View of Southeast Corner of Deck, Looking Southeast.

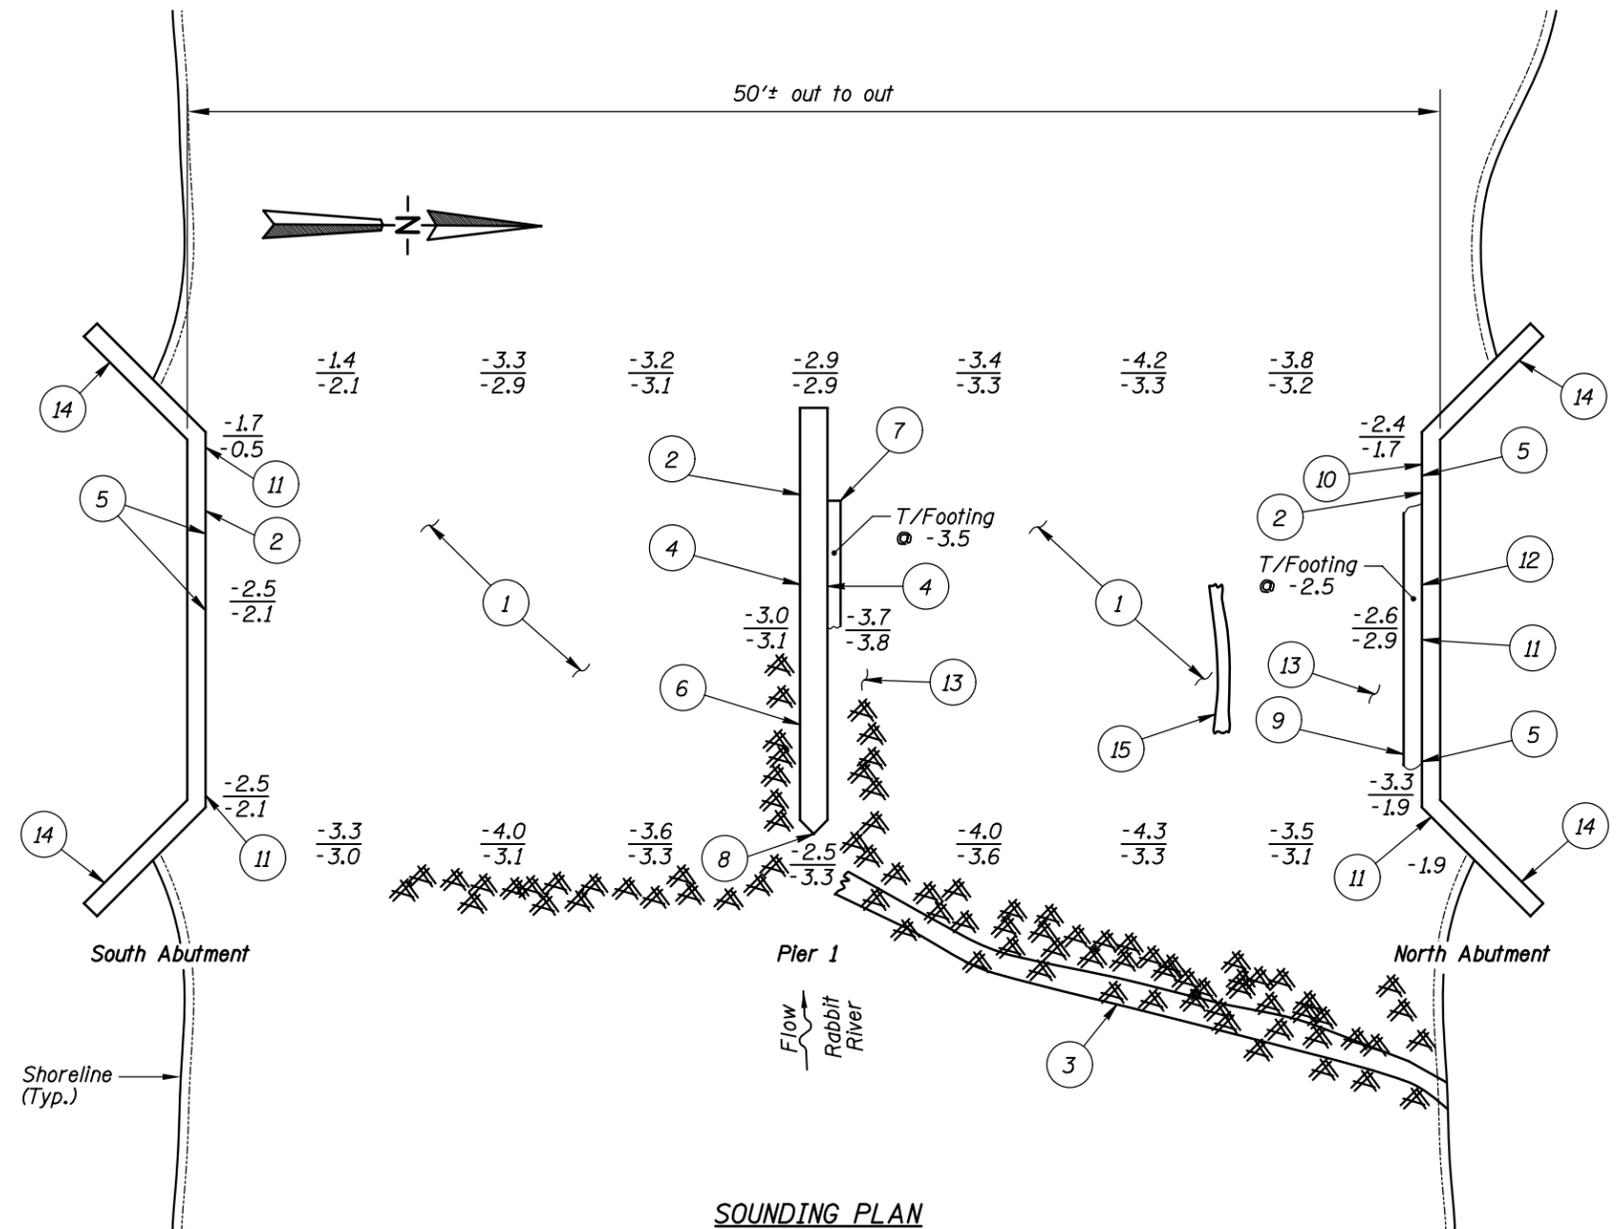
- INSPECTION NOTES:**
- The channel bottom material consisted of hard clay overlaid with silt and random gravel with a maximum probe rod penetration of 6 inches.

- Light to moderate scaling was observed around the perimeter of the pier and along the breastwalls of both abutments, with a maximum penetration of 1 inch, extending from the waterline to 2 feet above.

- A moderate accumulation of 1-foot-diameter and smaller timber debris was observed along the upstream fascia, extending from the North Abutment to midway between the pier and the South Abutment. A 2.5-foot-diameter tree along with a heavy accumulation of timber debris was also observed extending from the north embankment of Pier 1.

- Vertical crack, extending from the beam seat to the channel bottom with a maximum width of 1/8 inch, was observed on both sides of the pier.
 - Vertical crack, extending from the beam seat to the channel bottom with a maximum width of 1/8 inch, was observed on the breast wall.

- A construction joint 3 inches below the waterline exhibited areas of section loss around the entire perimeter of the pier with a maximum penetration of 1 inch.

- Footing exposure was detected at Pier 1 from the midpoint to 6 feet west with a maximum vertical exposure of 4 inches along the north side of pier. Timber forms were exposed along the footing face.

- Steel ice damage nosing protection extended from the top of the pier cap to 2 foot above the waterline.
 - Footing exposure was observed along the North Abutment with no vertical face exposure observed.

- Area of section loss, 6 inches in diameter, was observed 2 feet above the waterline with a penetration of 1 inch.
 - Vertical crack, extending from the beam seat to the channel bottom with a maximum width of 1/16 inch, was observed on the breast wall.

- Vertical crack, extending from the beam seat to the channel bottom with a maximum width of 1/32 inch, was observed on the breast wall.
 - Scattered timber debris consisting of 3-inch-diameter and smaller branches was observed along the North Abutment and the north face of Pier 1.

- Backfill behind wingwalls was eroded making it steeply sloped.
 - A 1.5-foot-diameter log was observed along the face of the North Abutment.
