UNDERWATER BRIDGE INSPECTION REPORT

STRUCTURE NO. L8228
TWP NO. 31
OVER THE
SOUTH BRANCH OF THE BUFFALO RIVER
DISTRICT 4 - CLAY COUNTY

PREPARED FOR THE
MINNESOTA DEPARTMENT OF TRANSPORTATION
BY
COLLINS ENGINEERS, INC.
JOB NO. 5221 (CEI 49)

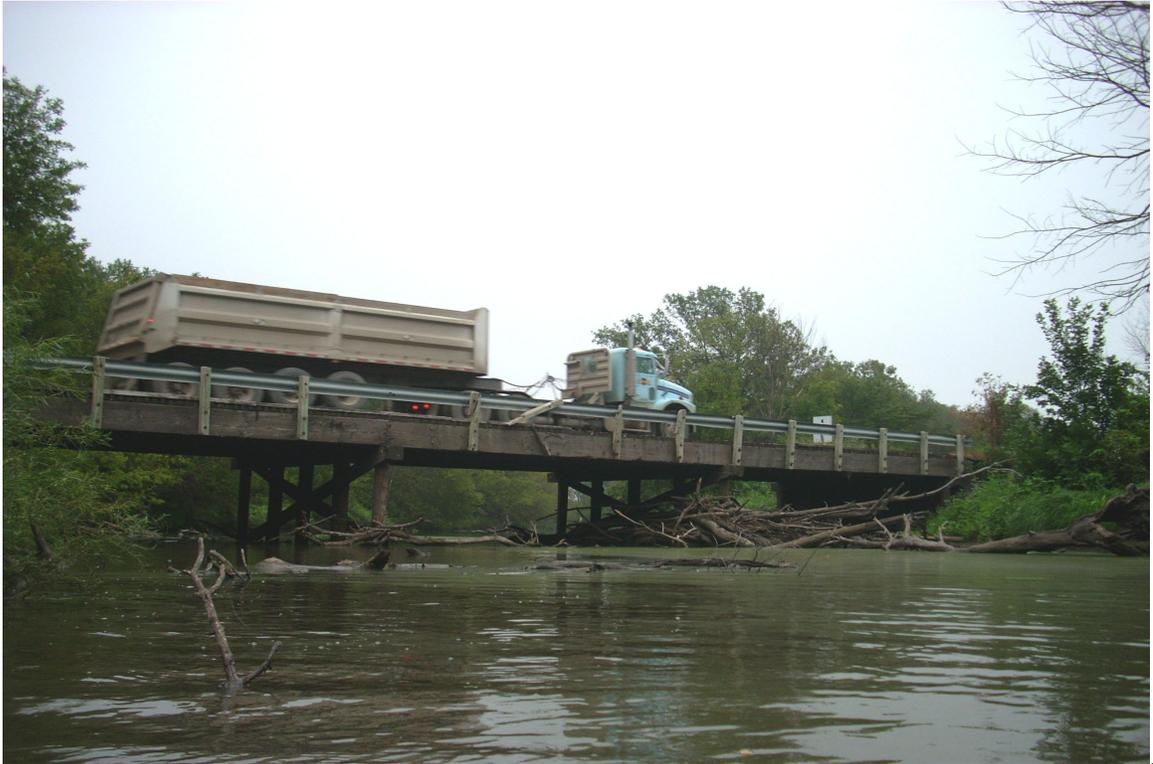
Photograph 1. Overall View of the Structure, Looking North. Note Heavy Timber Debris Accumulation at Pier 2.

- 9 A heavy accumulation of timber debris consisting of 12-inch-diameter and smaller logs and branches was observed along the entire west side and at the upstream nose of Pier 2. The debris extended from the channel bottom to 5 feet above the waterline and up to 10 feet off the west face and 30 feet off the upstream nose.

- (A) Remove the heavy accumulation of timber debris from around the structure to eliminate the potential for continued accumulation, scour influence, and excessive lateral loads on bridge.
- (B) Repair/replace the split timber braces to restore lateral stability to the piers.
- (C) Reinspect the submerged substructure units at the normal maximum recommended (NBIS) interval of five (5) years.

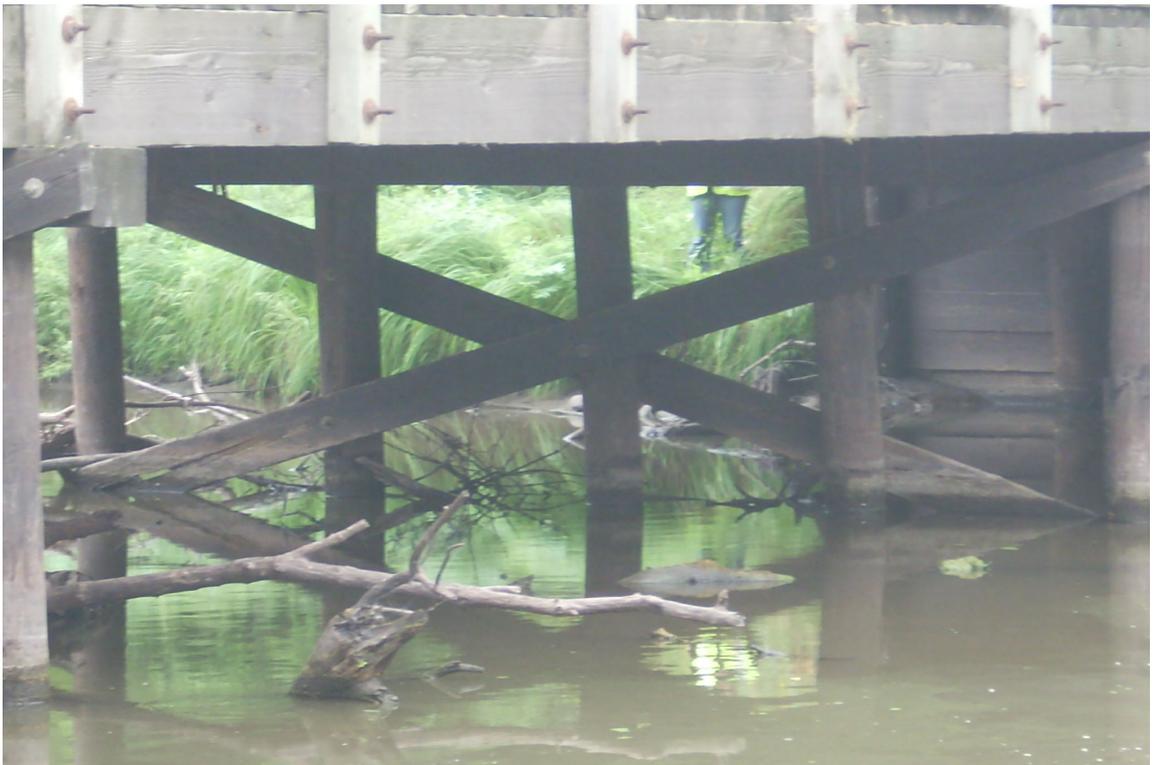
Photograph 2. View of Pier 1, Looking Southwest.

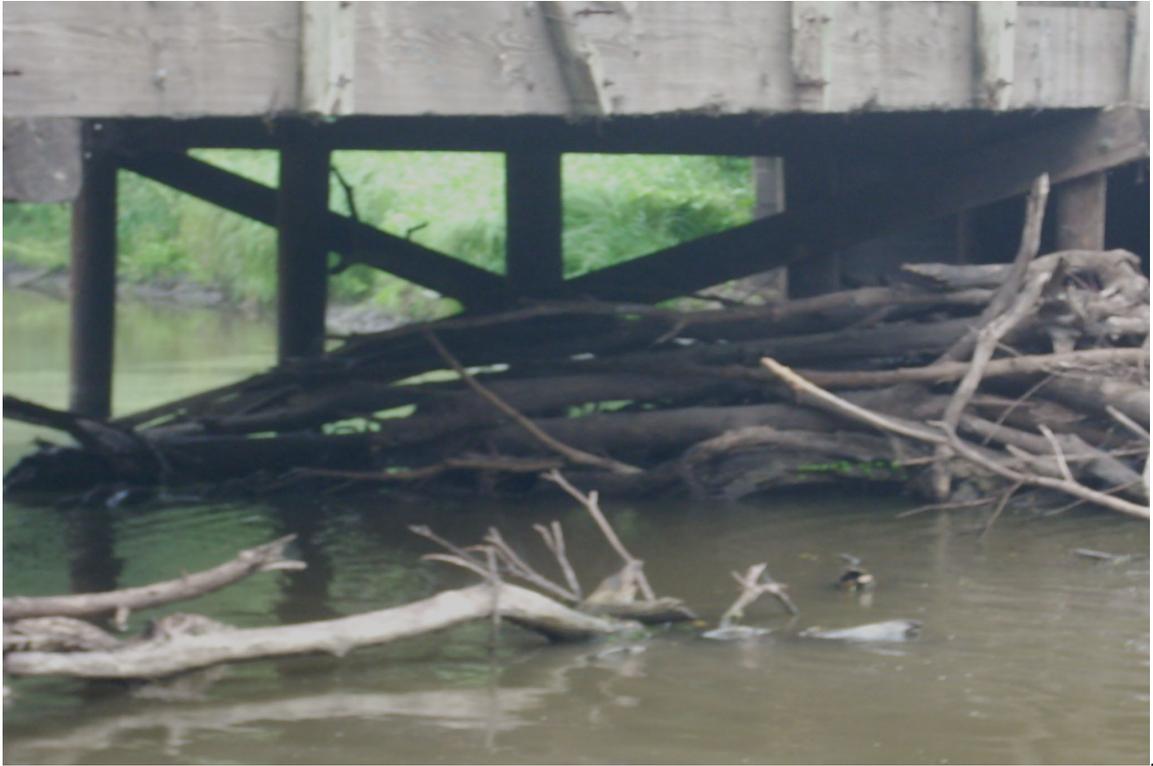
Photograph 3. View of Pier 2, Looking Northeast.

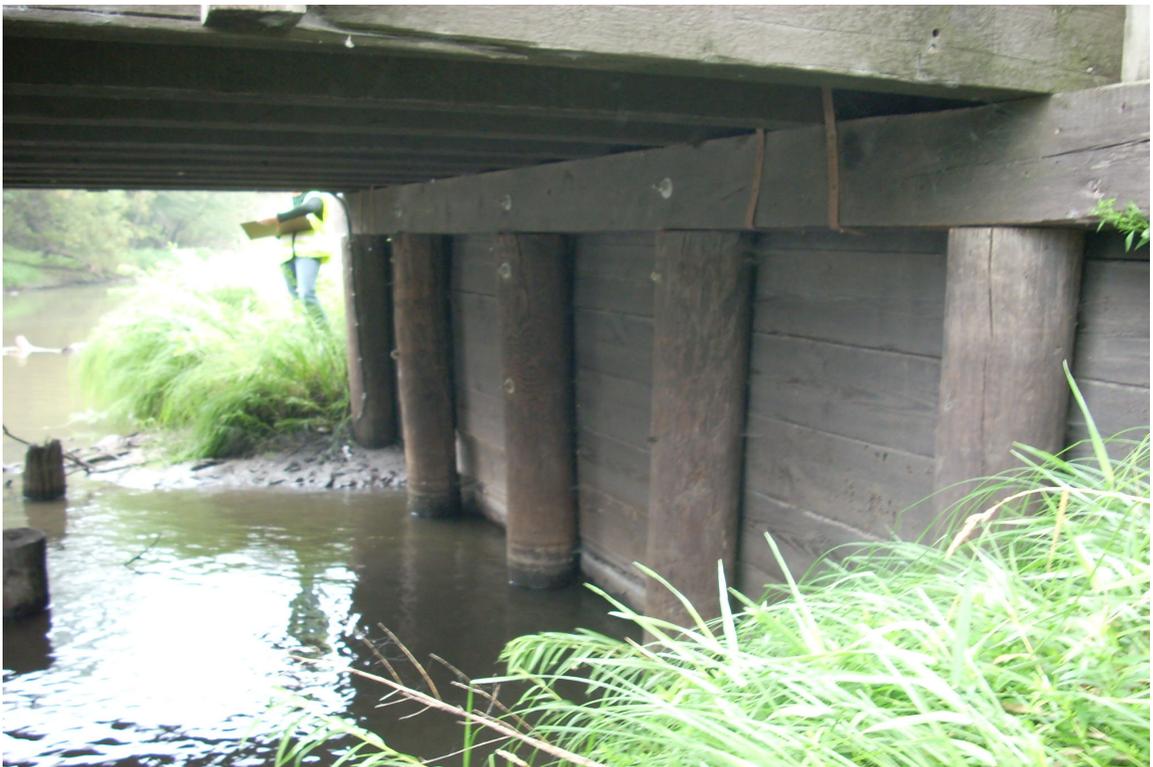
Photograph 4. View of West Abutment, Looking Southwest.

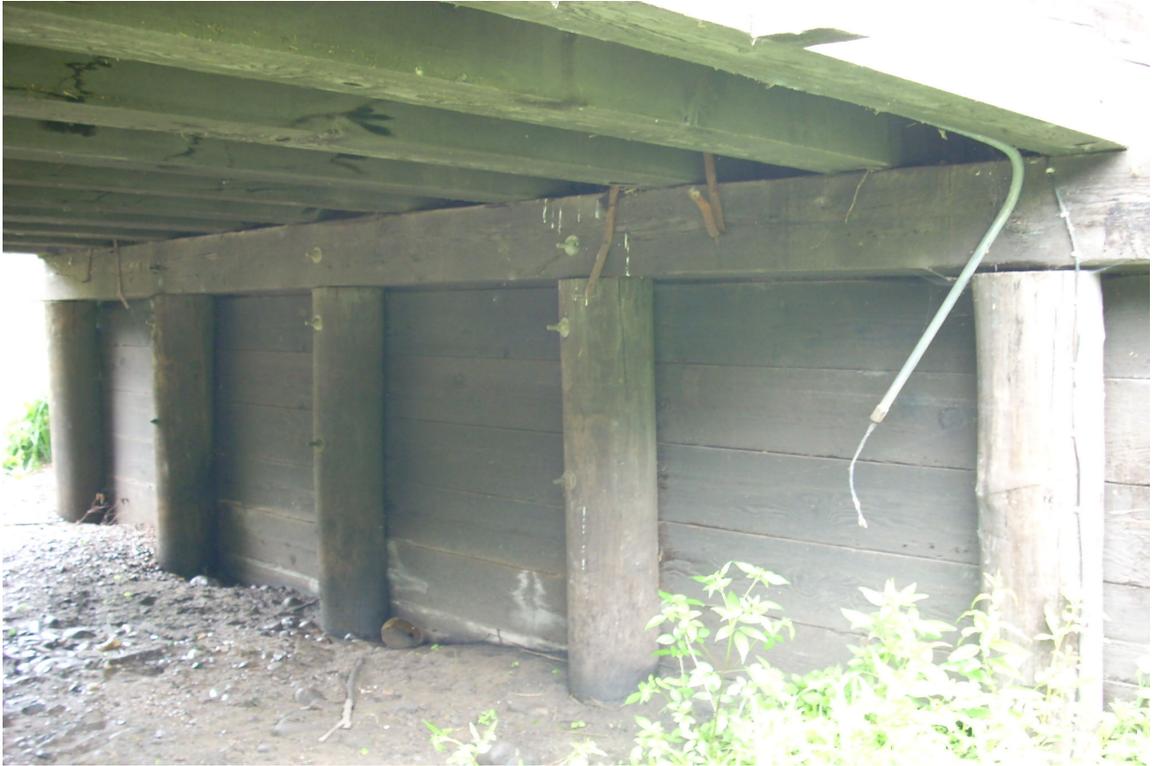
Photograph 5. View of East Abutment, Looking Northeast.

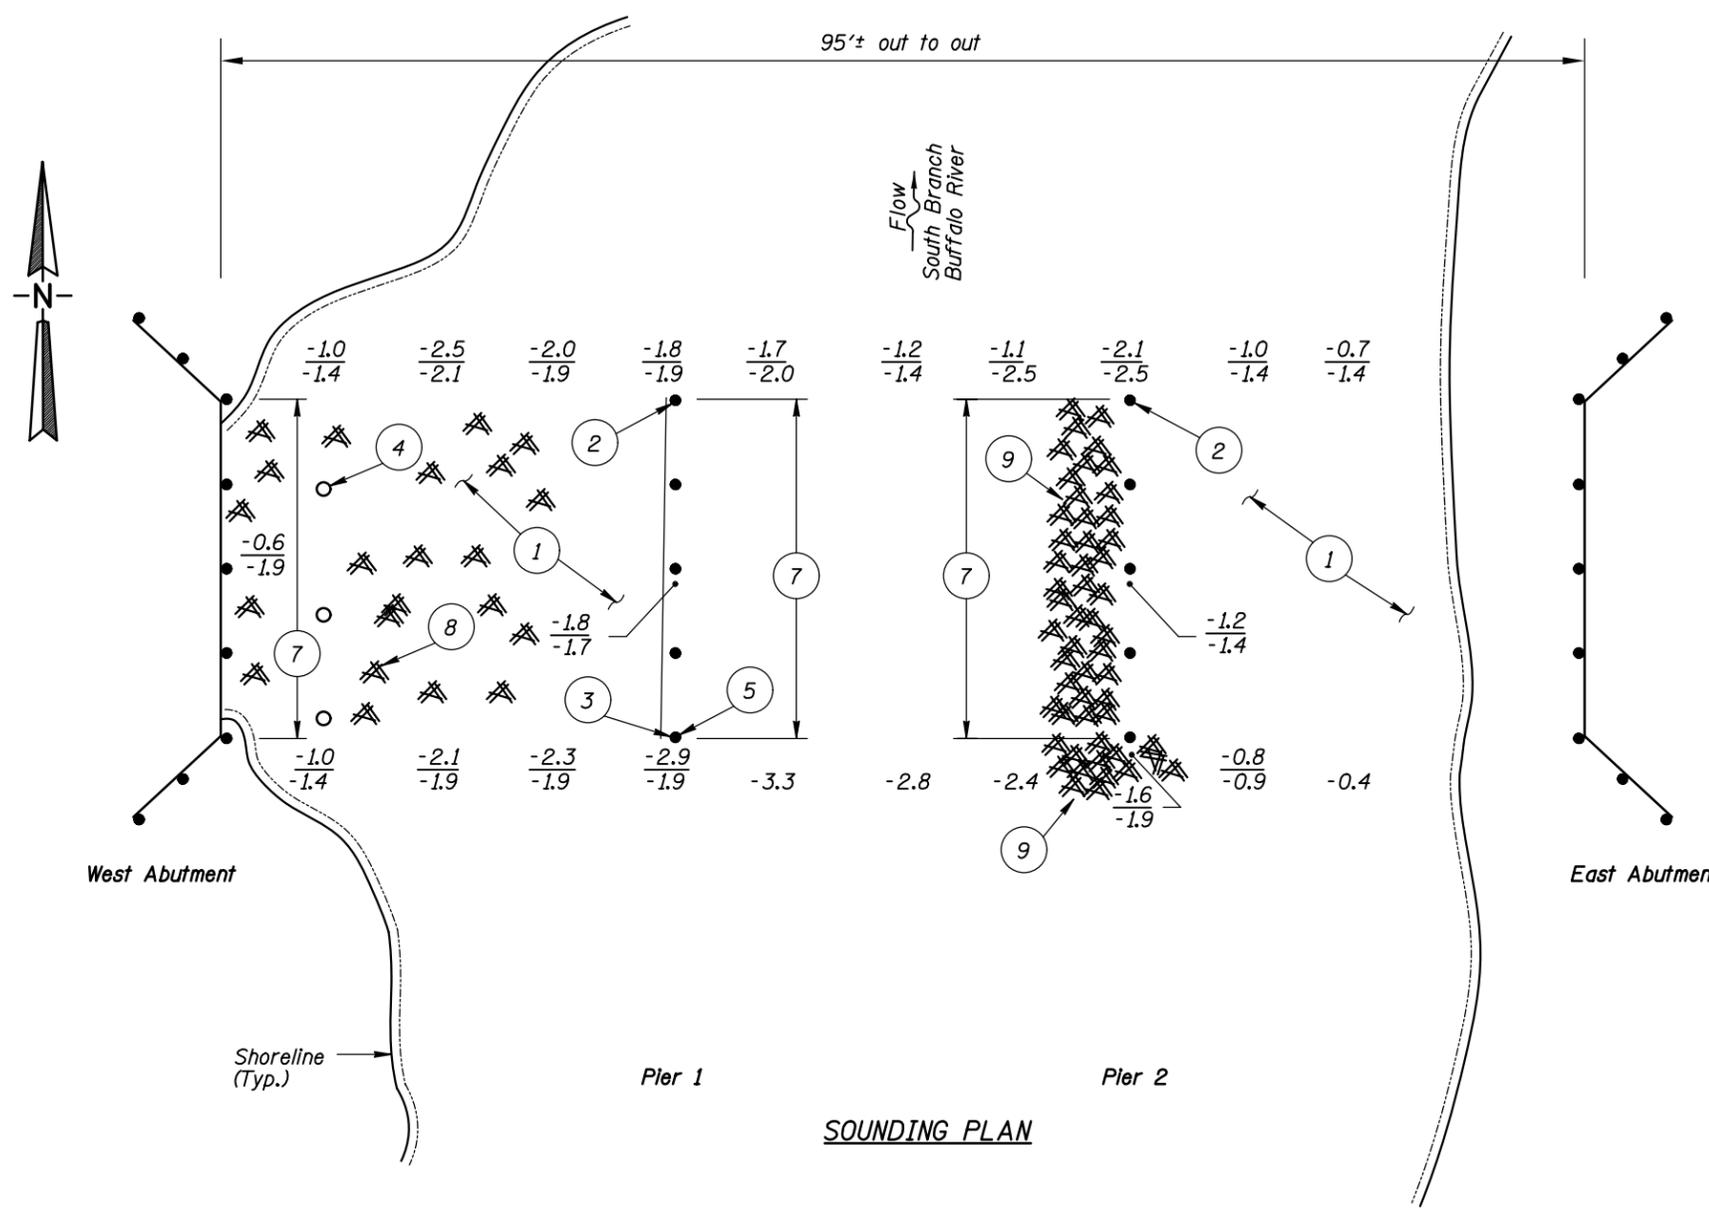
- 1 The channel bottom consisted of silt with up to 1 foot of probe rod penetration.
- 2 The diagonal bracing was split at the connection below the waterline, measuring 2 inches wide at the northernmost 8 feet of the diagonal bracing attached to the west face of Piers 1 and 2.

- 3 The diagonal bracing was split at the pile cap connection, measuring 1 inch wide at the southernmost 4 feet of the diagonal bracing attached to the west face of Pier 1.

- 4 Old cut off piles were observed protruding from the channel bottom up to 2 feet above the waterline (typical).
- 5 The diagonal bracing was split/broken for the southernmost 12 feet of the diagonal bracing attached of the East face of Pier 2.

- 6 The diagonal bracing was split for the southernmost 8 feet of the diagonal bracing attached to the East face of Pier 1.
- 7 All timber elements (piles, cross bracing, caps, and abutment sheeting) exhibited minor to moderate weathering with checks up to 1/2 inch wide and all penetrations 1/4 to 3/4 inch deep. The galvanized connection hardware exhibited only minor surface corrosion.

- 8 A light to moderate accumulation of timber debris consisting of 12-inch-diameter and smaller logs and branches was observed from the West Abutment to 10 feet West of Pier 2 throughout the entire channel under the structure and across the upstream nose of Pier 1. The debris extended from the channel bottom to 1 foot above the waterline.
