UNDERWATER BRIDGE INSPECTION REPORT

STRUCTURE NO. R0156
PEDESTRIAN WALKWAY
OVER THE
PELICAN RIVER (MILL POND)
DISTRICT 4 - OTTER TAIL COUNTY

PREPARED FOR THE
MINNESOTA DEPARTMENT OF TRANSPORTATION
BY
COLLINS ENGINEERS, INC.
JOB NO. 5221 (CEI 14A)

MINNESOTA DEPARTMENT OF TRANSPORTATION
UNDERWATER BRIDGE INSPECTION

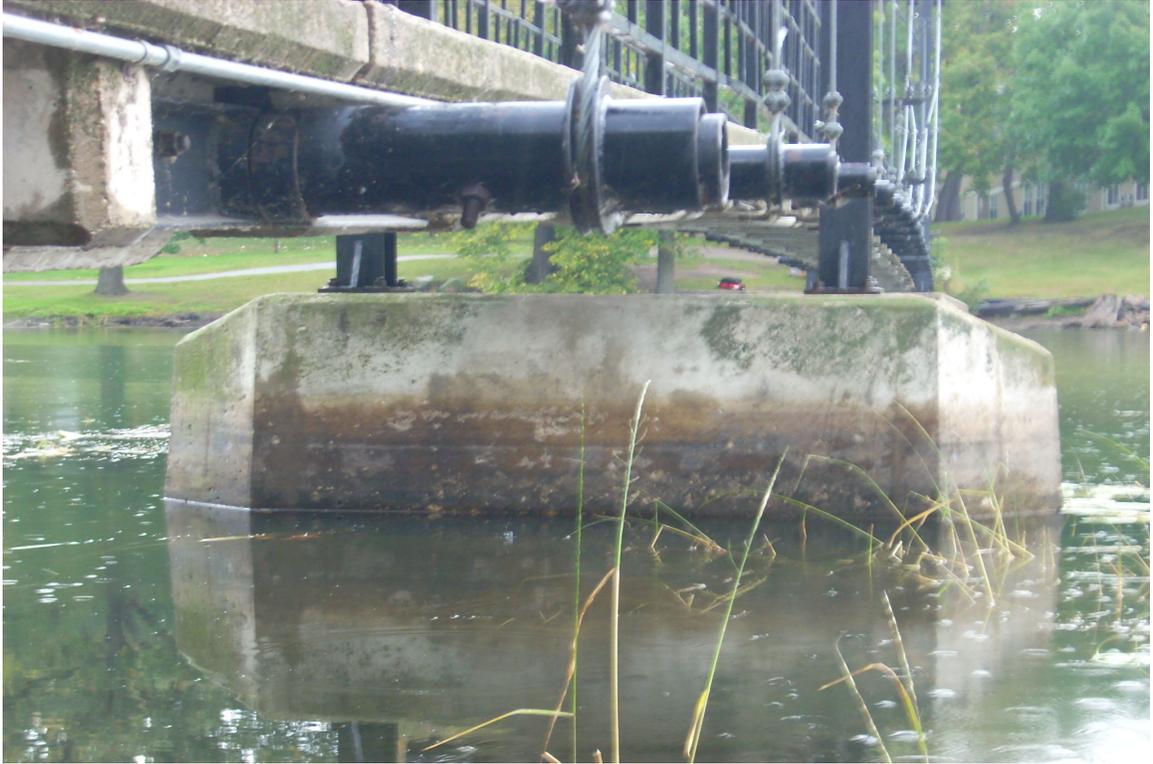
Photograph 1. View of Pier 1, Looking Northeast.

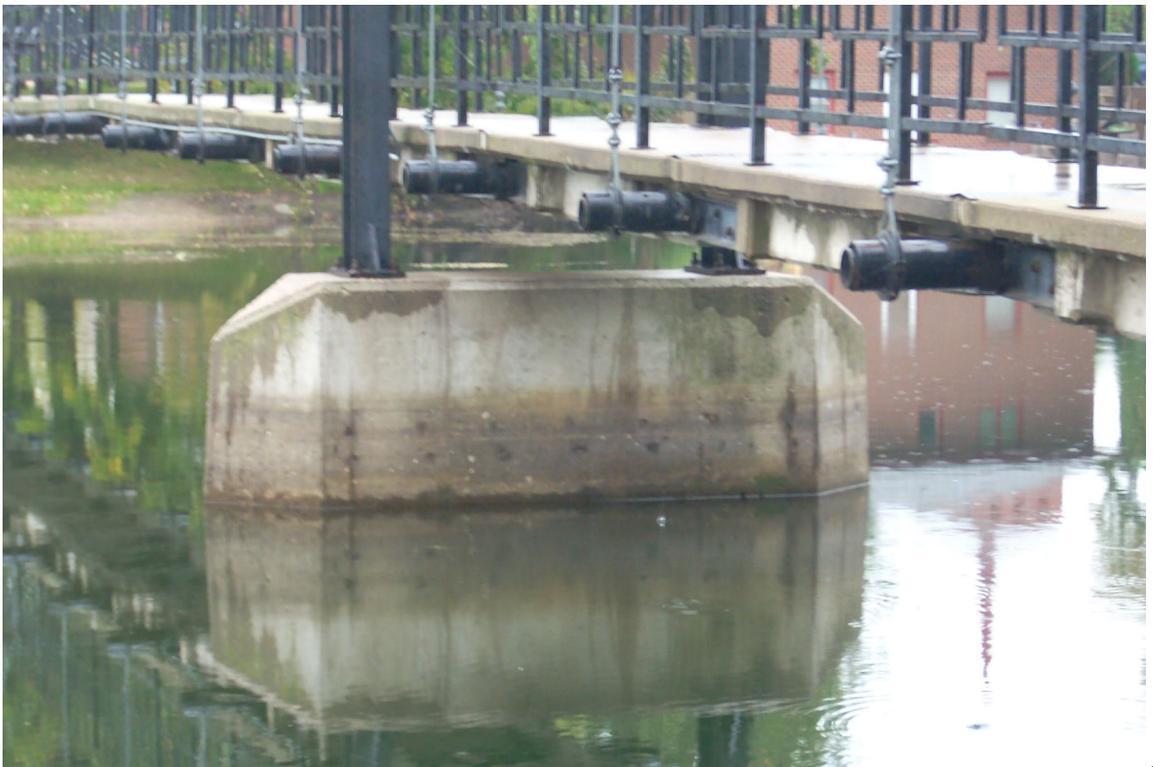
Photograph 2. View of Pier 2, Looking North.

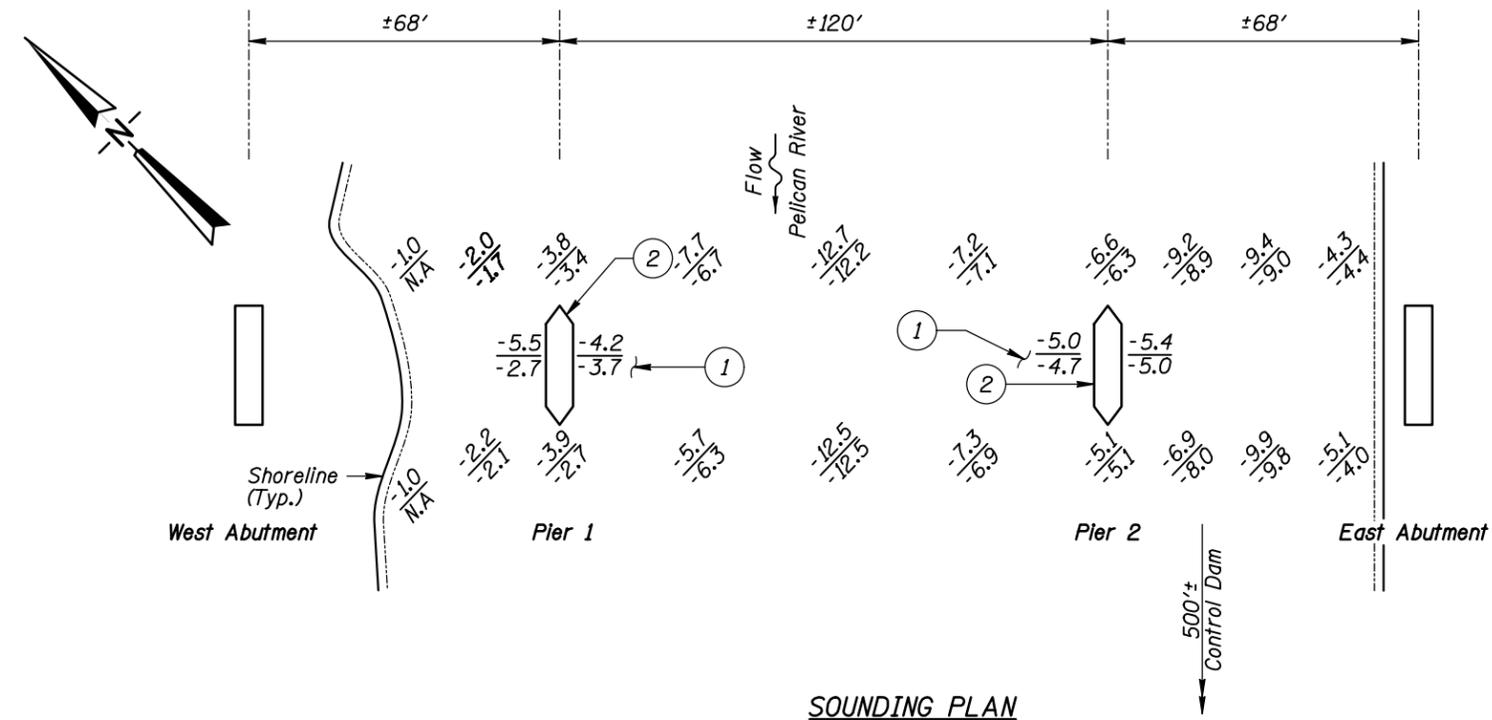
- ① The channel bottom consisted of firm sandy gravel with silt and scattered rocks with up to 2 inches of probe rod penetration.
- ② The concrete of both piers was in good and sound condition and exhibited only random concrete popouts / poor consolidation, up to 1 inch in diameter, on all surfaces.
