UNDERWATER BRIDGE INSPECTION REPORT

STRUCTURE NO. 03503

CSAH NO. 24

JULY 12, 2012

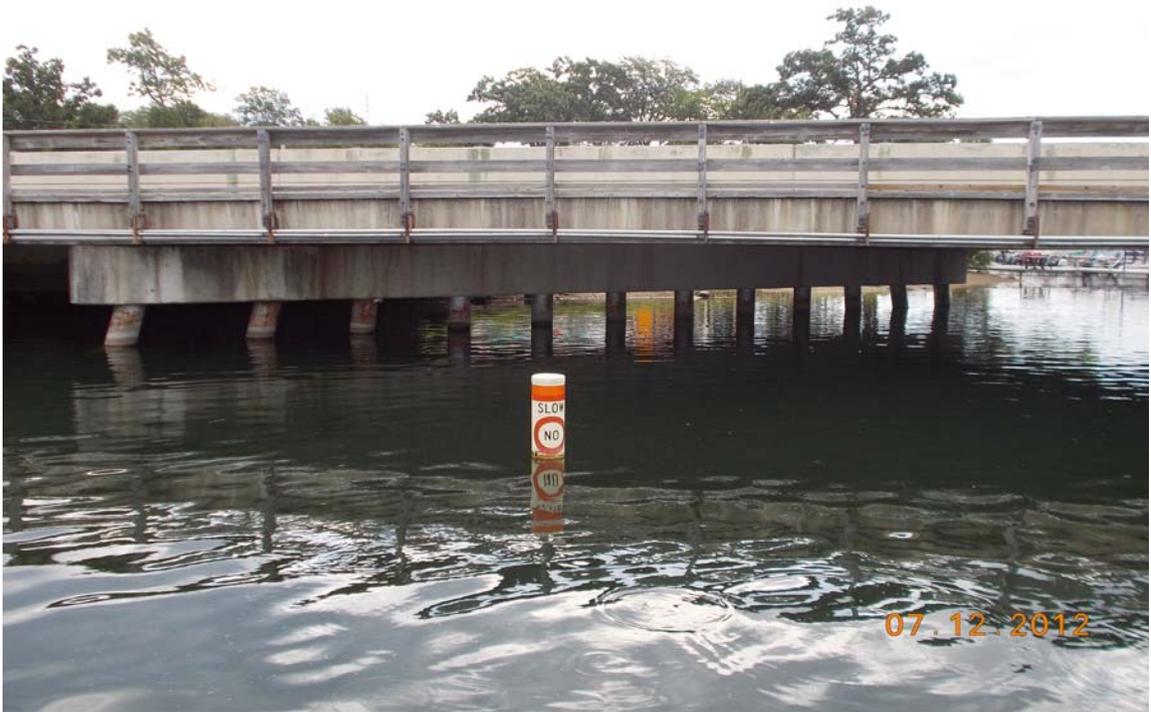
Photograph 1. View of Pier 1, Looking Northeast.

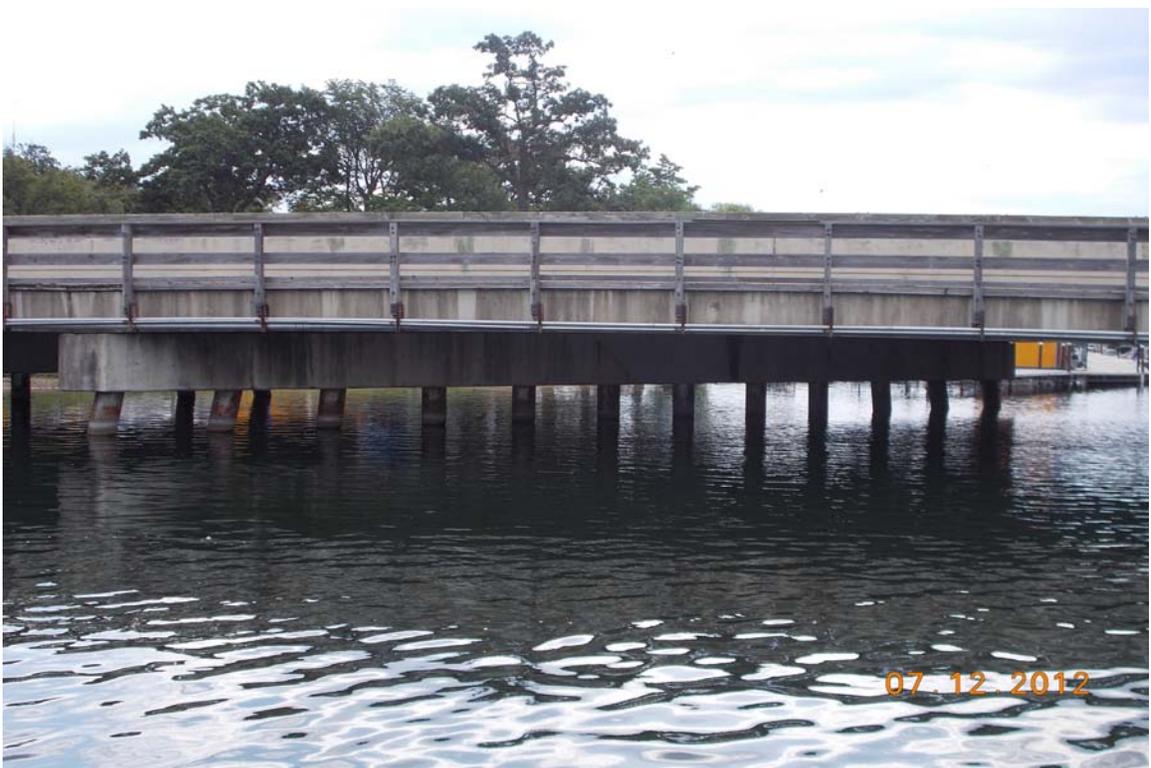
Photograph 2. View of Pier 2, Looking Northeast.

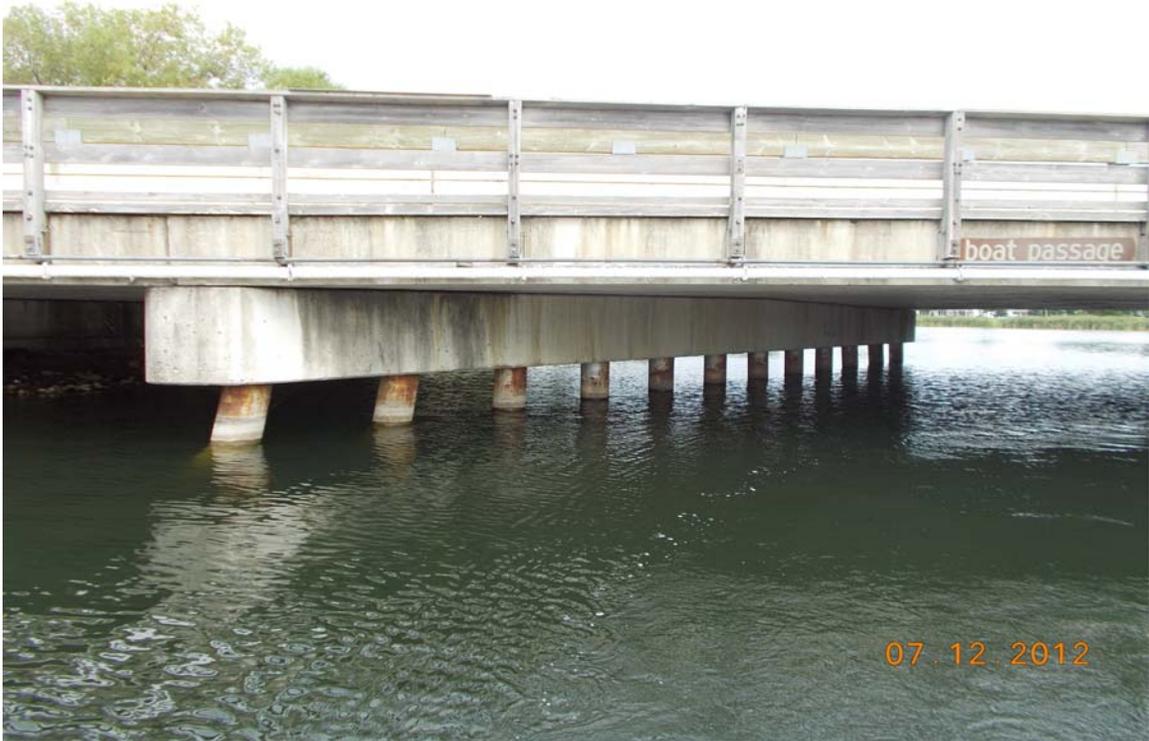
Photograph 3. View of Pier 3, Looking Southwest.

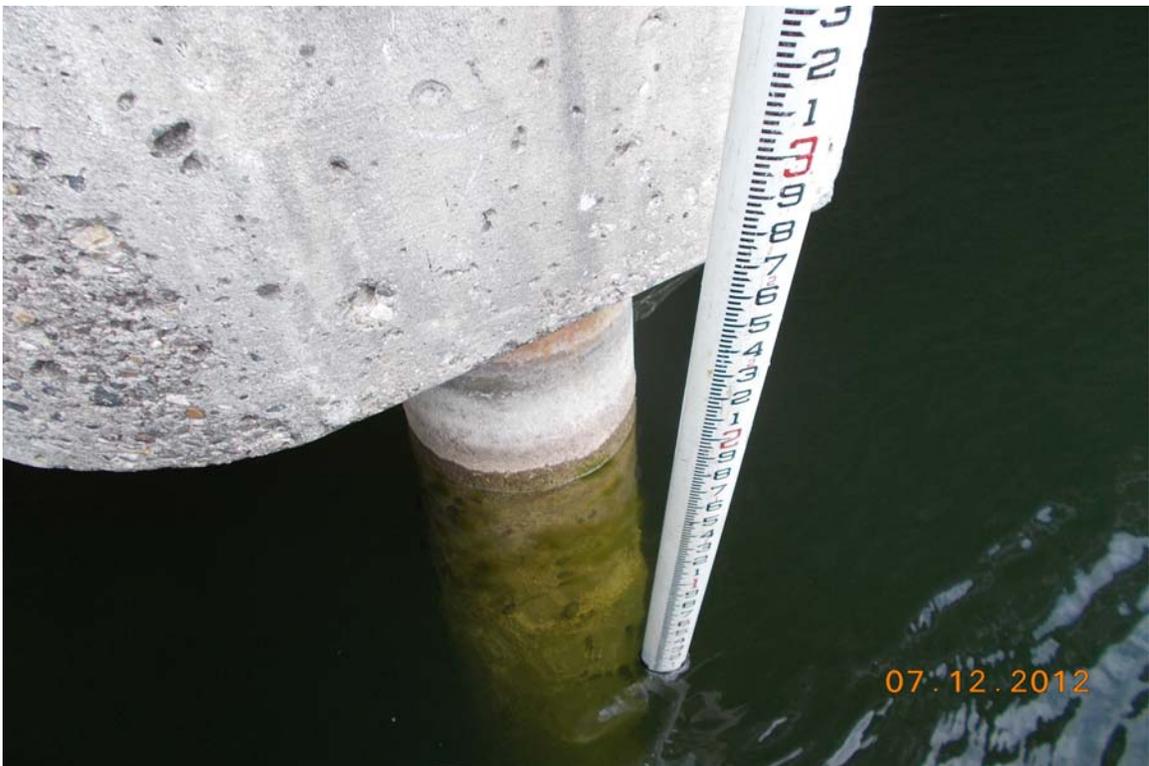
- (A) The protective coating on the cast-in-place steel pipe piles of all piers exhibited signs of initial breakdown from the top of the pile to the channel bottom.
- (B) Random rust nodules, 1/4 inch to 1 inch in diameter, were observed covering over 50 percent of the surface area of the piles from 10 feet below the waterline to the channel bottom, and between 10 to 20 percent of the surface area from the top of the pile to 10 feet below the waterline.
- (C) Timber debris was observed scattered throughout the channel bottom at all of the piers.

Photograph 4. Typical Conditions at Waterline.

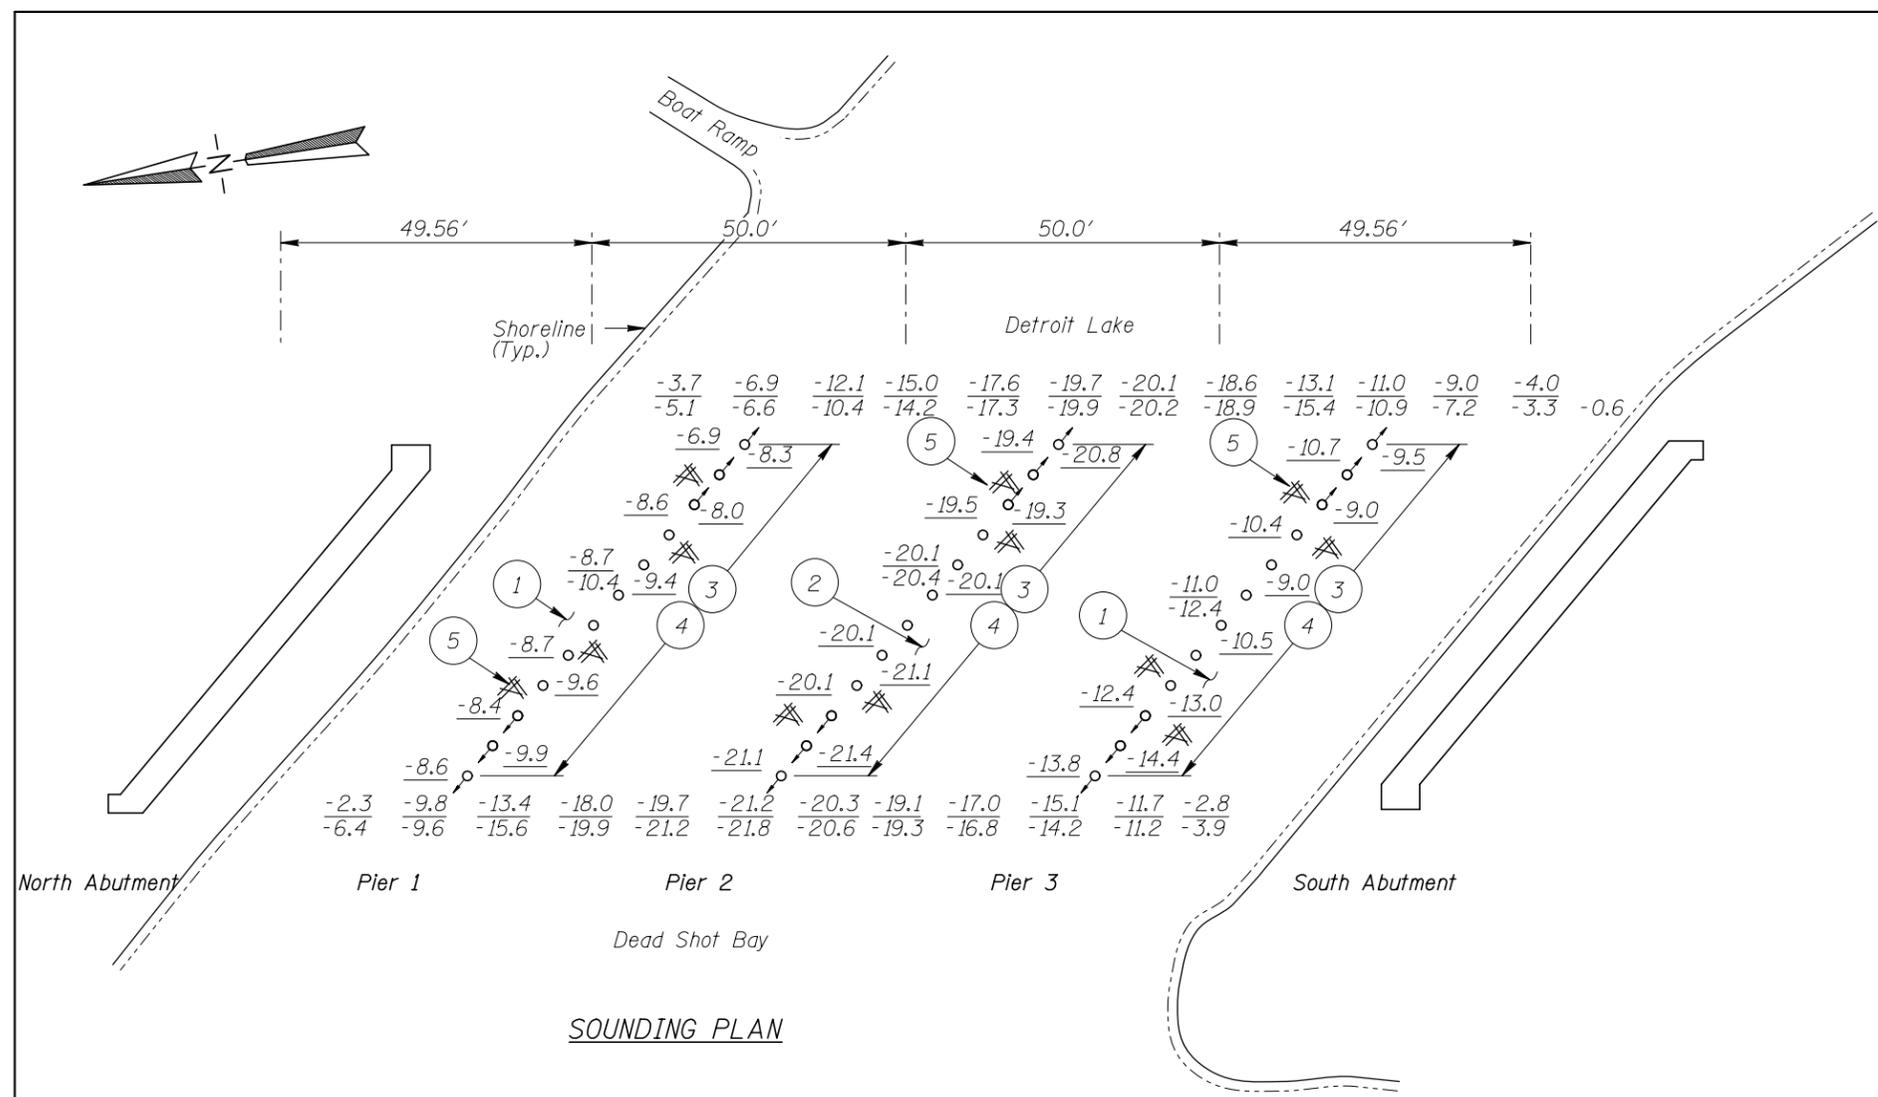
SOUNDING PLAN

- 1 The channel bottom consisted of 6 inch diameter cobbles and sandy silt with up to 1 foot of probe rod penetration.
- 2 The channel bottom consisted of sand with up to 6 inches of probe rod penetration.
- 3 The steel pipe piles had coating failure with light surface corrosion from top of pile to the channel bottom.
- 4 The steel pipe piles had rust nodules, typically 1/4 inch in diameter and up to 1 inch in diameter, over 50 percent of the surface area from 10 feet below the waterline to the channel bottom and over 10 to 20 percent from the top pile to 10 feet below the waterline.
- 5 Timber debris was scattered throughout the piles of all the piers.
