UNDERWATER BRIDGE INSPECTION REPORT

STRUCTURE NO. 14523

RED RIVER OF THE NORTH

MINNESOTA DEPARTMENT OF TRANSPORTATION
UNDERWATER BRIDGE INSPECTION

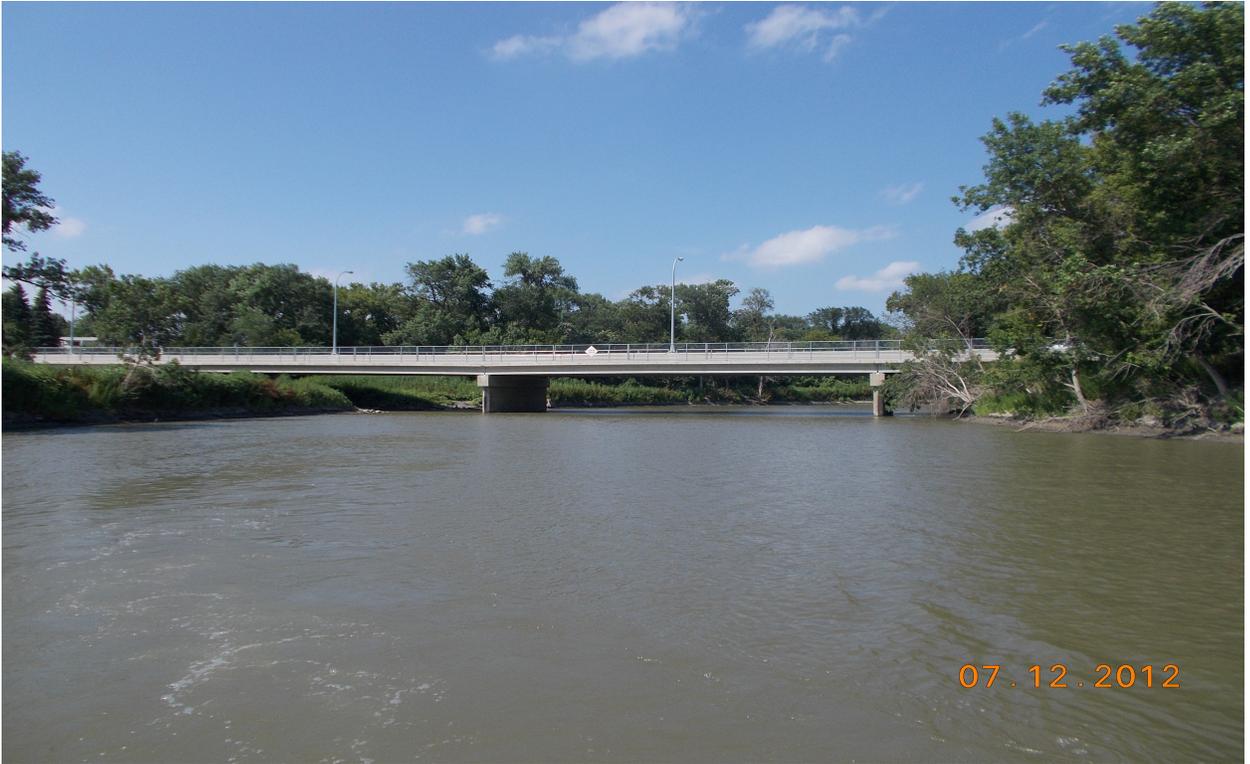
Photograph 1. Overall View of the Structure, Looking North.

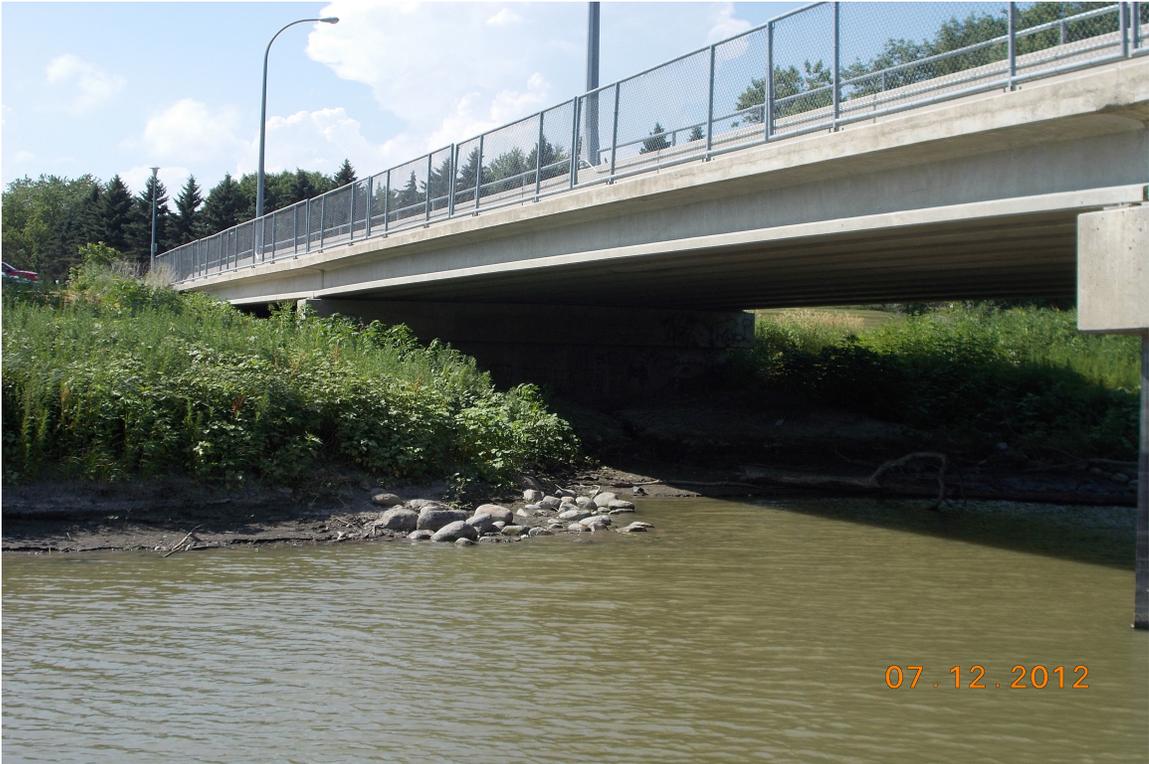
Photograph 2. View of Pier 1, Looking Northwest.

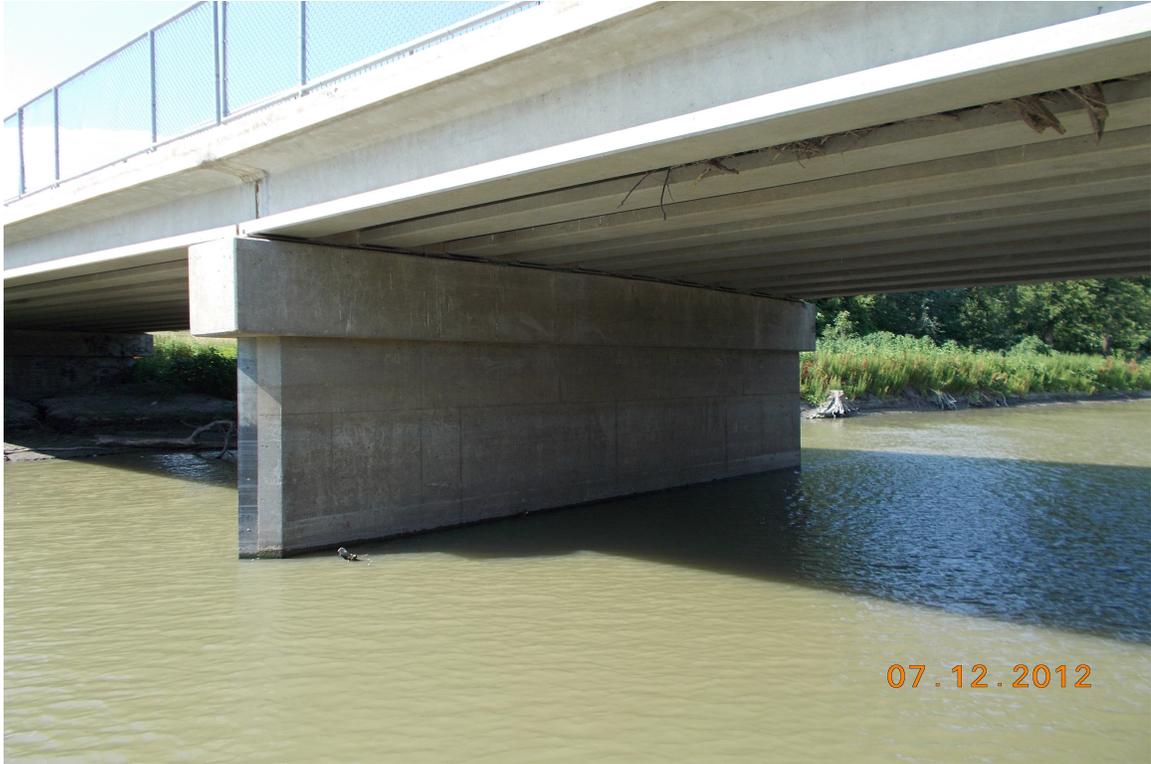
Photograph 3. View of Pier 2, Looking Northwest.

- (A) Remove the timber debris during future maintenance operations.

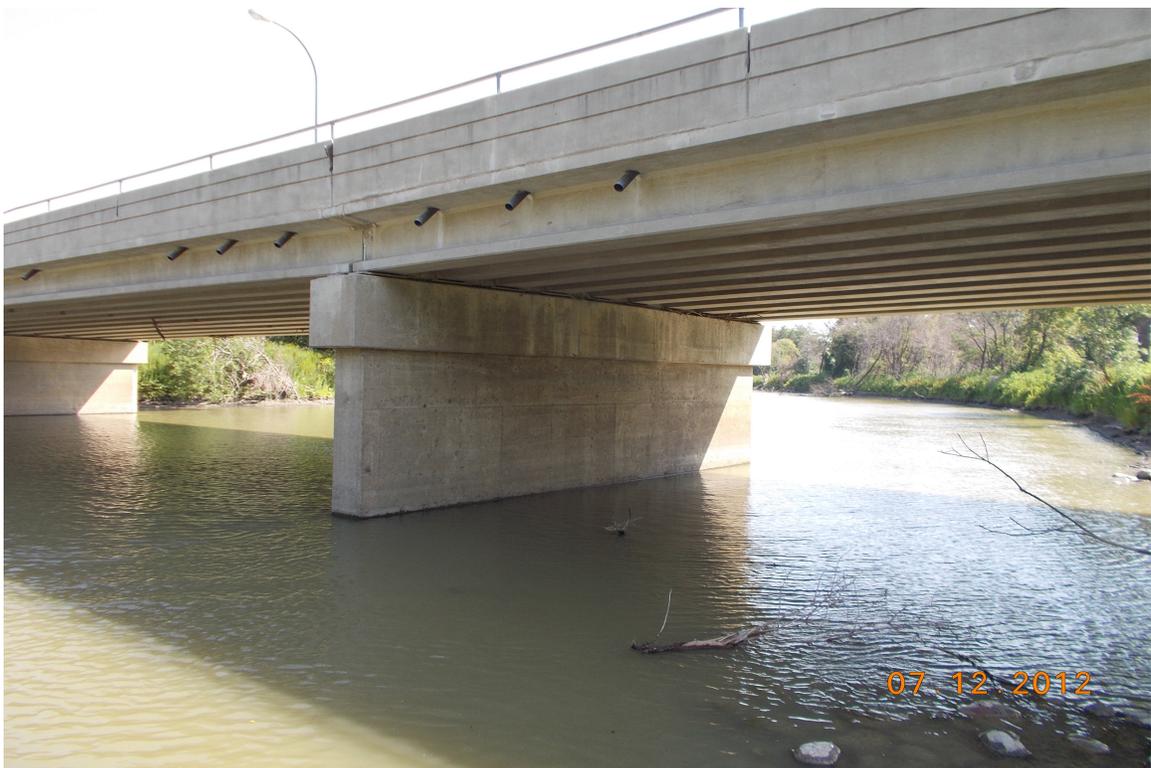
Photograph 4. View of Pier 2, Looking Southeast.

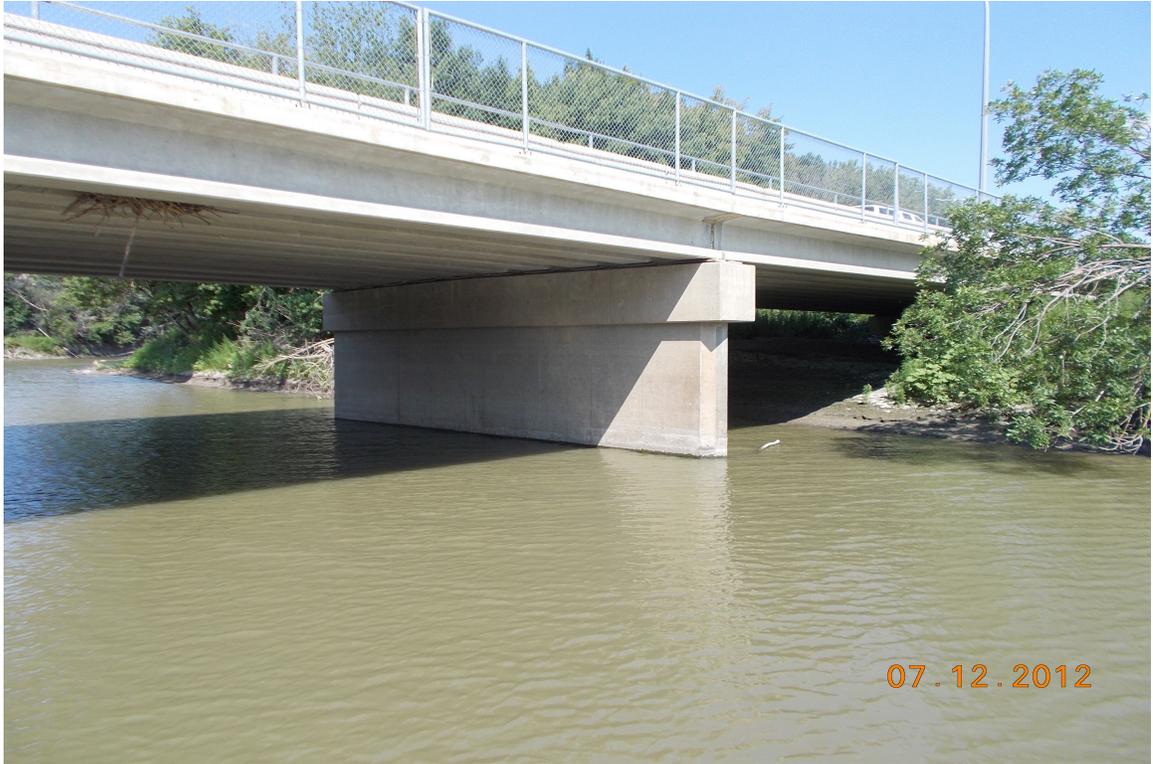
Photograph 5. View of Pier 3, Looking Northeast.

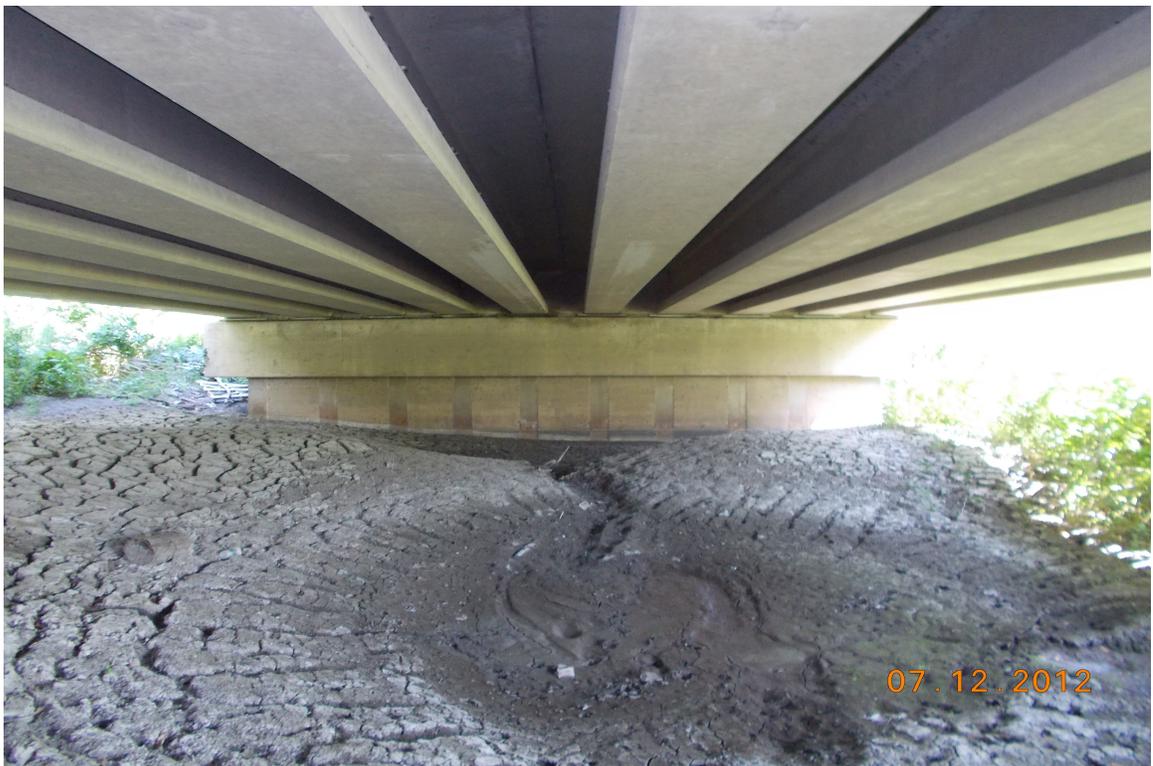
Photograph 6. View of Pier 4, Looking West.

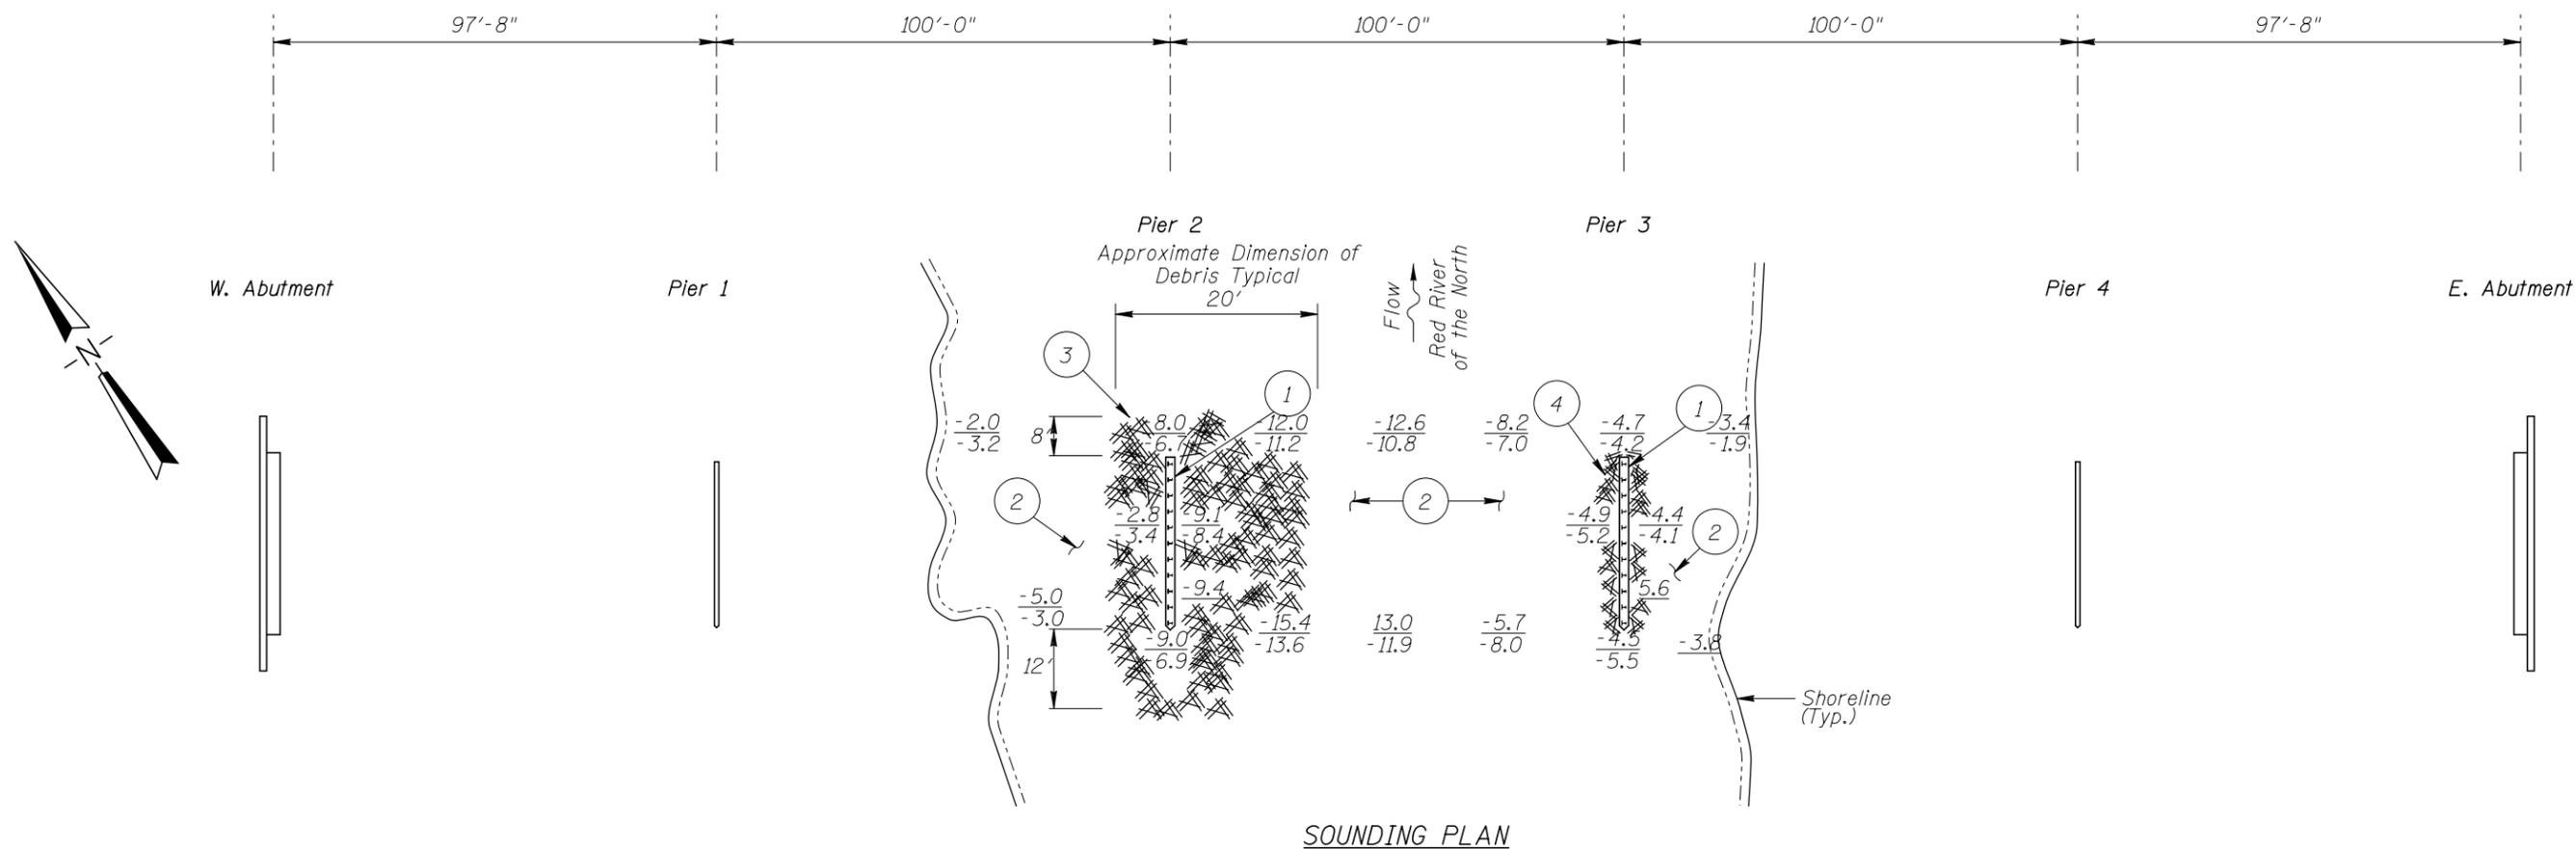
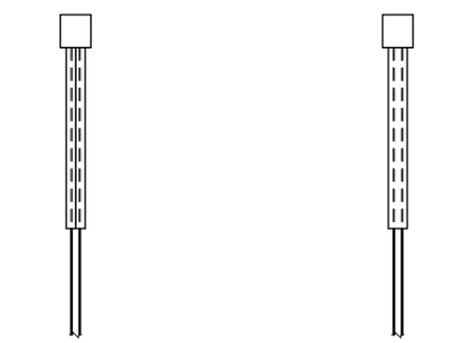
MINNESOTA DEPARTMENT OF TRANSPORTATION UNDERWATER BRIDGE INSPECTION	
STRUCTURE NO. 14523 OVER RED RIVER OF THE NORTH DISTRICT 4, CLAY COUNTY, CITY OF MOORHEAD	
INSPECTION AND SOUNDING PLAN	
Drawn JAC Checked By: BKS Code: 522114523	Date: JULY 2012 Scale: NTS Figure No.: 1

- 1 Overall, the concrete was smooth and sound.
- 2 The channel bottom consisted of soft clay with probe rod penetration up to 1.5 feet and random 12-inch-diameter cobbles.
- 3 A heavy accumulation of timber debris consisting logs and branches was observed around the entire perimeter of Pier 2 extending from stream bed to 6 feet above.
- 4 A light accumulation of timber debris consisting of limbs and branches was observed around the entire perimeter of Pier 3.
