UNDERWATER BRIDGE INSPECTION REPORT

STRUCTURE NO. 14550  
CSAH NO. 19  
OVER THE  
BUFFALO RIVER  
DISTRICT 4 - CLAY COUNTY

SEPTEMBER 21, 2012  
PREPARED FOR THE  
MINNESOTA DEPARTMENT OF TRANSPORTATION  
BY  
AYRES ASSOCIATES & COLLINS ENGINEERS, INC.  
JOB NO. 7423

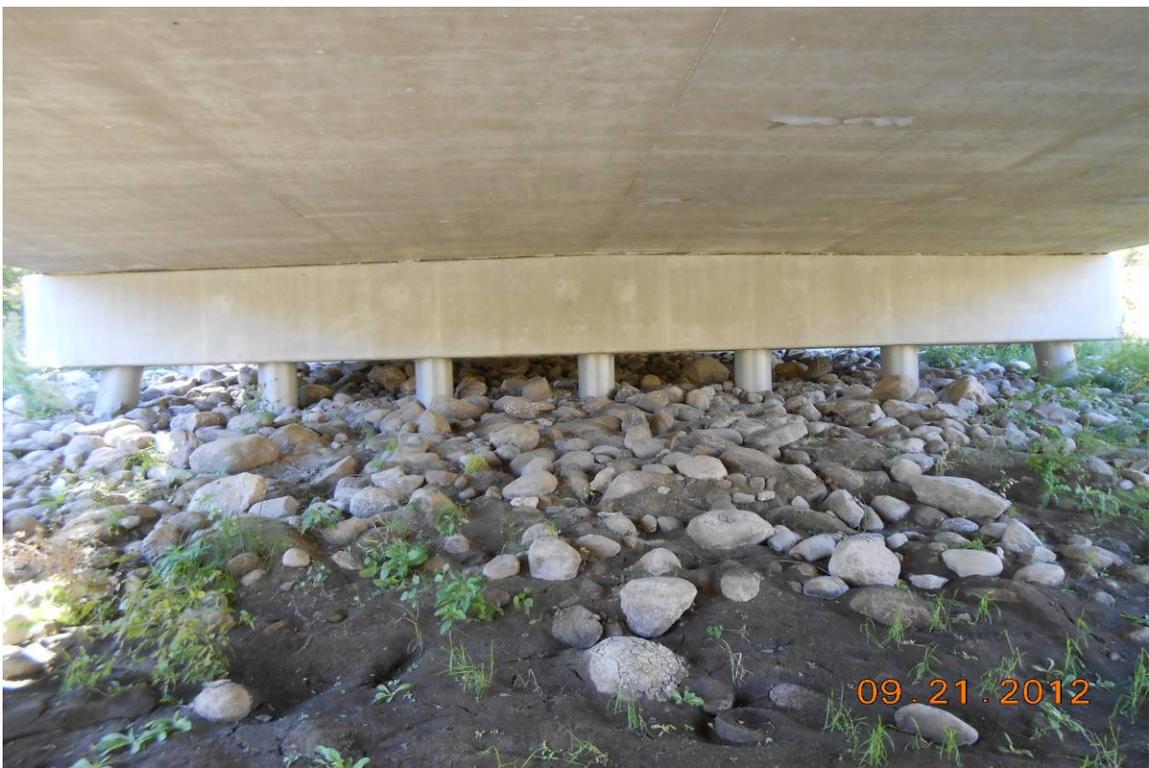
Photograph 2. View of Pier 1, Looking South.

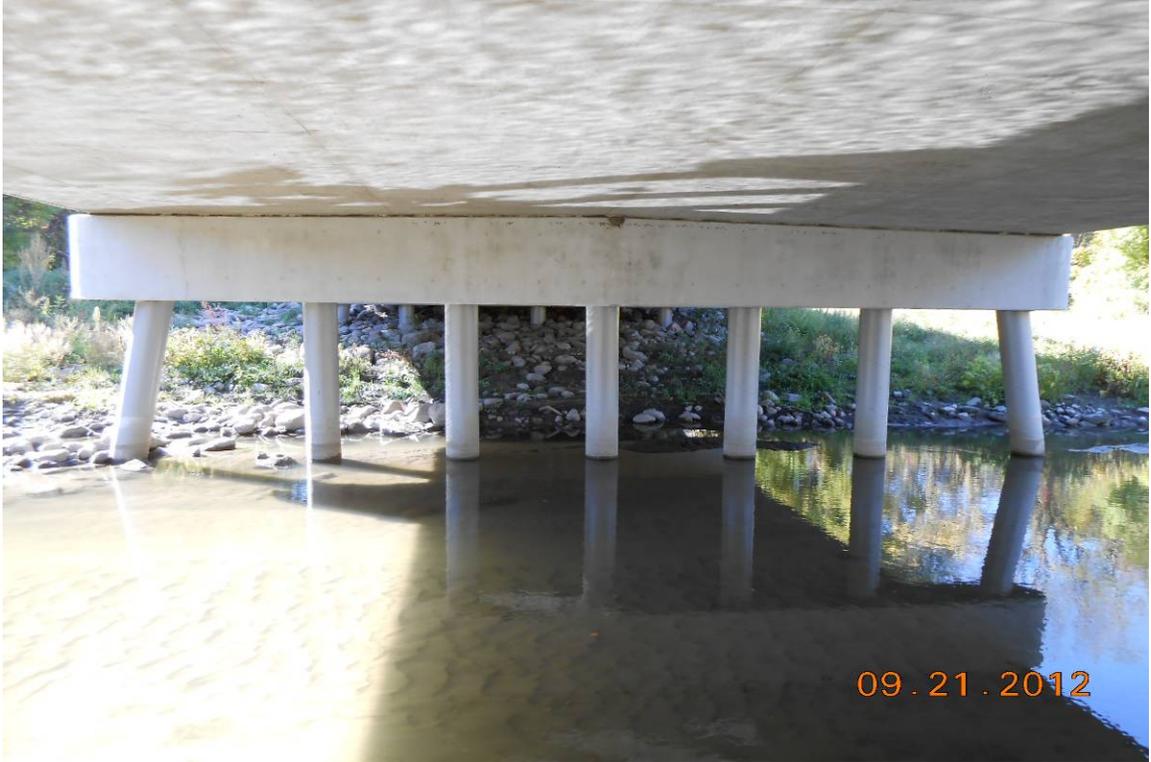
- (B) The cast-in-place piles at Pier 2 were sound and in good condition.

Photograph 3. View of Pier 2, Looking South.

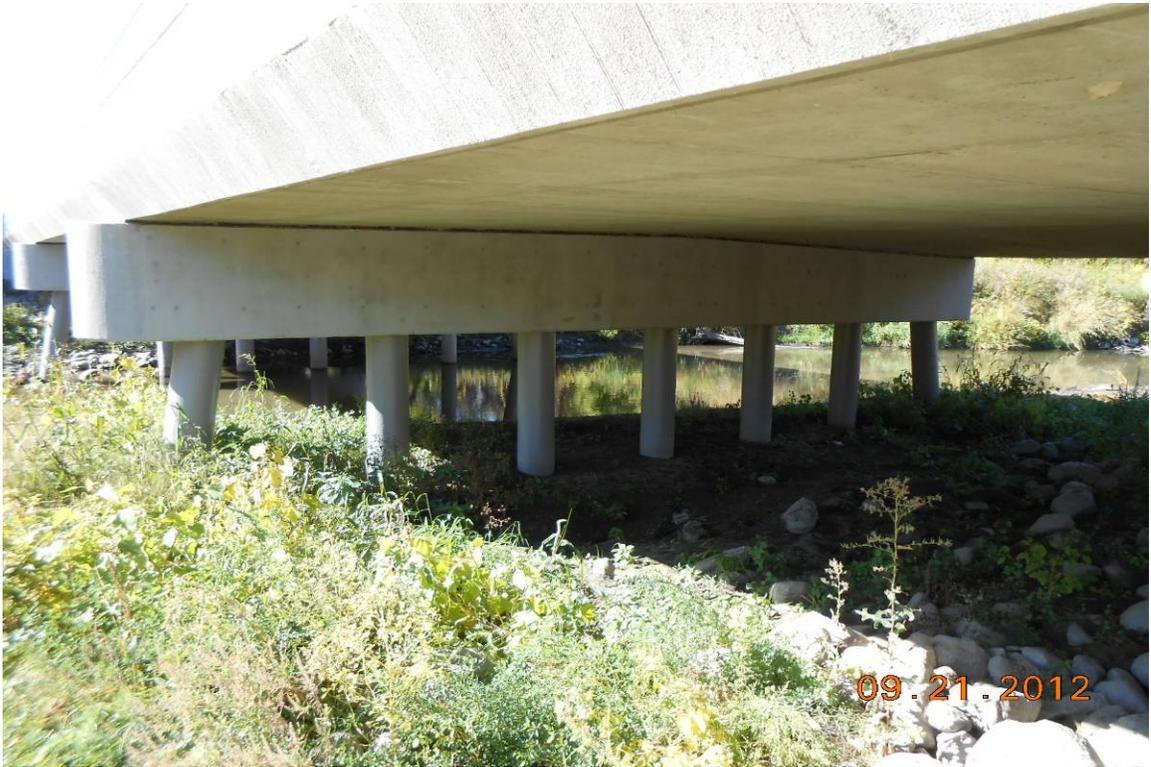
Photograph 4. Pier 3, Looking Southwest.

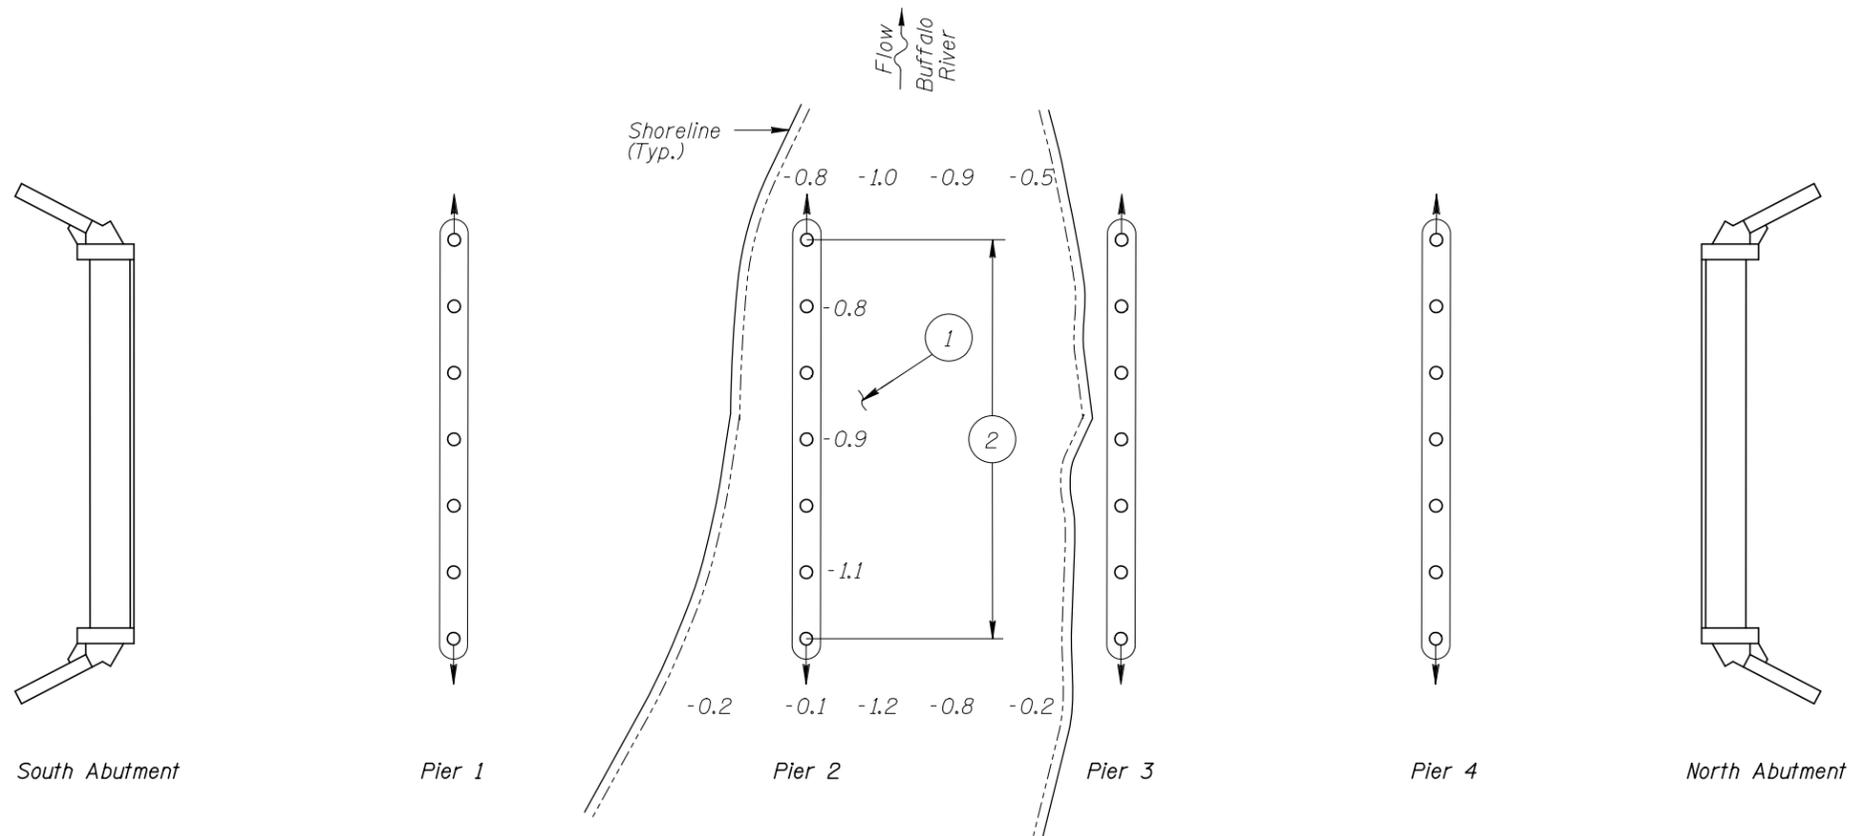
**SOUNDING PLAN**

- ① The channel bottom material consisted of silt with a maximum probe rod penetration of 1.5 feet.
- ② The cast-in-place concrete piles were sound and in good condition.
