UNDERWATER BRIDGE INSPECTION REPORT

STRUCTURE NO. 6646

RED RIVER OF THE NORTH

AUGUST 31, 2012

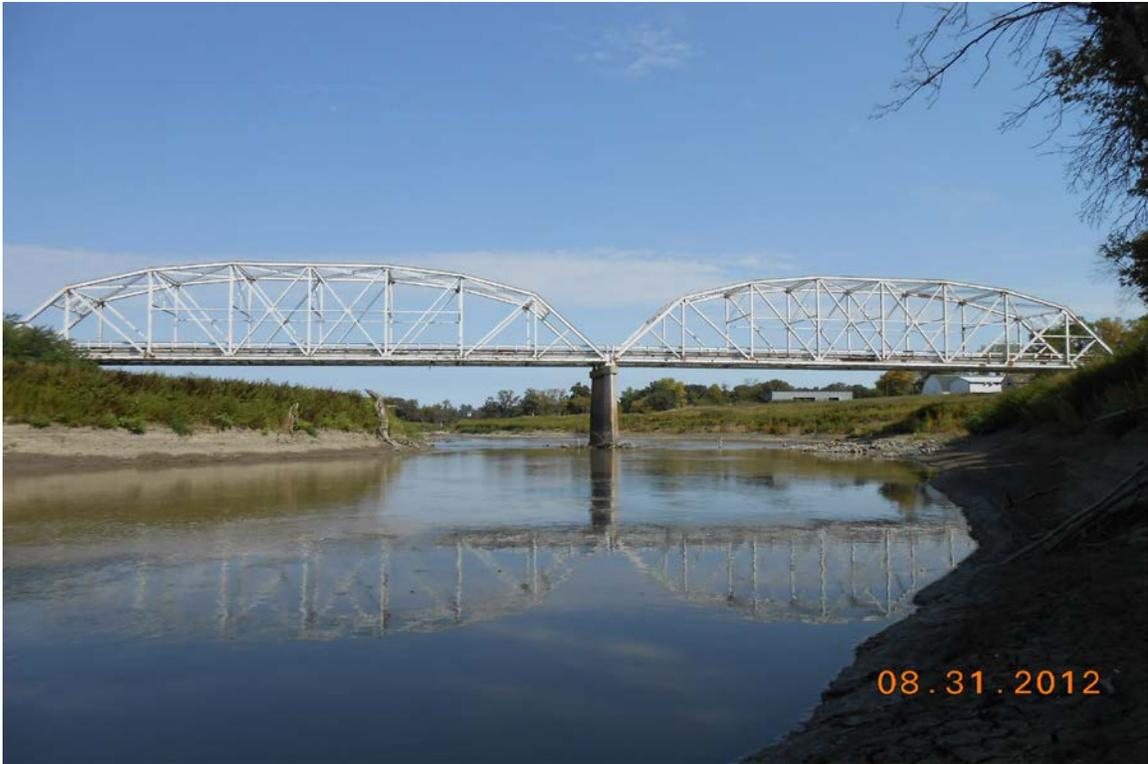
Photograph 1. Overall View of the Structure, Looking North.

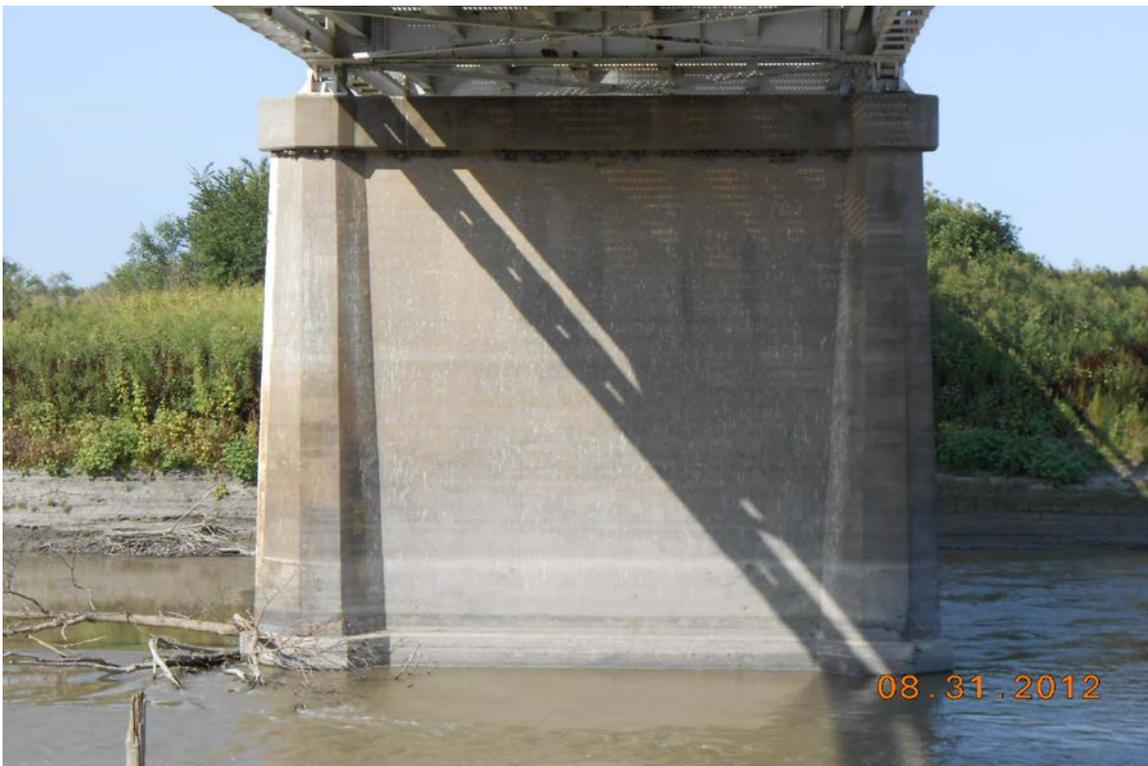
- (A) A heavy accumulation of timber debris, consisting of 18 inch diameter and smaller logs and branches, was observed at the upstream nose and along both sides of Pier 1. The debris extended from the channel bottom to the waterline, 6 feet off the nose, and up to 15 feet off the faces.

Photograph 2. View of Pier 1, Looking West.

Monitor the moderate accumulation of timber debris at the upstream end and along the sides of Pier 1, and if found to be progressing, removal operations may be warranted to alleviate further accumulations and scour problems.

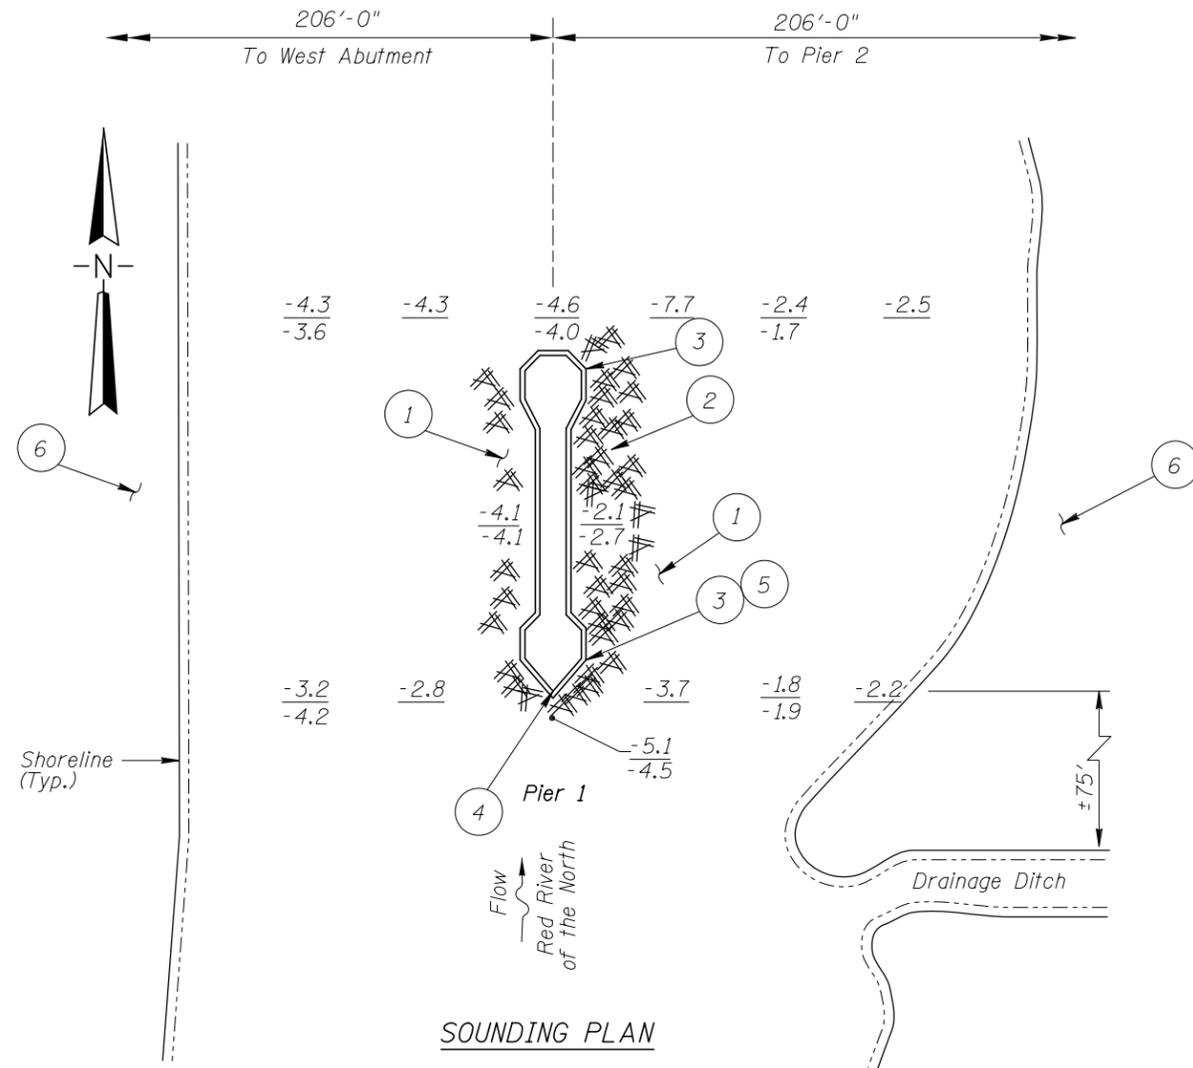
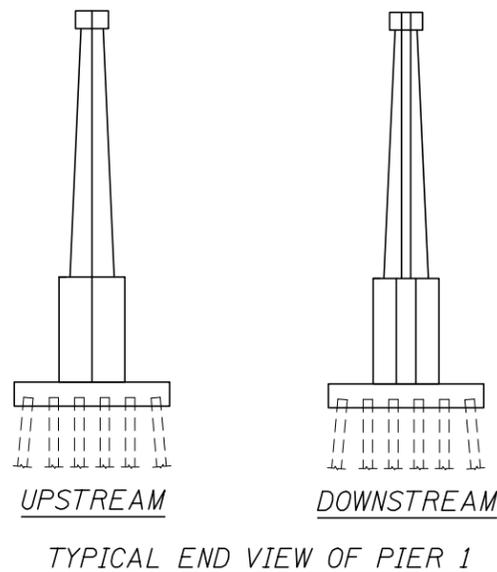
INSPECTION AND SOUNDING PLAN

- 1 The channel bottom around the entire perimeter of Pier 1 consisted of gravel with 2 inch diameter cobbles allowing up to 3 inches of probe rod penetration. In addition, an 18 inch thick layer of soft silty clay was observed on top of the channel bottom along the entire east face.

- 2 A heavy accumulation of timber debris, consisting of 18 inch diameter and smaller logs and branches, was observed at the upstream nose and along both faces of Pier 1. The debris extended from channel bottom to waterline, 6 feet off the nose and up to 15 feet off the faces.

- 3 4 feet long by 2 feet high areas of section loss and impending section loss were observed at the northeast and southeast corners of Pier 1 centered on the shaft step located 2.0 feet above waterline. The section loss had up to 8 inches maximum penetration and exposed reinforcing steel with up to 5% loss of section.

- 4 The steel icebreaker angle had 1/2-inch-diameter rust nodules with moderate pitting up to 1/4 inch deep from 1 foot below waterline to 1.5 foot above waterline.

- 5 14 inch by 6 inch by 2.5 inches deep spall was observed at the southeast corner of Pier 1, 3 feet below shaft step. No exposed reinforcement.
- 6 Both embankments had erosion in the vicinity of the structure.
