UNDERWATER BRIDGE INSPECTION REPORT

STRUCTURE NO. 75501
COUNTY STATE AID HIGHWAY 10
OVER THE
POMME DE TERRE RIVER
DISTRICT 4 – STEVENS COUNTY

SEPTEMBER 24, 2012

AYRES ASSOCIATES & COLLINS ENGINEERS, INC.

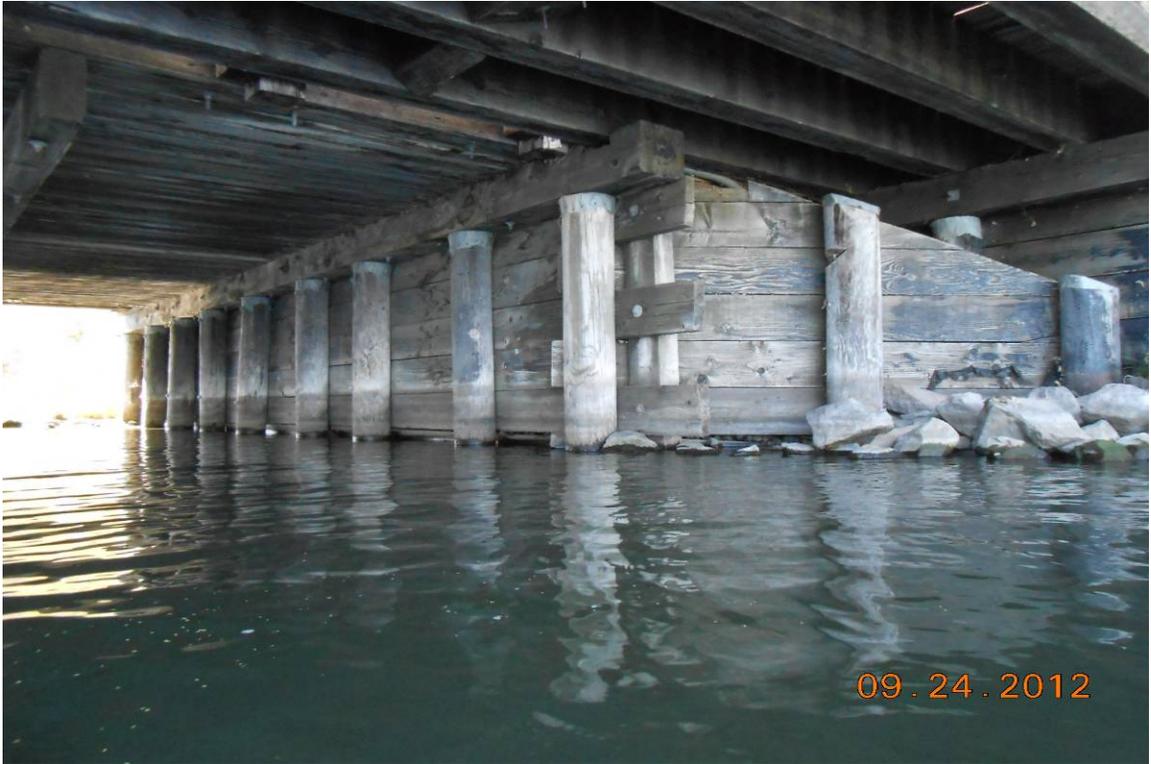
Photograph 1. View of the West Abutment, Looking Southwest.

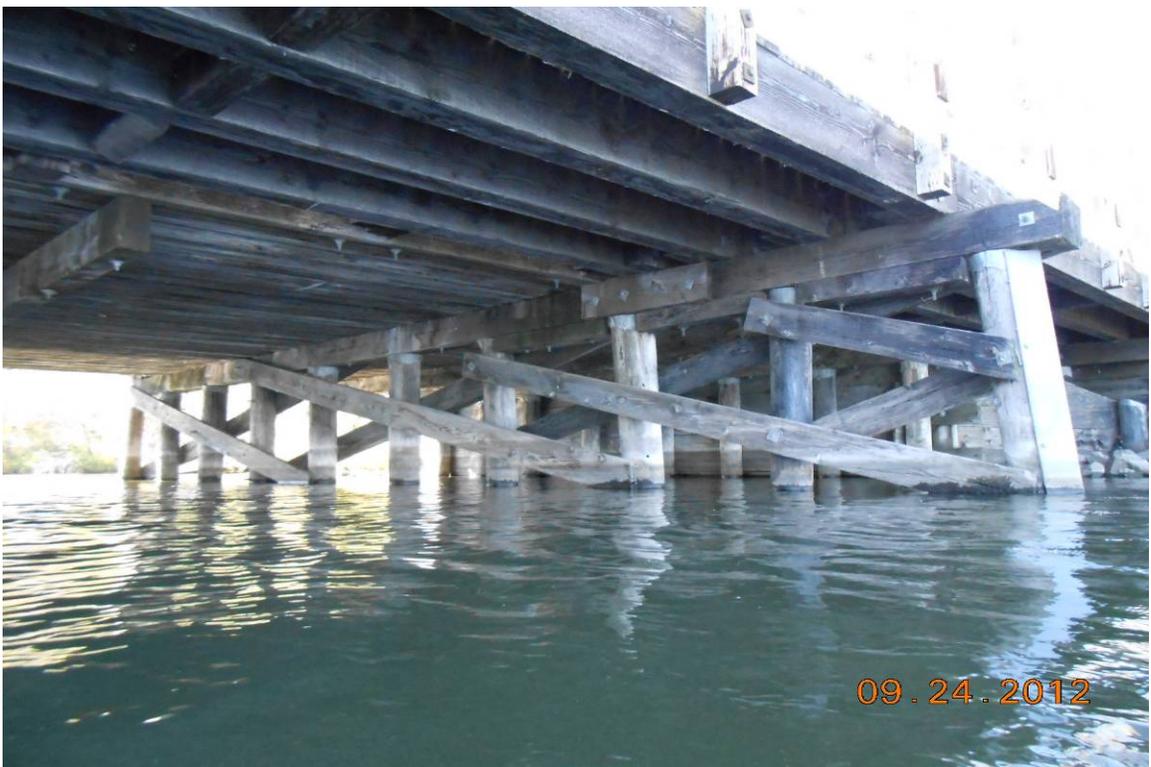
Photograph 2. View of Pier 1, Looking Southwest.

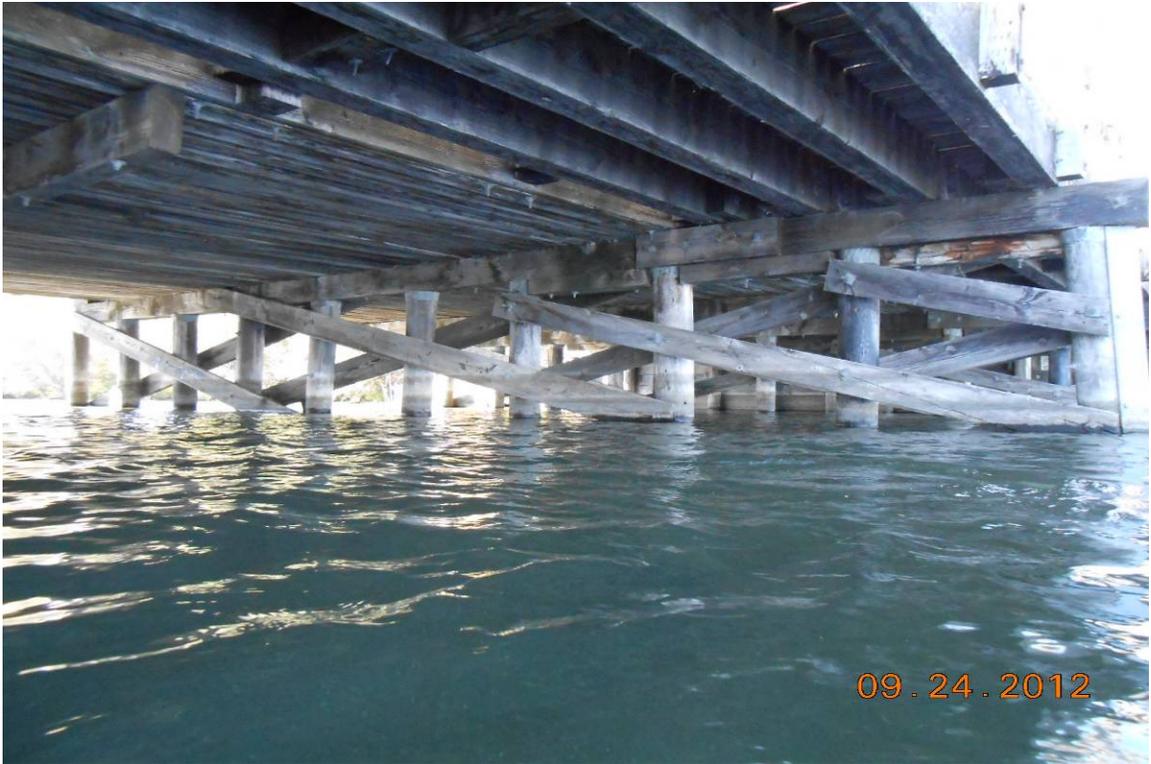
Photograph 3. View of Pier 2, Looking Southwest.

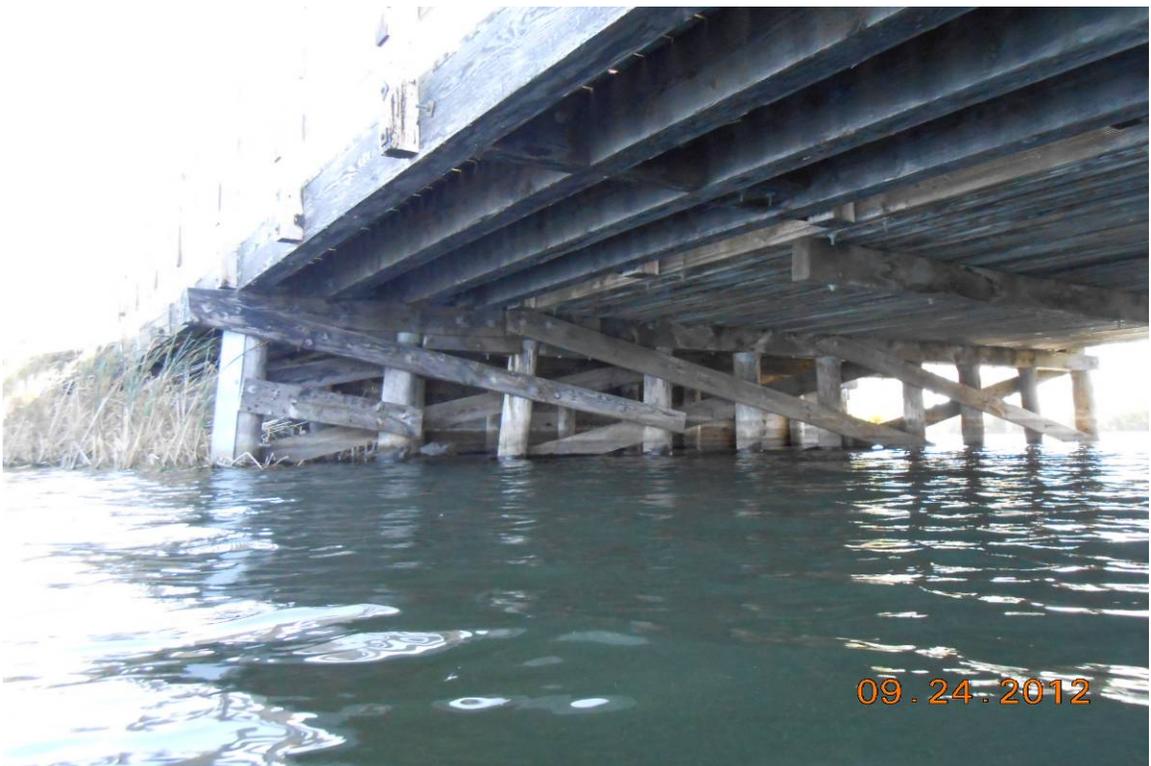
Photograph 4. View of Pier 3, Looking Southeast.

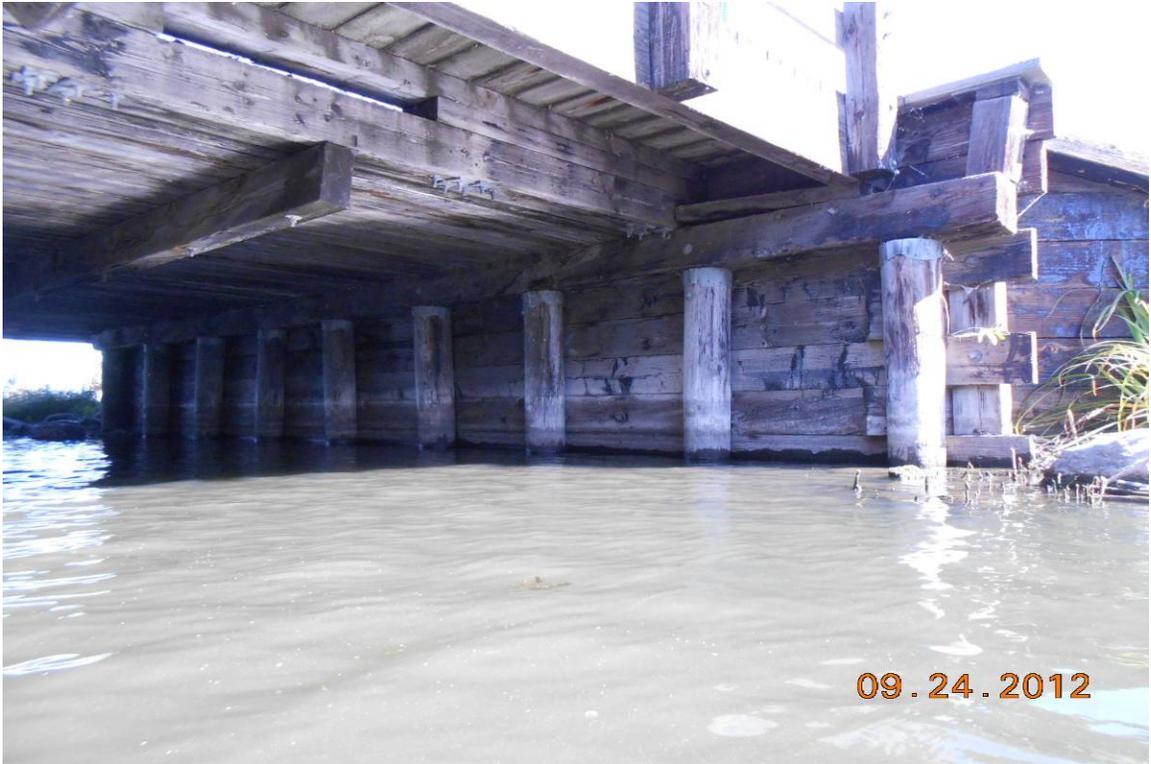
Photograph 5. View of the East Abutment, Looking Northeast.

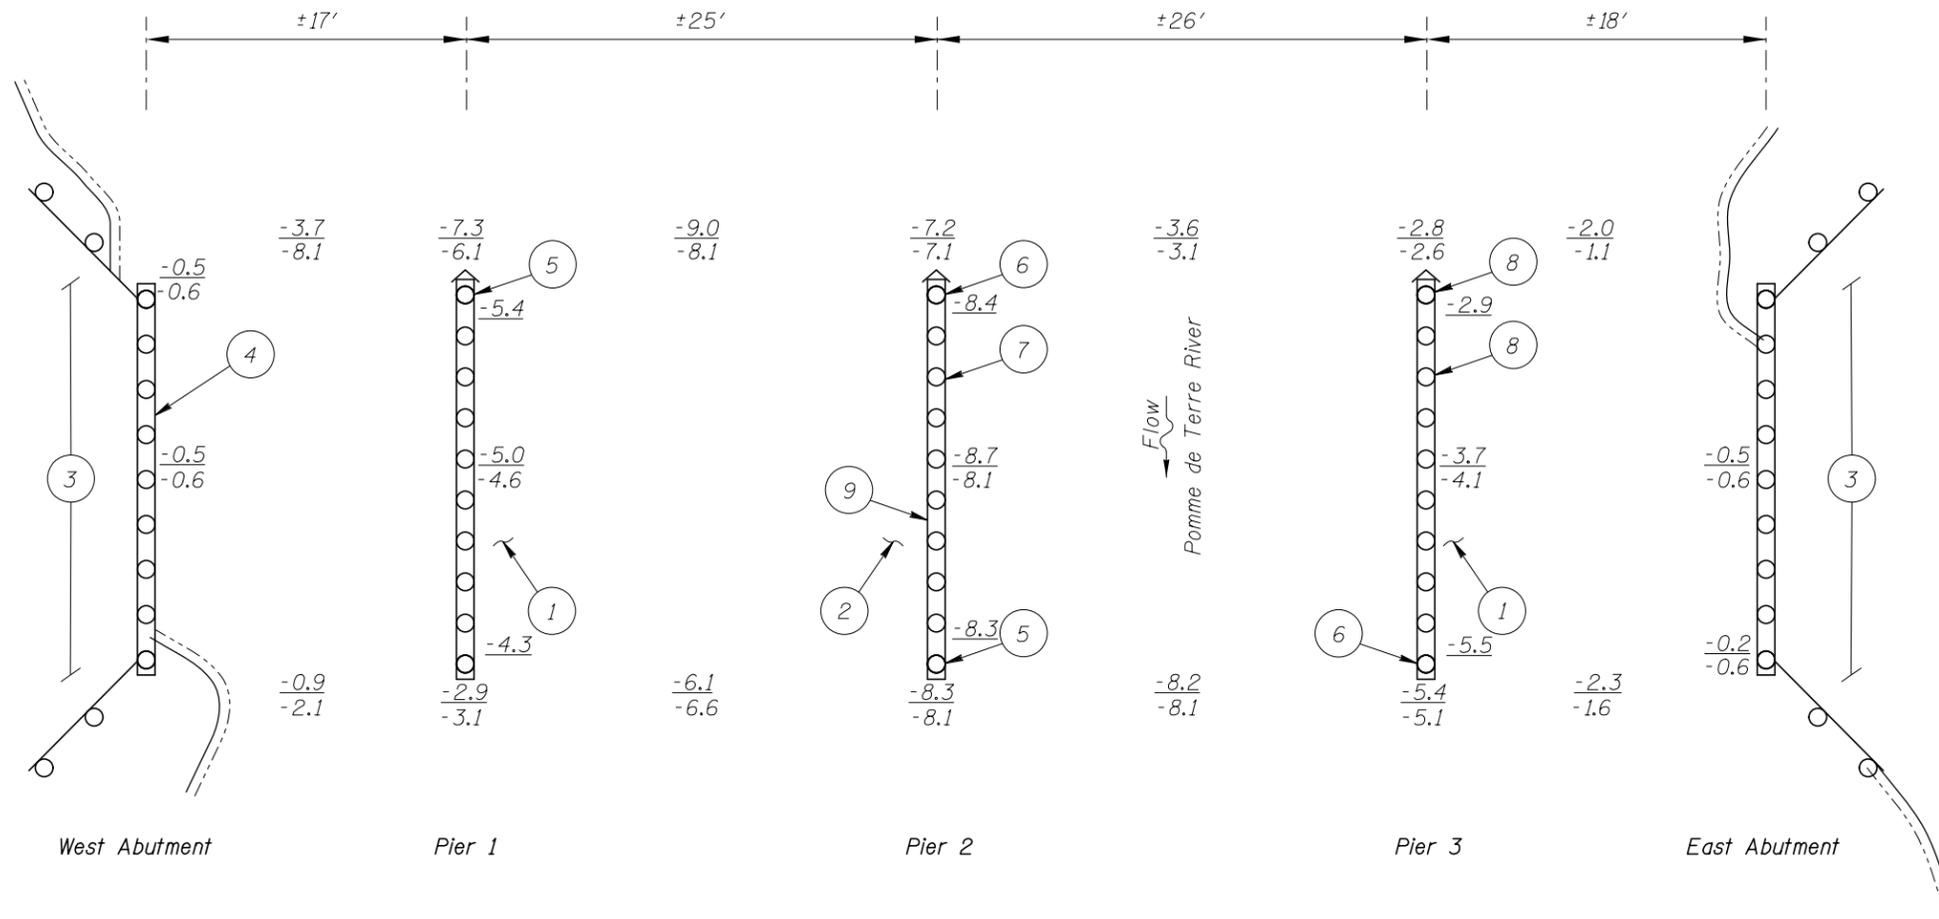
SOUNDING PLAN

- 1 The channel bottom material consisted of up to 3 foot diameter rocks with randomly scattered cobbles allowing no probe rod penetration.
- 2 The channel bottom material consisted of sandy gravel with 6 inch diameter and smaller cobbles allowing negligible probe rod penetration.

- 3 All of the timber piles were typically solid with only light weathering and material integrity allowing up to 1/8 inch awl penetration.
- 4 There was an up to 2 inch wide gap in the West Abutment bulkhead timber planking, located approximately 6 inches above the waterline.

- 5 Bracing split, 3 feet long and up to 1/2 inch wide, through pile fastener.
- 6 Bracing split, 1 foot long and up to 1/2 inch wide, through pile fastener.

- 7 Bracing split, 2 feet long and up to 1/4 inch wide, through pile fastener.
- 8 Bracing split, 2 feet long and up to 2 inches wide, through pile fastener.

- 9 Old abandoned timber pile was cut off at 1 foot above the waterline.

- (A) The deficient cross bracing connections should be restored/repared during routine bridge maintenance. Until corrected, monitor the cross bracing deterioration and cracking, and if found to be progressing to a more detrimental condition that would threaten the lateral stability of the bridge, corrective measures would be warranted at that time.
