UNDERWATER BRIDGE INSPECTION REPORT

STRUCTURE NO. L7352  
TWP NO. 140  
OVER THE  
RABBIT RIVER  
DISTRICT 4 - WILKIN COUNTY

SEPTEMBER 24, 2012  
PREPARED FOR THE  
MINNESOTA DEPARTMENT OF TRANSPORTATION  
BY  
AYRES ASSOCIATES & COLLINS ENGINEERS, INC.  
JOB NO. 7423

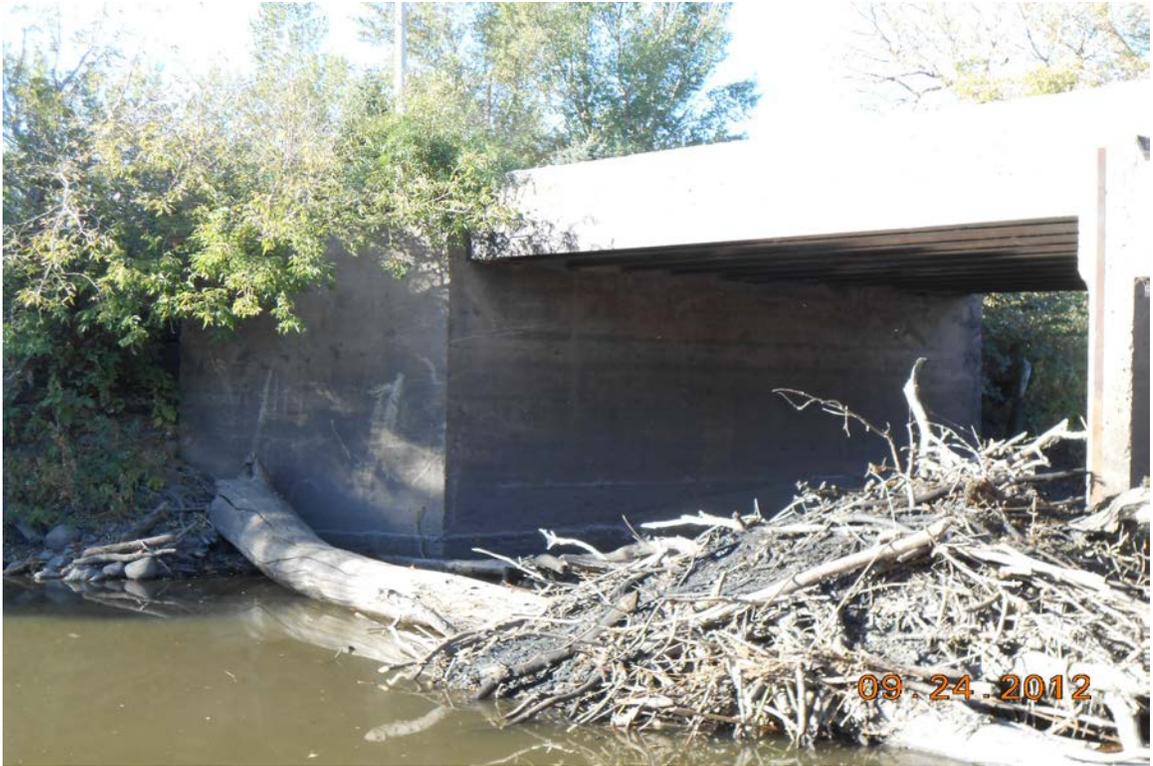
Photograph 1. View of South abutment, Looking Southwest.

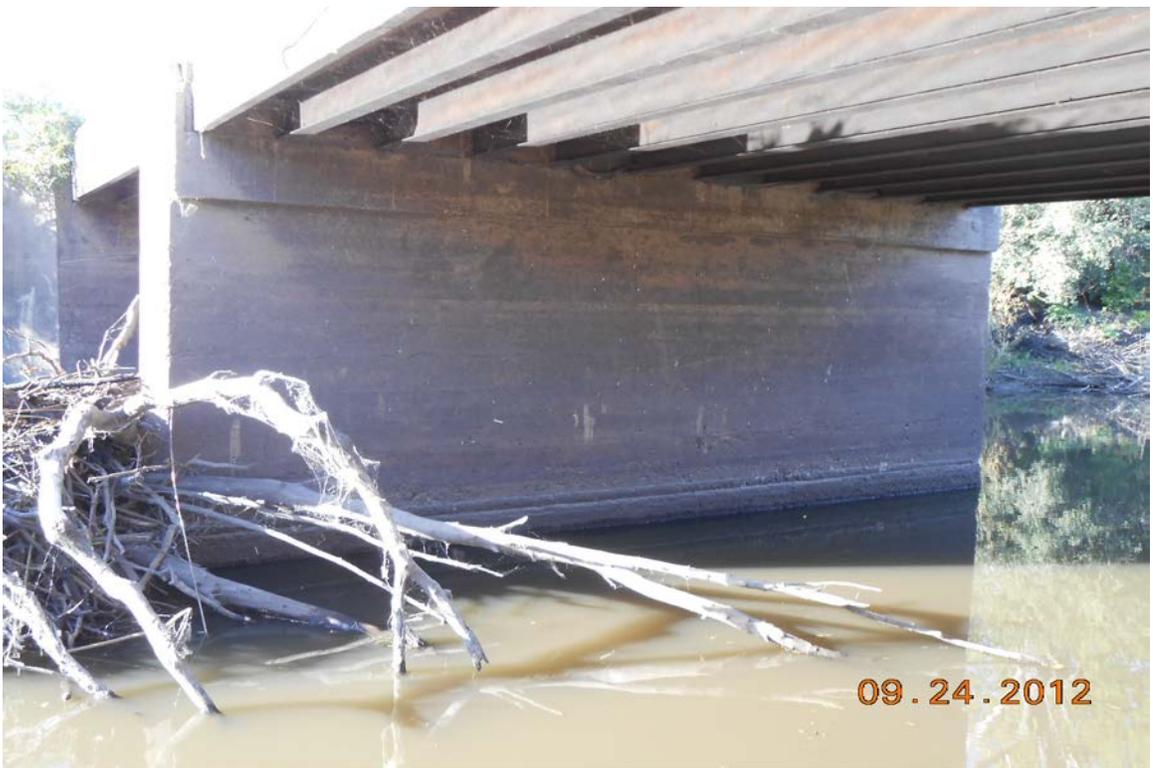
- (D) A construction joint, 3 inches below the waterline, exhibited random areas of section loss along both faces of Pier 1 with a maximum penetration of 1 inch.

Photograph 2. View of Pier 1, Looking Southwest.

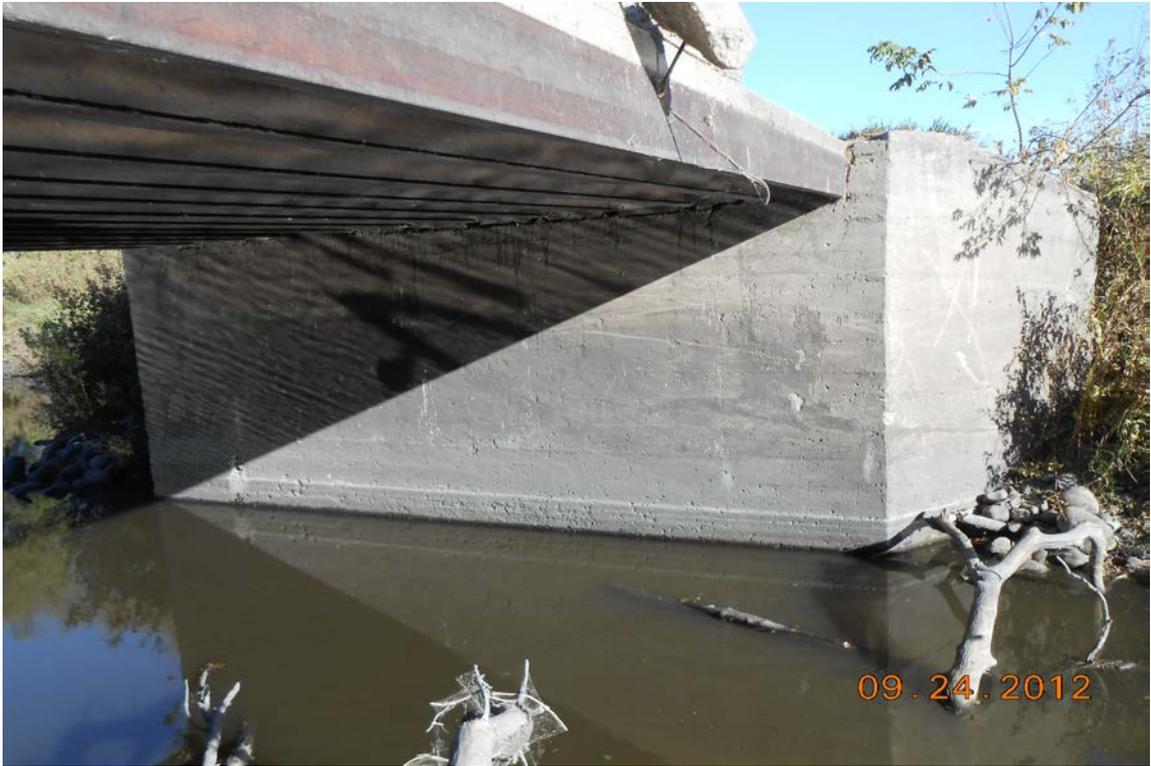
- (E) An area of section loss, 6 inches in diameter with 1 inch of penetration, was observed at 2 feet above the waterline on the North Abutment.

- (F) The top of the footing was partially exposed along the North Abutment with up to 6 inches of vertical face exposure detected.
- (G) The backfill behind each abutment wingwall was missing due to erosion making the area steeply sloped.

Photograph 3. View of North Abutment, Looking Northwest.

Monitor the extent of the local scour and footing exposure at the North Abutment during future inspections. If scour conditions and footing exposure increase, a scour evaluation, and/or countermeasures may be warranted.

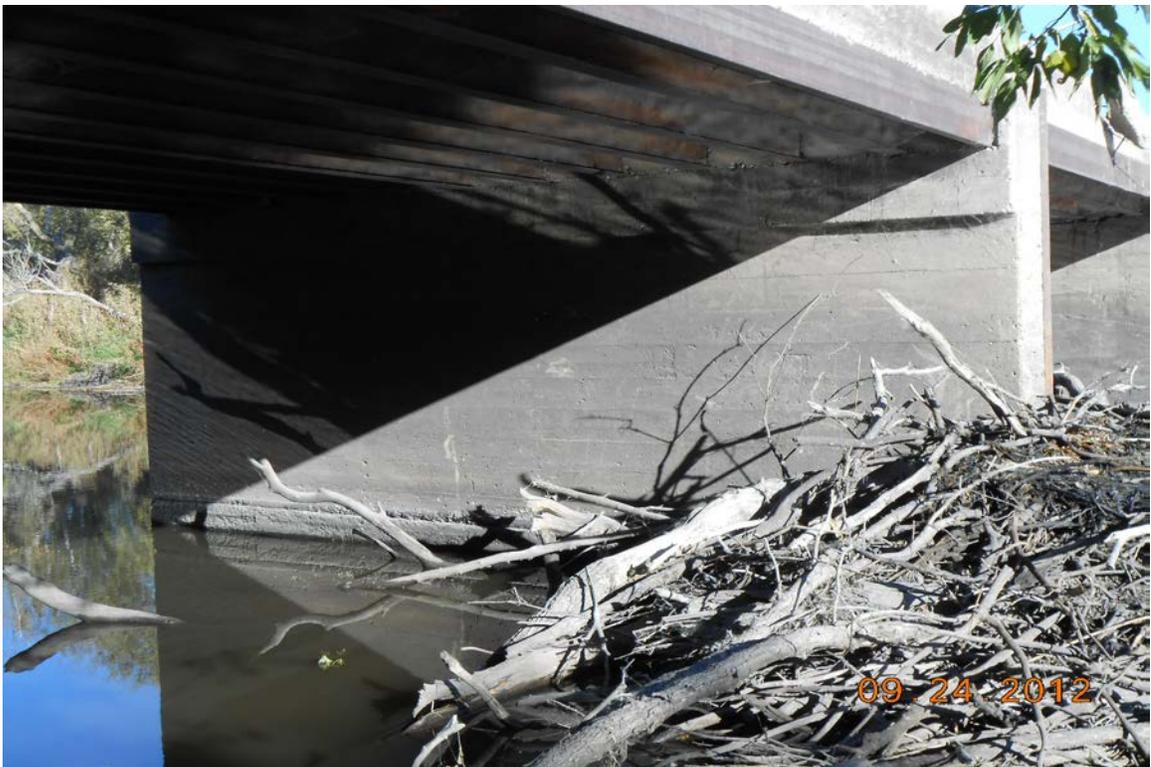
- (B) A 2.5-foot-diameter tree and a heavy accumulation of timber debris extended from the south embankment to midway between Pier 1 and the north abutment along the upstream fascia of the bridge. The debris extended from the channel bottom to 5 feet above the waterline

Photograph 4. View of Pier 1 and Timber Debris, Looking Northwest.

Remove the large tree and heavy accumulations of timber debris extending along the upstream fascia to eliminate the potential for continued accumulation and adverse affects on the bridge.

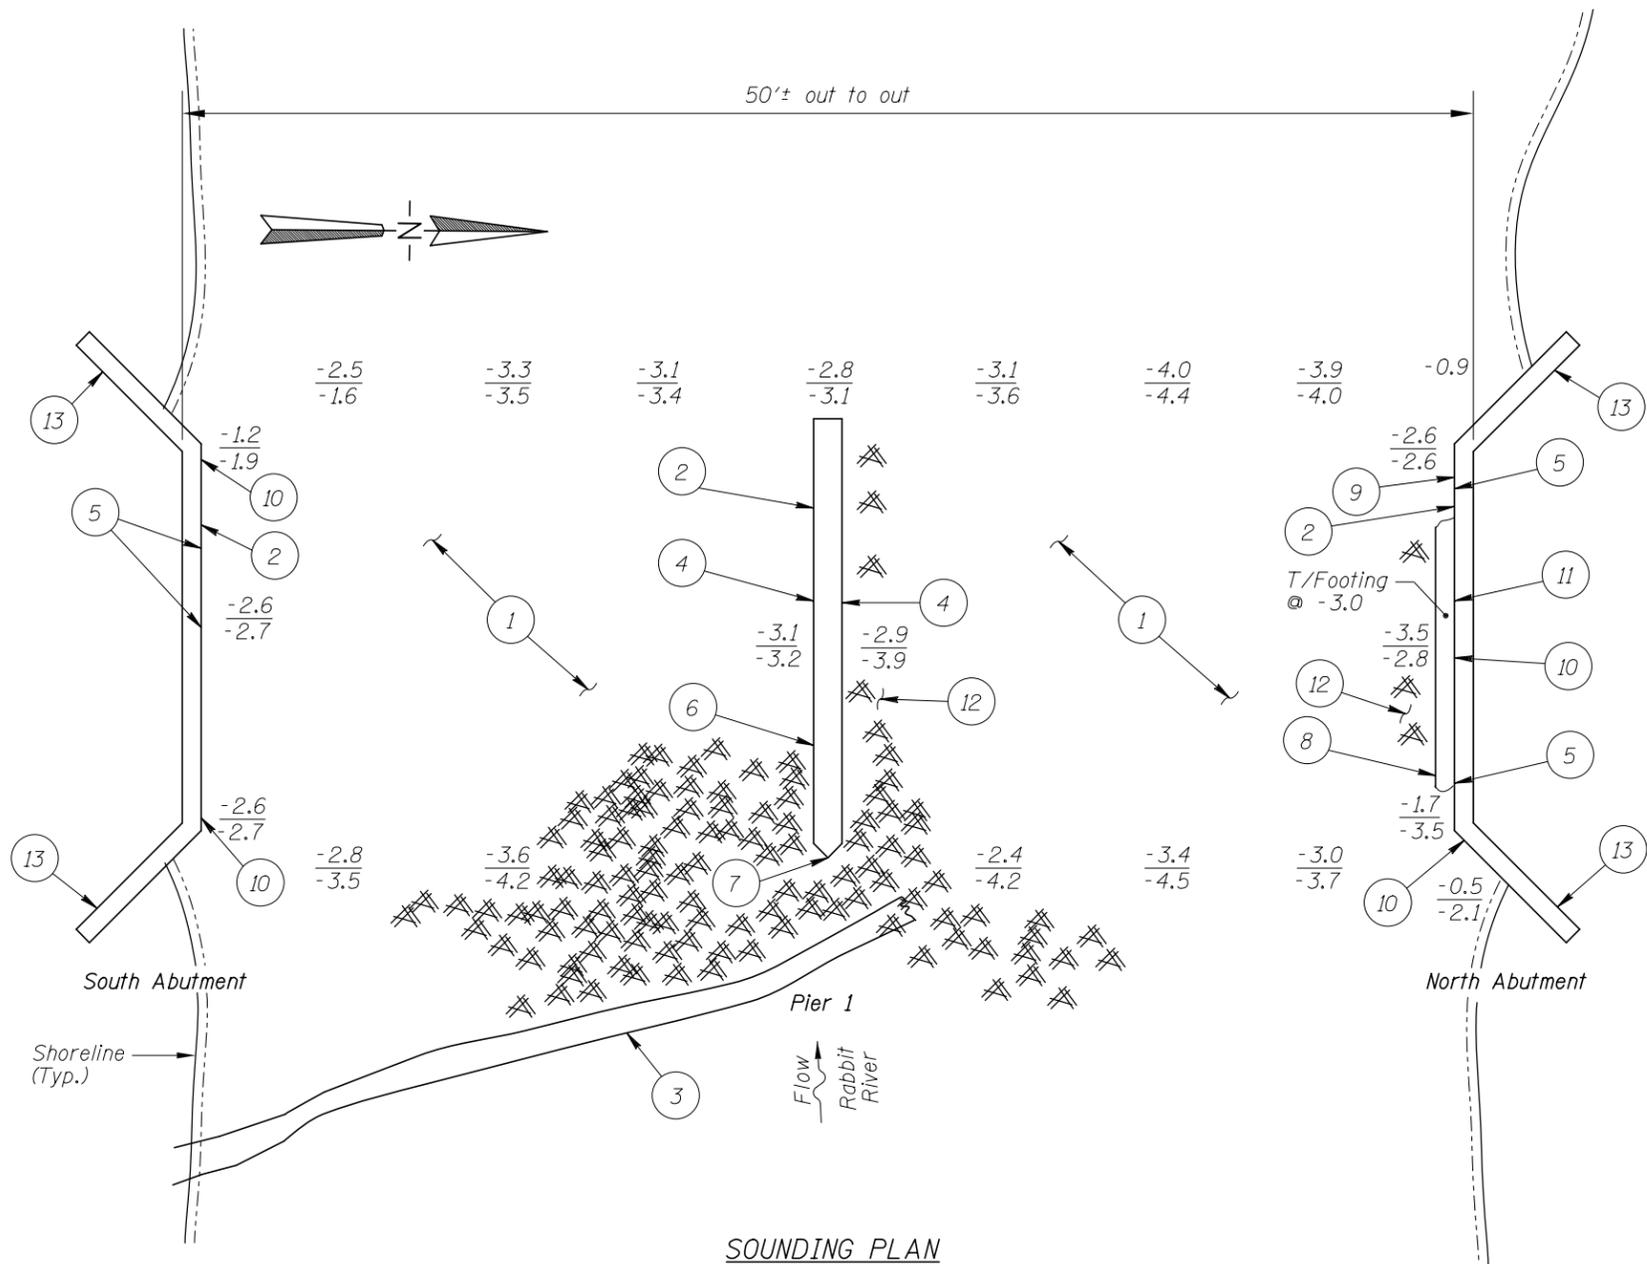
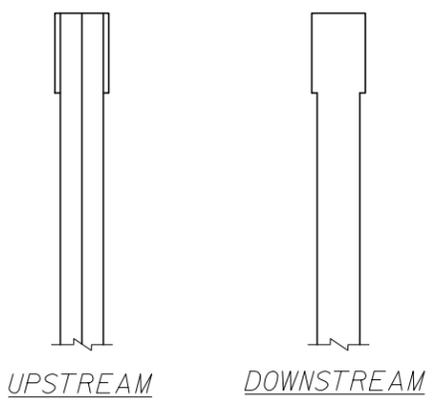
<b>MINNESOTA DEPARTMENT OF TRANSPORTATION UNDERWATER BRIDGE INSPECTION</b>	
STRUCTURE NO. L7352 OVER THE RABBIT RIVER DISTRICT 4, WILKIN COUNTY	
<b>INSPECTION AND SOUNDING PLAN</b>	
Drawn By: JAC	Date: NOV. 2012
Checked By: BKS	Scale: NTS
Code: 52210059	Figure No.: 1

- 1 The channel bottom material consisted of hard clay overlaid with silt and random gravel with a maximum probe rod penetration of 6 inches.
- 2 Light to moderate scaling was observed around the perimeter of the pier and along the breastwalls of both abutments, with a maximum penetration of 1 inch, extending from the waterline to 2 feet above.

- 3 A 2.5-foot-diameter tree along with a heavy accumulation of timber debris was observed along the upstream fascia extending from the south embankment to midway between Pier 1 and the North Abutment.

- 4 Vertical crack, extending from the beam seat to the channel bottom with a maximum width of 1/8 inch, was observed on both sides of the pier.
- 5 Vertical crack, extending from the beam seat to the channel bottom with a maximum width of 1/8 inch, was observed on the breast wall.

- 6 A construction joint 3 inches below the waterline exhibited areas of section loss around the entire perimeter of the pier with a maximum penetration of 1 inch.

- 7 Steel ice damage nosing protection extended from the top of the pier cap to 2 foot above the waterline.
- 8 Footing exposure was observed along the North Abutment with up to 6 inches of vertical face exposure observed.

- 9 Area of section loss, 6 inches in diameter, was observed 2 feet above the waterline with a penetration of 1 inch.
- 10 Vertical crack, extending from the beam seat to the channel bottom with a maximum width of 1/16 inch, was observed on the breast wall.

- 11 Vertical crack, extending from the beam seat to the channel bottom with a maximum width of 1/32 inch, was observed on the breast wall.
- 12 Scattered timber debris consisting of 3-inch-diameter and smaller branches was observed along the North Abutment and the north face of Pier 1.

- 13 Backfill behind wingwalls was eroded making it steeply sloped.
