UNDERWATER BRIDGE INSPECTION REPORT

STRUCTURE NO. 23503

ROOT RIVER

MINNESOTA DEPARTMENT OF TRANSPORTATION
UNDERWATER BRIDGE INSPECTION

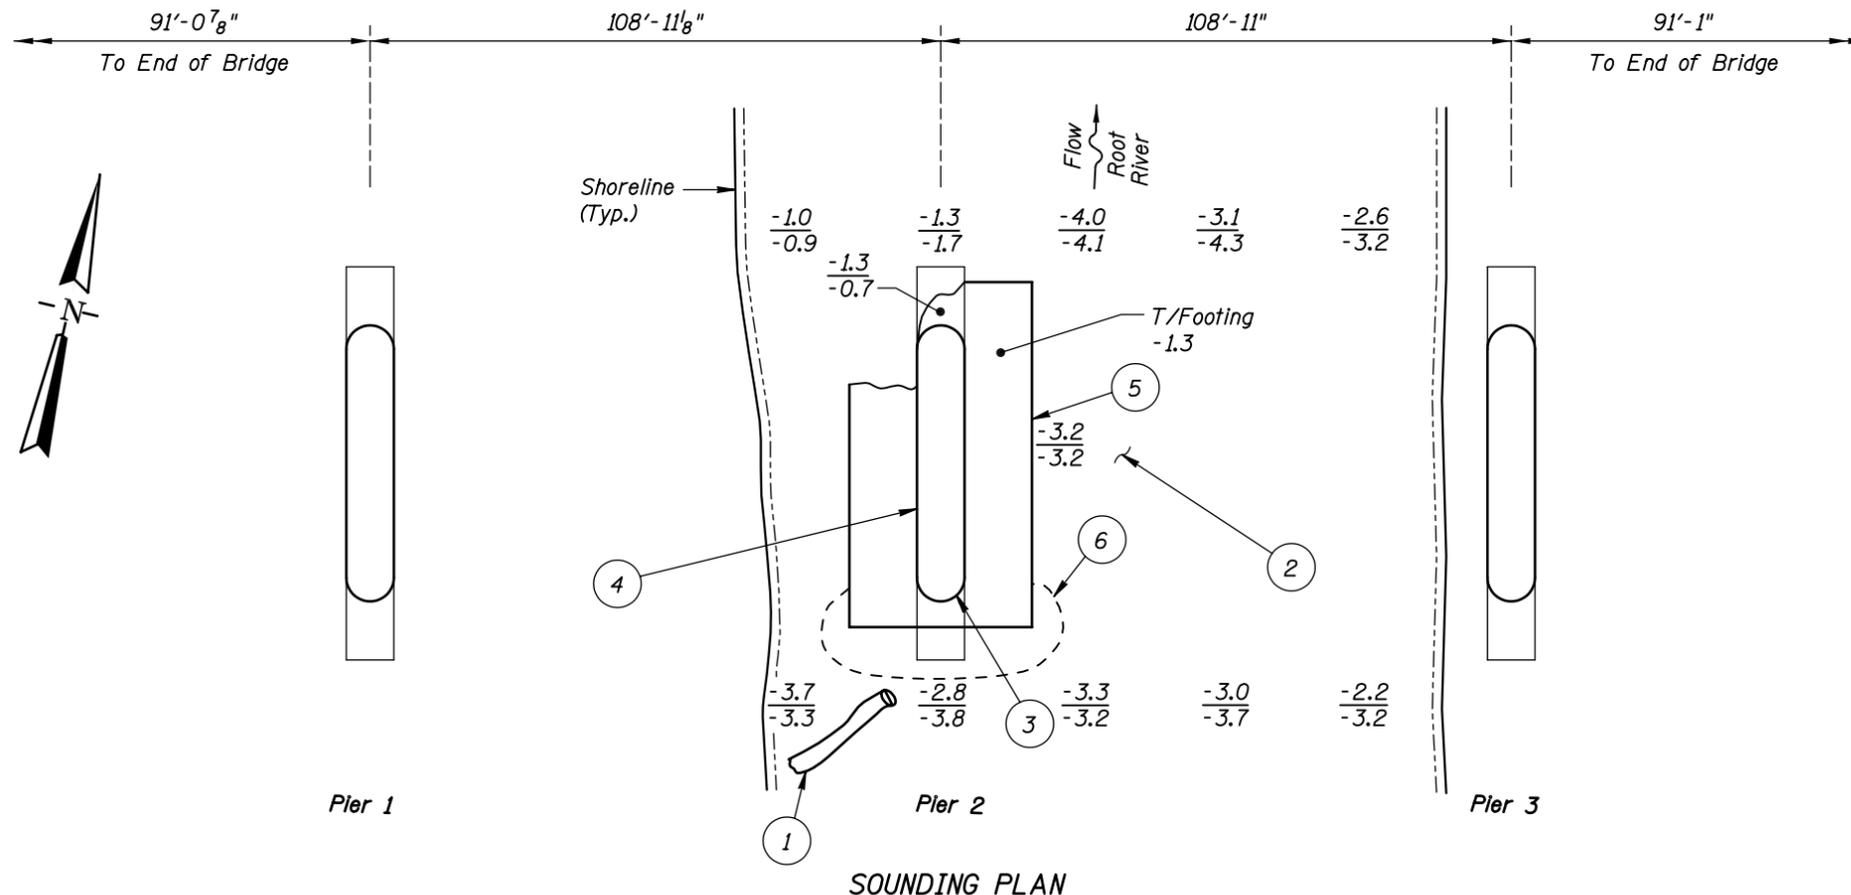
SOUNDING PLAN

- ① A 1-foot-diameter, 10-foot-long tree with branchy debris was observed on the channel bottom.
- ② The channel bottom material consisted of fine sandy gravel with 6 inches of maximum probe rod penetration.
- ③ Two horizontal impact related voids were observed on the upstream nose of Pier 2 above the waterline, 2-foot-long by 1-inch-wide with 1/2 inch of penetration and exposed aggregate.
- ④ Light scaling of concrete was observed from the top of the footing to 1 foot above the waterline.
- ⑤ The footing was exposed with 2.8 feet of vertical exposure at the upstream end and 1.7 feet of exposure at the downstream end. There was no undermining of the footing present. The concrete was smooth and in good condition.
- ⑥ A 3-foot-radius, 3-foot-deep scour depression was observed at the upstream end of Pier 2.

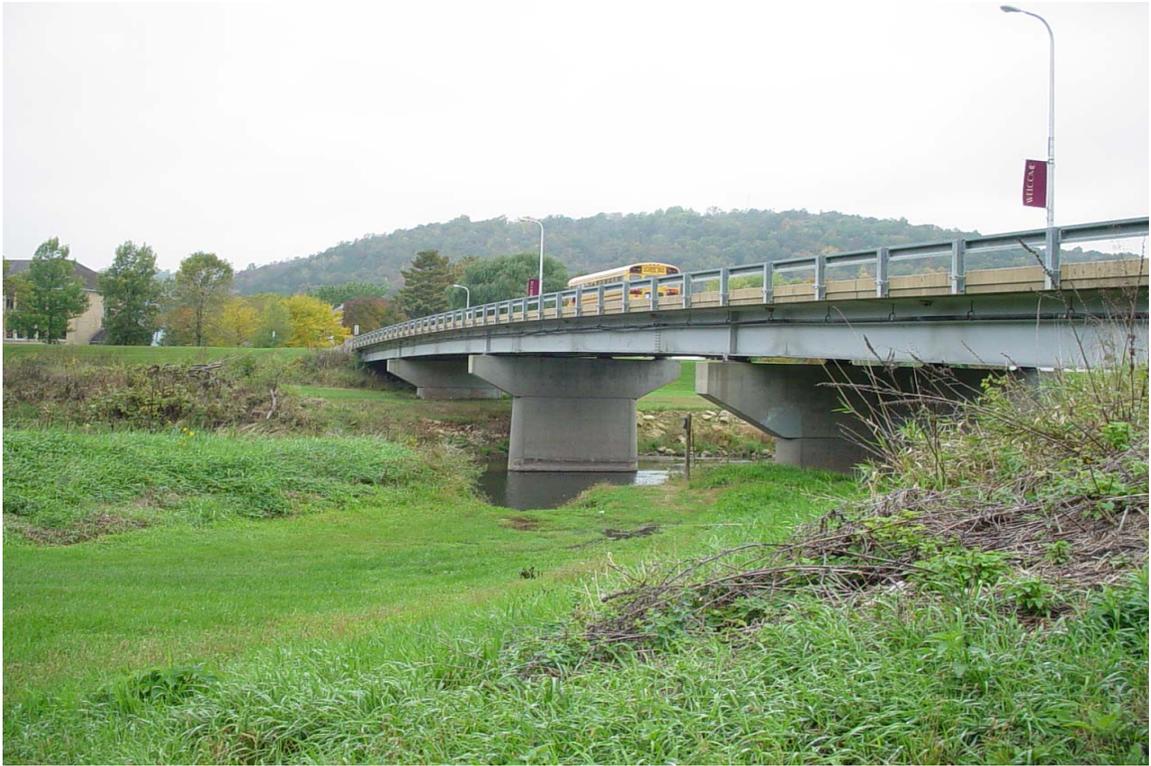
Photograph 1. Overall View of the Structure, Looking Northwest.

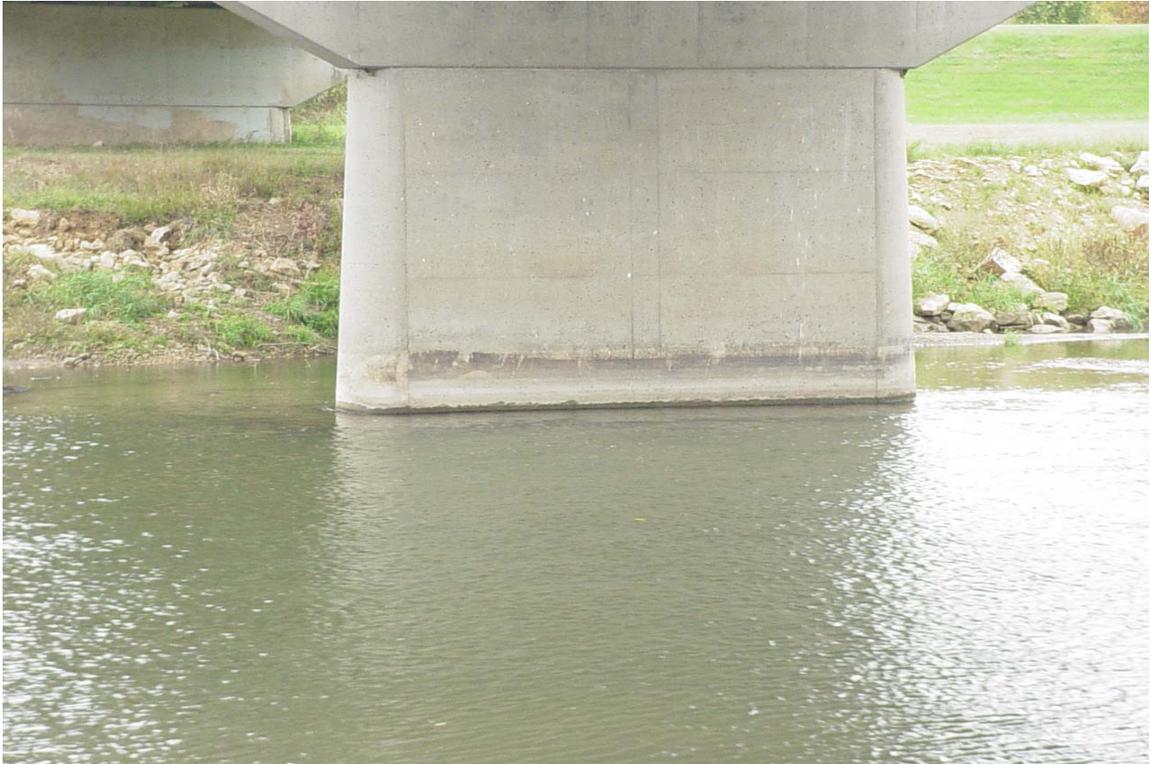
- (C) The footing at Pier 2 was exposed along the entire east side, around the upstream end, and to the downstream quarter point along the west side, with a maximum vertical face exposure of 2.8 feet at the upstream end. The footing fully entered the mudline with no undermining detected.

- (D) A scour depression was observed at the upstream end of Pier 2 with a radius of 3 feet and a depth of 3 feet.
- (E) Two areas of section loss, possibly related to impact damage, were observed at the upstream end of Pier 2, at 0.5 feet and 1.5 feet above the waterline, each being 2 feet long by 1 inch wide with 1/2 inch of penetration.

Photograph 2. View of Pier 2, Looking Northwest.

- (A) Monitor the scour depression and footing exposure at Pier 2 during future inspections. If these conditions progress, repairs can be considered including filling the scour hole at the upstream end of Pier 2 by designing and placing properly sized riprap.

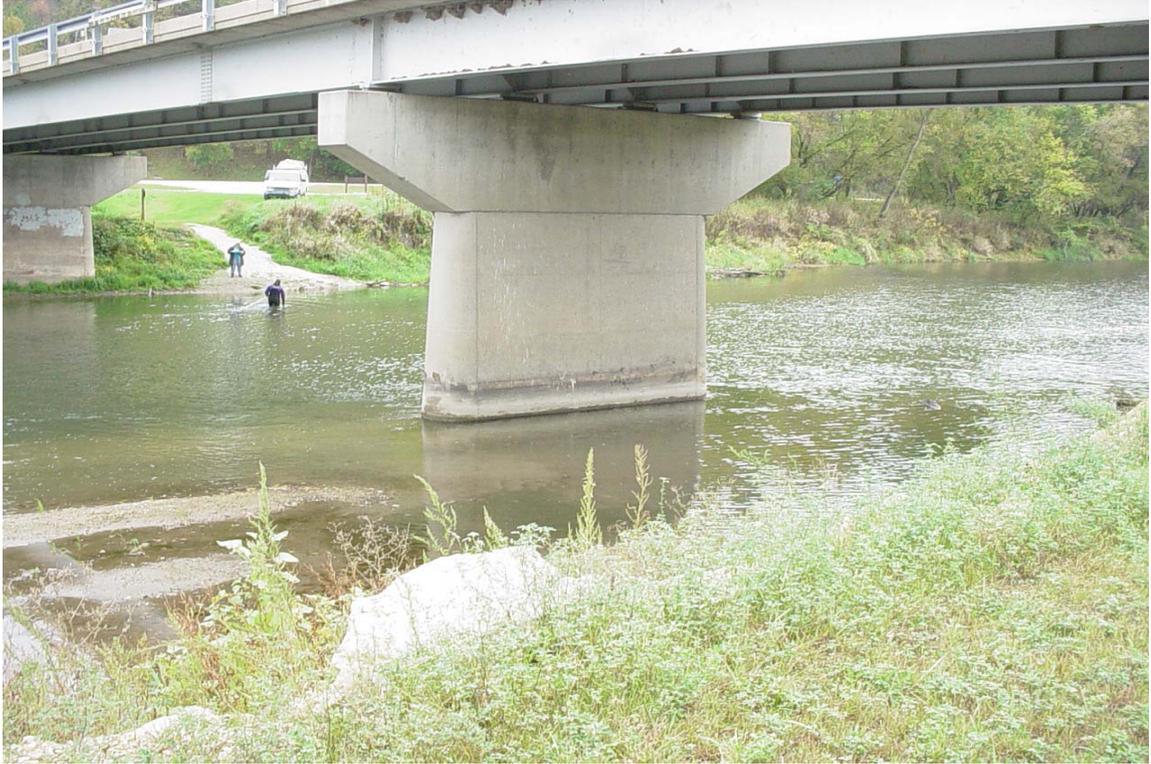
Photograph 3. View of Pier 2, Looking Southeast.

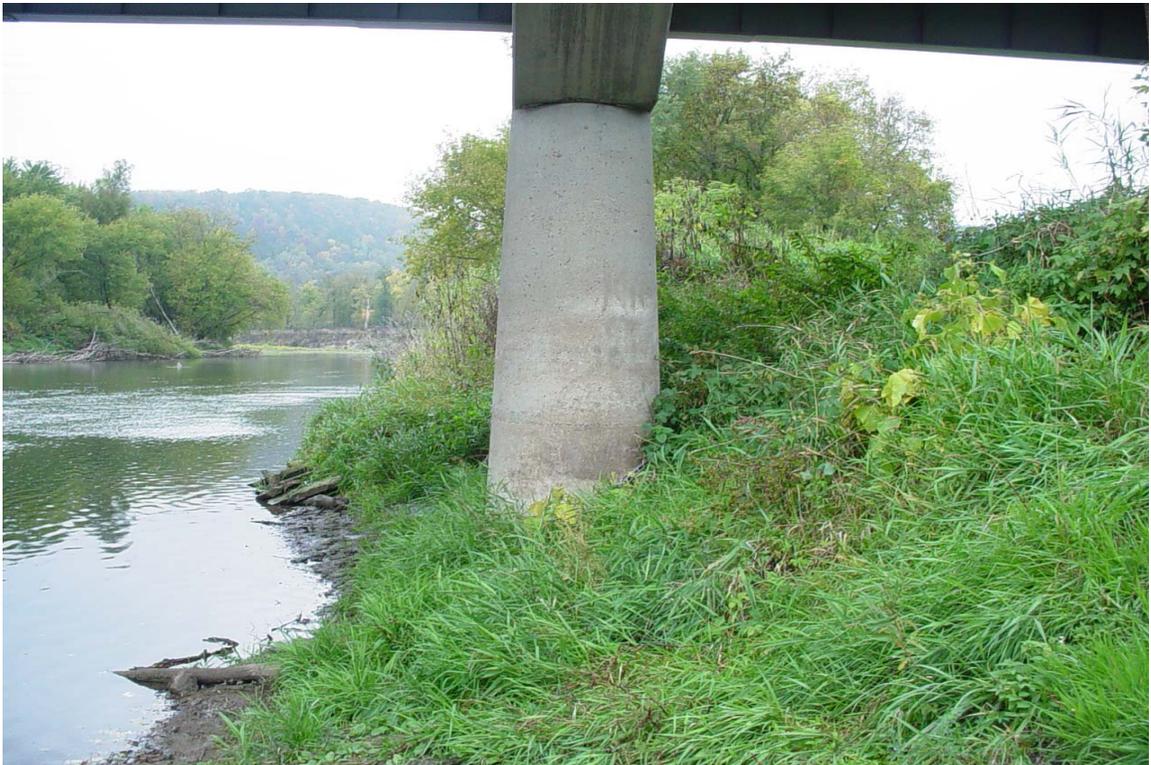
Photograph 4. View of Pier 3, Looking North.
