UNDERWATER BRIDGE INSPECTION REPORT

STRUCTURE NO. L4870

ROOT RIVER

PREPARED FOR THE  
MINNESOTA DEPARTMENT OF TRANSPORTATION

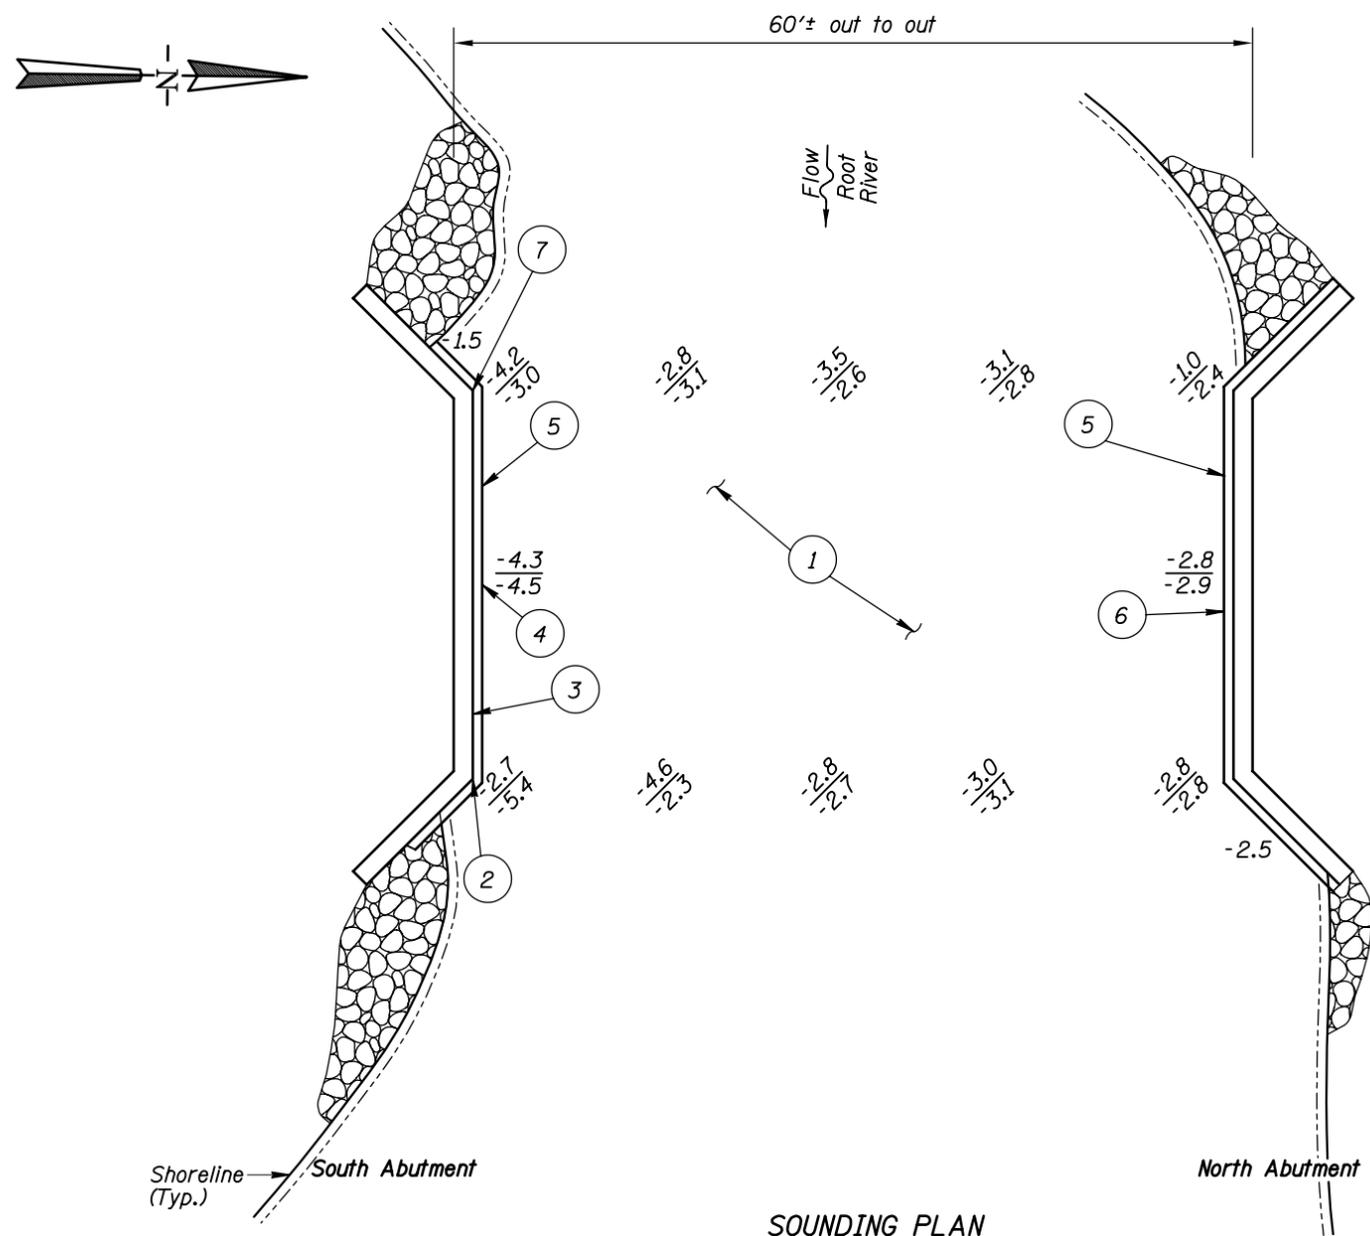
- 1 The channel bottom consisted of riprap with no probe rod penetration.
- 2 An area of poor consolidation was observed on the east corner of the South Abutment from 0.5 feet below to 2 feet above the waterline with 3 inches of maximum penetration.

- 3 A 6 inch band of poorly consolidated concrete was observed at the waterline extending from the downstream 1/4 point to the east wingwall.
- 4 Undermining of the concrete face was observed along the downstream half of the South Abutment which exposed the underlying masonry. Random areas of section loss were observed on the submerged portion of the South Abutment facing with average penetrations of 6 inches which exposed heavily corroded vertical reinforcing steel at the center of the abutment.

- 5 A concrete ledge was located at 1 foot below the waterline at both abutments.
- 6 Random areas of section loss were observed on the submerged portion of the North Abutment with average penetrations of 6 inches and no reinforcing steel detected.

- 7 A formed steel angle was exposed due to an area of section loss, up to 1 foot wide and 4 inches deep, on the west corner of the South Abutment which extended from 3 feet above to 1 foot below the waterline.

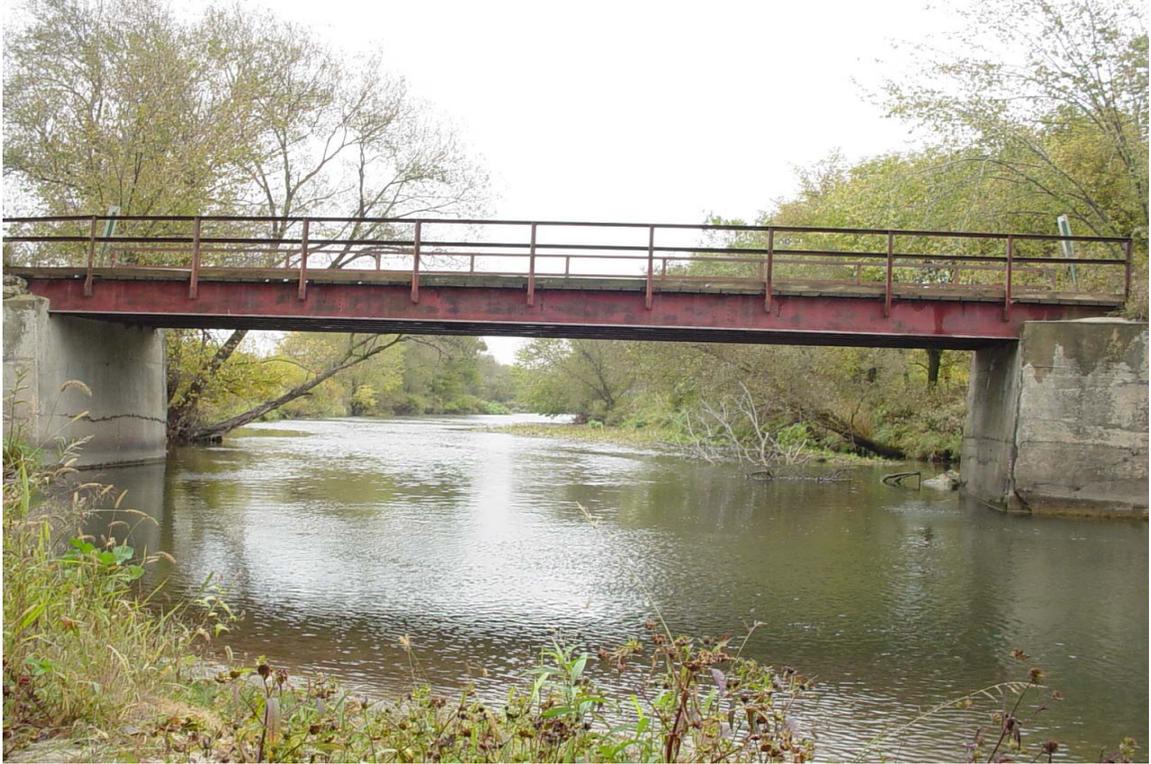
Photograph 1. Overall View of the Structure, Looking East.

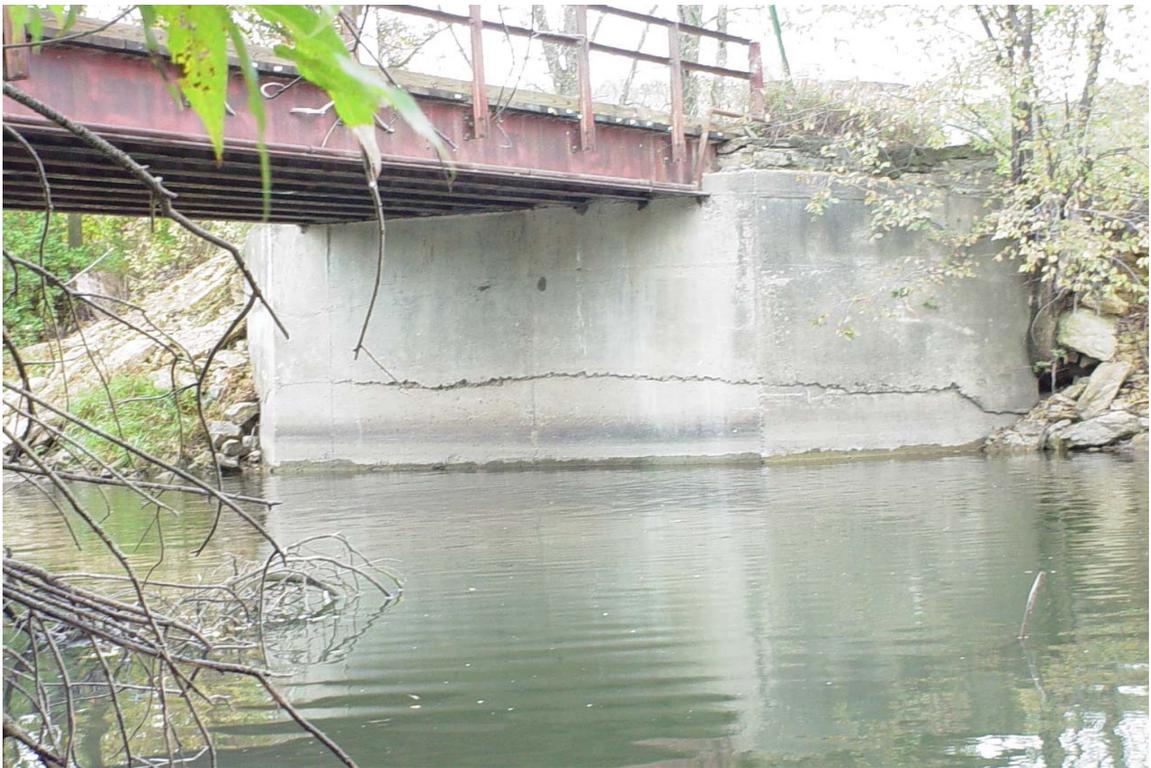
Photograph 2. View of North Abutment, Looking Northwest.

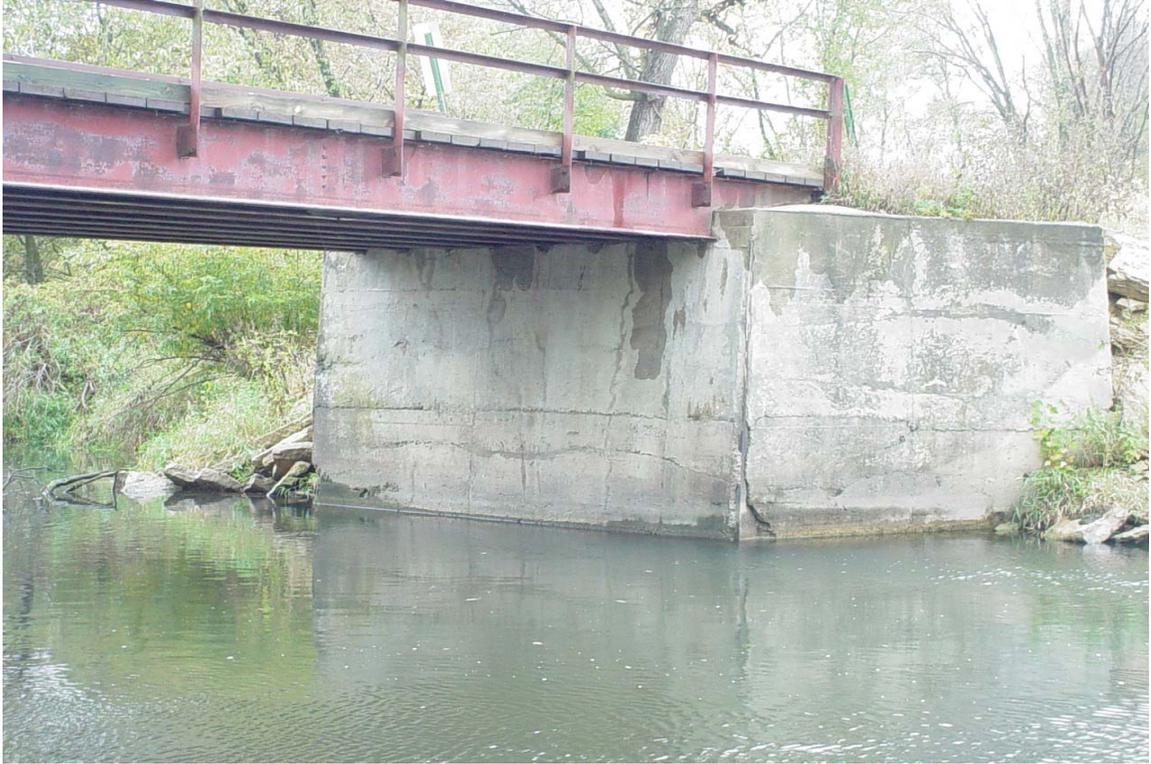
- (A) Undermining of the concrete facing was observed at the South Abutment, exposing the underlying masonry wall which was found to be in good condition.
- (B) An area of poor consolidation was observed on the east corner of the South Abutment from 0.5 feet below to 2 feet above the waterline with 3 inches of maximum penetration. A formed steel angle was exposed due to an area of section loss, up to 1 foot wide and 4 inches deep, on the west corner of the South Abutment that extended from 3 feet above to 1 foot below the waterline.
- (C) Random areas of section loss were observed on the submerged walls at both abutments with average penetrations of 6 inches. At the center of the South Abutment, exposed and corroded reinforcement was observed below water.

Photograph 3. View of South Abutment, Looking Southeast.

- (A) Recast the areas of section loss in the concrete facing, especially those with exposed reinforcement, with a concrete mix which provides a high durability and low permeability.
- (B) Monitor height of exposure and condition of the masonry wall exposed below the concrete facing at the South Abutment, and if deterioration continues, further concrete encasement may be required.
- (C) Reinspect the submerged substructure units at the normal maximum recommended (NBIS) interval of five (5) years.

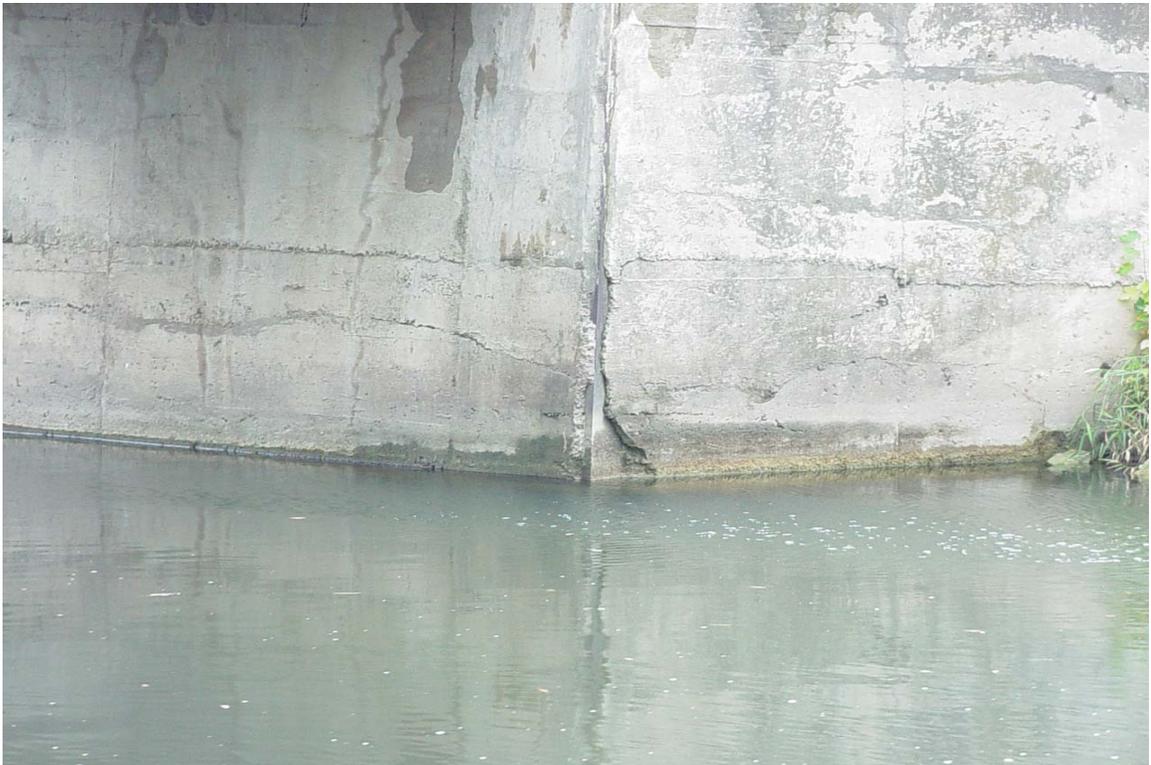
Photograph 4. View of West Corner of South Abutment, Looking Southeast.
