UNDERWATER BRIDGE INSPECTION REPORT

STRUCTURE NO. 1232

4th STREET BRIDGE

CANNON RIVER

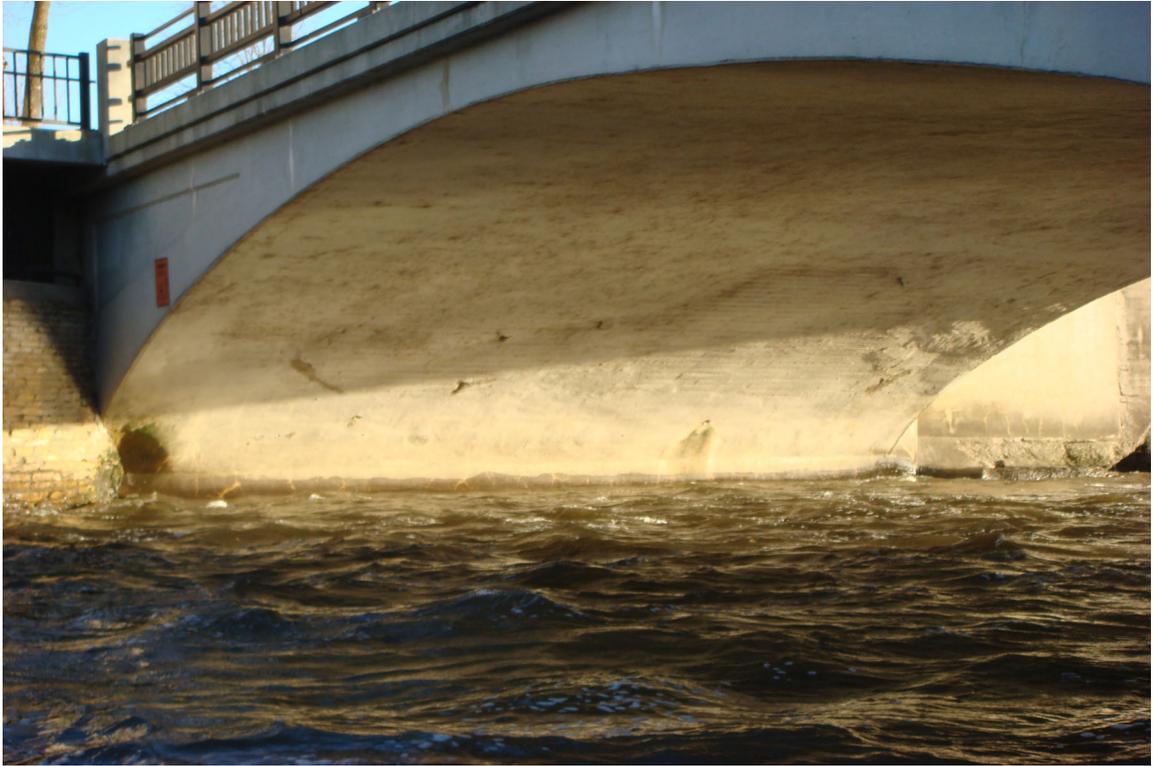
Photograph 1. View of East Abutment, Looking Southeast.

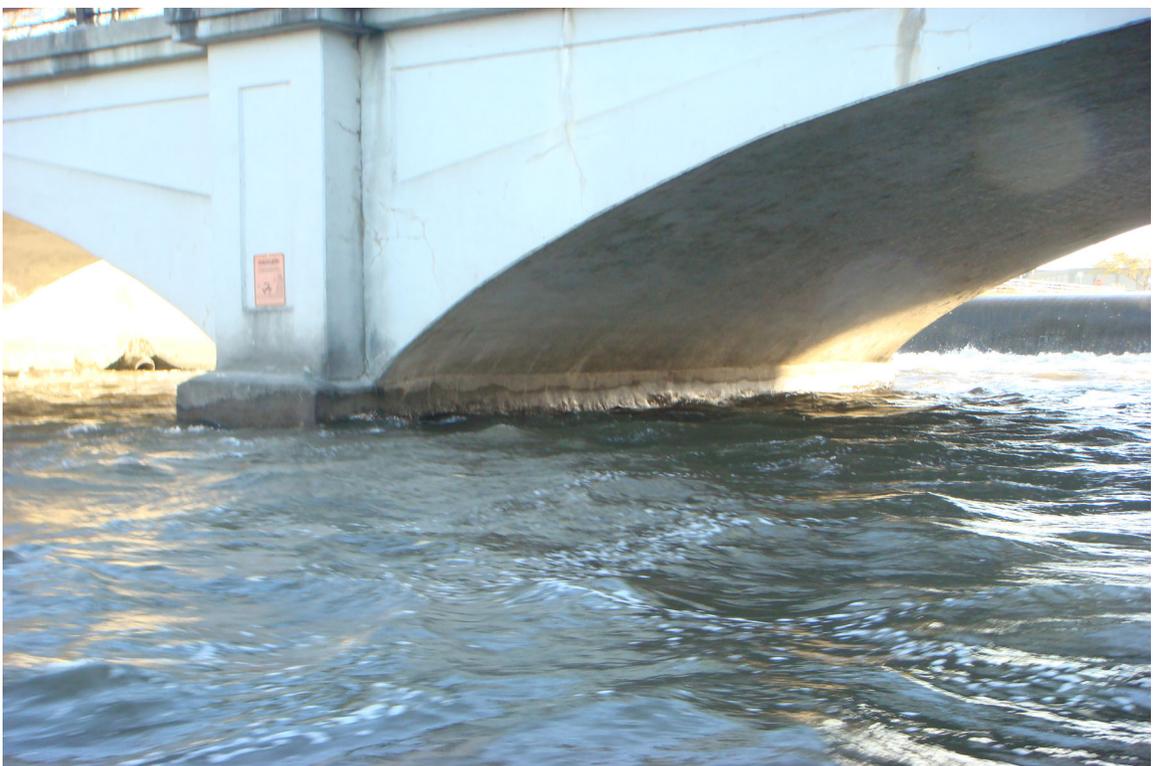
Photograph 2. View of Center Pier, Looking Southeast.

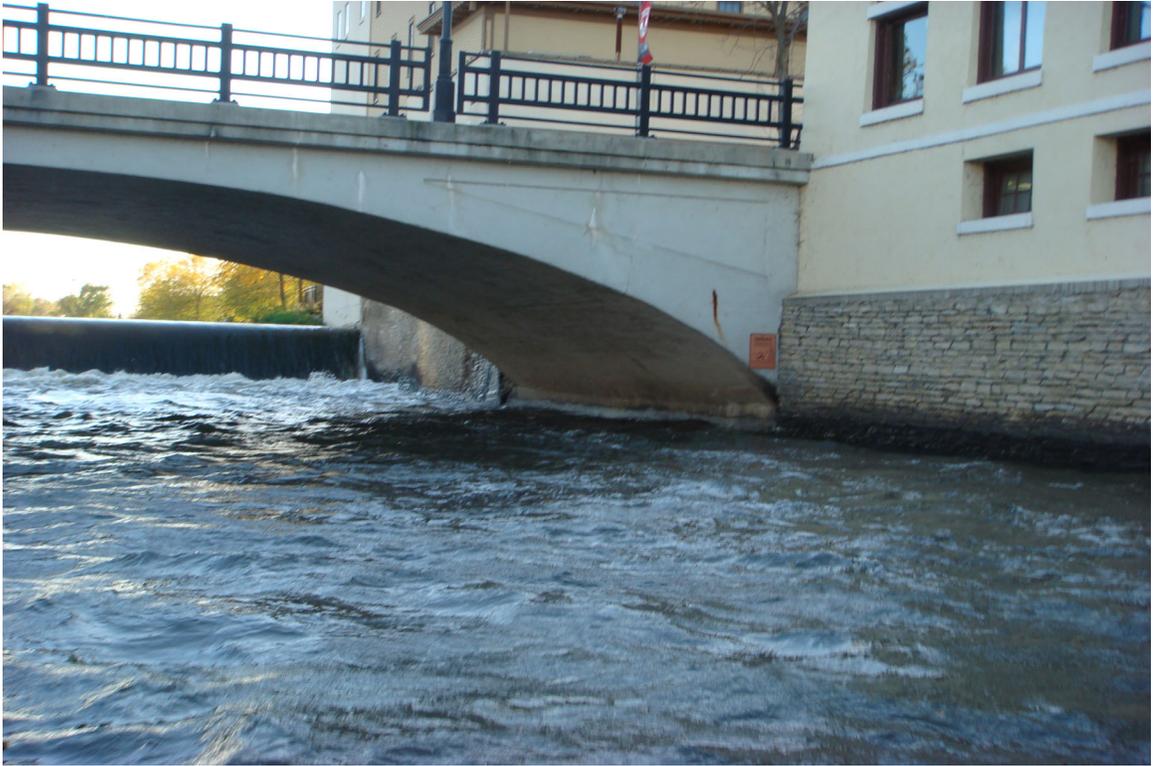
Photograph 3. View of West Abutment, Looking Southwest.

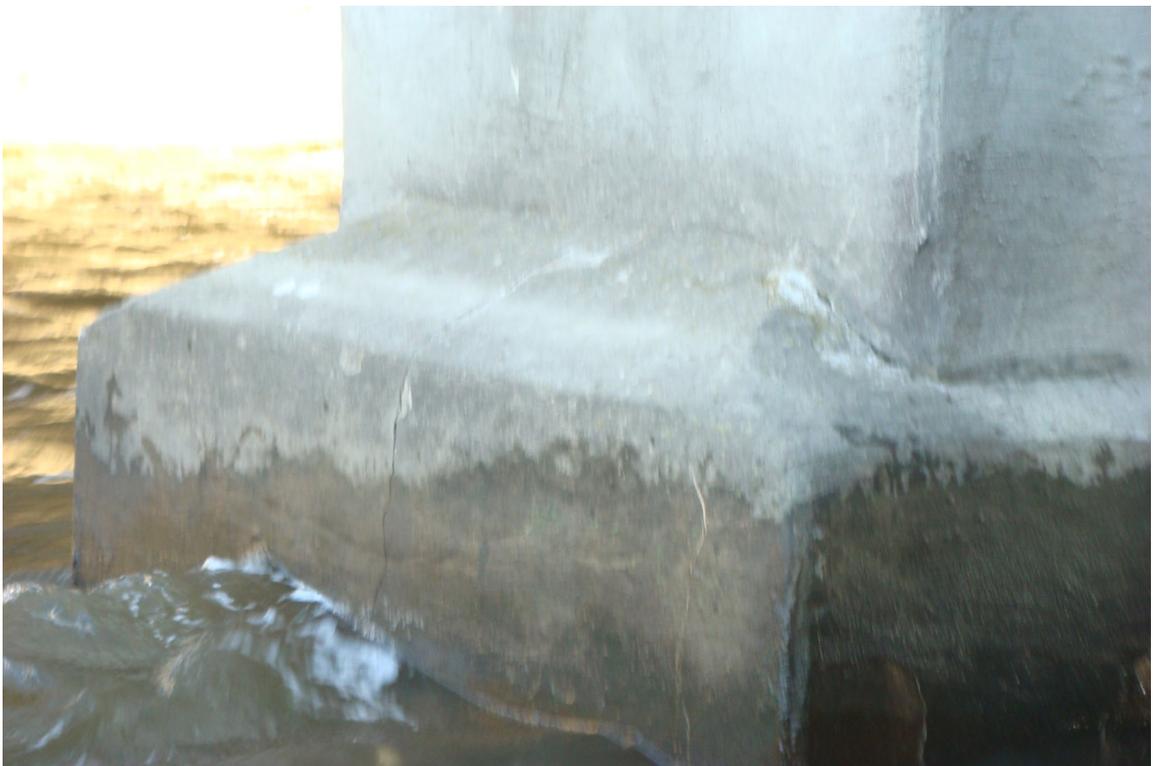
- (A) The concrete of the substructure units was smooth and sound with only random minor cracking of the resurfacing repairs.
- (B) The channel bottom consisted of stone and natural bed rock with no probe rod penetration possible.

Photograph 4. View of the Downstream End of Center Pier, Looking Southeast. Note typical minor cracking of surfacing of all substructure units.

- (A) Reinspect the submerged substructure units at the normal maximum recommended (NBIS) interval of five (5) years.

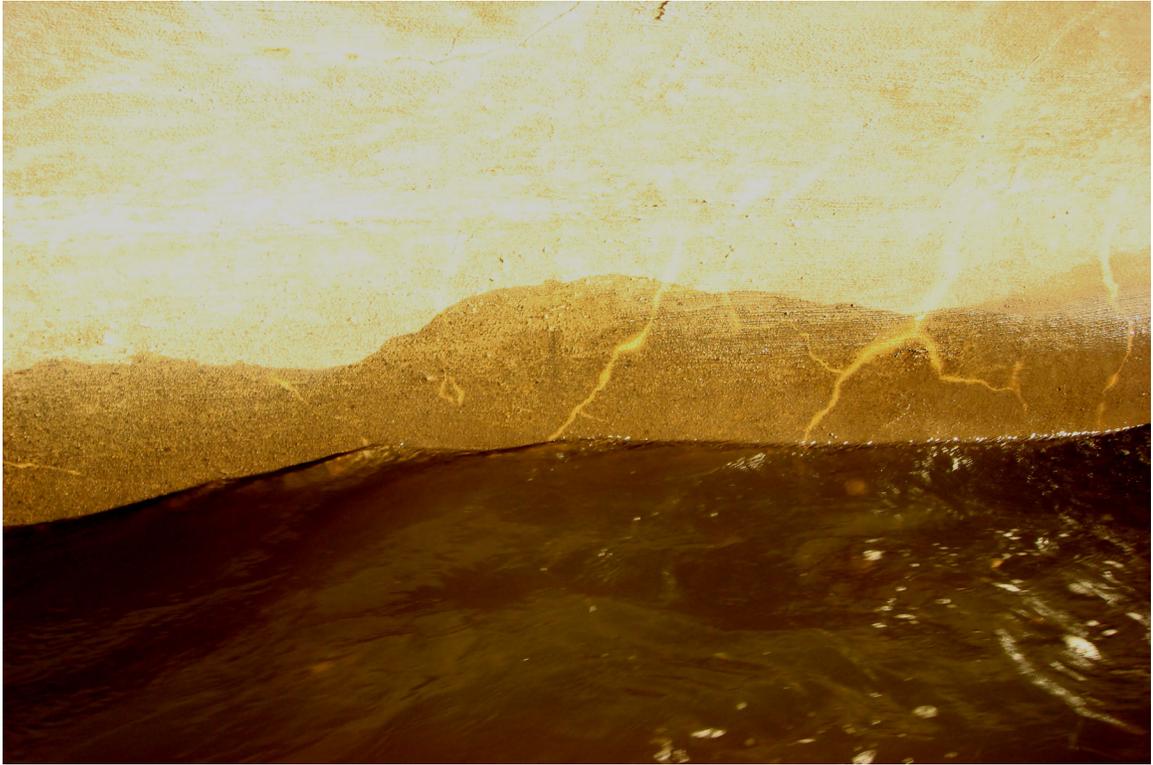
Photograph 5. View of Typical Cracking at East Abutment, Looking East.

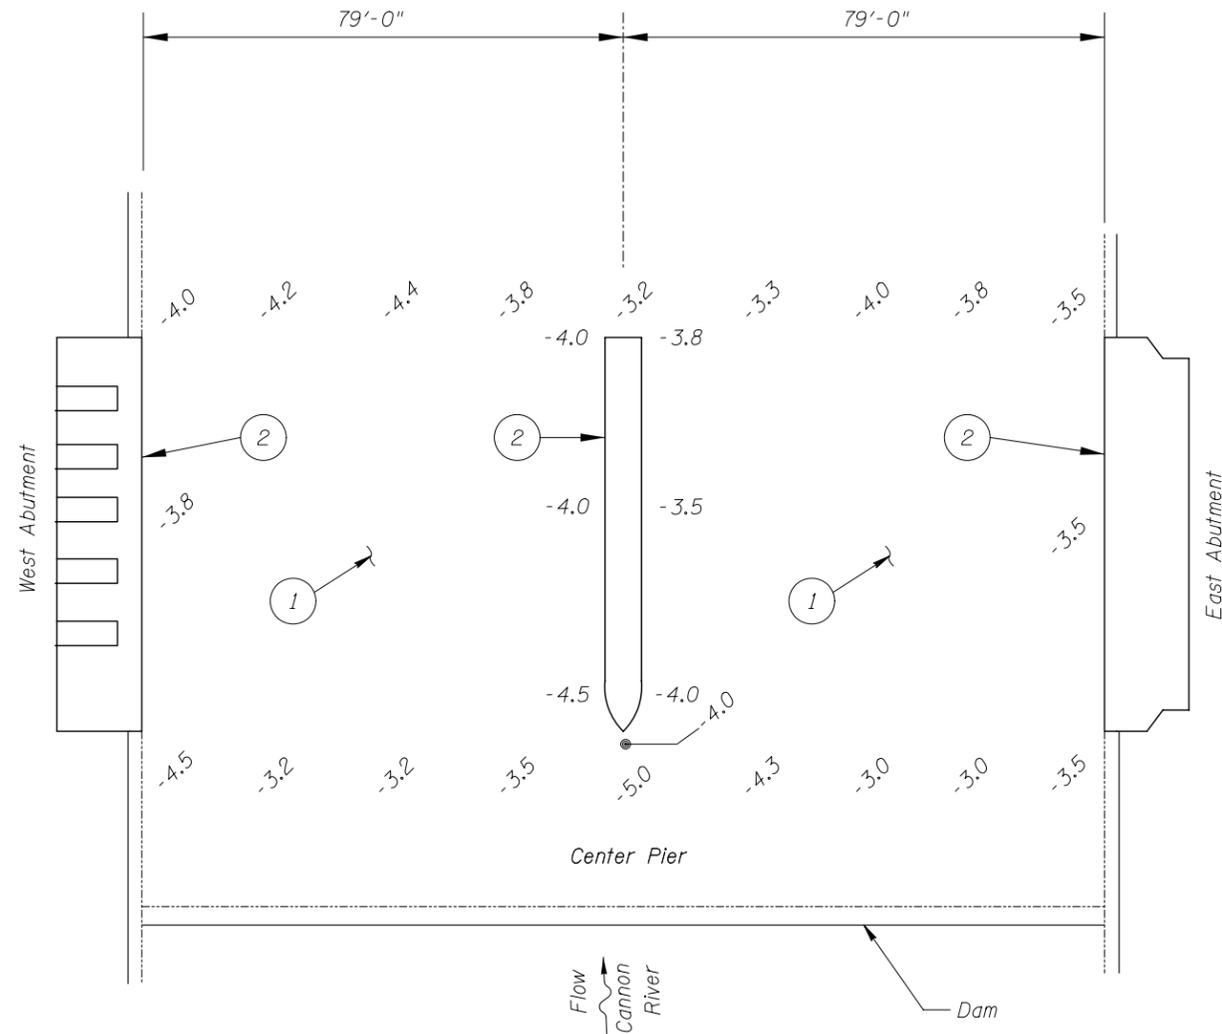
INSPECTION AND SOUNDING PLAN

- ① The channel bottom consisted of stone and natural bedrock with no probe rod penetration possible.
- ② The concrete was in smooth and sound condition with only random minor cracking of the resurfacing repairs.
