UNDERWATER BRIDGE INSPECTION REPORT

STRUCTURE NO. 23513

CSAH NO. 36

ROOT RIVER

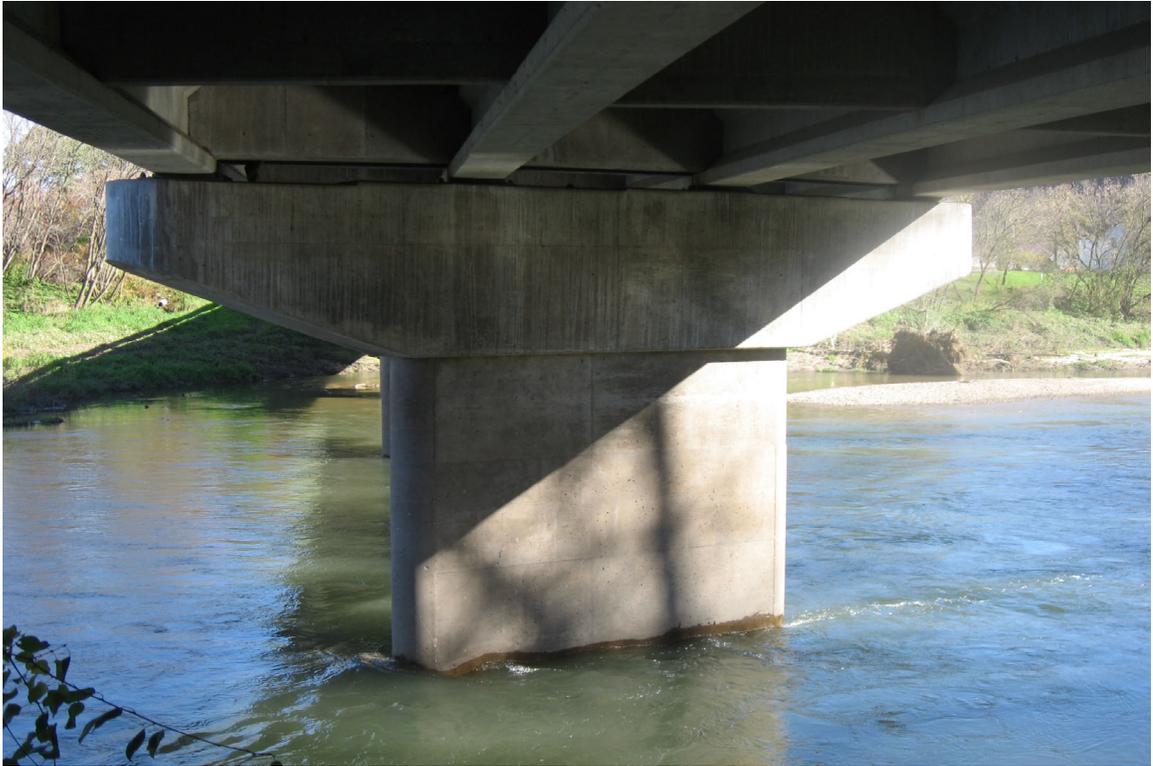
Photograph 1. View of Pier 1, Looking Southeast.

- (A) A minor scour depression was observed at the upstream end of Pier 1 measuring 3 foot deep and 6 feet in radius. The footing was exposed around the entire perimeter of Pier 1, with a maximum vertical face exposure of 3.5 feet at the upstream end and with no undermining detected.
- (B) A minor scour depression was observed at the upstream nose of Pier 3 and measured 6 inches deep by approximately 2 feet in radius with no footing exposure observed.
- (C) A scour depression 4 feet deep by 3 feet in radius was observed at the west face of Pier 4.
- (D) A 12 inch diameter log was observed along the west face of Pier 4. An accumulation of branchy timber debris was observed along the east face and downstream nose of Pier 3. A 2 foot diameter tree was observed at the upstream end of Pier 1 on top of the footing.

- 4 A scour depression, 3 foot deep and 6 feet in radius, was observed at the upstream nose of Pier 1.
- 5 The top of the footing was exposed around the entire perimeter of Pier 1 with up to 3.5 feet of vertical footing exposure at the upstream end of the pier with no undermining observed.

- 8 A 2 feet diameter tree was observed at the upstream end of Pier 1 on the top of footing.
- 9 A 1 foot diameter log was observed along the west face of Pier 4.

- (A) Monitor the timber debris, and if found to be increasing in the future, removal operations may become warranted.
- (B) Since scour screening indicated that bridge is at low risk for scour, only monitor the footing exposure and extent of scour during future inspections.
- (C) Reinspect the submerged substructure units at the normal maximum recommended (NBIS) interval of five (5) years.

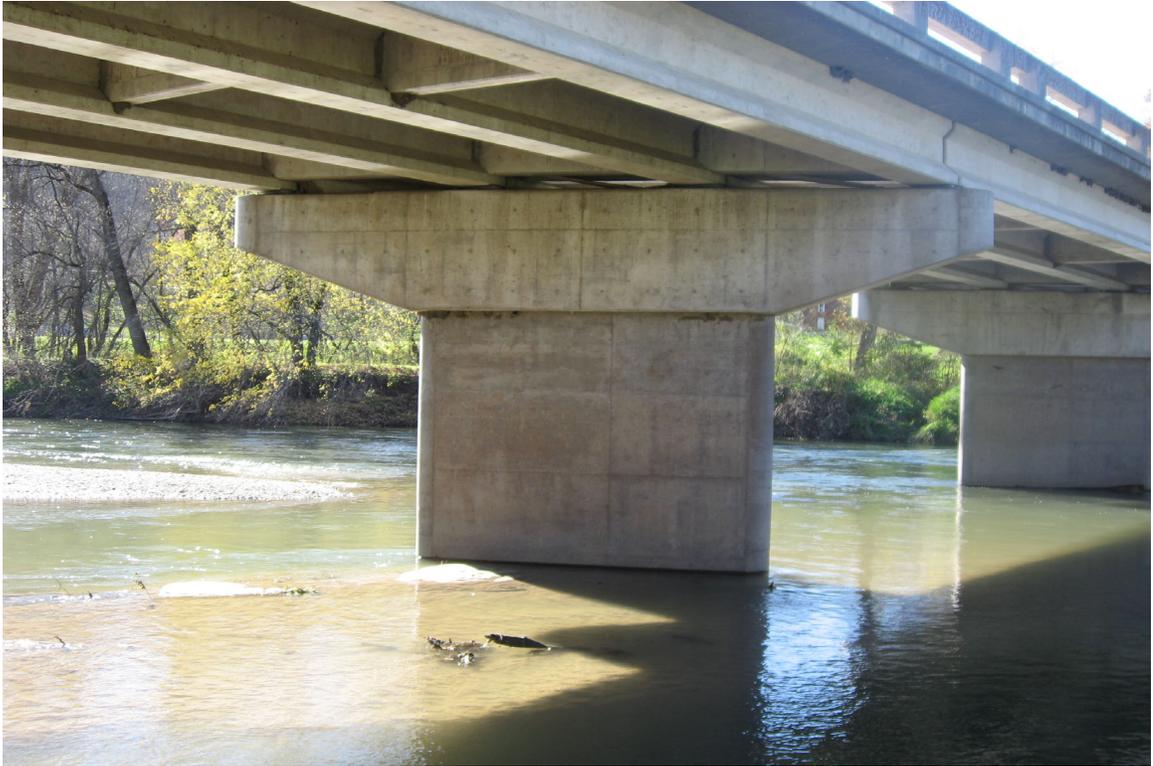
Photograph 3. View of Pier 3, Looking Southwest.

- 6 A scour depression, 6 inches deep and 2 feet in radius, was observed at the upstream nose of Pier 3.
- 7 A light accumulation of branchy timber debris was observed along the east face and downstream nose of Pier 3.

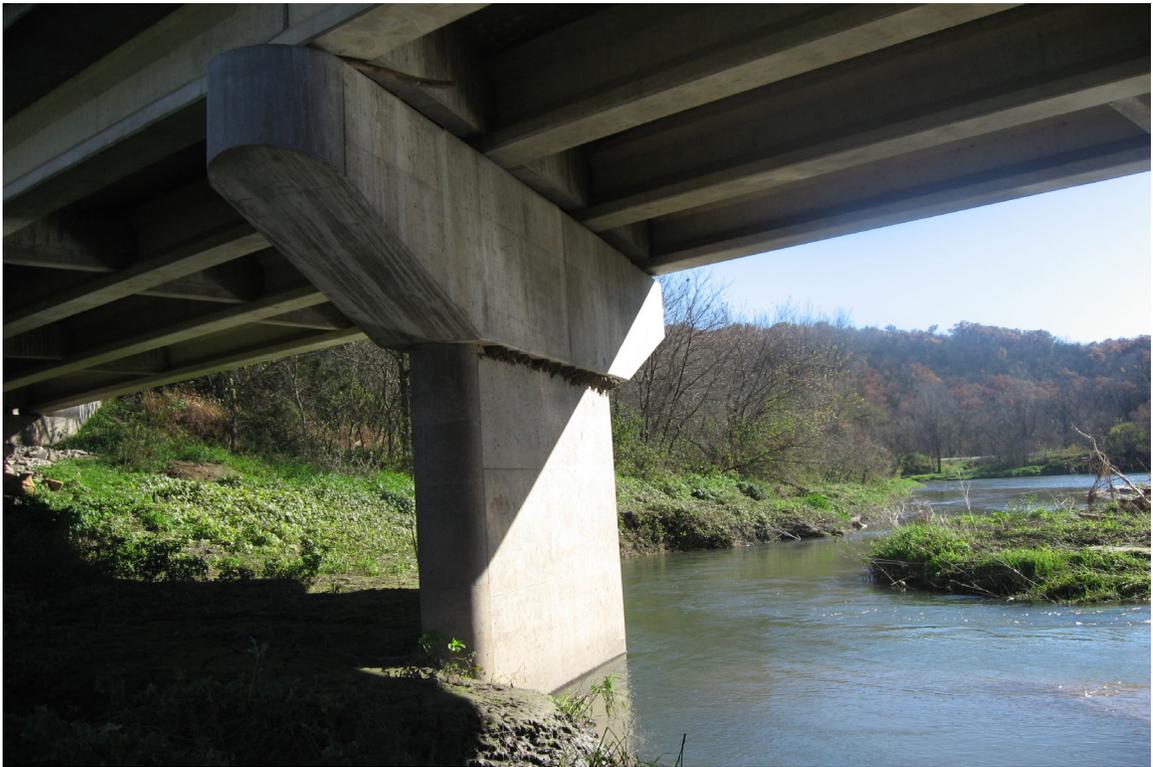
Photograph 4. View of Pier 4, Looking Southeast.

- 10 A scour depression 4 feet deep, 3 feet in radius was observed at the west face of Pier 4.

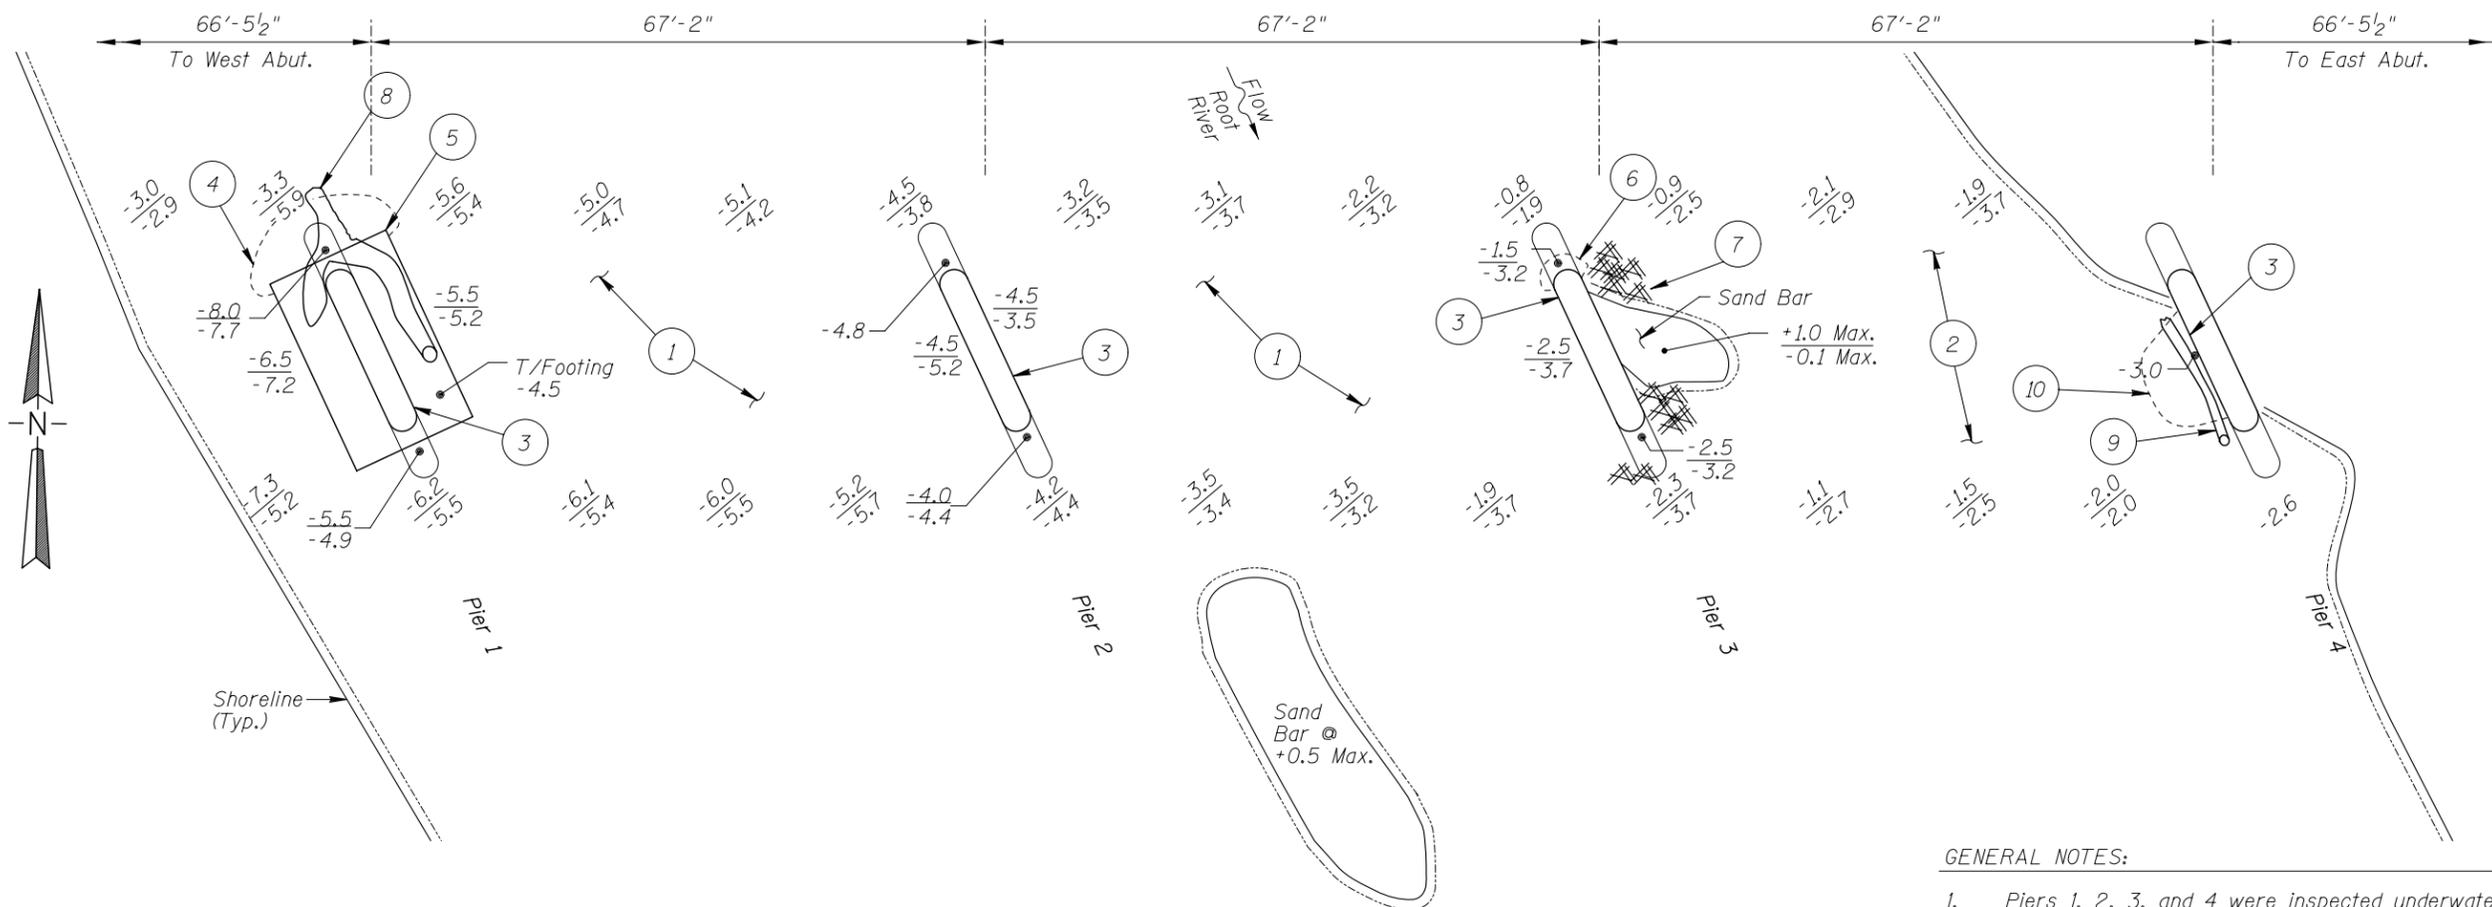
SOUNDING PLAN

- 1 The channel bottom material consisted of firm silty sand with gravel and scattered 5 inch diameter cobbles with maximum probe rod penetrations of 2 to 4 inches.

- 2 The channel bottom material consisted of soft silt over gravel with a maximum probe rod penetration of 1.5 feet.
- 3 The concrete of the piers was in good and sound condition with no significant deterioration.
