UNDERWATER BRIDGE INSPECTION REPORT

STRUCTURE NO. 24506

SHELL ROCK RIVER

DISTRICT 6 - FREEBORN COUNTY, CITY OF ALBERT LEA

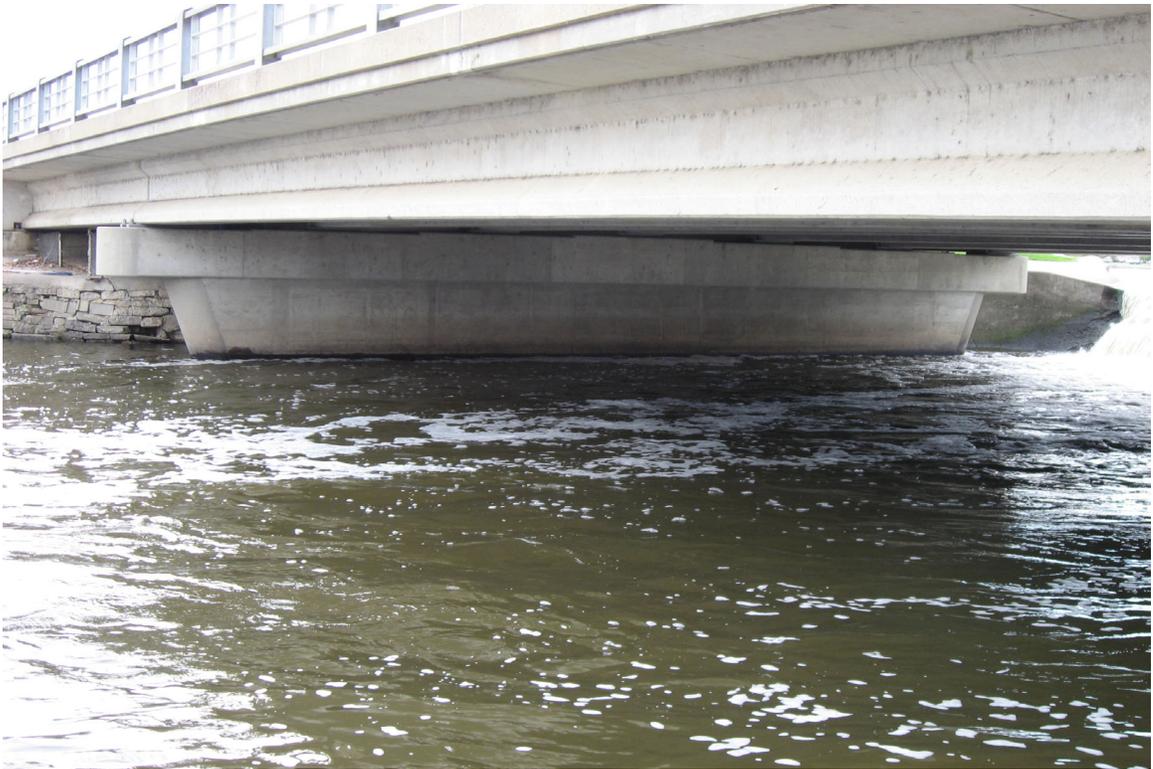
- (A) The concrete of the piers was in good condition with random areas of light scaling observed near the waterline.
- (B) An area of poorly formed concrete and section loss with exposed reinforcing steel was observed on the concrete apron near the downstream end of Pier 2 with 6 inches of maximum penetration.

Photograph 1. View of Pier 1, Looking West.

- (A) Reinspect the submerged substructure units at the normal maximum recommended (NBIS) interval of five (5) years.

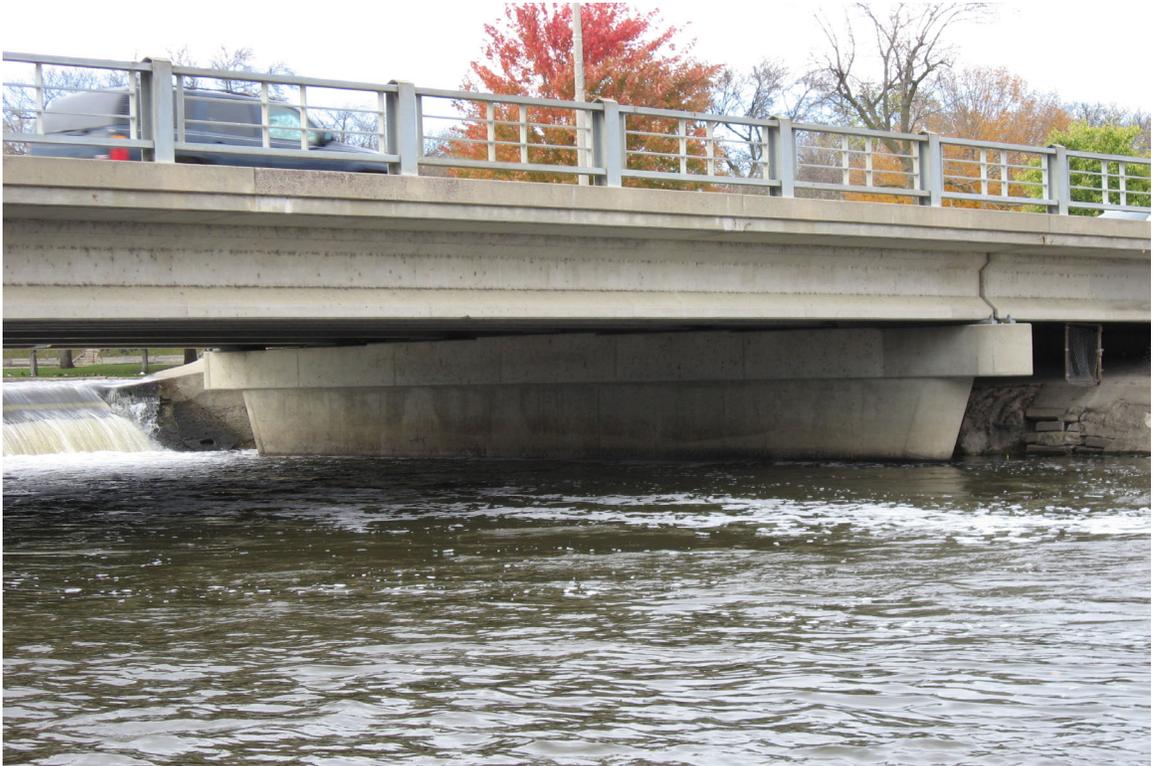
Photograph 2. View of Pier 2, Looking North.

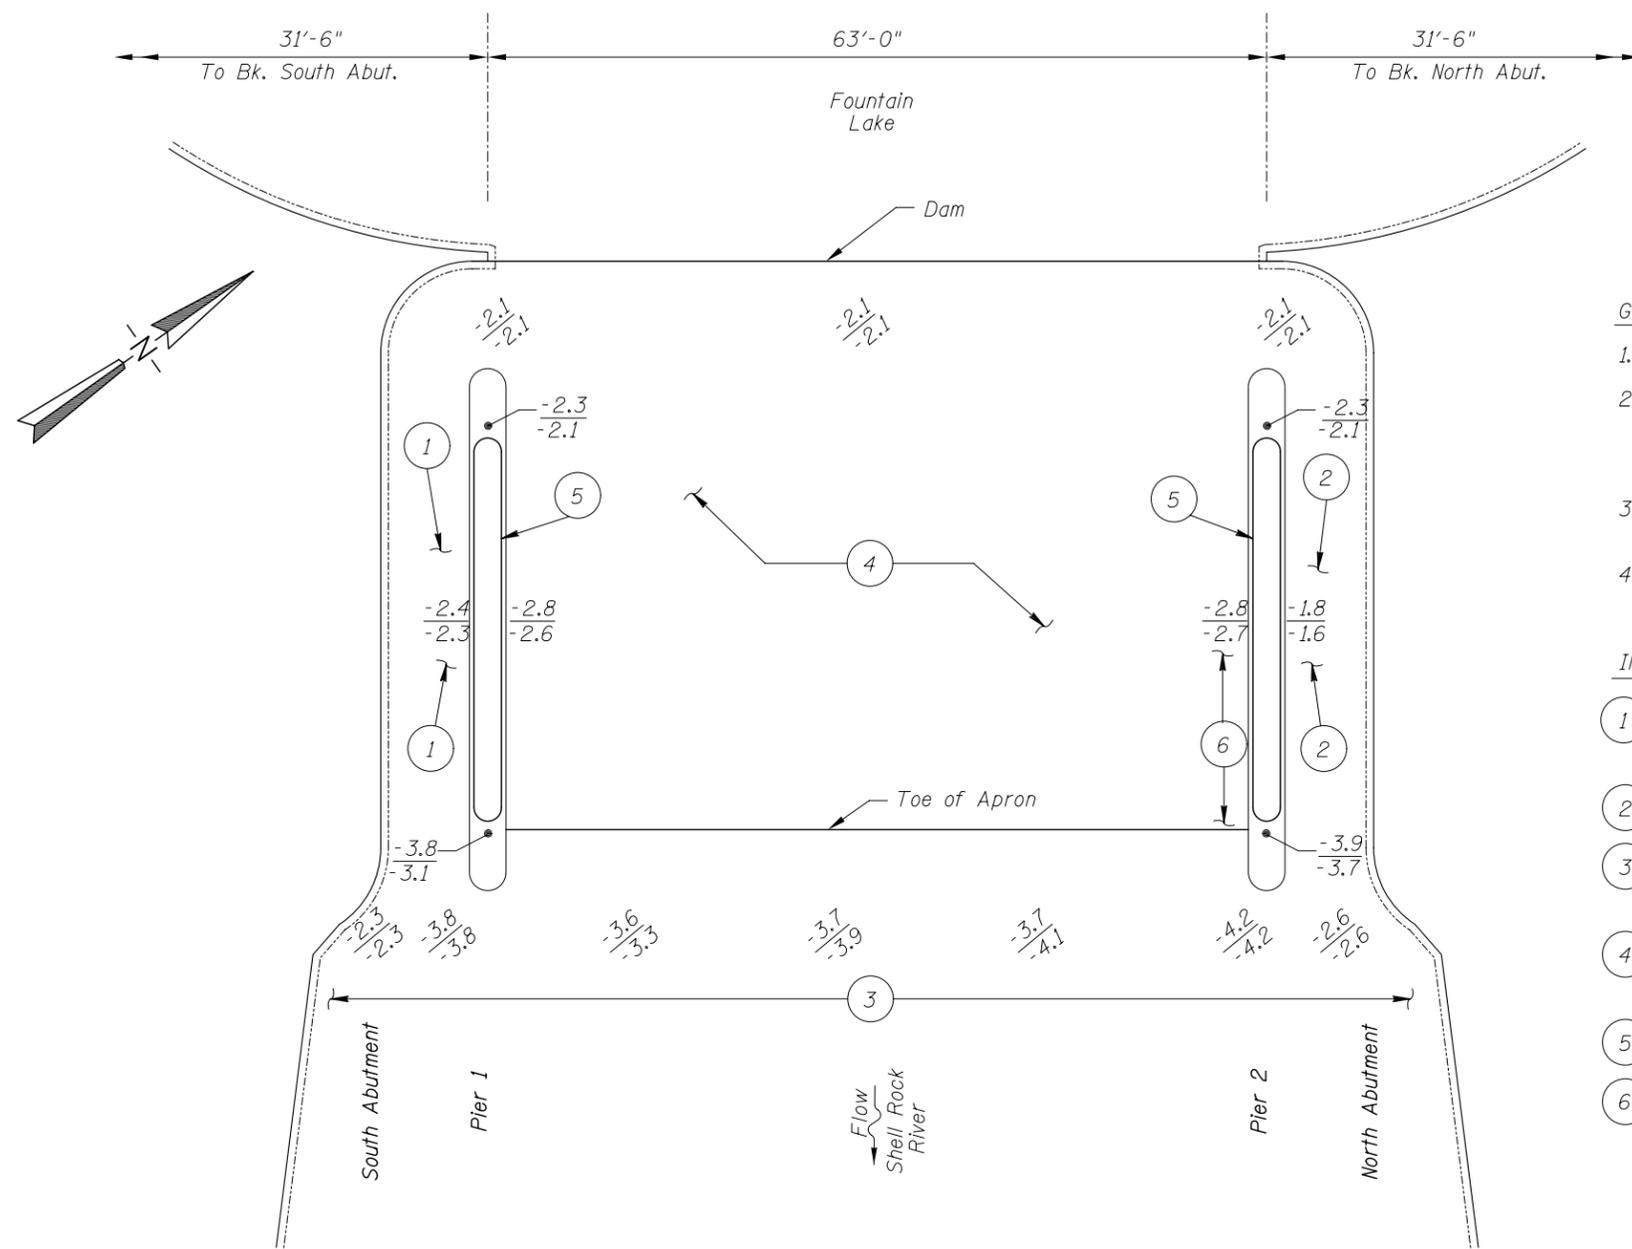
SOUNDING PLAN

- ① The channel bottom material consisted of sand and gravel with random riprap up to 1 foot in diameter.
- ② The channel bottom material consisted of sandy gravel.
- ③ The channel bottom material consisted of silty gravel with scattered cobbles at the end of the concrete apron.
- ④ The channel bottom consisted of a concrete apron. The apron was in good condition with no undermining observed.
- ⑤ Random light scaling was observed near the waterline on both piers.
- ⑥ The concrete apron exhibited a 3 to 4 feet long area of poorly formed concrete and section loss with exposed reinforcing near the downstream end of Pier 2 with 6 inches of penetration.
