UNDERWATER BRIDGE INSPECTION REPORT

STRUCTURE NO. 66505
5th STREET
OVER THE
CANNON RIVER
DISTRICT 6 - RICE COUNTY

PREPARED FOR THE
MINNESOTA DEPARTMENT OF TRANSPORTATION
BY
COLLINS ENGINEERS, INC.
JOB NO.5221

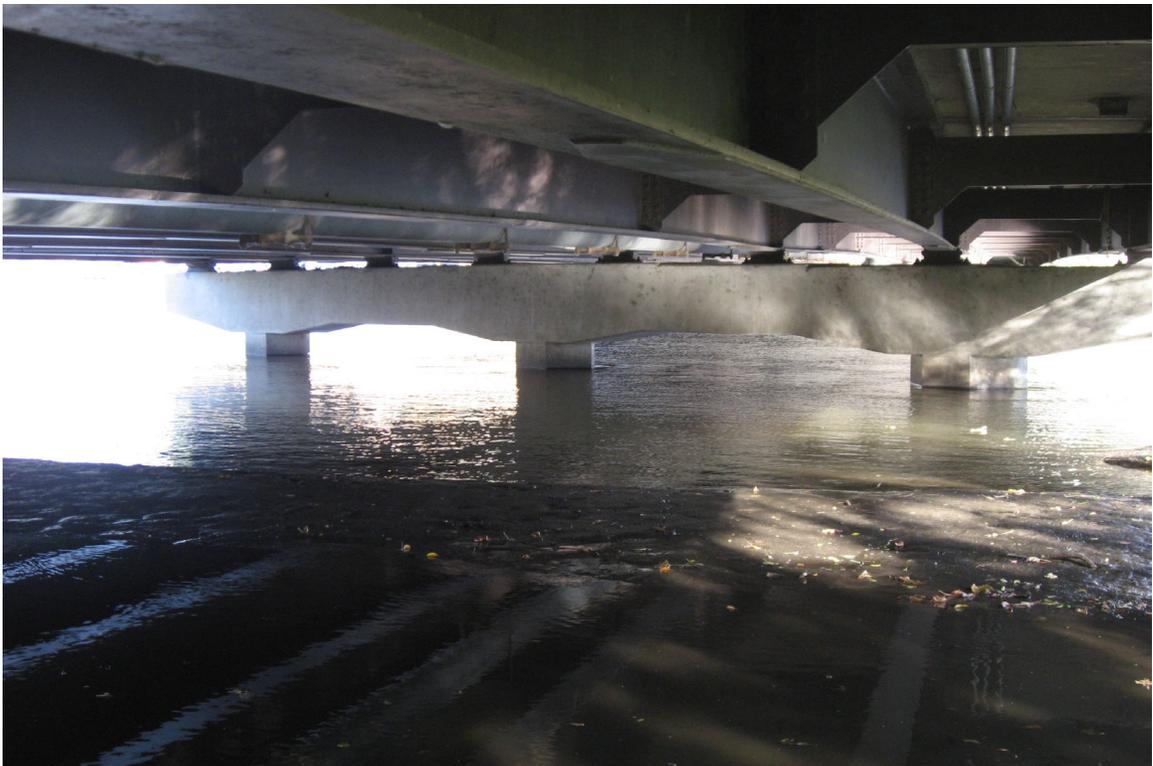
Photograph 2. View of Pier 1, Looking East.

- (A) A light accumulation of 4-inch-diameter and smaller timber debris was observed on the channel bottom along the center column of Pier 1 and at the upstream column of Pier 2.
- (B) The concrete of the piers was typically in smooth and sound condition.

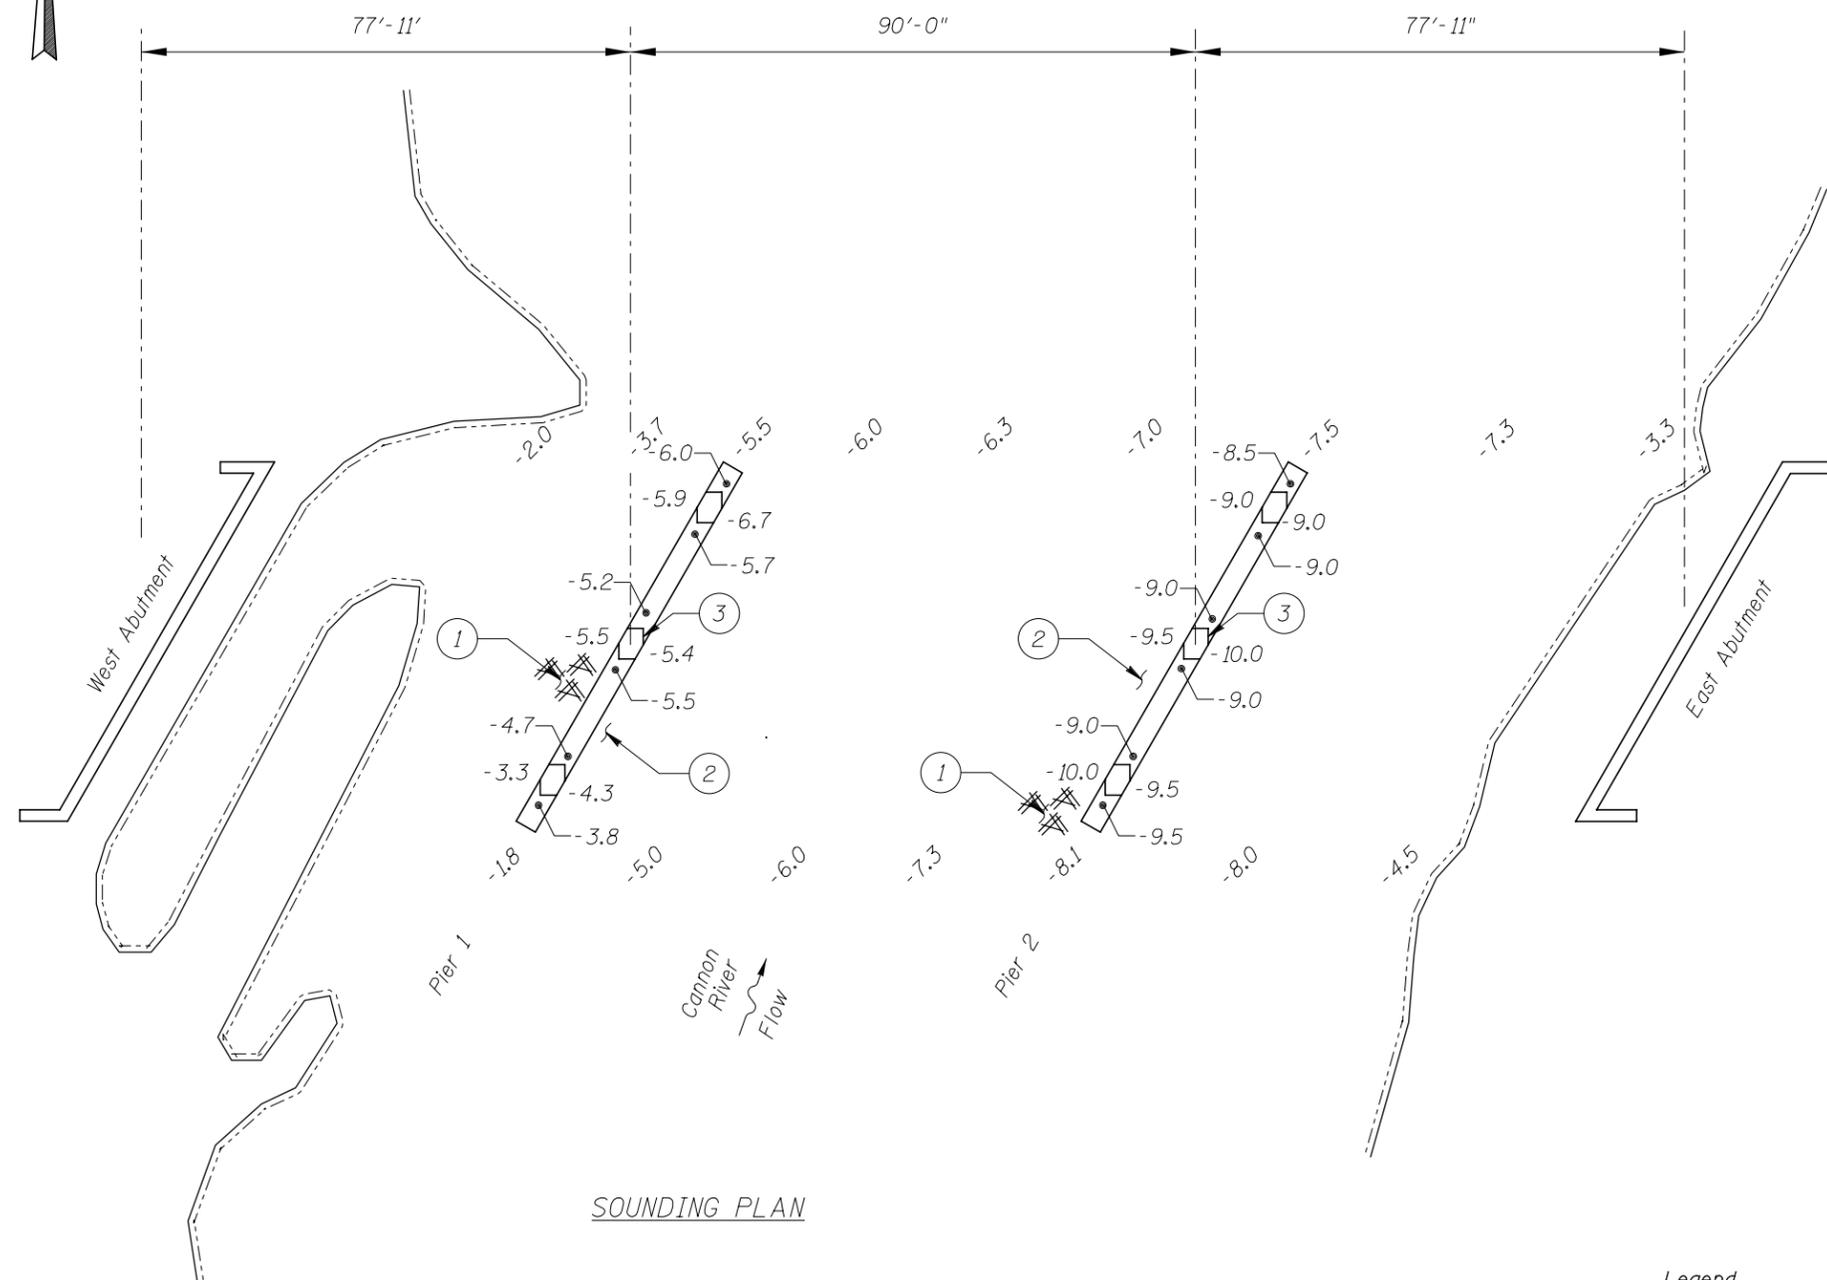
SOUNDING PLAN

- ① A light accumulation of 4-inch-diameter and smaller timber debris was observed on the channel bottom along the center column at Pier 1 and at the upstream column at Pier 2.
- ② The channel bottom consisted of silty clay and sand with up to 8 inches of probe rod penetration.
- ③ The concrete of the columns was typically in smooth and sound condition.
