UNDERWATER BRIDGE INSPECTION REPORT

STRUCTURE NO. 66506
CSAH NO. 11
OVER THE
CANNON RIVER
DISTRICT 6 - RICE COUNTY

PREPARED FOR THE
MINNESOTA DEPARTMENT OF TRANSPORTATION
BY
COLLINS ENGINEERS, INC.
JOB NO. 5221 (CEI 23A)

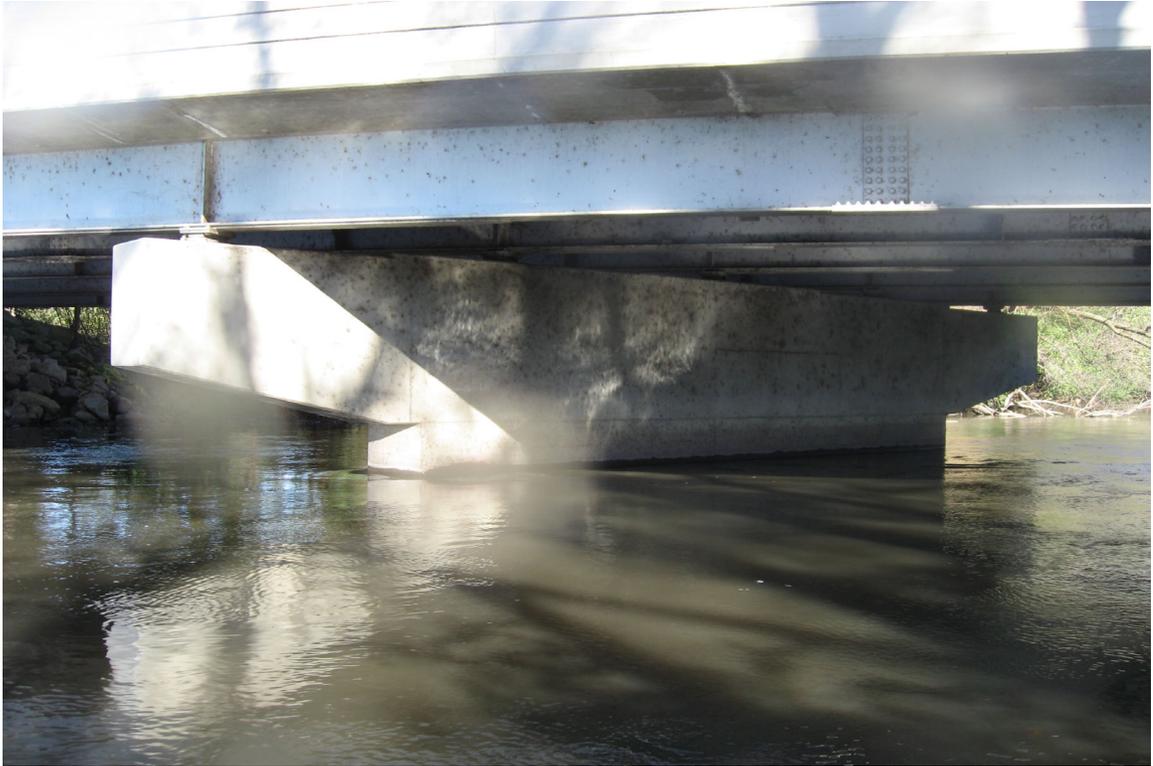
- (A) The concrete was smooth and sound and in good condition with light to moderate scaling from the channel bottom to 2 feet above the waterline exhibiting ¼ inch maximum penetration.

Photograph 1. View of Pier 1, Looking Northeast.

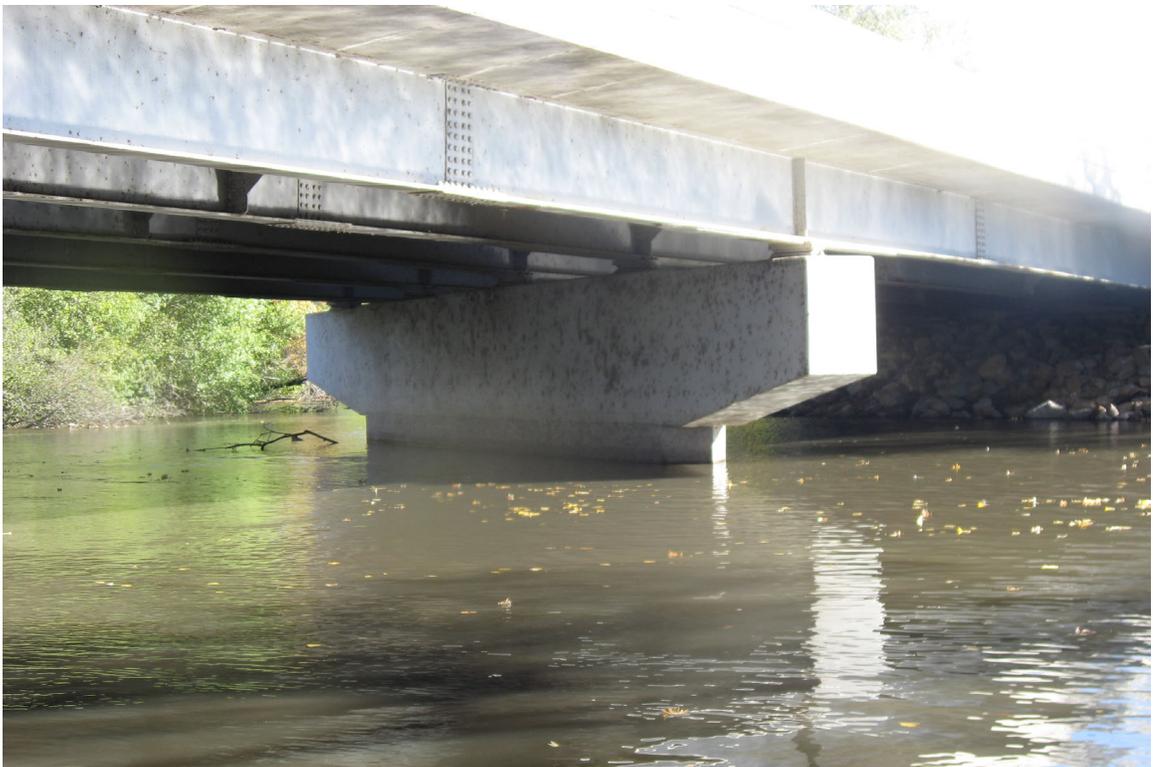
Photograph 2. View of Pier 2, Looking Southeast.

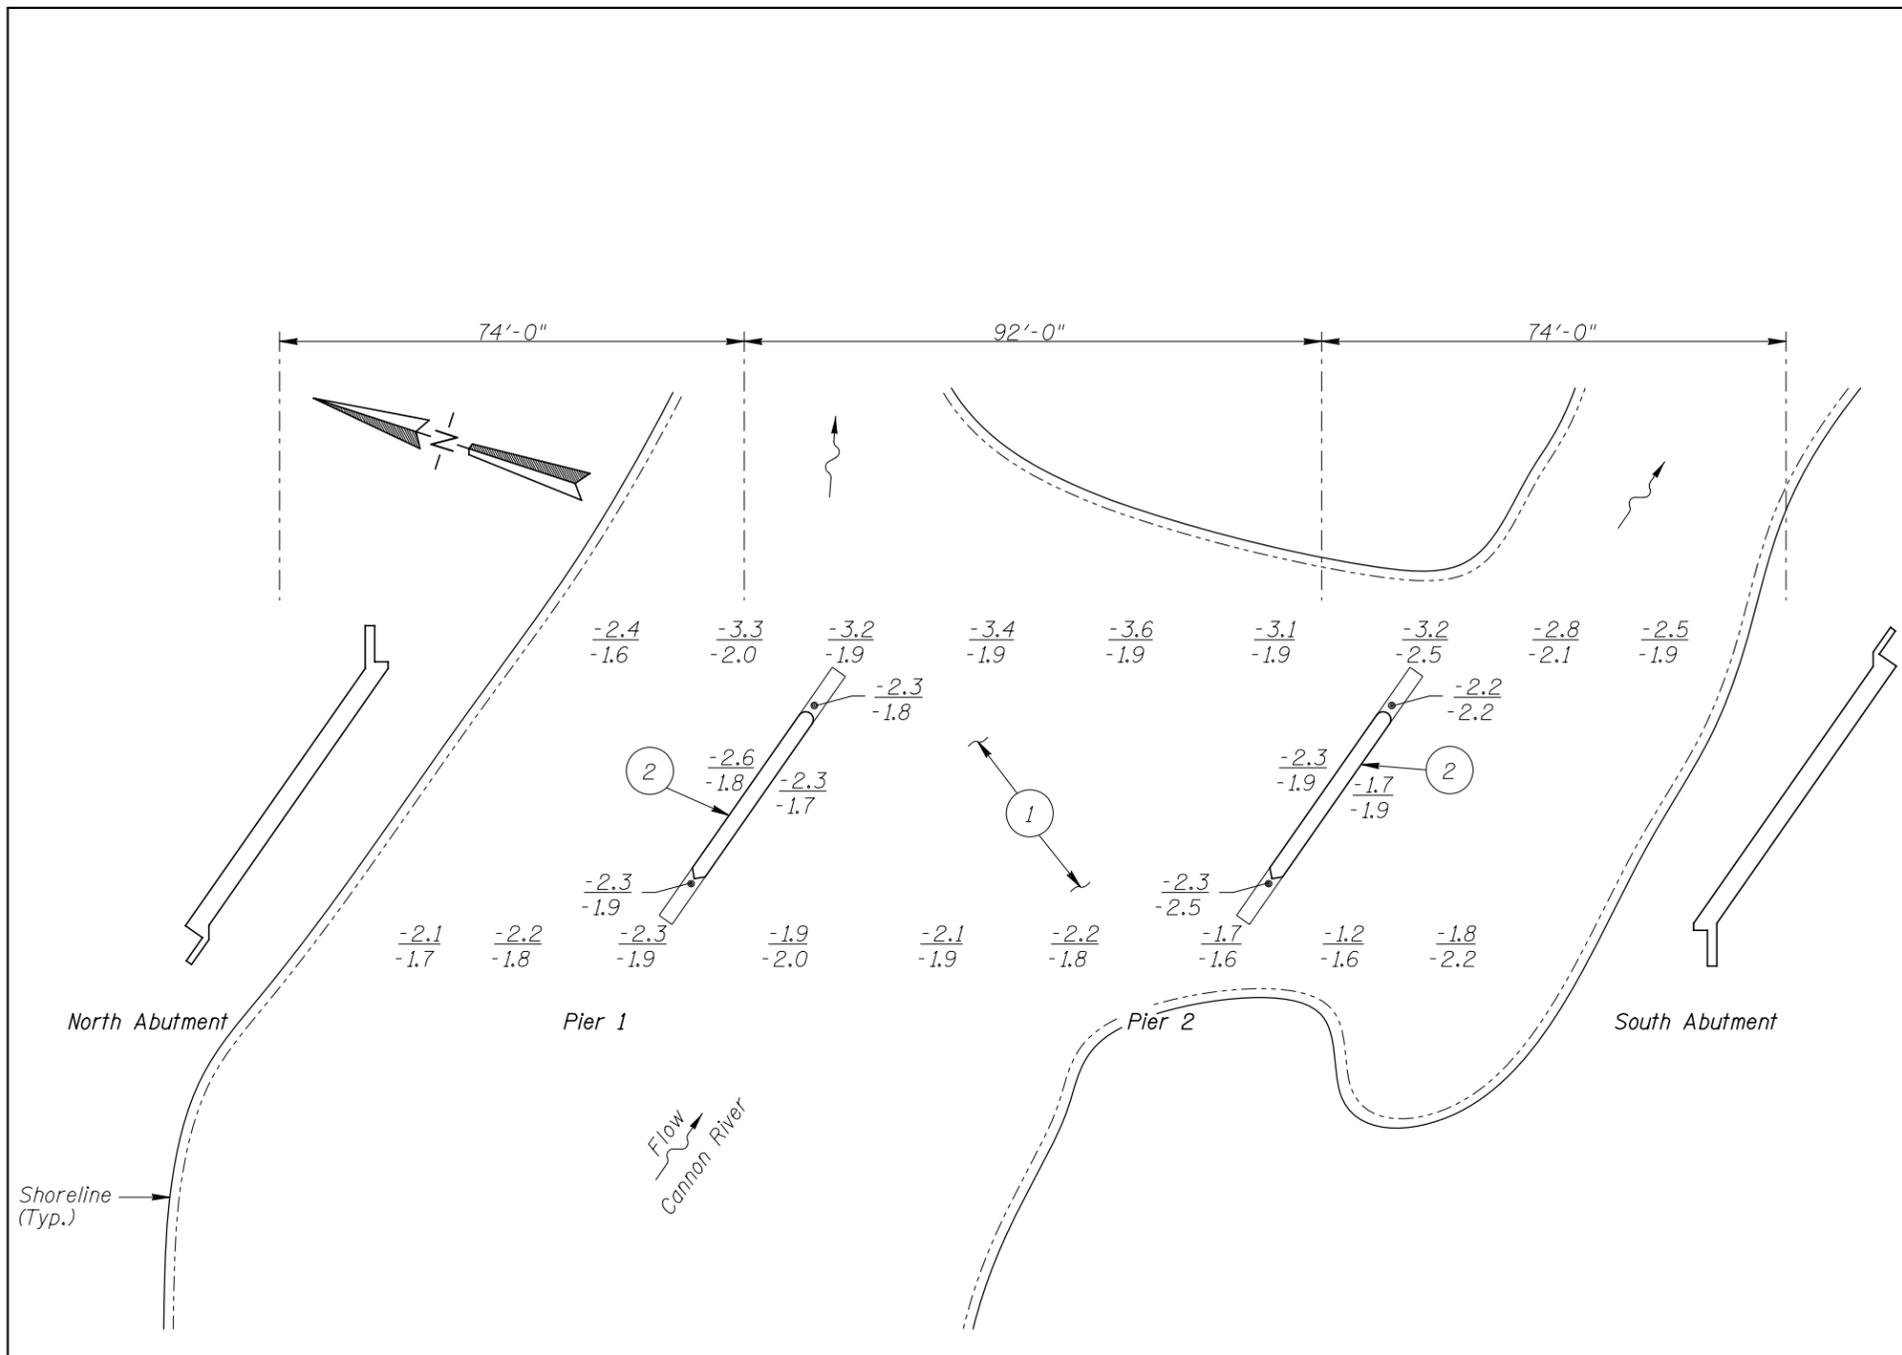
SOUNDING PLAN

- 1 The channel bottom material consisted of gravel and cobbles, 1 foot diameter and smaller, with no appreciable probe rod penetration possible.
- 2 Light to moderate concrete scaling from the channel bottom to 2 feet above the waterline, 1/4 inch maximum penetration.
