UNDERWATER BRIDGE INSPECTION REPORT

STRUCTURE NO. 66508
RAVN STREET (MSAS NO. 108)
OVER THE
STRAIGHT RIVER
DISTRICT 6 - RICE COUNTY

PREPARED FOR THE
MINNESOTA DEPARTMENT OF TRANSPORTATION
BY
COLLINS ENGINEERS, INC.
JOB NO. 5221

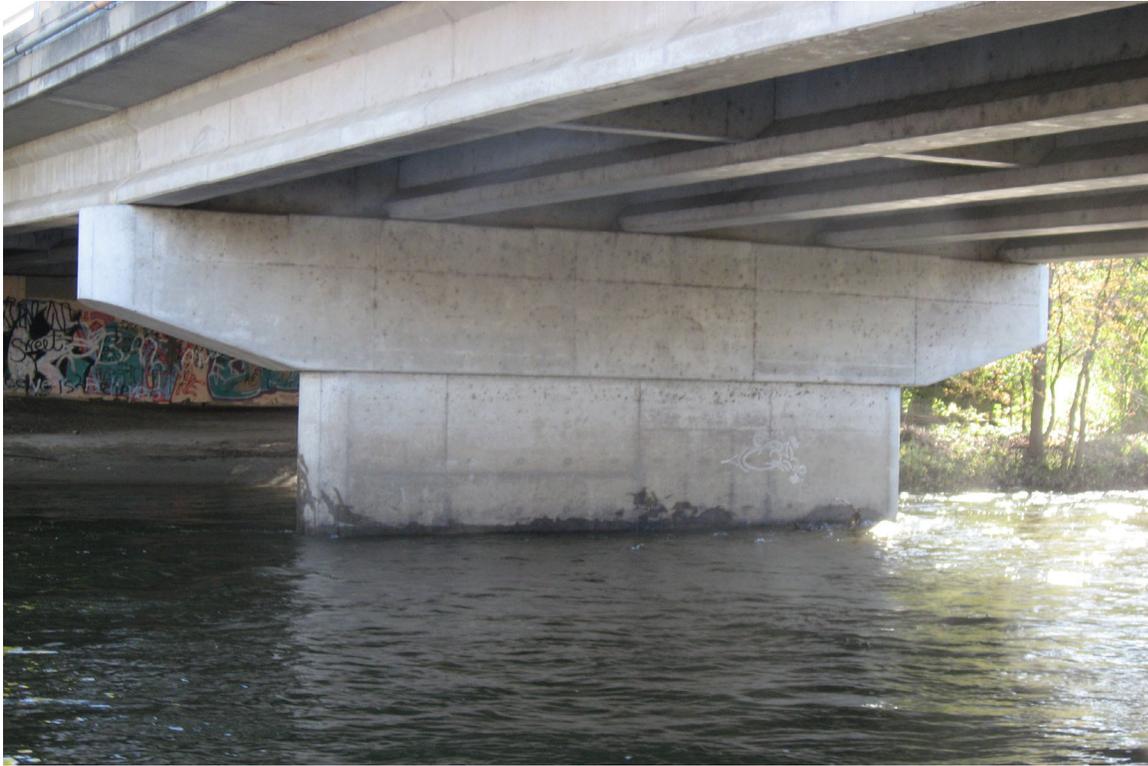
The substructure units inspected at Bridge No. 66508, Center Pier and West Abutment, were sound and in good condition with no structurally significant defects observed. A moderate accumulation of timber debris was observed at the upstream end of the Center Pier. A scour depression was also observed at the upstream end of the pier. The channel bottom appeared stable with only the minor scour at the pier.

- (A) A moderate accumulation of timber debris consisting of logs and branches 1 foot in diameter and smaller was observed at the upstream nose and along the sides to the midpoint on the west face and to 10 feet downstream on the east face, extending from the channel bottom to 1 foot below the waterline.
- (B) A scour depression 5 feet in radius by 1 foot deep was observed at the upstream end of Center Pier.

Photograph 1. View of Center Pier, Looking Southeast.

- (A) Reinspect the submerged substructure units at the normal maximum recommended (NBIS) interval of five (5) years.

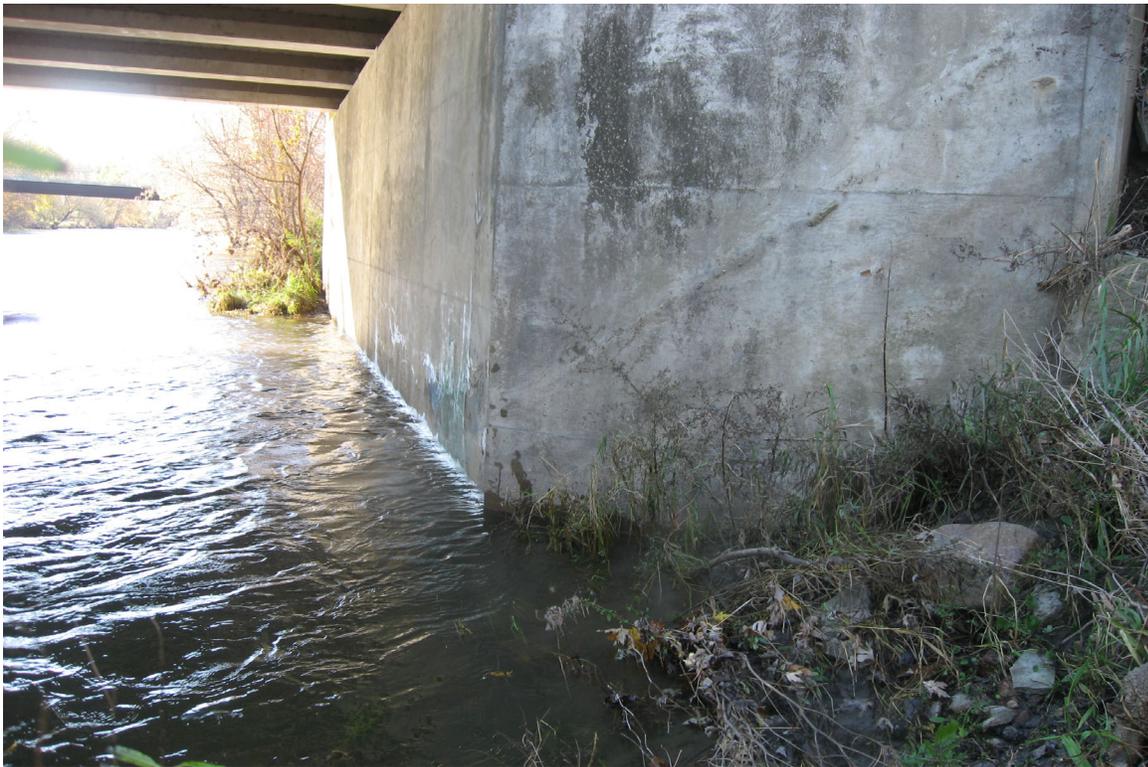
Photograph 2. View of West Abutment, Looking South.

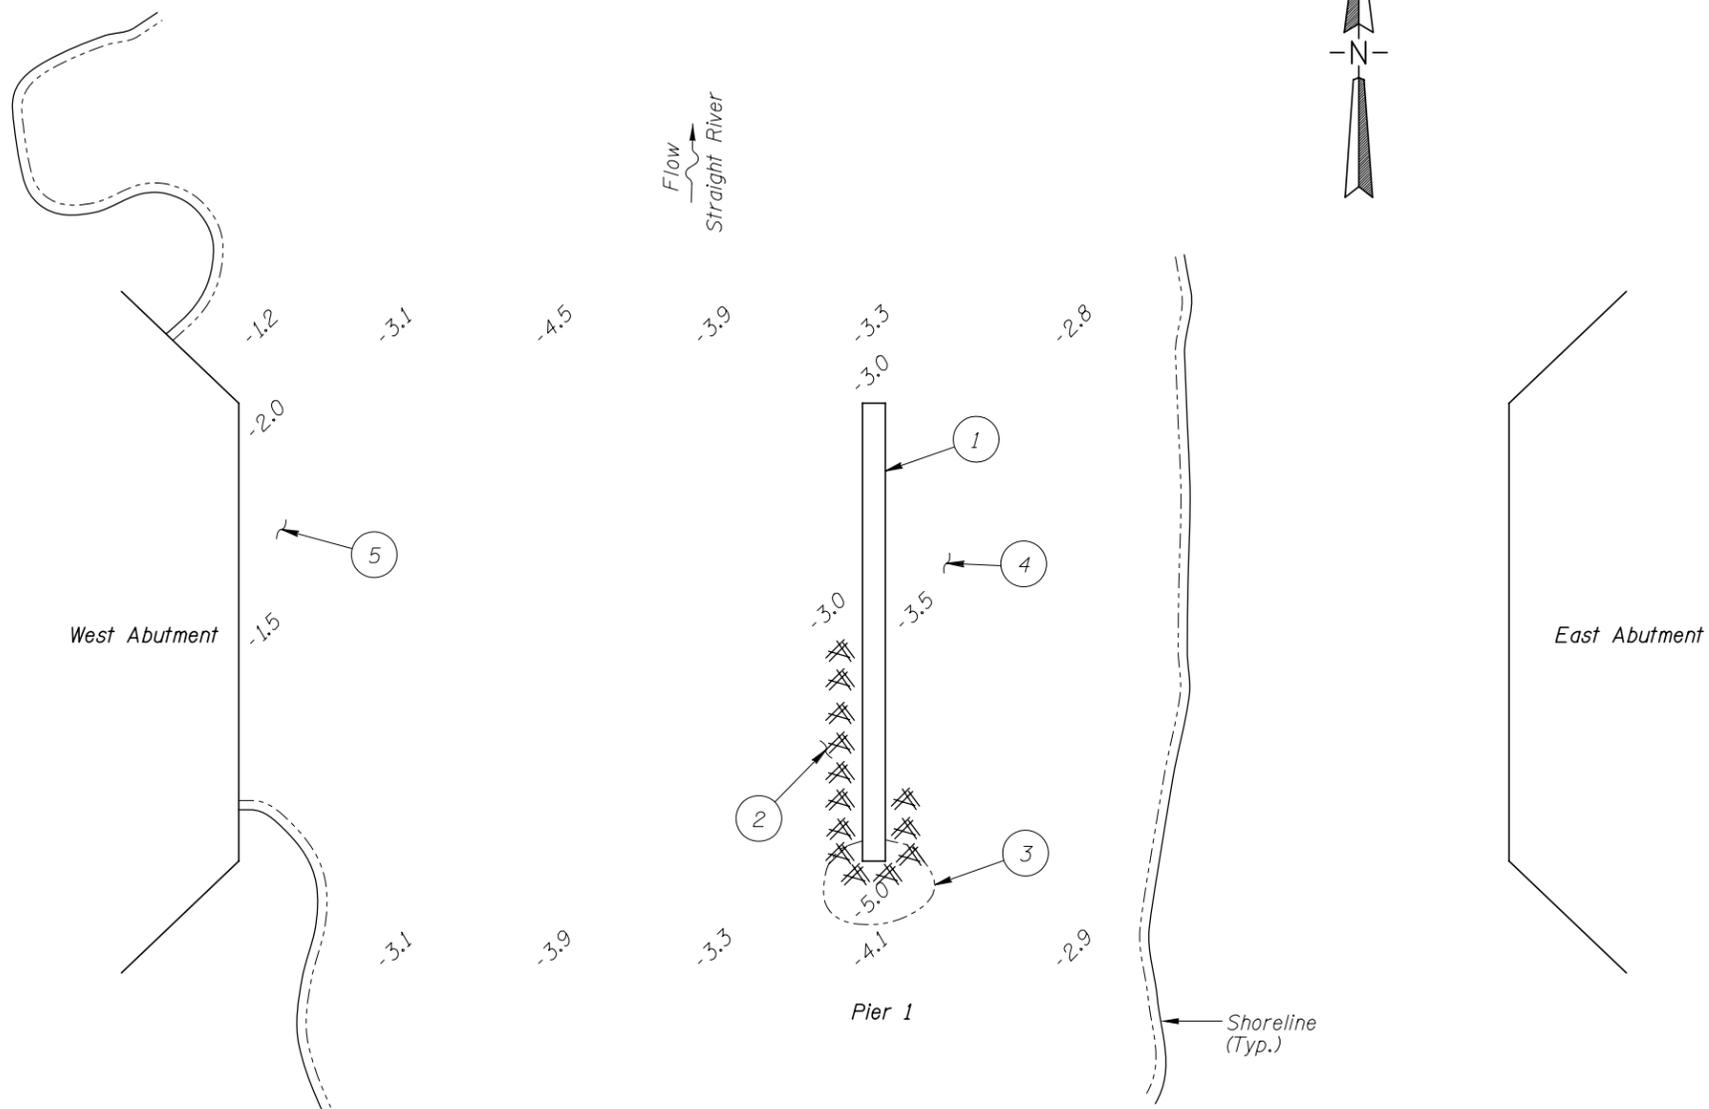
SOUNDINGS PLAN

- ① Concrete was in smooth and sound condition.
- ② A moderate accumulation of timber debris consisting of 1-foot-diameter and smaller logs and branches was observed at the upstream nose and extended along the west face to the midpoint, along the east face for 10 feet, and from the channel bottom up to 1 foot below the waterline.
- ③ A scour depression measuring 5 feet in radius by 1 foot deep was observed at the upstream nose of Pier 1.
- ④ The channel bottom consisted of rocks and gravel with a probe rod penetration up to 2 inches at the upstream and downstream noses and rocks and gravel with no probe rod penetration at the midpoints.
- ⑤ The channel bottom consisted of sand with up to 6 inches of probe rod penetration along most of the West Abutment with rocks and no probe rod penetration at the downstream end.
