UNDERWATER BRIDGE INSPECTION REPORT

STRUCTURE NO. 66548
C.S.A.H. 29
OVER THE
CANNON RIVER
DISTRICT 6 - RICE COUNTY

PREPARED FOR THE
MINNESOTA DEPARTMENT OF TRANSPORTATION
BY
COLLINS ENGINEERS, INC.
JOB NO.5221

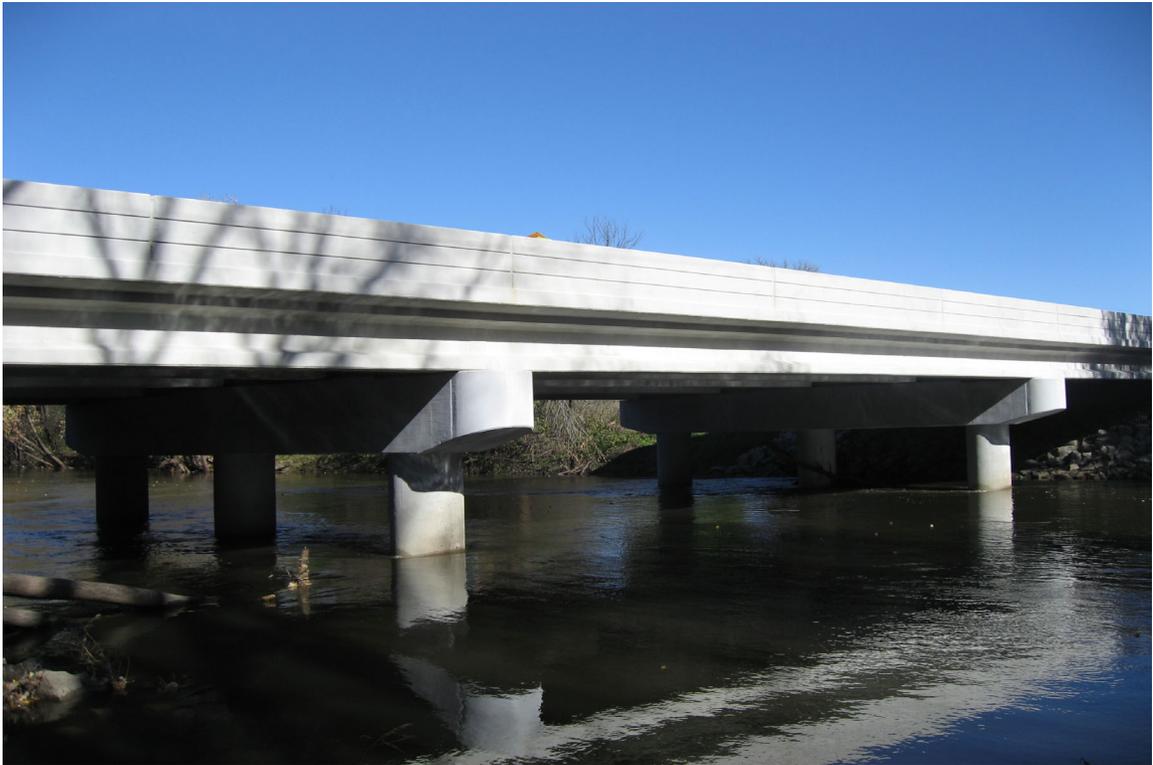
Photograph 1. Overall View of Bridge, Looking Northeast.

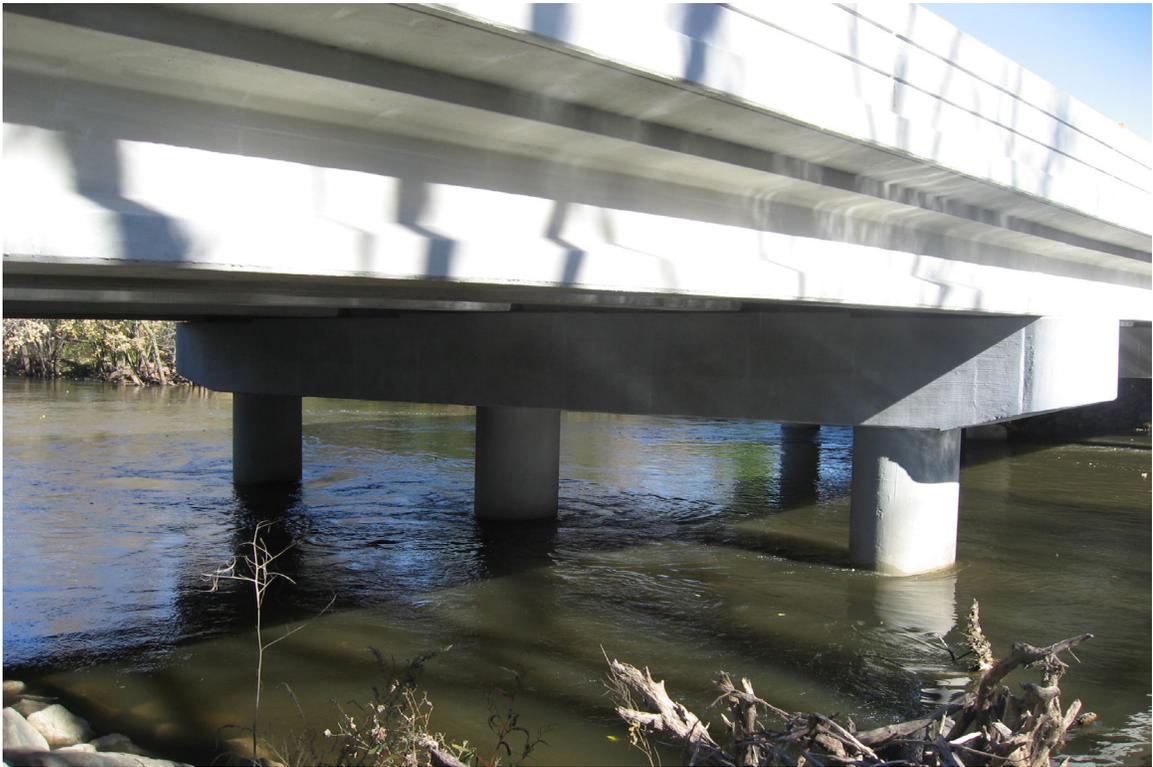
- (A) A moderate accumulation of 1-foot-diameter and smaller timber debris (primarily one tree trunk) was observed at the upstream column of Pier 1 that extended towards the west embankment.
- (B) A moderate accumulation of 2-foot-diameter and smaller timber debris was observed at the center column of Pier 2 that extended from the channel bottom up to 5 feet above the waterline.
- (C) The concrete of the piers was typically in smooth and sound condition.

Photograph 2. View of Pier 1, Looking Northeast.

- (A) Monitor the extent of the timber debris accumulation at both piers, and if shown to be increasing, removal during routine maintenance may become necessary.

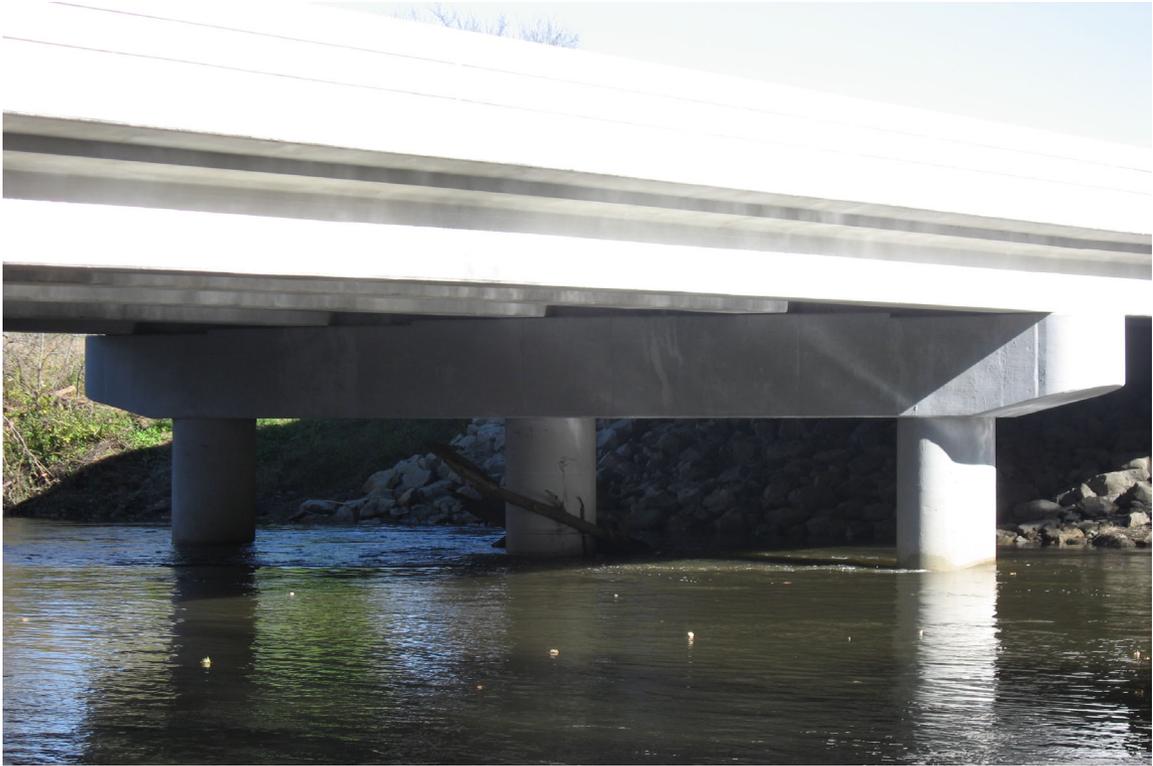
Photograph 3. View of Pier 2, Looking Northeast.

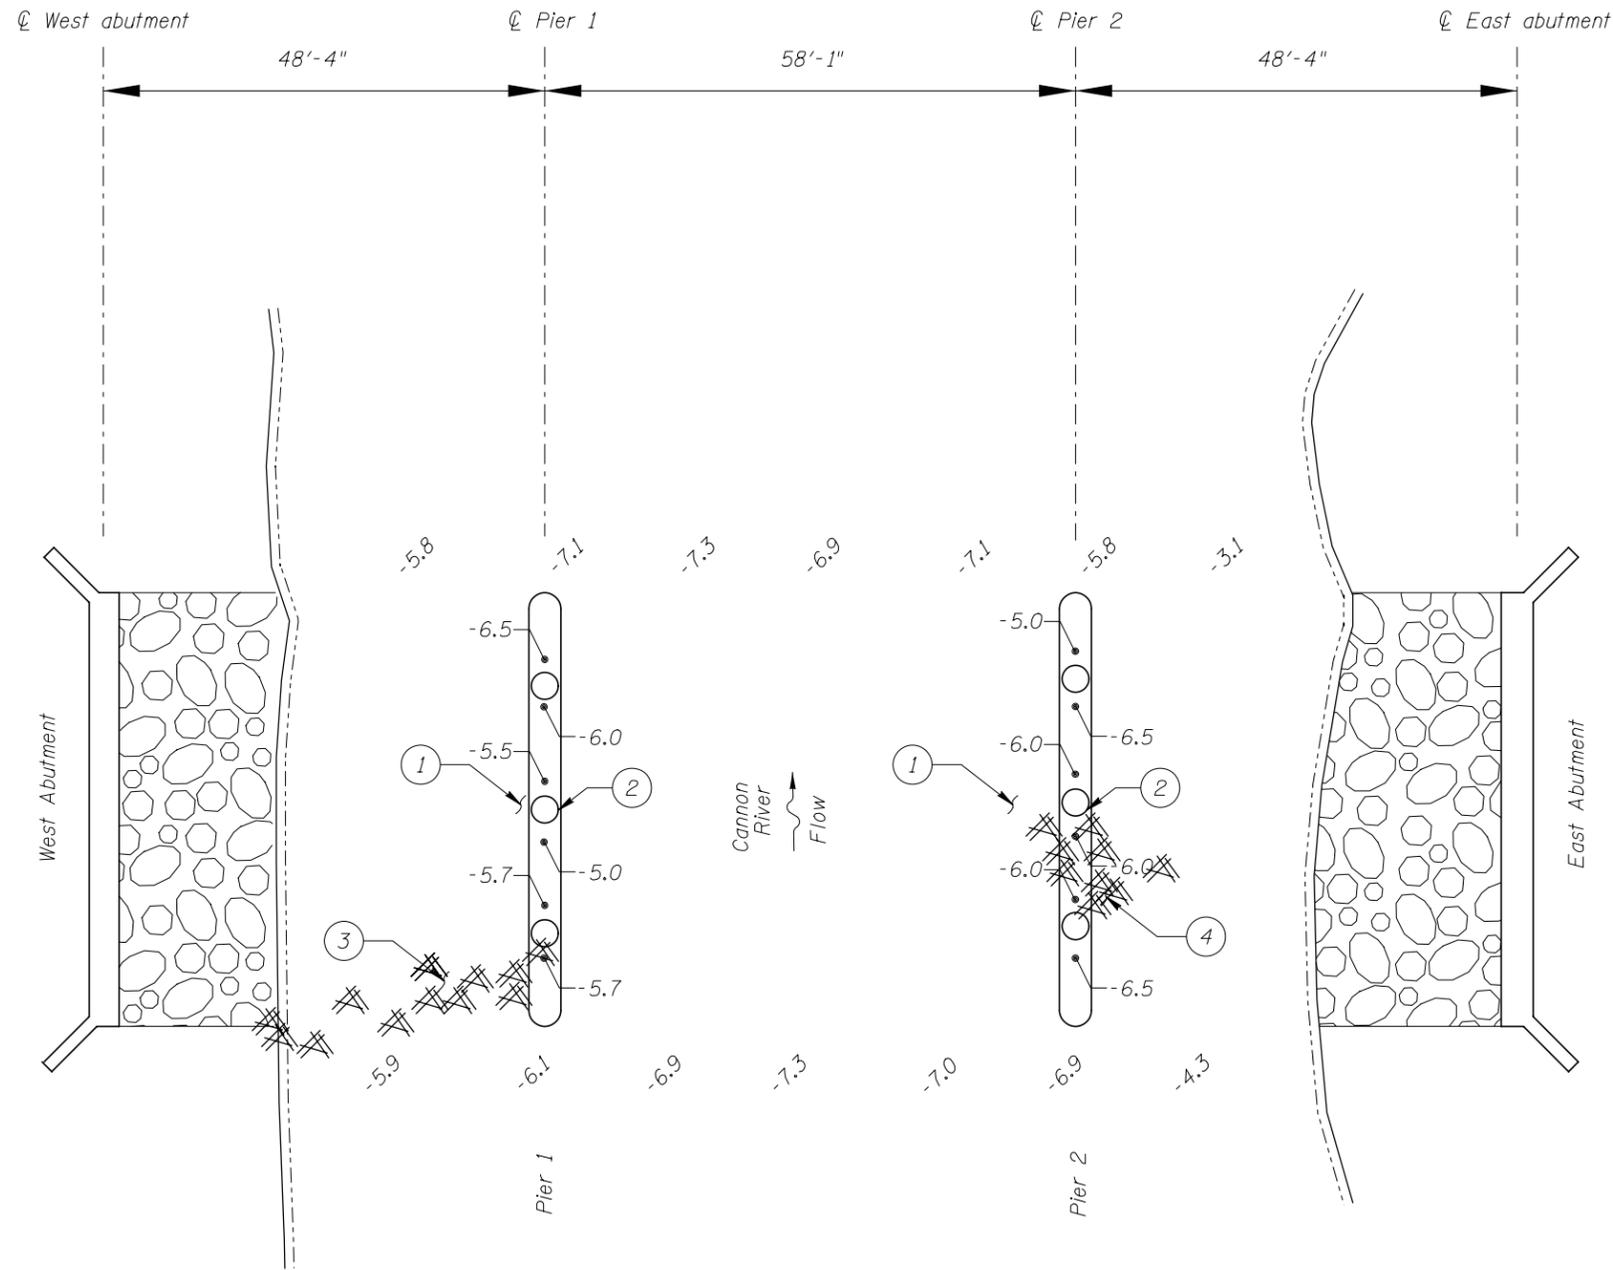
INSPECTION AND SOUNDING PLAN

- ① The channel bottom consisted of rock and gravel with soft silt infilling with minimal probe rod penetration.
- ② Concrete of the columns was in smooth and sound condition.
- ③ A moderate accumulation of 1-foot-diameter and smaller timber debris (primarily one tree trunk) was observed at the upstream column of Pier 1 and extended towards the west embankment.
- ④ A moderate accumulation of 2-foot-diameter and smaller timber debris was observed at the center column of Pier 2 and extended from the channel bottom up to 5 feet above the waterline.

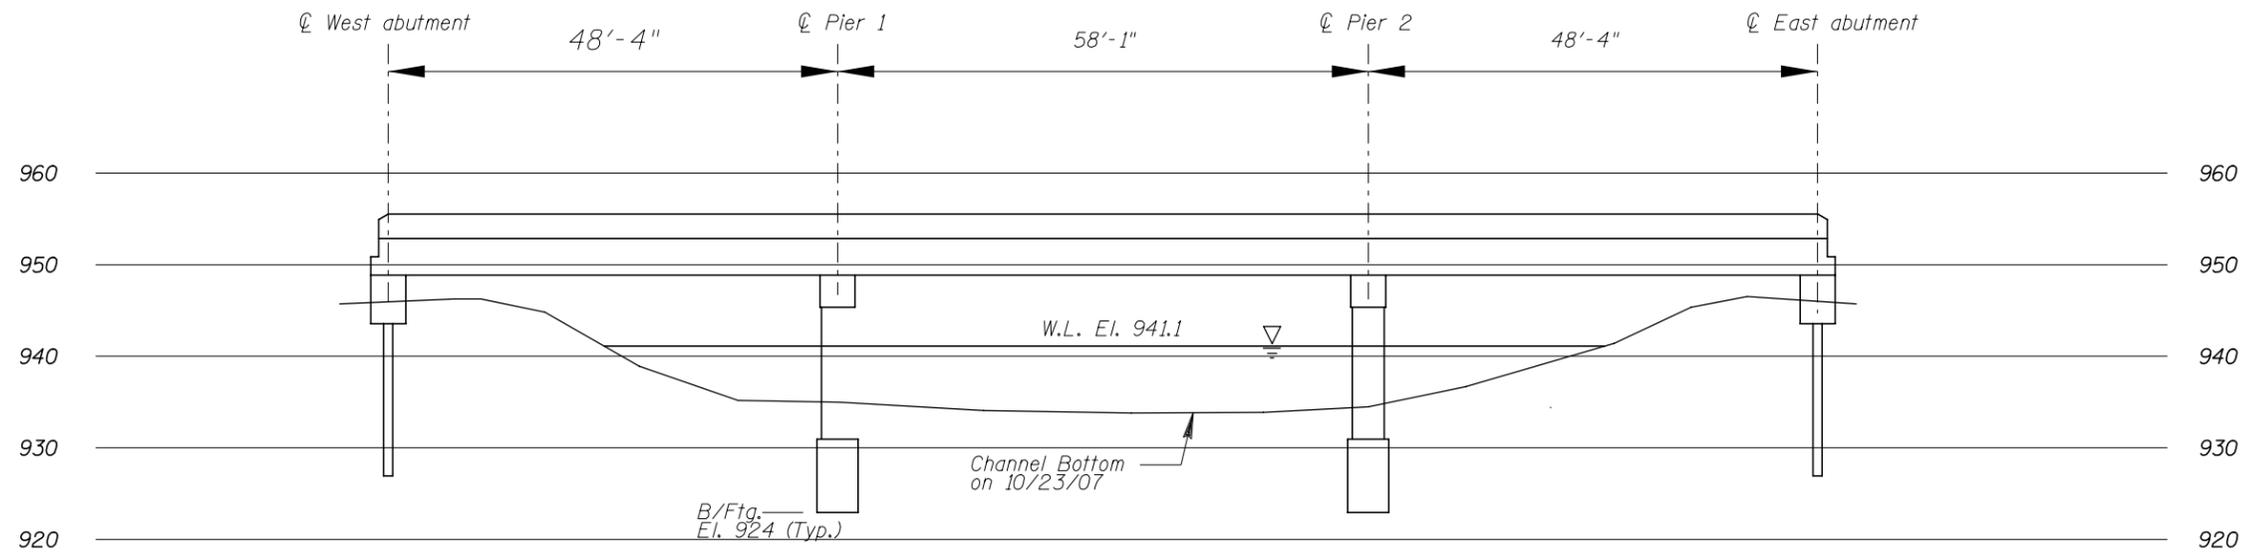
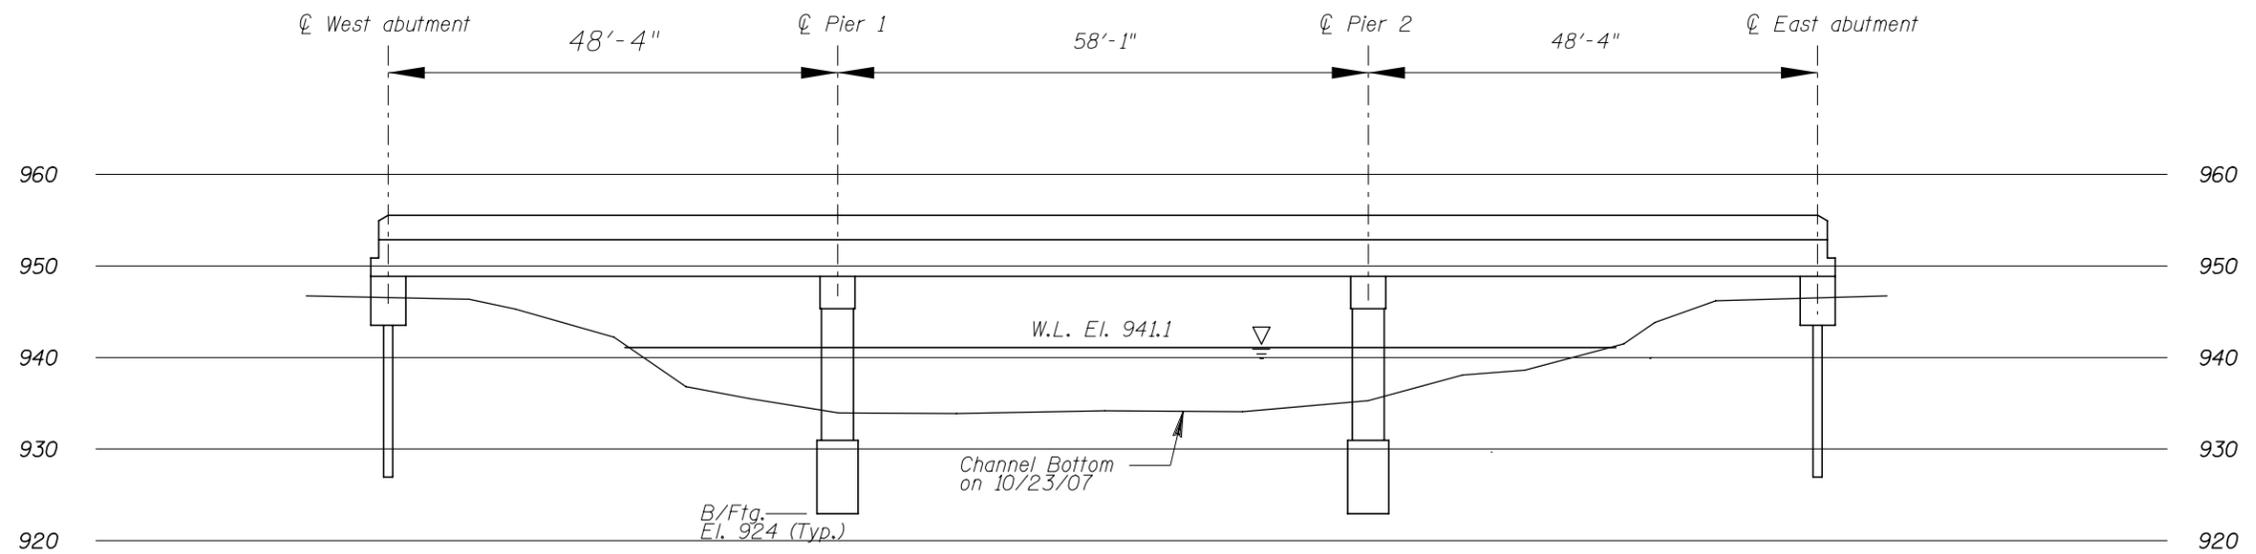
UPSTREAM FASCIA PROFILE

DOWNSTREAM FASCIA PROFILE
