UNDERWATER BRIDGE INSPECTION REPORT

STRUCTURE NO. 89188
7th STREET
OVER THE
ZUMBRO RIVER
DISTRICT 6 - RICE COUNTY

PREPARED FOR THE
MINNESOTA DEPARTMENT OF TRANSPORTATION
BY
COLLINS ENGINEERS, INC.
JOB NO.5221

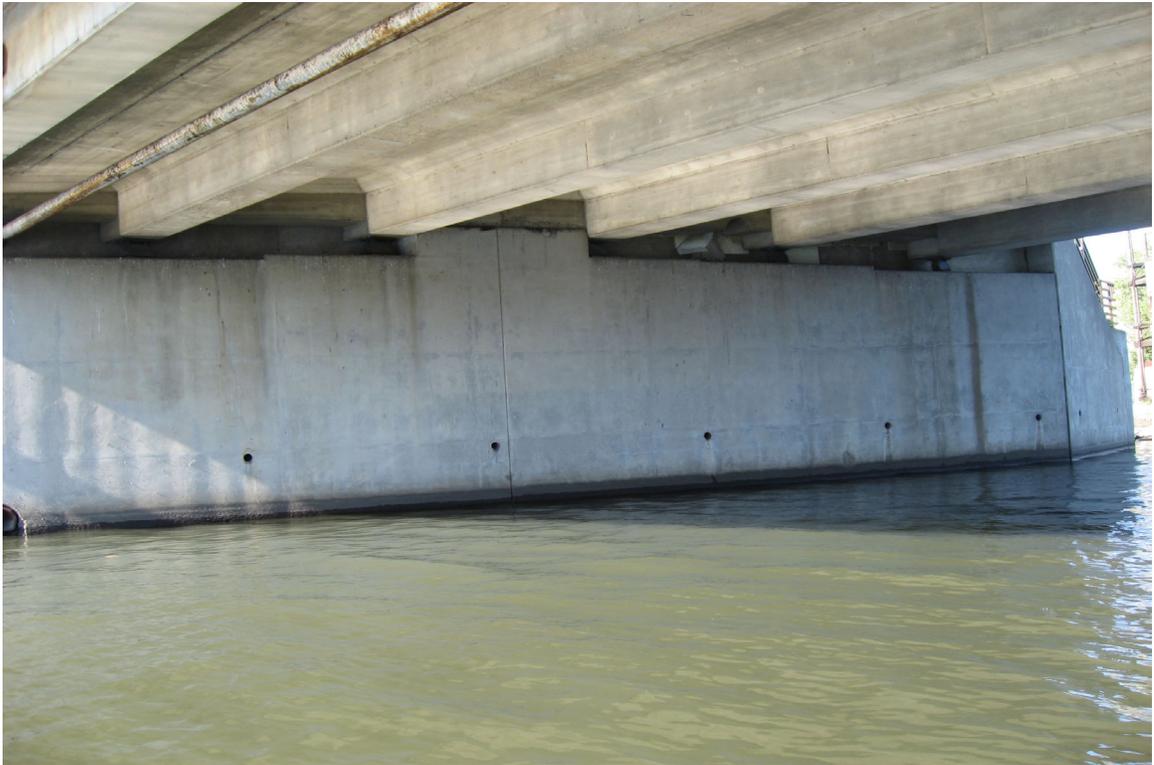
Photograph 1. Overall View of the West Abutment, Looking Northwest.

- (F) A 4-inch-diameter spall was observed at the upstream quarter point along the West Abutment with up to 2 inches of penetration and an associated hairline crack that extended to the wingwall.
- (G) A 1/16-inch-wide vertical crack was observed along the entire center joint along the West Abutment.
- (H) A hairline crack was observed at the downstream quarter point of the West Abutment that extended from the top of the abutment to the top of the concrete scour protection at the channel bottom.
- (I) A vertical hairline crack extended from the bottom of the pier cap to the channel bottom at the downstream quarter point along the west side of Pier 2.
- (J) A light accumulation of 6-inch-diameter and smaller timber debris was observed at the upstream end of Pier 1.

- 8 A vertical 1/8-inch-wide crack was observed at the upstream 1/4 point along West Abutment and extended from the top of the abutment to the concrete scour protection.

- 9 A 4-inch-diameter spall was observed near the outfall at the upstream 1/4 point along the West Abutment with up to 2 inches of penetration and an associated hairline crack that extended to the wingwall.

- 10 A 1/16-inchwide vertical crack was observed at along the middle joint of the West Abutment.
- 11 A hairline crack was observed at the downstream 1/4 point of the West Abutment and extended from the top of abutment to top of concrete scour protection.

- (A) Monitor the cracking along the pier shafts at Piers 1, 2 and 3 and the West Abutment, with special attention to the minor 1/16-inch-wide differential along the northern end of Pier 1 for any further progression and/or movement.
- (B) Monitor the extent of the timber debris accumulation at Piers 1 and 2, and if shown to be increasing, removal during routine maintenance may become necessary.
- (C) Reinspect the submerged substructure units at the normal maximum recommended (NBIS) interval of five (5) years.

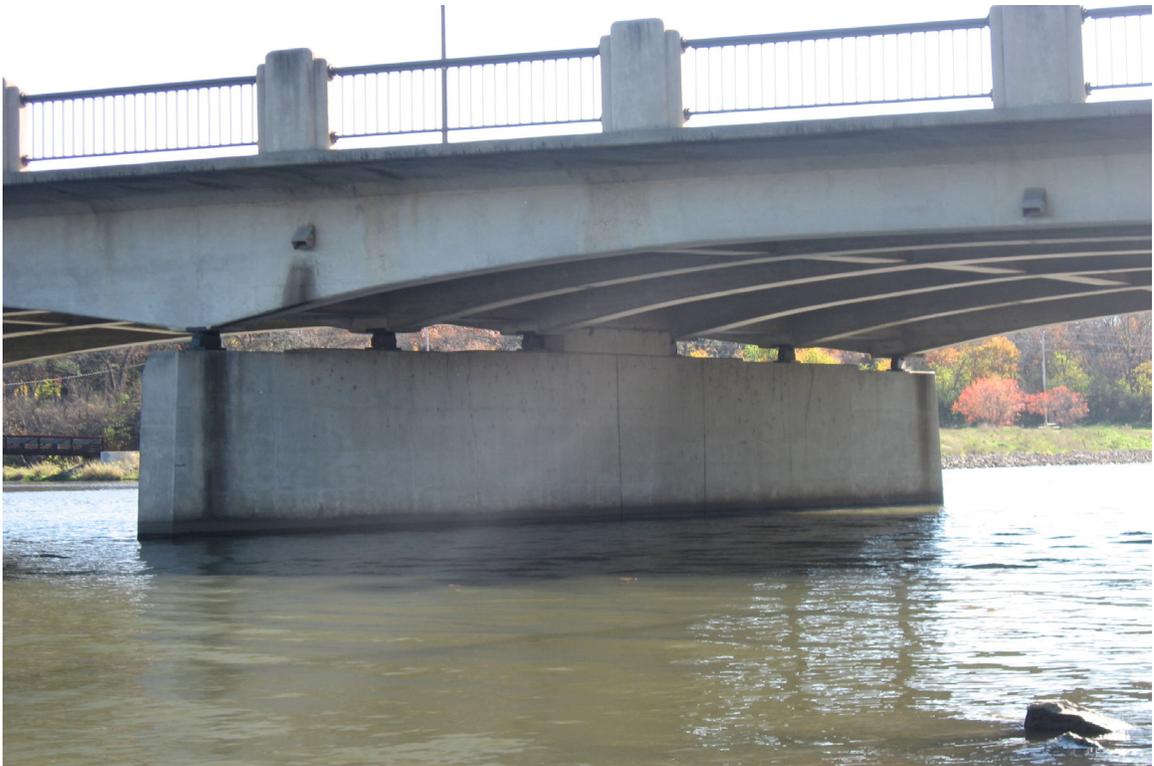
Photograph 2. View of Pier 1, Looking Southeast.

- (B) Four vertical hairline to 1/4-inch-wide cracks were observed along the pier shaft at Pier 1 that extended from the top of the pier to the concrete scour protection at the channel bottom. All of the cracks extended through the full depth of the pier shaft.

- (C) A 1/16-inch-wide differential (in direction of pier shaft depth) was observed along one of the 1/4-inch-wide cracks at the downstream quarter point of Pier 1.

- (D) A light accumulation of 3-inch-diameter and smaller timber debris was observed at the upstream end of Pier 2.
- (E) A moderate accumulation of 3-inch-diameter and smaller timber debris was observed at the upstream end of Pier 1 that extended from the channel bottom up 2 feet.

- 5 Four vertical hairline to 1/4-inch-wide cracks were observed along pier shaft and extended from the top of the pier to top of the concrete scour protection. All cracks extended through the full depth of the pier shaft.

- 6 A 1/16-inch differential (east / west) was observed at the top of the pier shaft at the northern 1/4 point along the southernmost 1/4-inch wide crack.

- 7 A moderate accumulation of 3-inch-diameter and smaller timber debris was observed at the upstream end of Pier 1 and extended from the channel bottom up 2 feet.

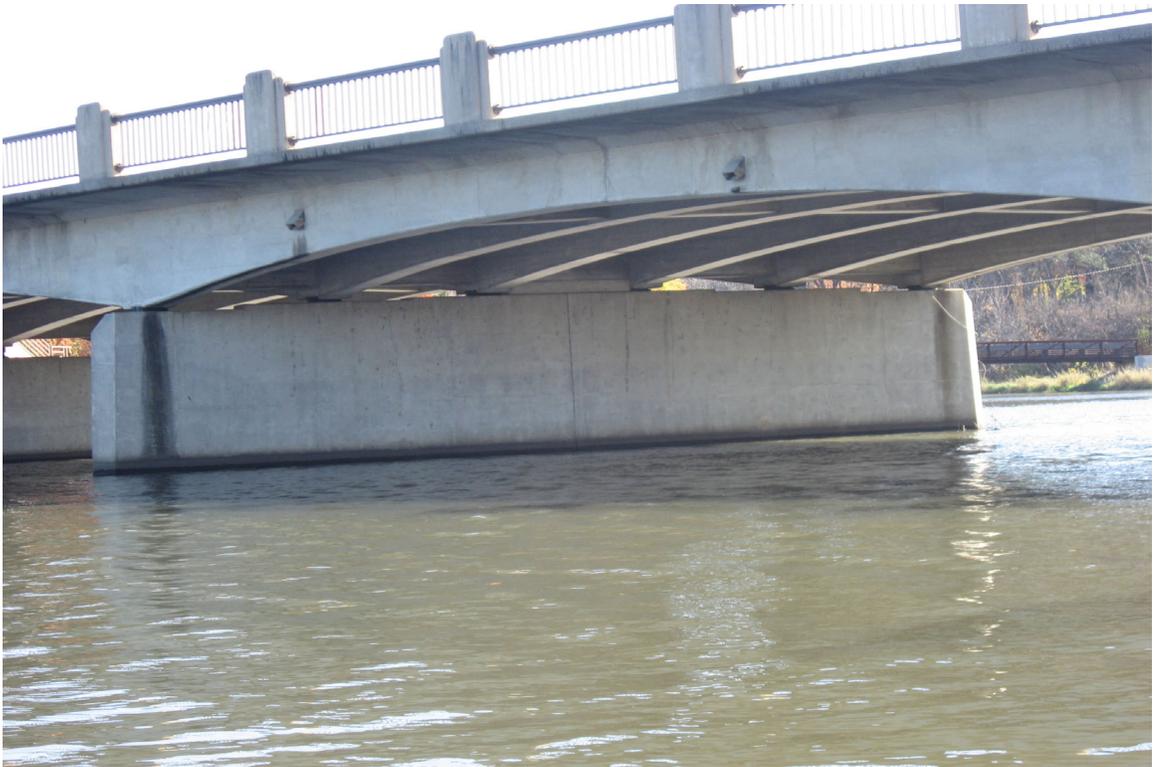
Photograph 3. View of Pier 2, Looking Southeast.

- (A) Two vertical 1/18-inch-wide cracks were observed at the upstream and downstream quarter points along the pier shaft at Piers 2 and 3 that extended from the top of the pier to the concrete scour protection at the channel bottom. All of the cracks extended through the full depth of the pier shafts.

- 1 The concrete piers were typically in smooth and sound condition.
- 2 Two vertical 1/8-inch-wide cracks were observed at the upstream and downstream 1/4 points along the pier shaft and extended from the top of the pier to the top of the concrete scour protection. Both cracks extended through the full depth of the pier shaft.

- 3 A light accumulation of 3-inch-diameter and smaller timber debris was observed at the upstream end of Pier 2.
- 4 The channel bottom consisted of gravel and silty sand outside of the concrete scour protection around the substructure units.
