UNDERWATER BRIDGE INSPECTION REPORT

STRUCTURE NO. L4675

WEISEL CREEK

MINNESOTA DEPARTMENT OF TRANSPORTATION  
UNDERWATER BRIDGE INSPECTION

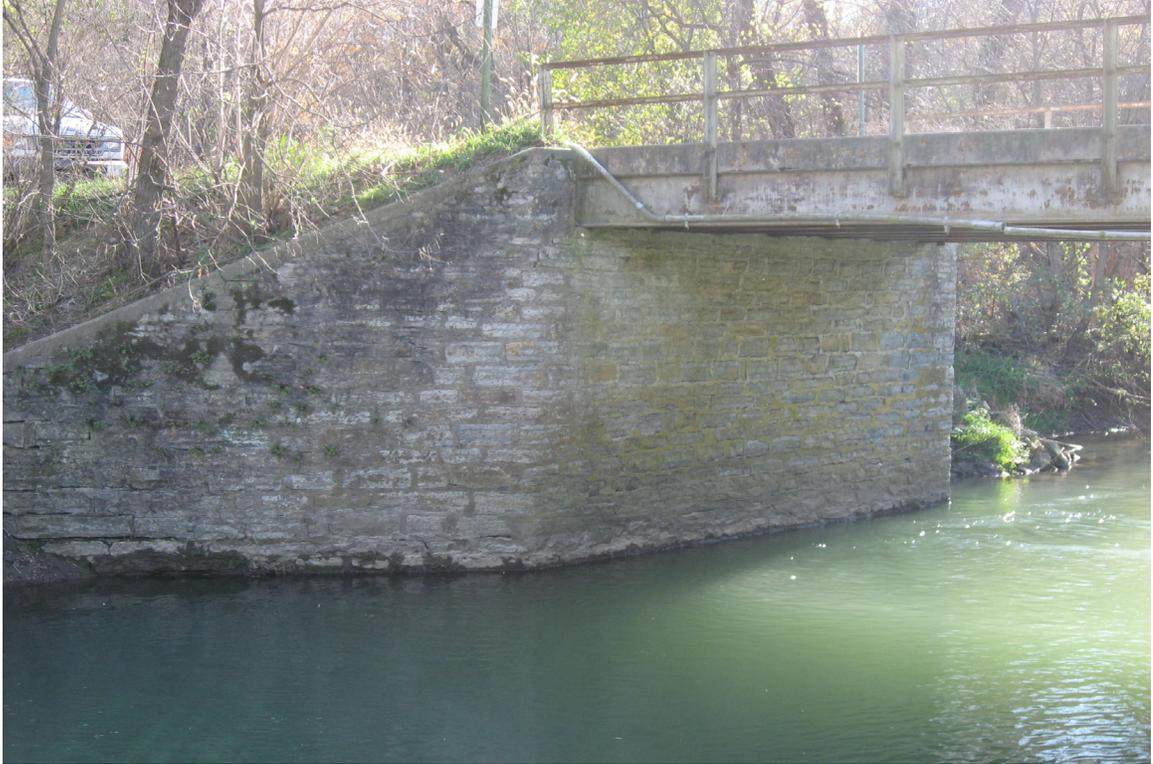
The substructure unit inspected at Bridge No. L4675, the East Abutment, was found to be in satisfactory condition. The masonry exhibited moderate deterioration of the mortar joints along the waterline. A minor localized scour depression was observed at the upstream corner of the East Abutment, and no significant changes have been found to have occurred since the previous inspection.

Photograph 1. View of East Abutment, Looking Southeast.

- (A) Since insufficient bridge foundation information was available, monitor the East Abutment for any further ledge exposure and/or undermining during future inspections.

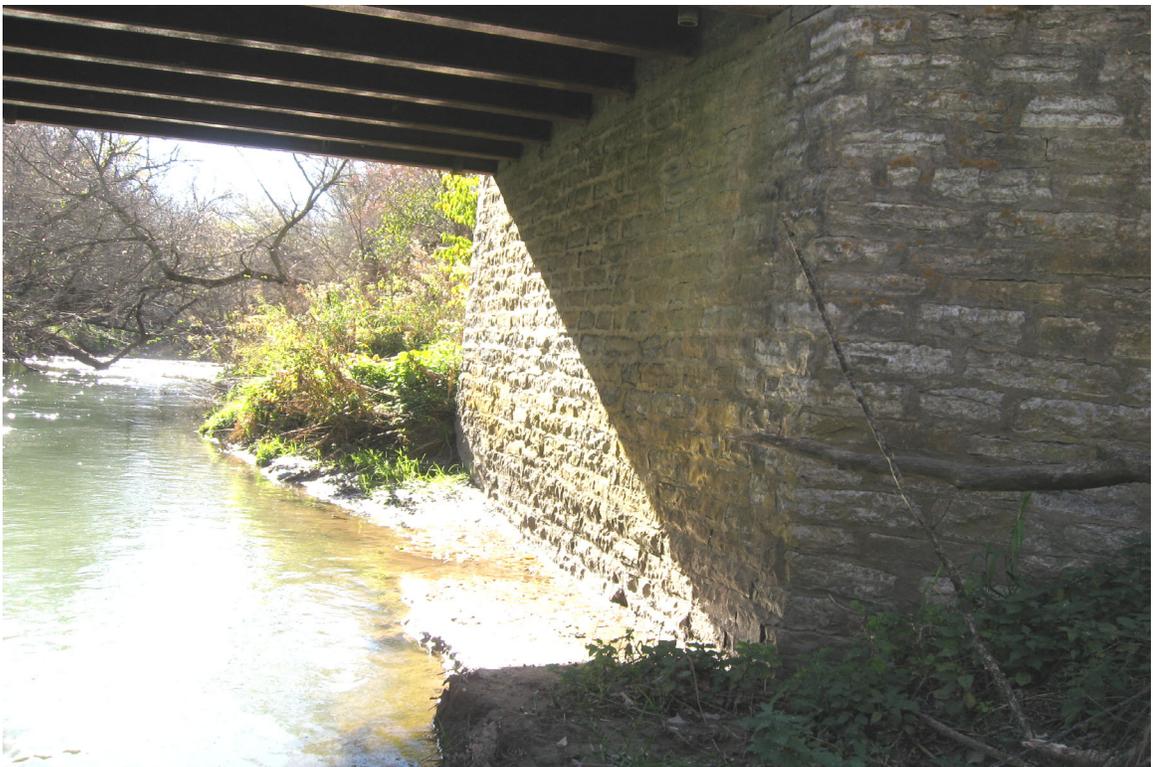
Photograph 2. View of West Abutment, Looking North.

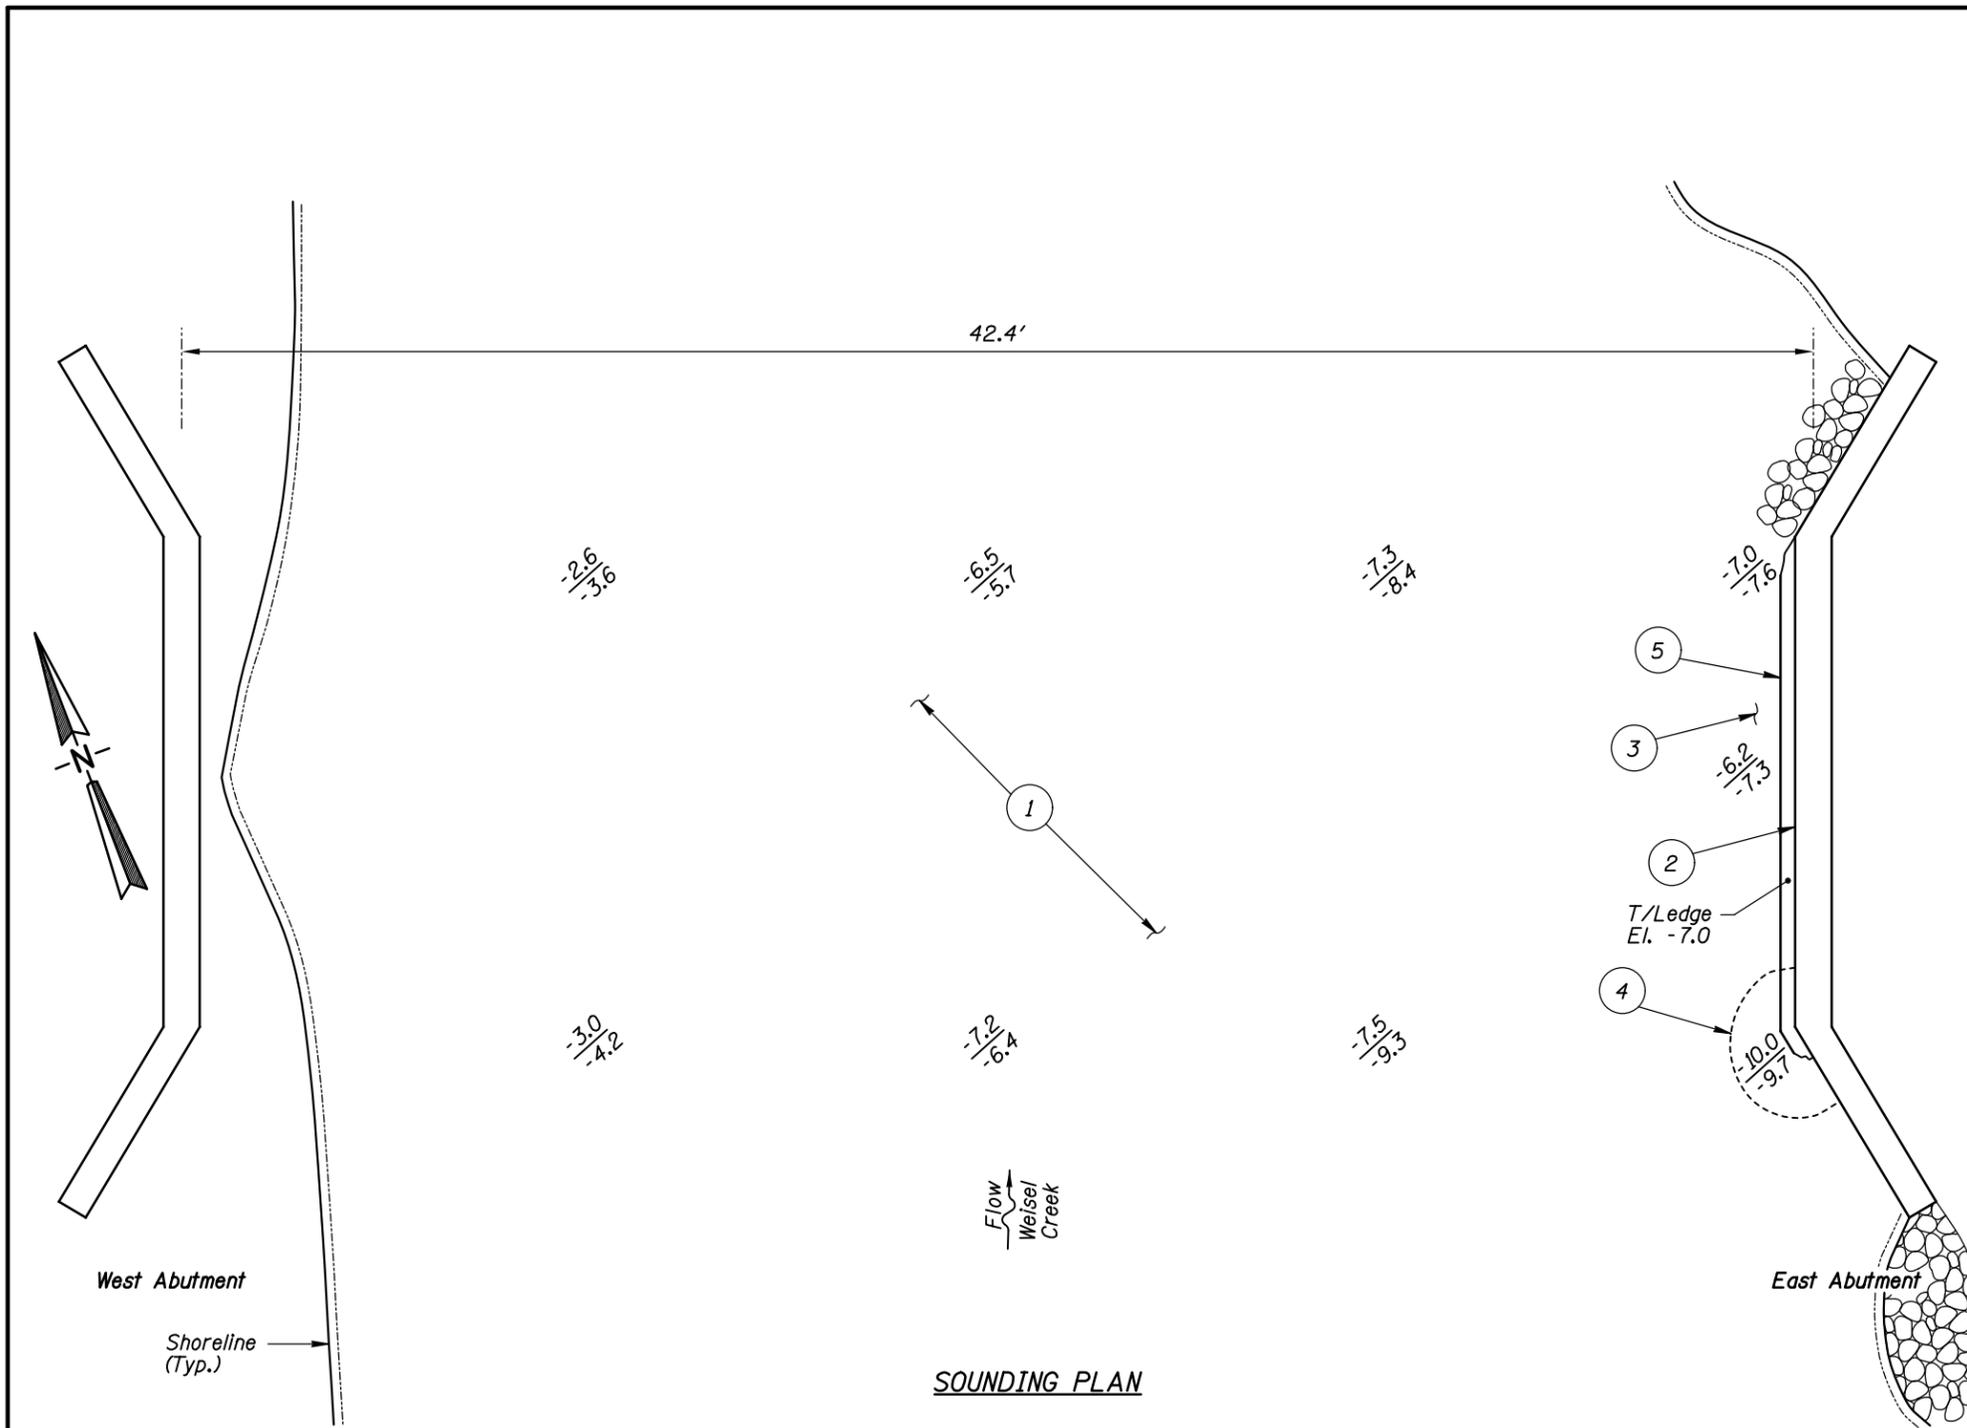
**SOUNDING PLAN**

- ① The channel bottom material consisted of a soft silt material with 1 foot of maximum probe rod penetration.
- ② The mortar in the joints was deteriorated along the abutment wall from the waterline to 2 feet below the waterline with 4 inch typical penetrations, and 12 inch maximum penetrations near the waterline.
- ③ Riprap was observed along the entire face of the abutment, extending 3 feet into the channel.
- ④ A minor scour depression was observed, 1.5 foot deep with a radius of 4 feet. Riprap lined the bottom of the depression.
- ⑤ A 1.5-foot-wide ledge was exposed along the breastwall with up to 3 feet of vertical exposure and with no undermining detected.

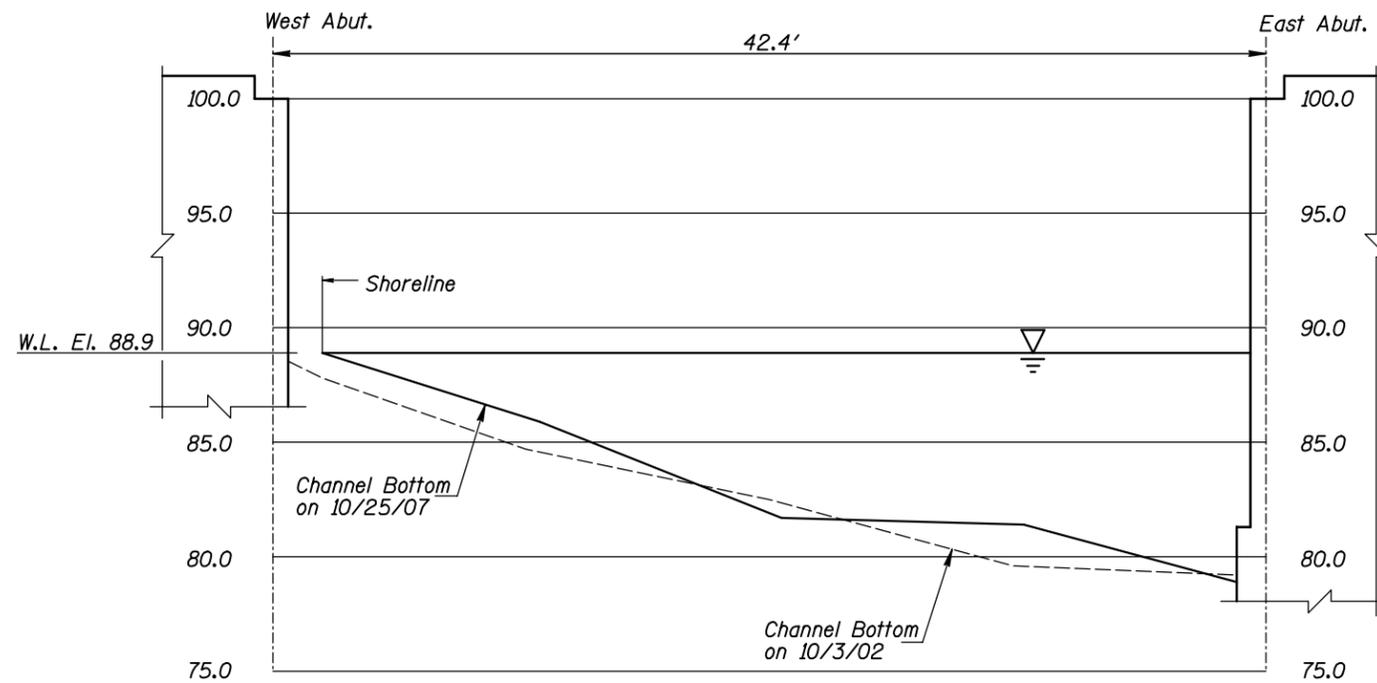
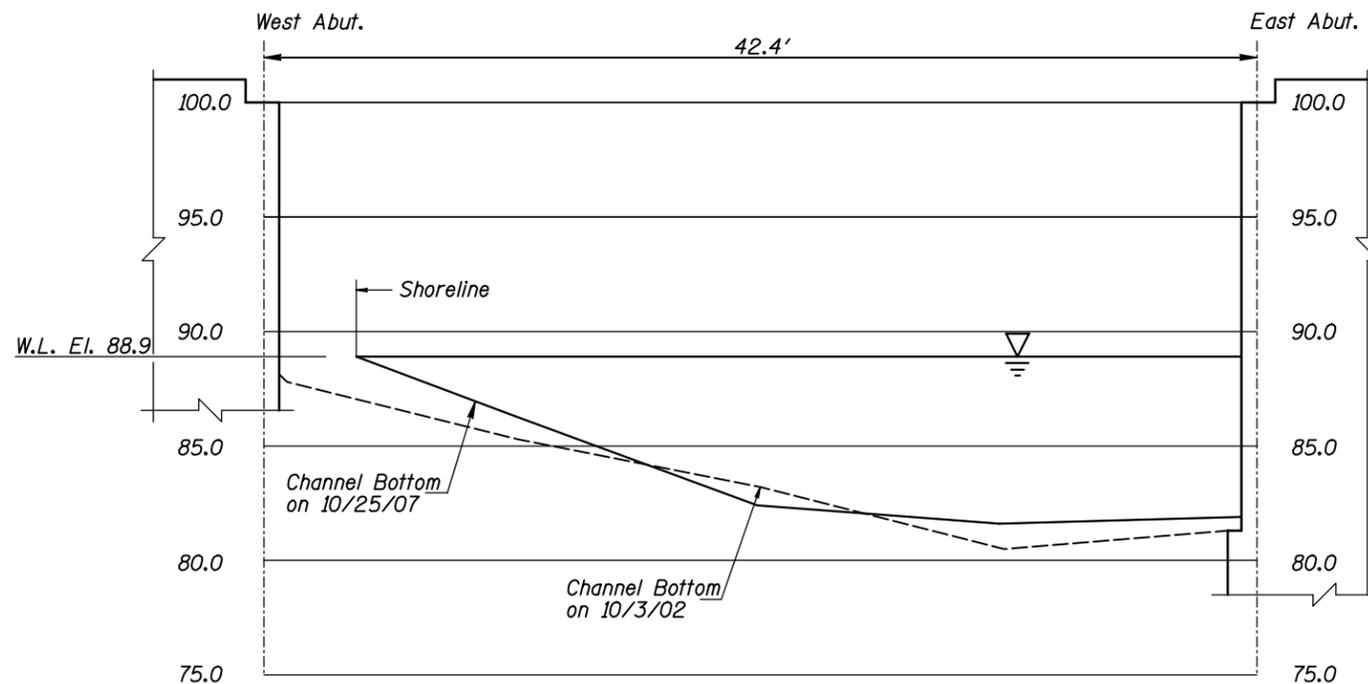
- (A) The abutment was in satisfactory condition with moderate deterioration of the masonry and a loss of joint mortar from the waterline to 2 feet below the waterline with typical penetrations of 4 inches and a maximum penetration of 12 inches.
- (B) A minor scour depression, 1 foot deep with a radius of 4 feet, was observed at the upstream corner of the East Abutment. The bottom of the depression was lined with riprap.
- (C) A 1.5-foot-wide ledge was exposed along the entire breastwall of the abutment with up to 3 feet of vertical face exposure and with no undermining below the ledge detected.
