UNDERWATER BRIDGE INSPECTION REPORT

STRUCTURE NO. 1232

4th STREET BRIDGE

MAY 23, 2012

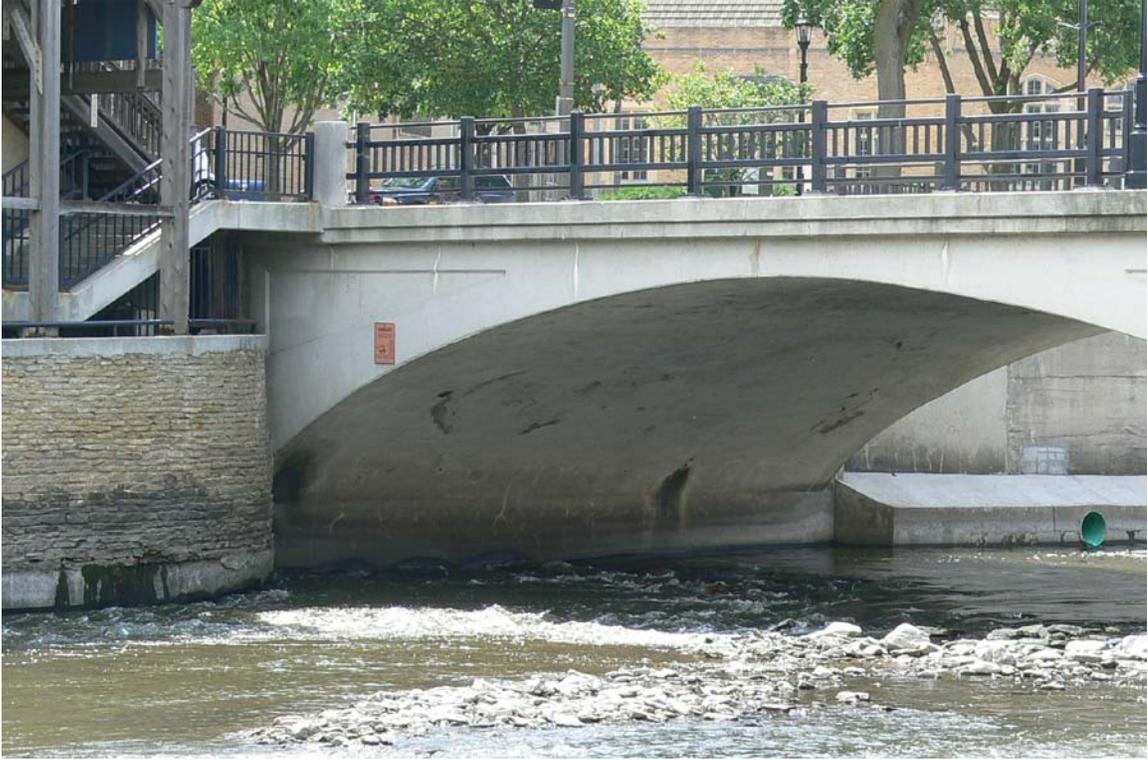
Photograph 1. View of East Abutment, Looking Southeast.

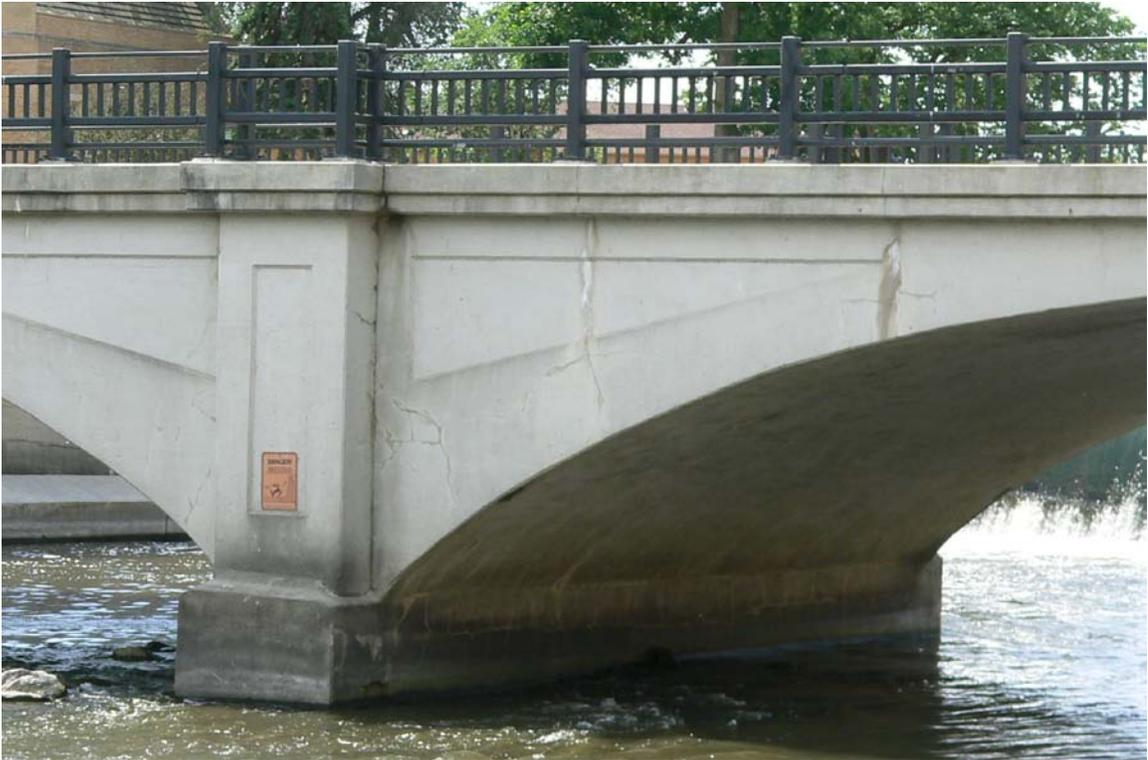
- (B) A 1/4-inch vertical crack was observed at the downstream nose of the center pier and extended from the channel bottom to 4 feet above the water line. A 4 inch wide by 4 inch long spall was observed along the crack near the water line with a maximum penetration of 1 inch.

- (C) A 1/8-inch vertical crack was observed at the downstream nose of the center pier and extended from the channel bottom to 2 feet above the water line.

- (D) A 2-foot diameter spall was observed on the downstream west face of the center pier at the water line with a maximum penetration of 2 inches. No reinforcing steel was exposed.

Photograph 2. View of Center Pier, Looking Southeast.

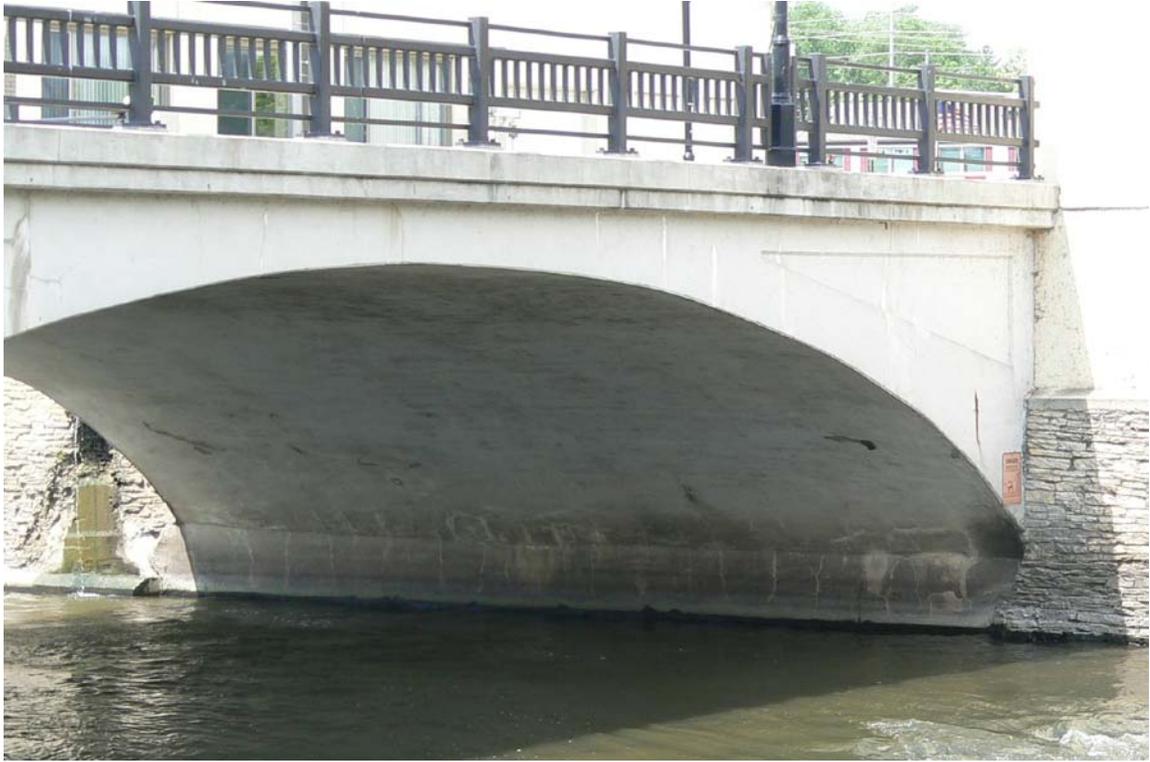
Photograph 3. View of West Abutment, Looking Southwest.

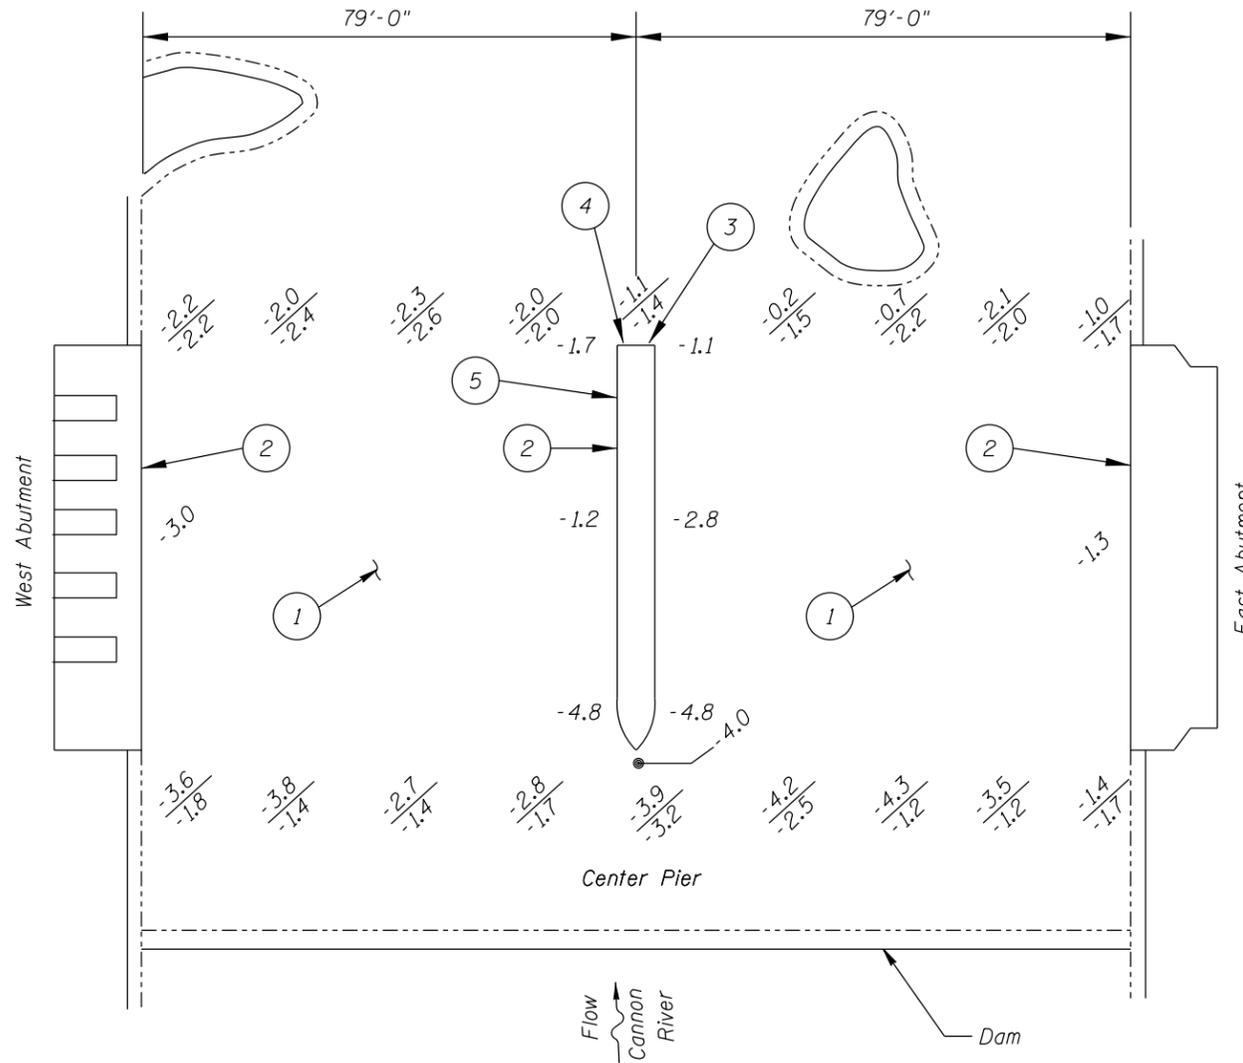
SOUNDING PLAN

- 1 The channel bottom consisted of stone and natural bedrock with no probe rod penetration possible.
- 2 The concrete was generally smooth and sound with only random minor cracking of the resurfacing repairs.
- 3 Vertical crack 1/4 inch wide extended from 4 feet above waterline to channel bottom with a 4 inch by 4 inch spall at the waterline on the downstream nose of the center pier with a maximum penetration of 1 inch.
- 4 Vertical crack located on the downstream nose of the center pier was 1/8 inch wide and extended from channel bottom to 2 feet above the waterline.
- 5 Spall had a diameter of 2 feet at waterline and was located on west face of the center pier near the downstream nose. Maximum penetration was 2 inches. No steel reinforcement was exposed.
- 6 Random hairline cracks with efflorescence were observed at the waterline extending 5 feet above the waterline.
