UNDERWATER BRIDGE INSPECTION REPORT

STRUCTURE NO. 23501

ROOT RIVER

COLLINS ENGINEERS, INC.

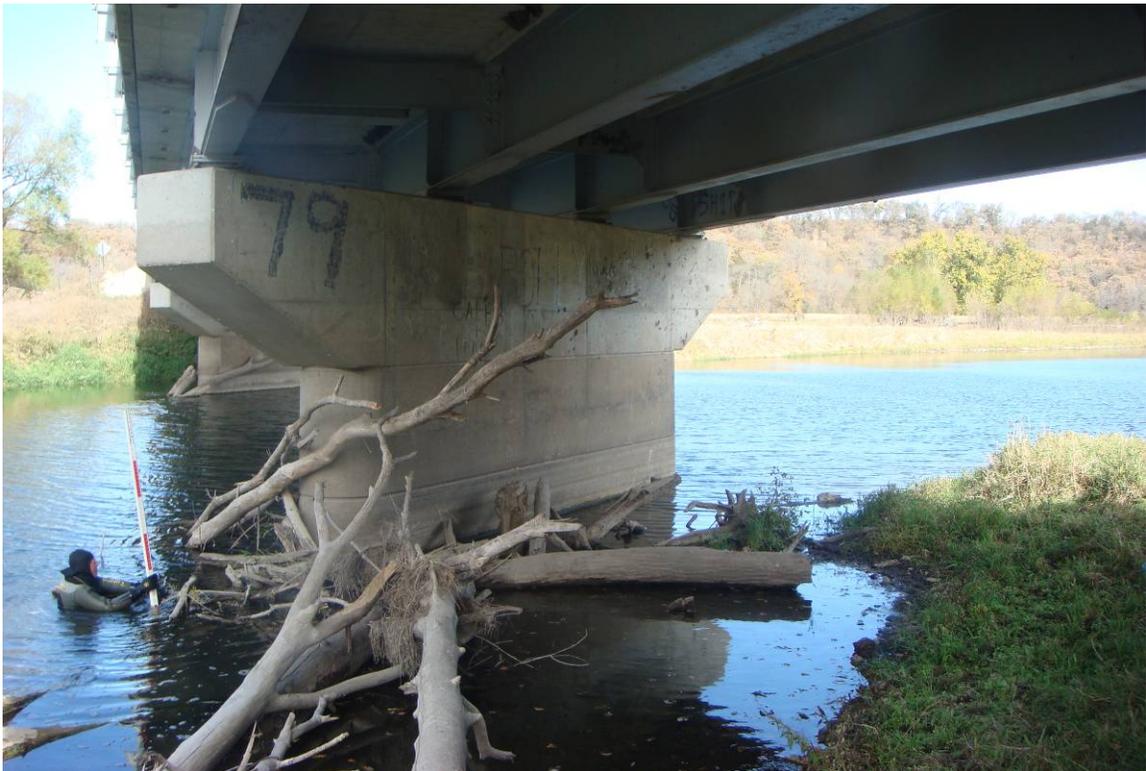
Photograph 2. View of Pier 1, Looking Northwest.

7. A heavy accumulation of 2-foot-diameter-and-smaller timber debris was observed extending from the channel bottom to 8 feet above the waterline at the upstream end and along both faces of Pier 1.

Remove the heavy accumulations of timber debris around Piers 1 and 2 to alleviate any adverse effects for the channel bottom and the piers.

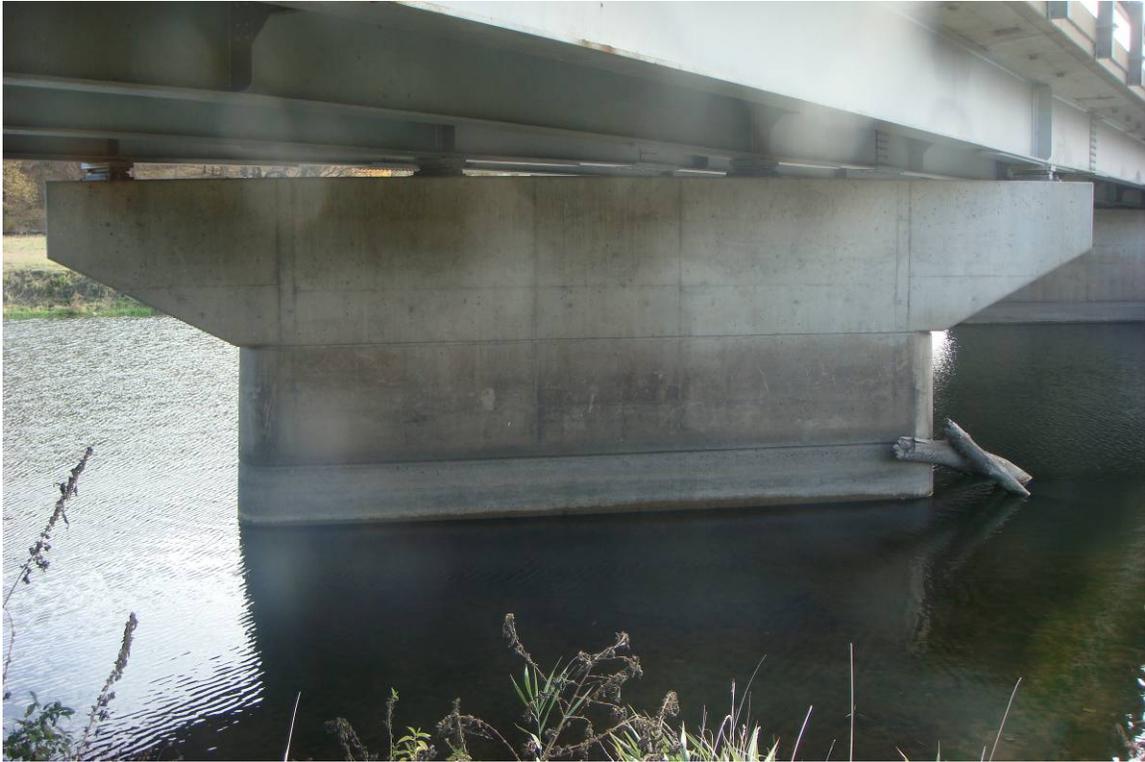
Photograph 3. View of Pier 2, Looking West.

8. A 1.5-foot-diameter tree trunk (forked around the pier nose) was observed extending from the channel bottom to 4 feet above the waterline at the upstream end of Pier 2.

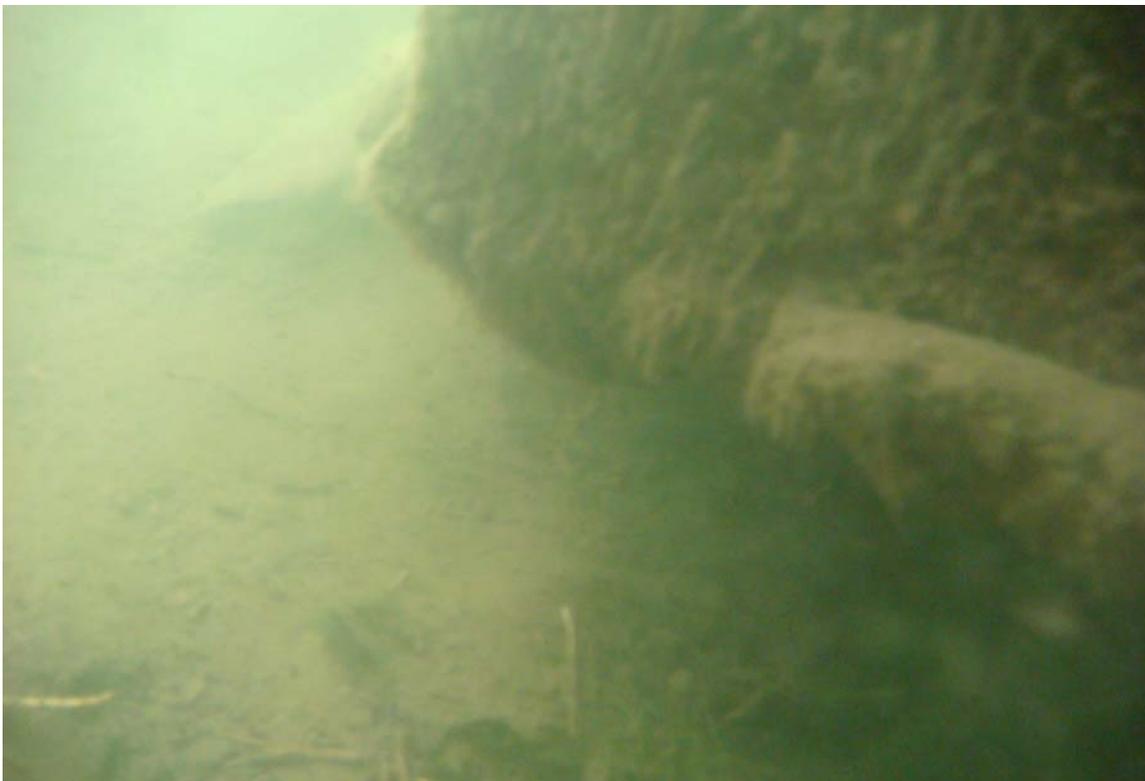
Photograph 4. View of Undermining Cavity Under the Pier 2 Footing at the Upstream End, Looking Down.

9. The footing was exposed along the east face of Pier 2 with undermining and steel H-piles observed from the midpoint along the downstream nose, around the upstream southeast corner, and extending to the upstream southwest corner, with a maximum height of approximately 1.5 feet along most of the undermined area on the east side of the pier, and 4 to 5 feet of maximum horizontal penetration. The exposed steel H-piles (4) were sound without any notable deterioration (just spotty surface corrosion).

Giving the undermining, consideration may need to be given for riprap to be properly designed and placed around the piers (especially Pier 2) and in the scour/undermining areas to armor against further channel bottom degradation, unless further scour analysis indicates differently.

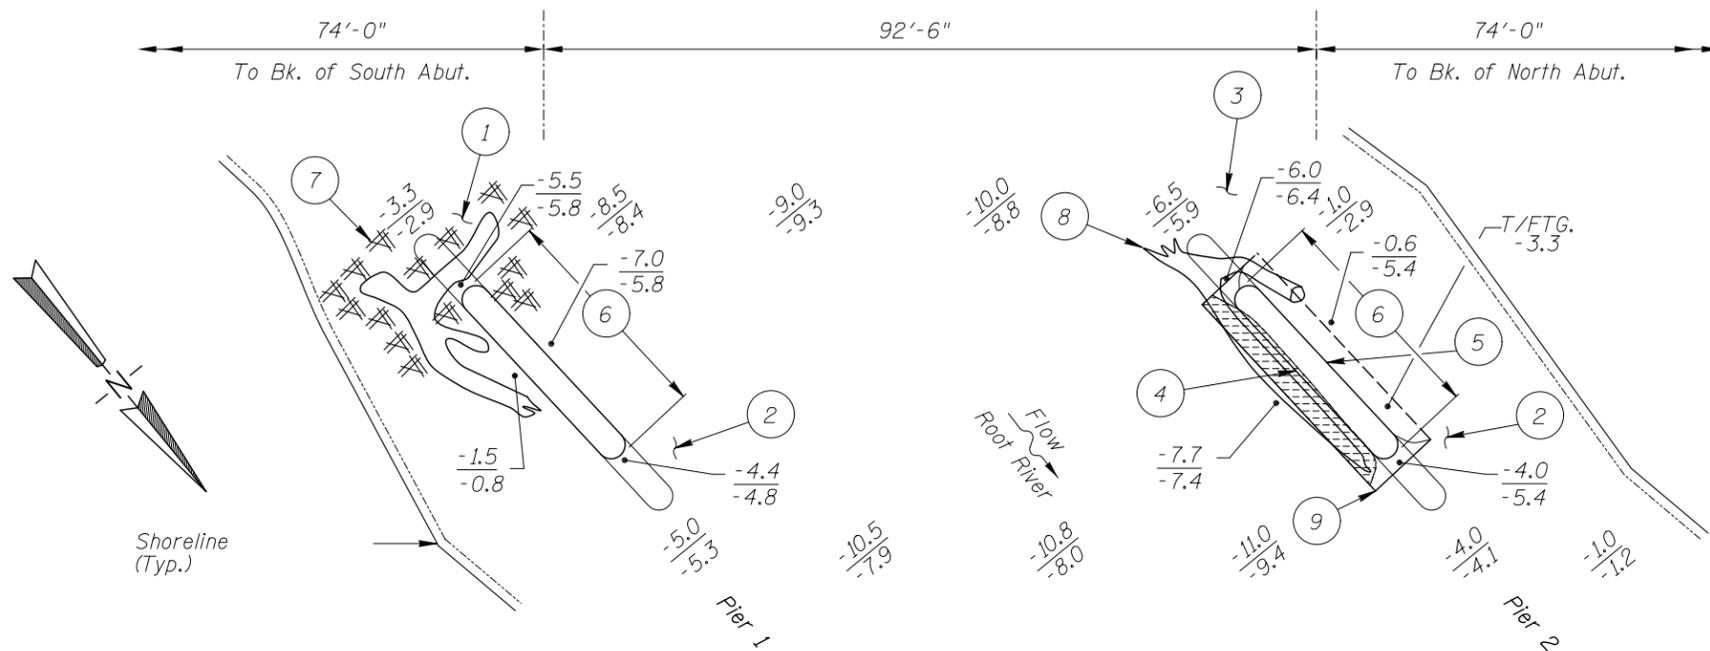
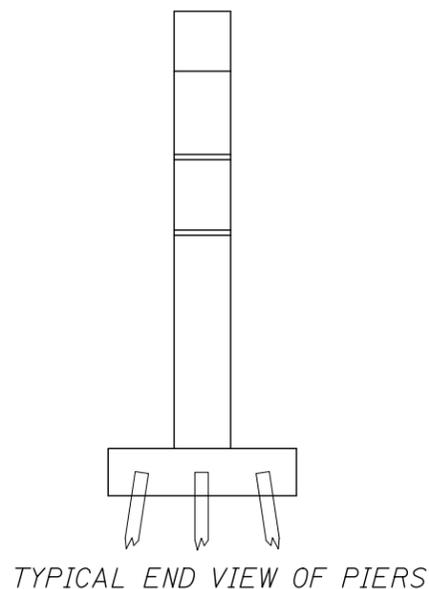
| INSPECTION AND SOUNDING PLAN | | |

1. The channel bottom consisted of gravel and silt allowing up to 2 inches of probe rod penetration.
2. The channel bottom consisted of silty sand allowing up to 1 foot of probe rod penetration.

3. The channel bottom consisted of soft silt allowing up to 1.5 feet of probe rod penetration.
4. A vertical hairline crack was observed at the midpoint of Pier 2 that extended from the top of the pier cap to 2 feet below the waterline.

5. A vertical hairline crack was observed at the midpoint of Pier 2 that extended from the top of the pier cap to the top of the footing.
6. Light scaling was observed along all pier faces from 1 foot above to 1 foot below the waterline with a maximum penetration of 1/16 inch.
