UNDERWATER BRIDGE INSPECTION REPORT

STRUCTURE NO. 23503

ROOT RIVER

FILLMORE COUNTY

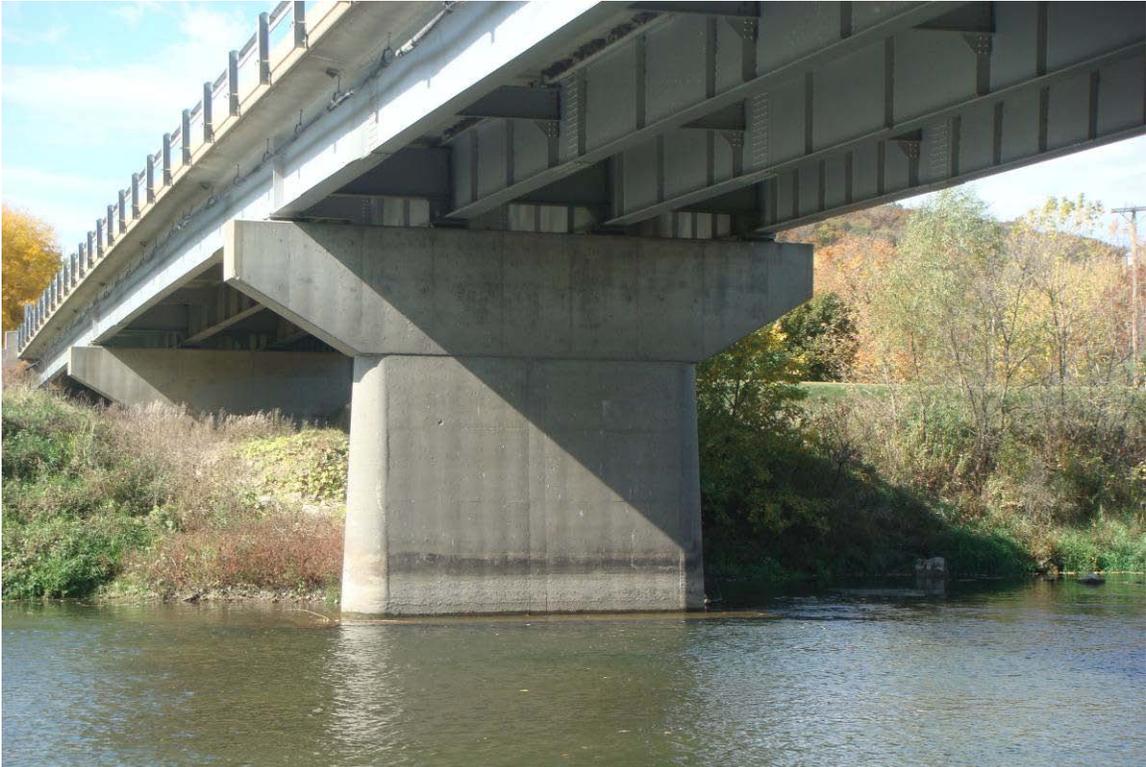
Photograph 2. View of Pier 2, Looking Northwest.

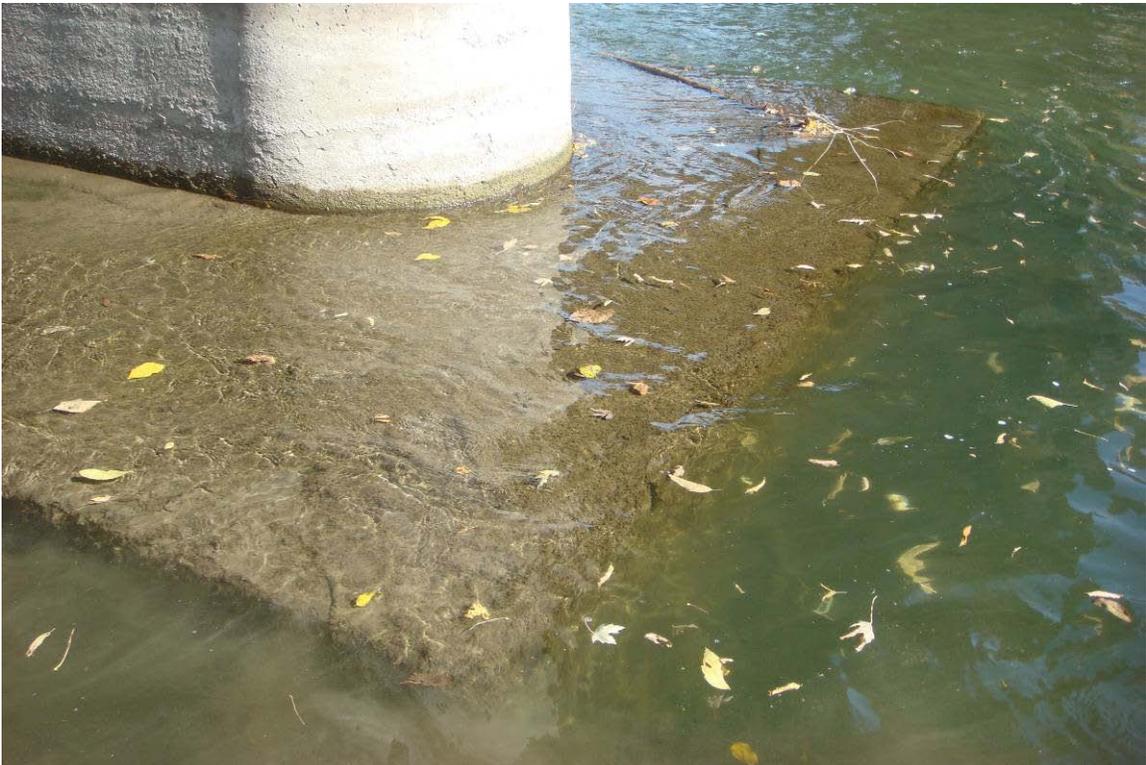
- (C) The footing of Pier 2 was exposed along the entire perimeter with a maximum vertical exposure of 4 feet at the upstream end with a 3 foot long section undermined. The undermining cavity was 4 inches high with 6 inches of penetration.

Photograph 4. View of the Exposed Footing at the Upstream Nose of Pier 2, Looking East.

- (A) Monitor the scour depression and footing exposure at Pier 2 during future inspections. If these conditions progress, scour countermeasures may be considered.
- (B) Reinspect the submerged substructure units at the normal maximum recommended (NBIS) interval of sixty (60) months.

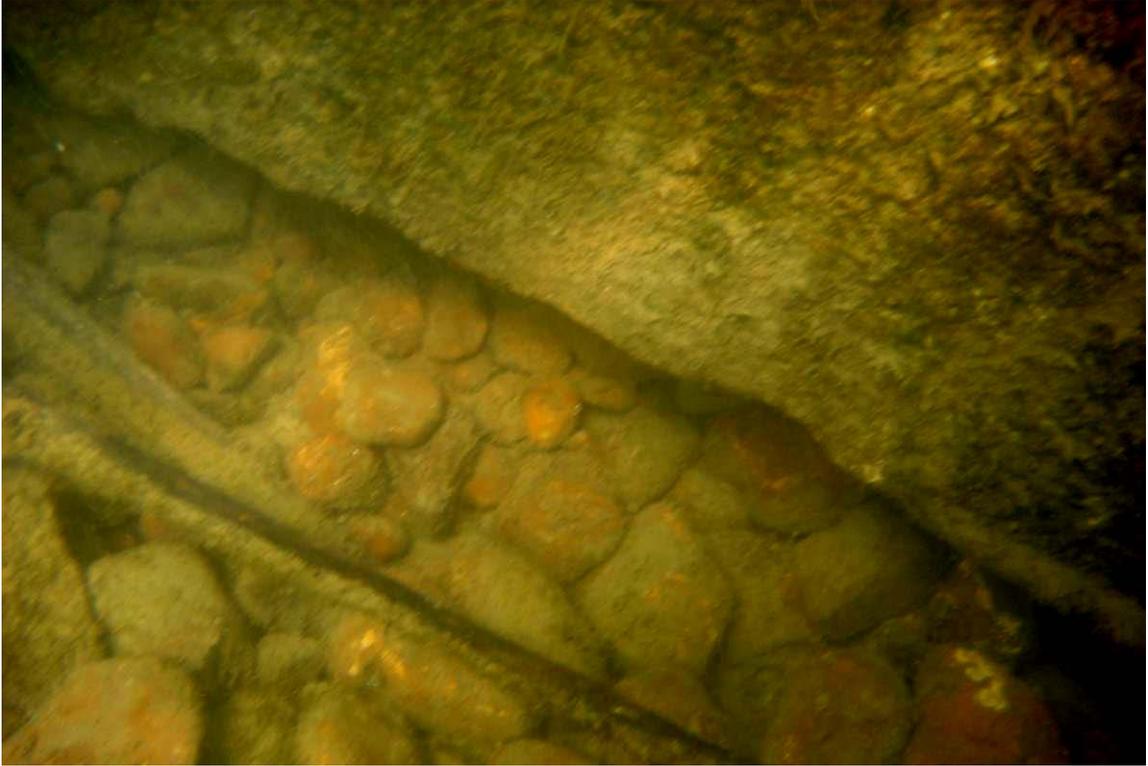
Photograph 5. View of the Undermining Cavity at the Upstream Nose of Pier 2, Looking Down.

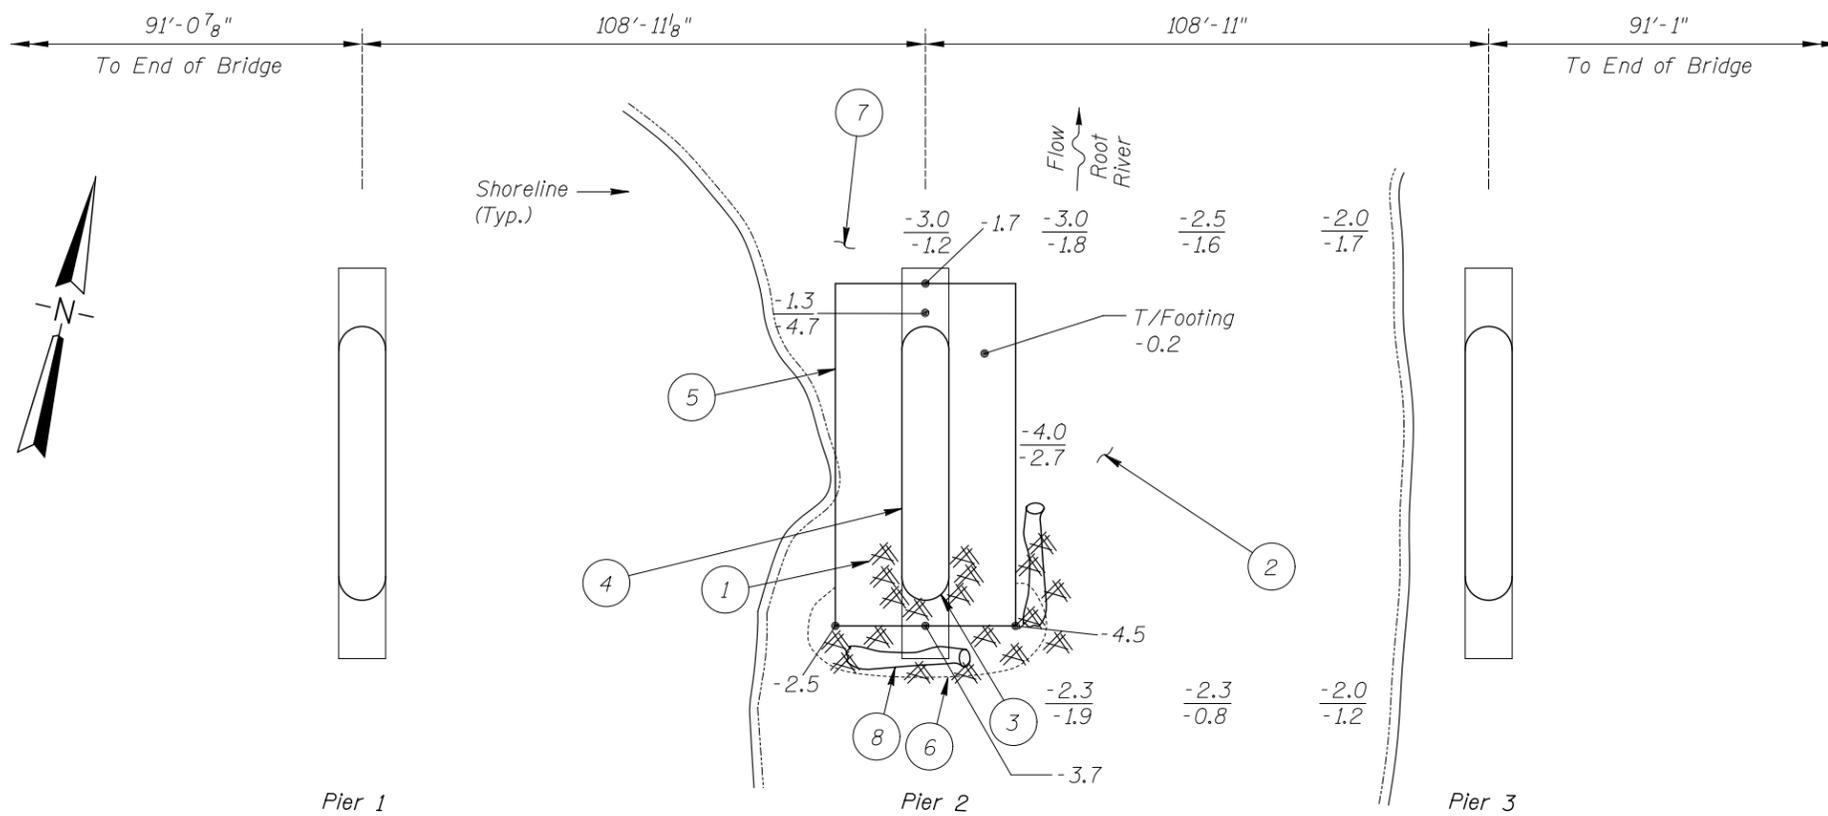
SOUNDING PLAN

- ① A light accumulation of timber debris consisting of 2 inch diameter and smaller branches was observed at the upstream nose of Pier 2 at waterline.
- ② The channel bottom material consisted of fine sandy gravel allowing 2 inches of maximum probe rod penetration.

- ③ Two horizontal impact related voids were observed on the upstream nose of Pier 2 above the waterline, measuring 2-foot-long by 1-inch-wide with 1/2 inch of penetration and exposed aggregate.

- ④ Light scaling of concrete was observed from the top of the footing to 4 feet above the waterline, with 1/4 inch maximum penetration.
- ⑤ The footing was exposed along the entire perimeter of Pier 2 with a maximum vertical exposure of 4 feet at the southeast corner with a 3 feet long section of undermining measuring 4 inches high and 6 inches maximum penetration. Vertical exposure at the southwest corner was 2.5 feet, along the east face was 3 feet, and at the downstream end was 6 inches.

- ⑥ A 5-foot-radius, 3-foot-deep scour depression was observed at the southeast corner of Pier 2.
- ⑦ The channel bottom at the downstream end of Pier 2 consisted of sandy infilling with 3 inch probe rod penetration.

- ⑧ A moderate accumulation of timber debris, up to 1.5 feet diameter, was observed within the scour depression at the upstream end and along the east face of the pier, extending from the channel bottom up 3 feet.
