UNDERWATER BRIDGE INSPECTION REPORT

STRUCTURE NO. 23513

CSAH NO. 36

MINNESOTA DEPARTMENT OF TRANSPORTATION
UNDERWATER BRIDGE INSPECTION

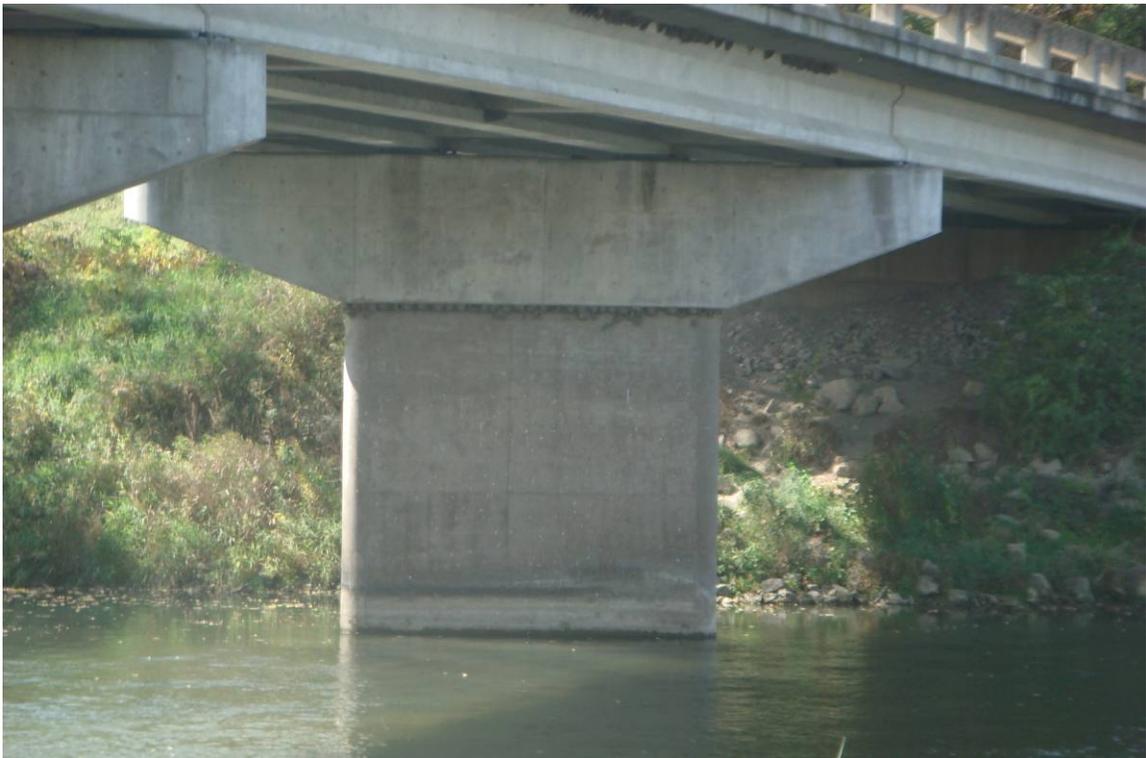
Photograph 2. View of Pier 1, Looking Southwest.

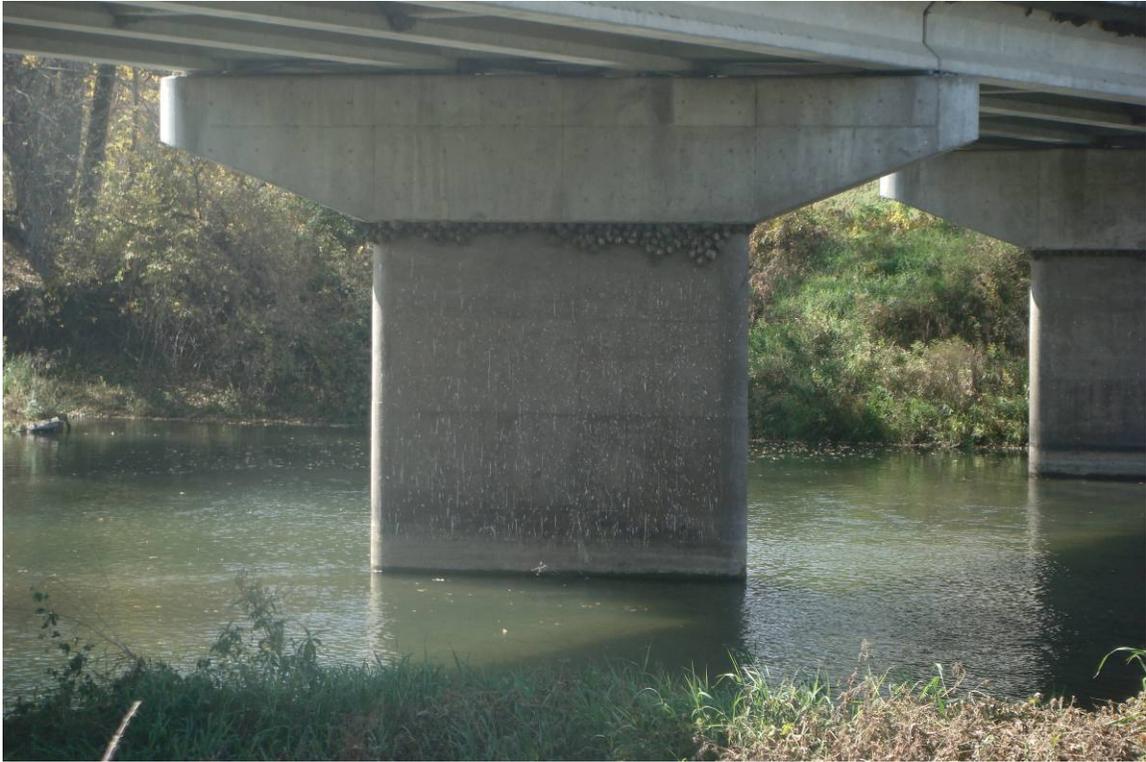
Photograph 3. View of Pier 2, Looking Southwest.

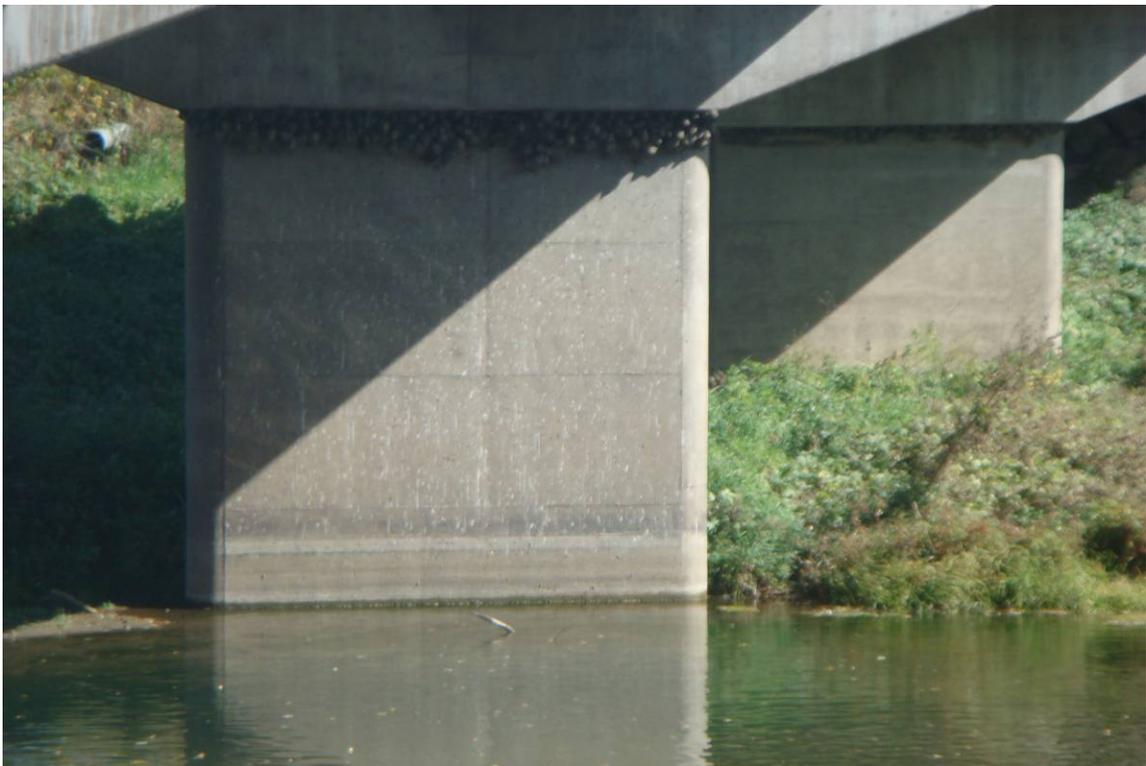
Photograph 4. View of Pier 3, Looking Northeast.

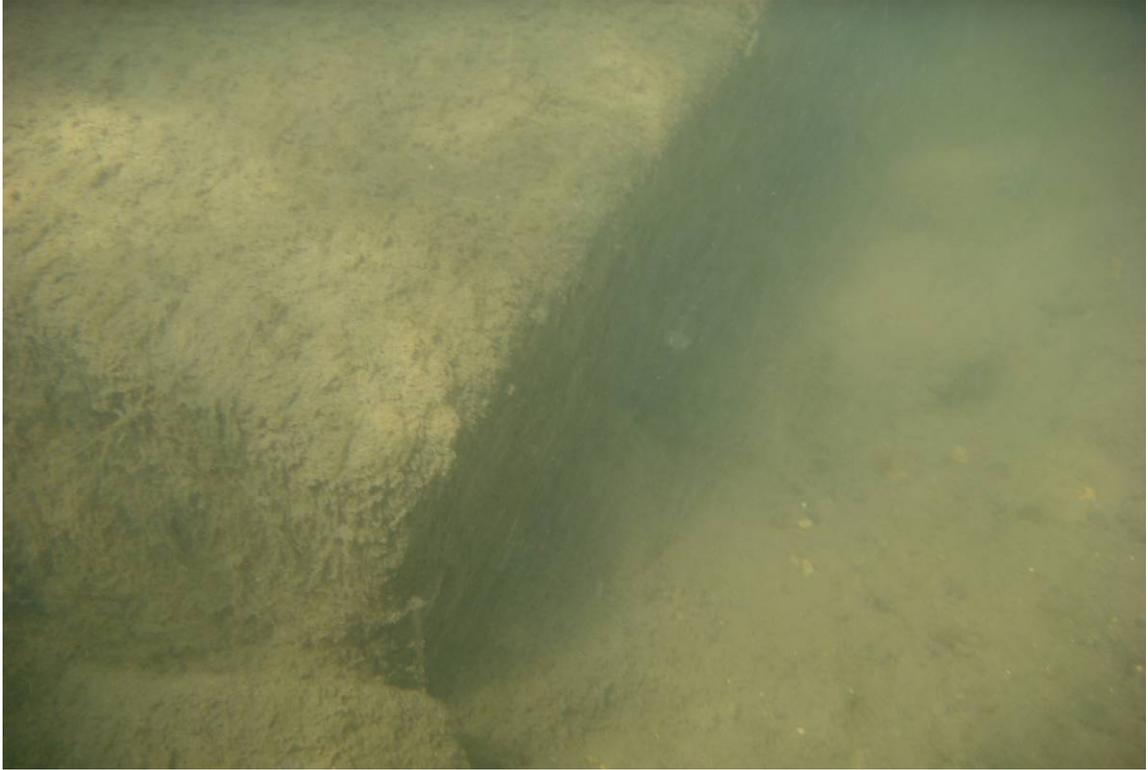
Photograph 5. View of Pier 1 Footing Exposure, Looking Down.

- A scour depression, 1.5 feet deep and 10 feet in radius, was observed at the upstream nose of Pier 1.
 - The top of the footing was exposed around the entire perimeter of Pier 1 with up to 3.5 feet of vertical footing exposure at the upstream end of the pier with no undermining observed.

Since scour screening indicated that bridge is at low risk for scour, only monitor the footing exposure and extent of scour during future inspections.

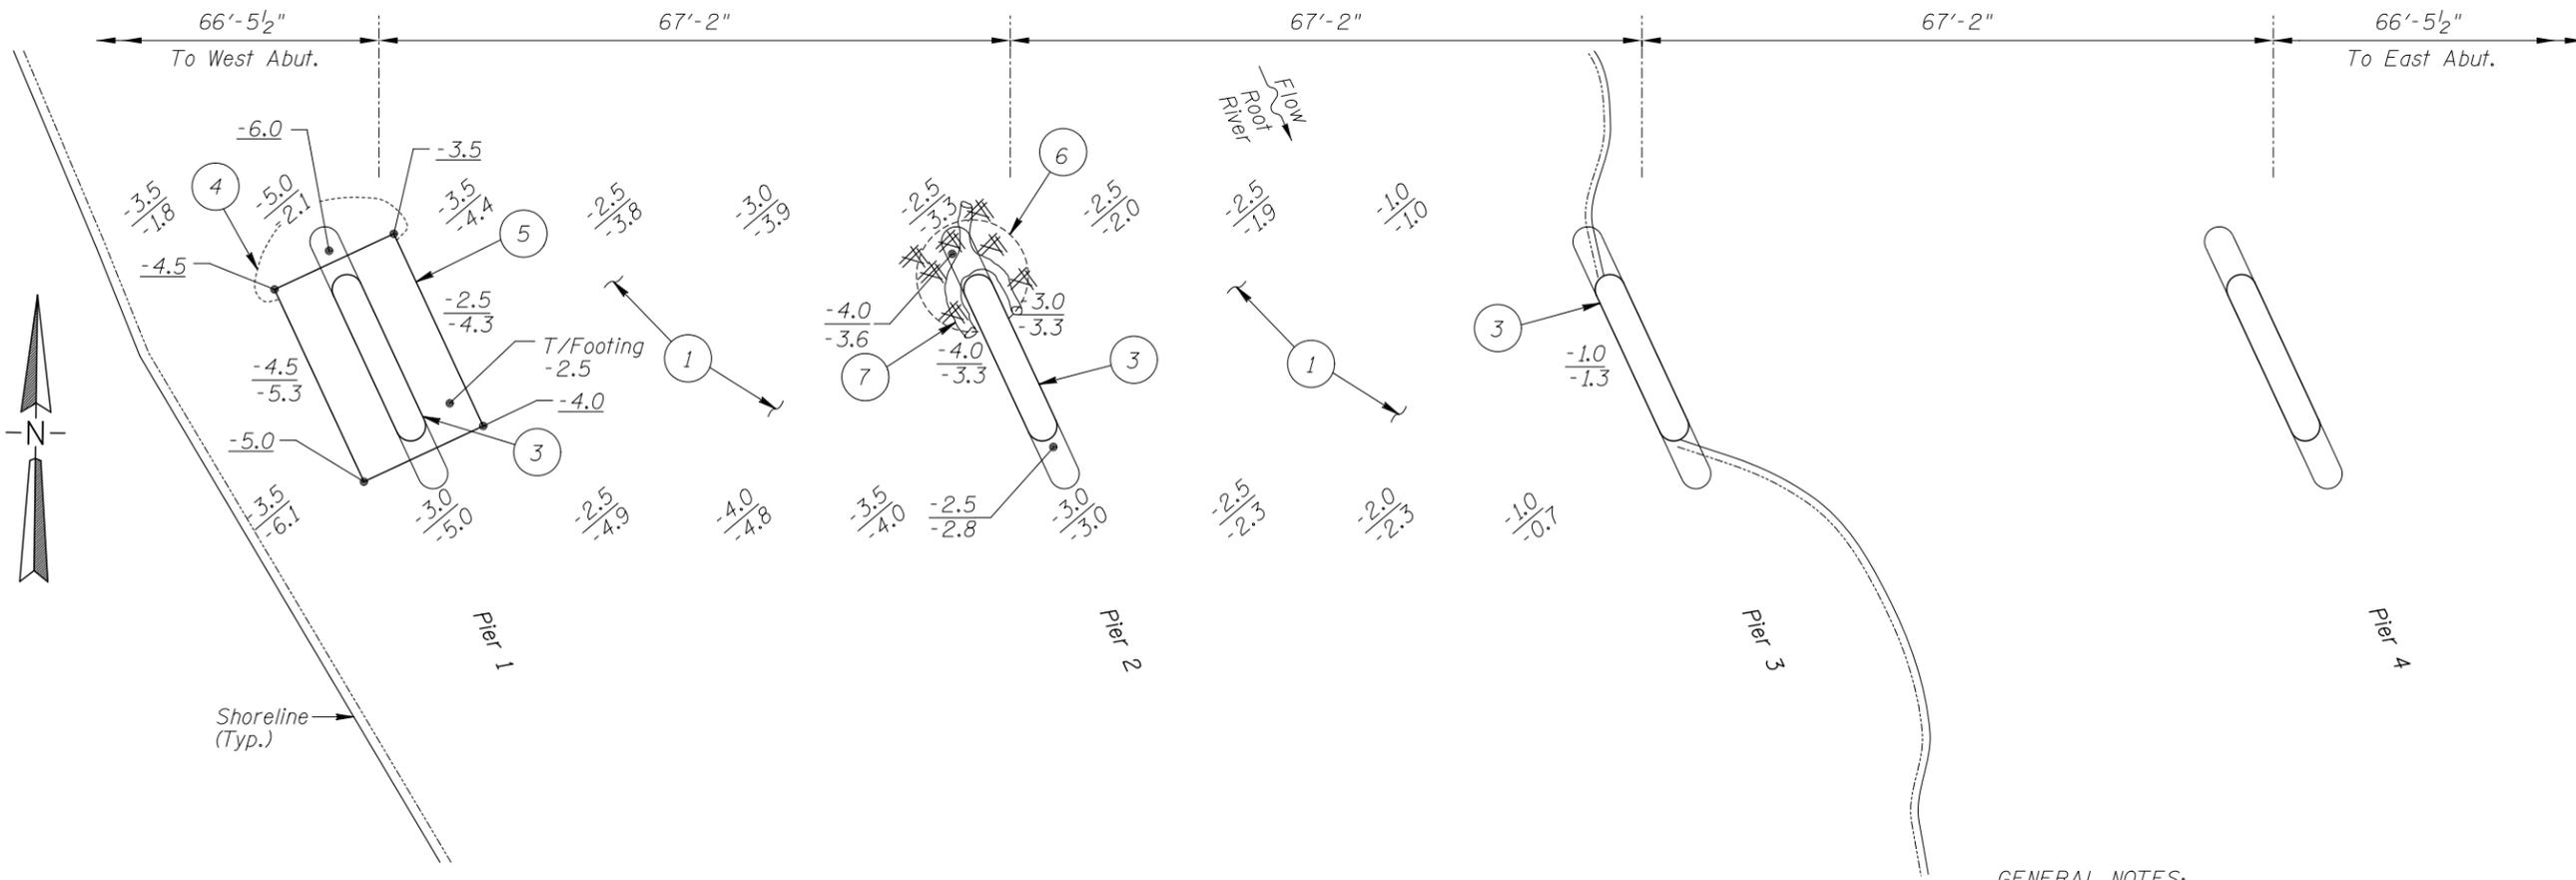
SOUNDING PLAN

- INSPECTION NOTES:**
- The channel bottom material consisted of firm silty sand with gravel and scattered 5 inch diameter cobbles allowing maximum probe rod penetrations of 2 to 4 inches.

- The channel bottom material consisted of soft silt over gravel allowing a maximum probe rod penetration of 1.5 feet.
 - The concrete of the piers was in good and sound condition with no significant deterioration.

- A scour depression, 1 foot deep and 6 feet in radius, was observed at the upstream nose of Pier 2.
 - A moderate accumulation of timber debris was observed at the upstream nose of Pier 2 consisting of 1.5 feet diameter and smaller trees and branches (including a tree trunk forked around the nose) that extends from the channel bottom to the waterline.
