UNDERWATER BRIDGE INSPECTION REPORT

STRUCTURE NO. 24506

MSAS NO. 107 (BRIDGE AVE.)

MINNESOTA DEPARTMENT OF TRANSPORTATION  
UNDERWATER BRIDGE INSPECTION

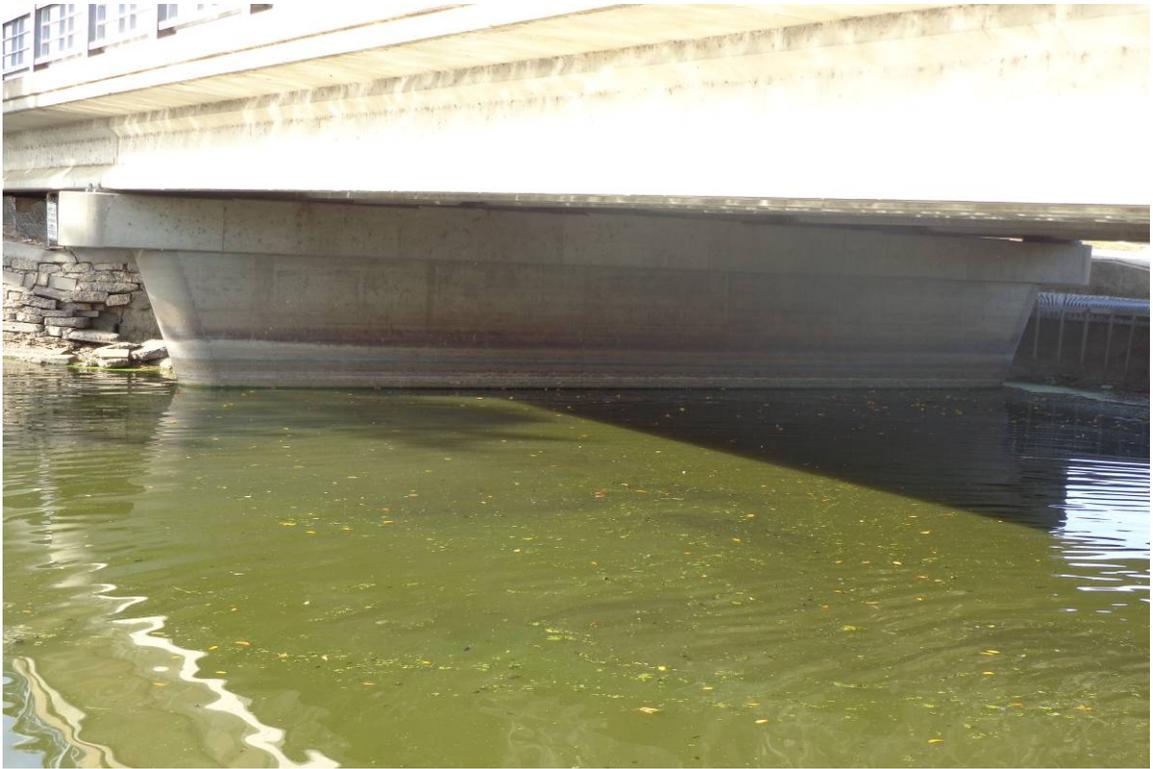
Photograph 1. View of Pier 1, Looking West.

The substructure units inspected at Bridge No. 24506, Piers 1 and 2, were found to be in good condition with no defects of structural significance observed. Random light scaling was observed on the faces of both piers. The channel bottom between the substructure units consisted of a concrete apron extending from the base of a dam located just upstream of the bridge to the downstream end of the piers. The apron was in typically good condition with no undermining or scour observed at the toe.

REMARKS: The concrete of the piers was in good condition with random areas of light scaling observed at the waterline. An area of poorly formed concrete and section loss with exposed reinforcing steel was observed on the concrete apron near the downstream end of Pier 2. Otherwise, the concrete apron was in good condition with no notable defects or undermining observed.

- (A) Reinspect the submerged substructure units at the normal maximum recommended (NBIS) interval of sixty (60) months.

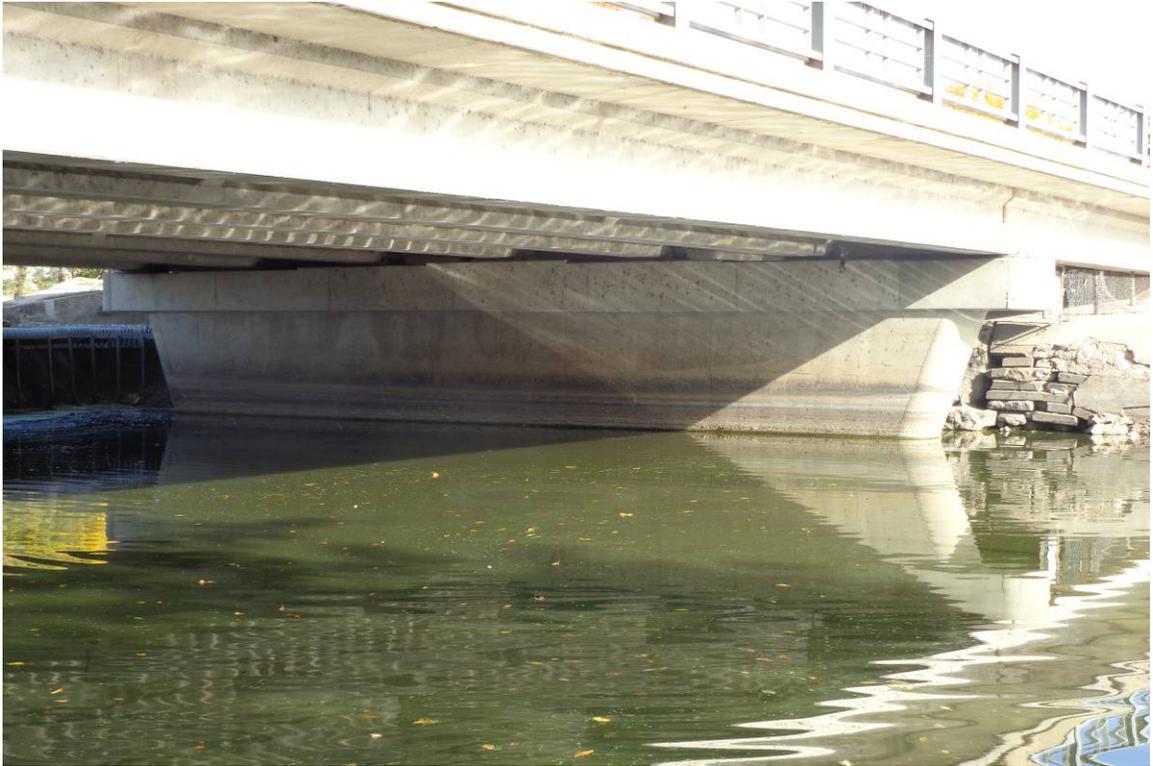
Photograph 2. View of Pier 2, Looking North.

- (A) The channel bottom material along the south face of Pier 1 consisted of sand and gravel with random riprap up to 1 foot in diameter.
- (B) The channel bottom material along the downstream fascia consisted of silty gravel with scattered cobbles along the edge of the concrete apron.
- (C) The channel bottom under the bridge consisted of a concrete apron. The apron was in good condition with no undermining observed.
- (D) Random light scaling was observed near the waterline on both piers.
- (E) The concrete apron exhibited a 3 to 4 feet long area of poorly formed concrete and section loss with exposed reinforcing steel and up to 6 inches of penetration near the downstream end of Pier 2.

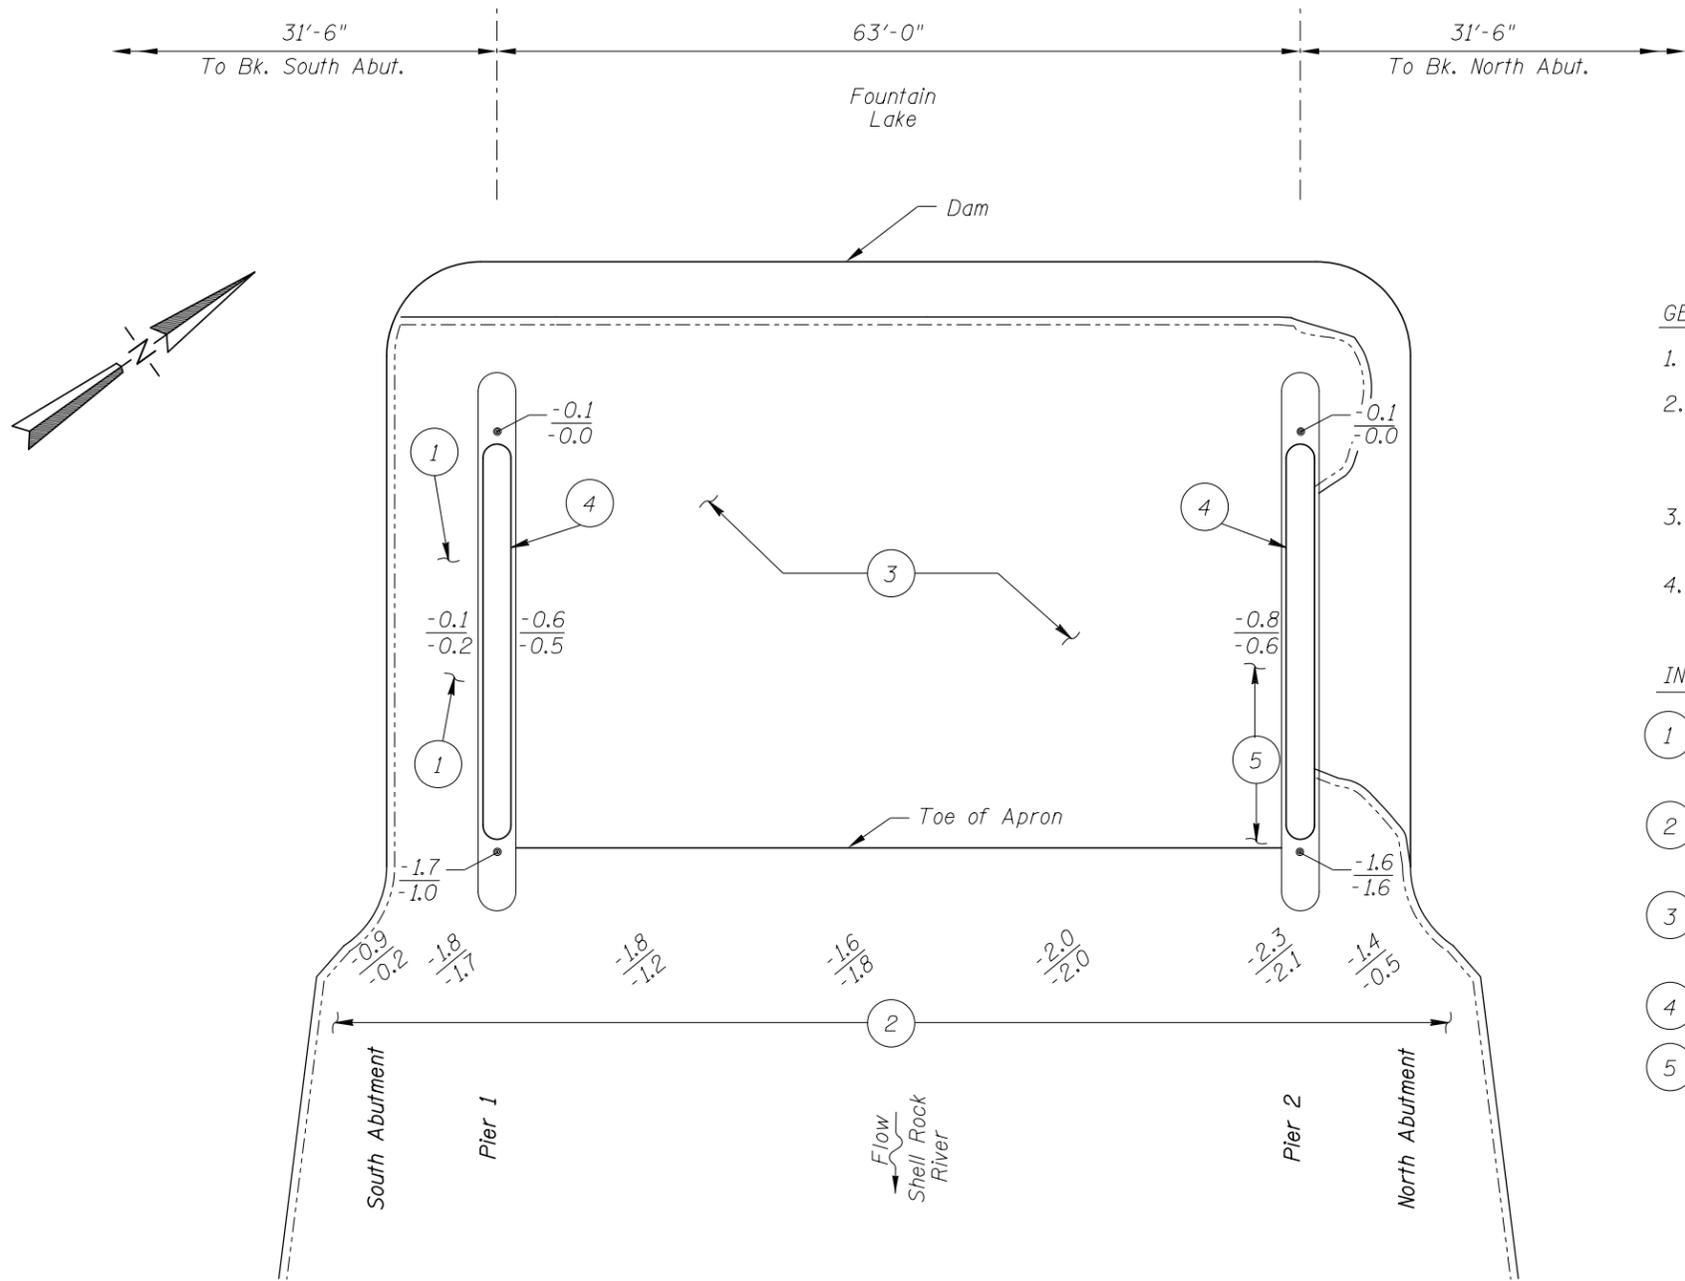
**SOUNDING PLAN**

- 1 The channel bottom material consisted of sand and gravel with random riprap up to 1 foot in diameter.
- 2 The channel bottom material along the downstream fascia consisted of silty gravel with scattered cobbles at the end of the concrete apron.
- 3 The channel bottom consisted of a concrete apron. The apron was in good condition with no undermining observed.
- 4 Random light scaling was observed near the waterline on both piers.
- 5 The concrete apron exhibited a 3 to 4 feet long area of poorly formed concrete and section loss with 6 inches of penetration and exposed reinforcing steel near the downstream end of Pier 2.
