UNDERWATER BRIDGE INSPECTION REPORT

STRUCTURE NO. 24514

MSAS NO. 109 (FRONT ST.)

SHELL ROCK CHANNEL

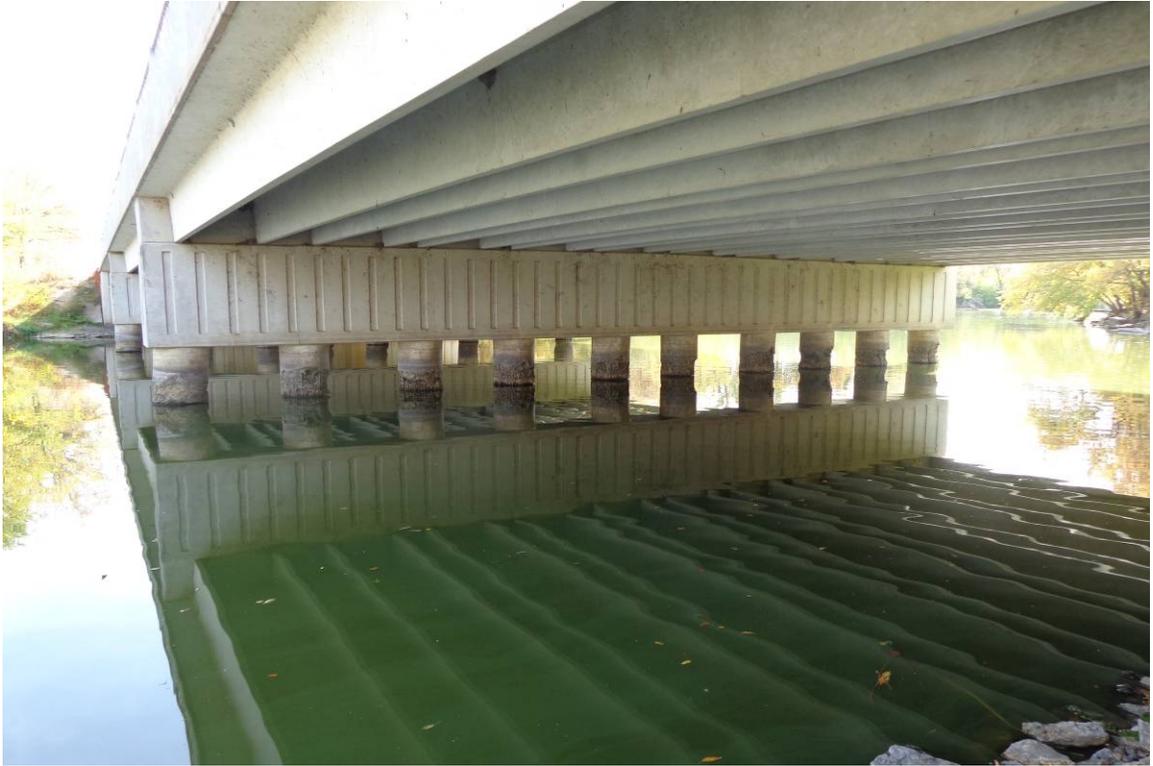
Photograph 1. View of Pier 1, Looking Southeast.

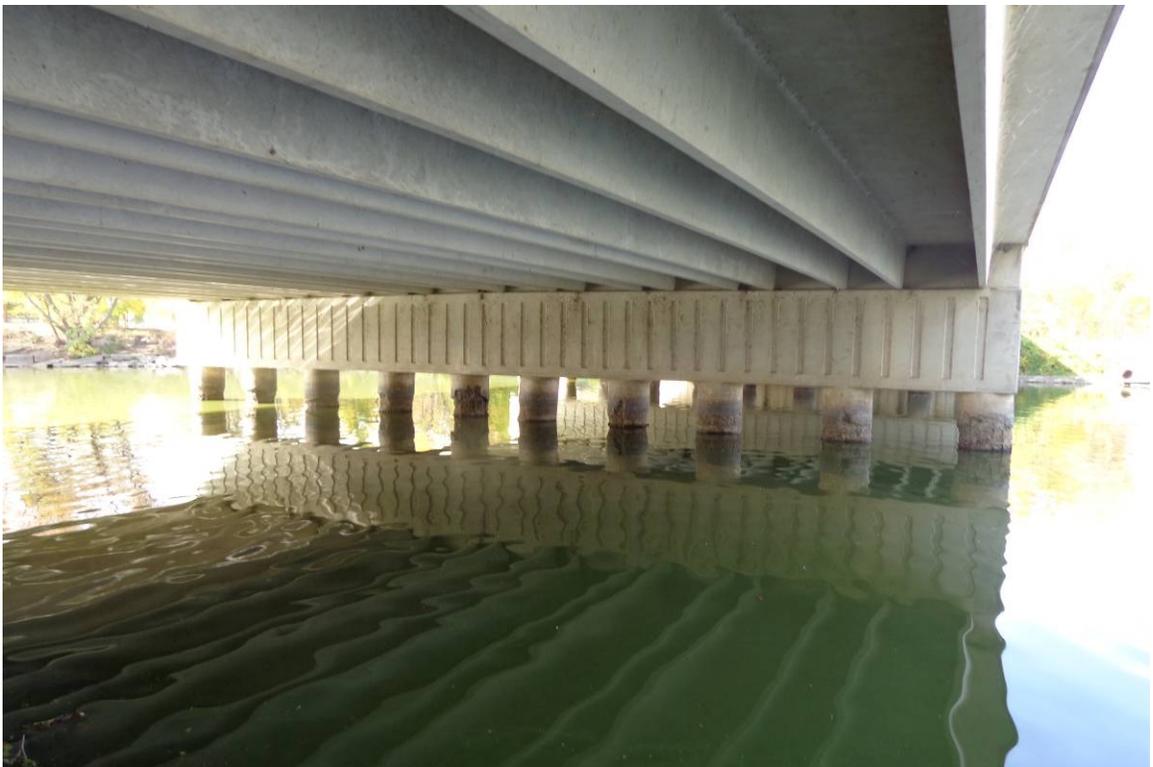
Photograph 2. View of Pier 2, Looking Southwest.

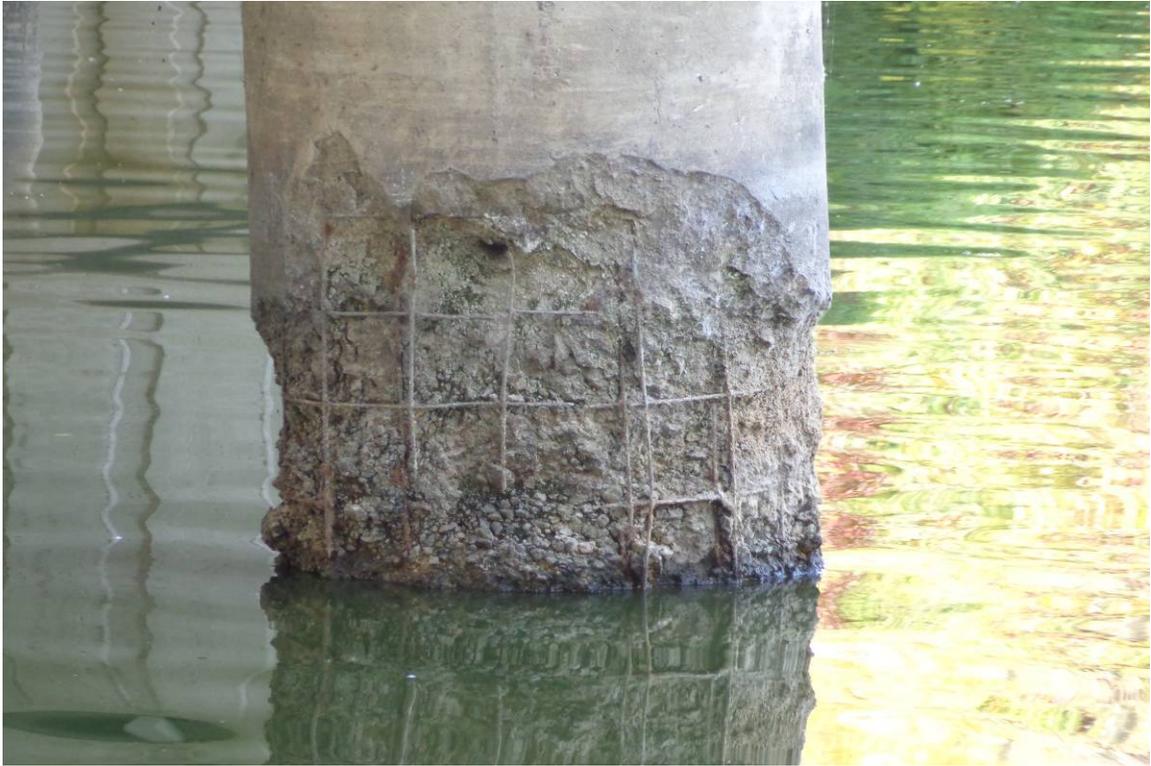
Photograph 3. View of Typical Concrete Section Loss Near the Waterline, Looking West.

- ⑤ The concrete encasements exhibited map cracking and widespread areas of section loss with up to 6 inches of penetration. Frequent areas of exposed reinforcing were also observed.

- (A) The concrete encasements of the steel H-piles have deteriorated to the point where repair is not cost-effective. It should be noted that the encasements are for cosmetic and pile protection reasons, and that overall pier and pile integrity has yet to be adversely affected by the encasement problems. If full protective encasement is considered necessary, encasement replacement would be the appropriate remedial measure.

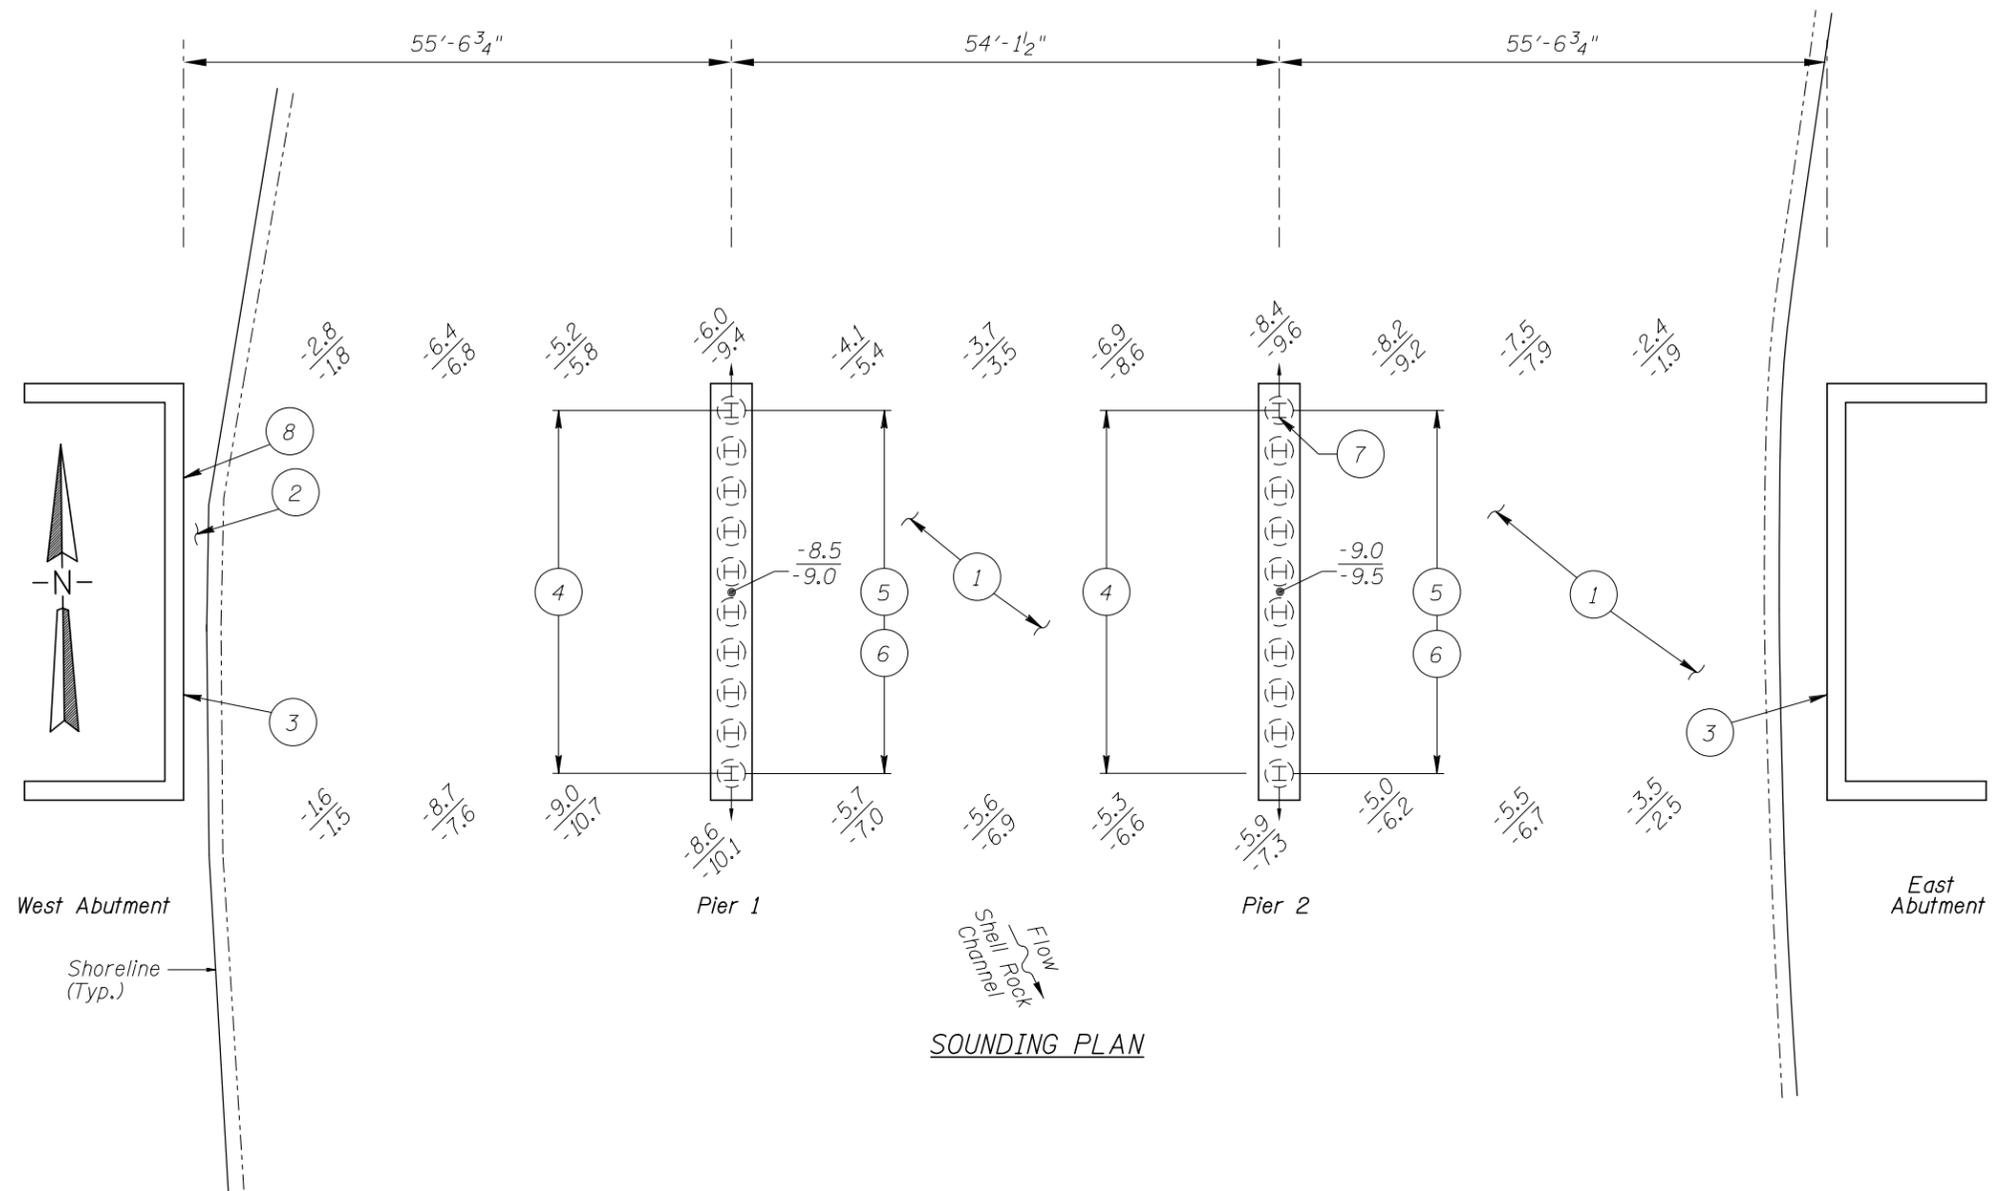
SOUNDING PLAN

- ① The channel bottom consisted of silty sand with 4 inch to 2 feet of probe rod penetration.
- ② The channel bottom consisted of sandy gravel, cobbles and rocks up to 2 feet in diameter with up to 8 inches of probe rod penetration.

- ③ Overall, the concrete abutments were in smooth and sound condition with no structurally significant defects observed.
- ④ The steel H-piles exhibited 100 percent coating failure with moderate surface corrosion and 1/4-inch typical to 1 inch maximum diameter rust nodules and 1/32-inch-deep pitting over approximately 50 percent of the surface area.

- ⑥ Timber and steel formwork was still in place at bottom of encasements.
- ⑦ A welded steel H-pile splice was observed 6 feet below the waterline and appeared to be in good condition.

- ⑧ An area of section loss, 2 feet high by 2 feet wide, was observed above the waterline with up to 1 inch of penetration.
