UNDERWATER BRIDGE INSPECTION REPORT

STRUCTURE NO. 24542

LAKEVIEW BLVD.

MINNESOTA DEPARTMENT OF TRANSPORTATION
UNDERWATER BRIDGE INSPECTION

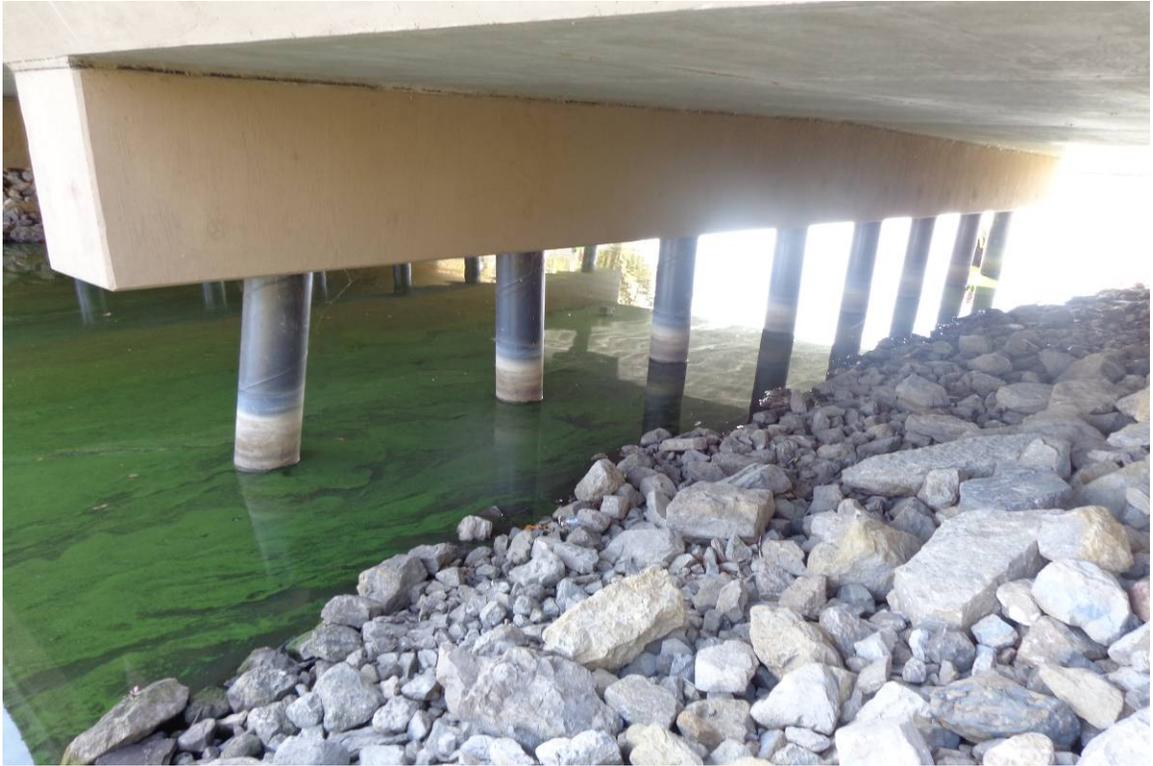
Photograph 1. View of Pier 1, Looking Southeast.

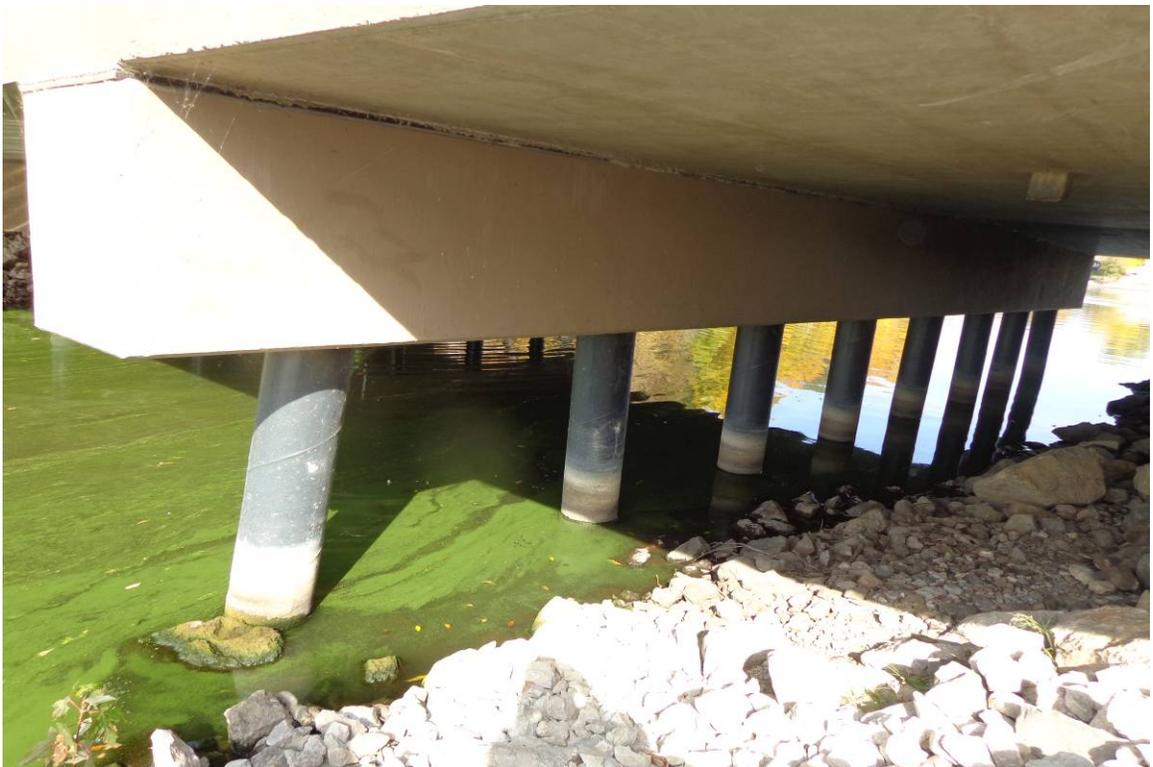
Photograph 2. View of Pier 2, Looking Northwest.

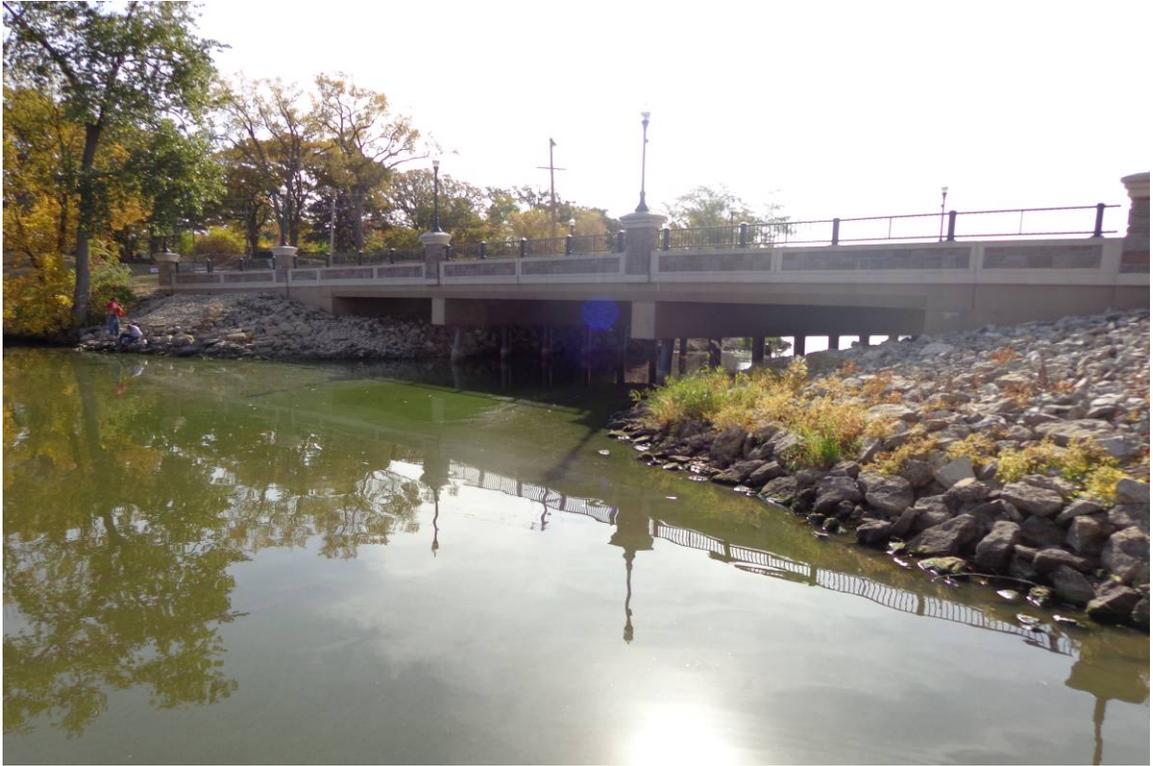
Photograph 3. Overall View of the Structure, Looking Southeast.

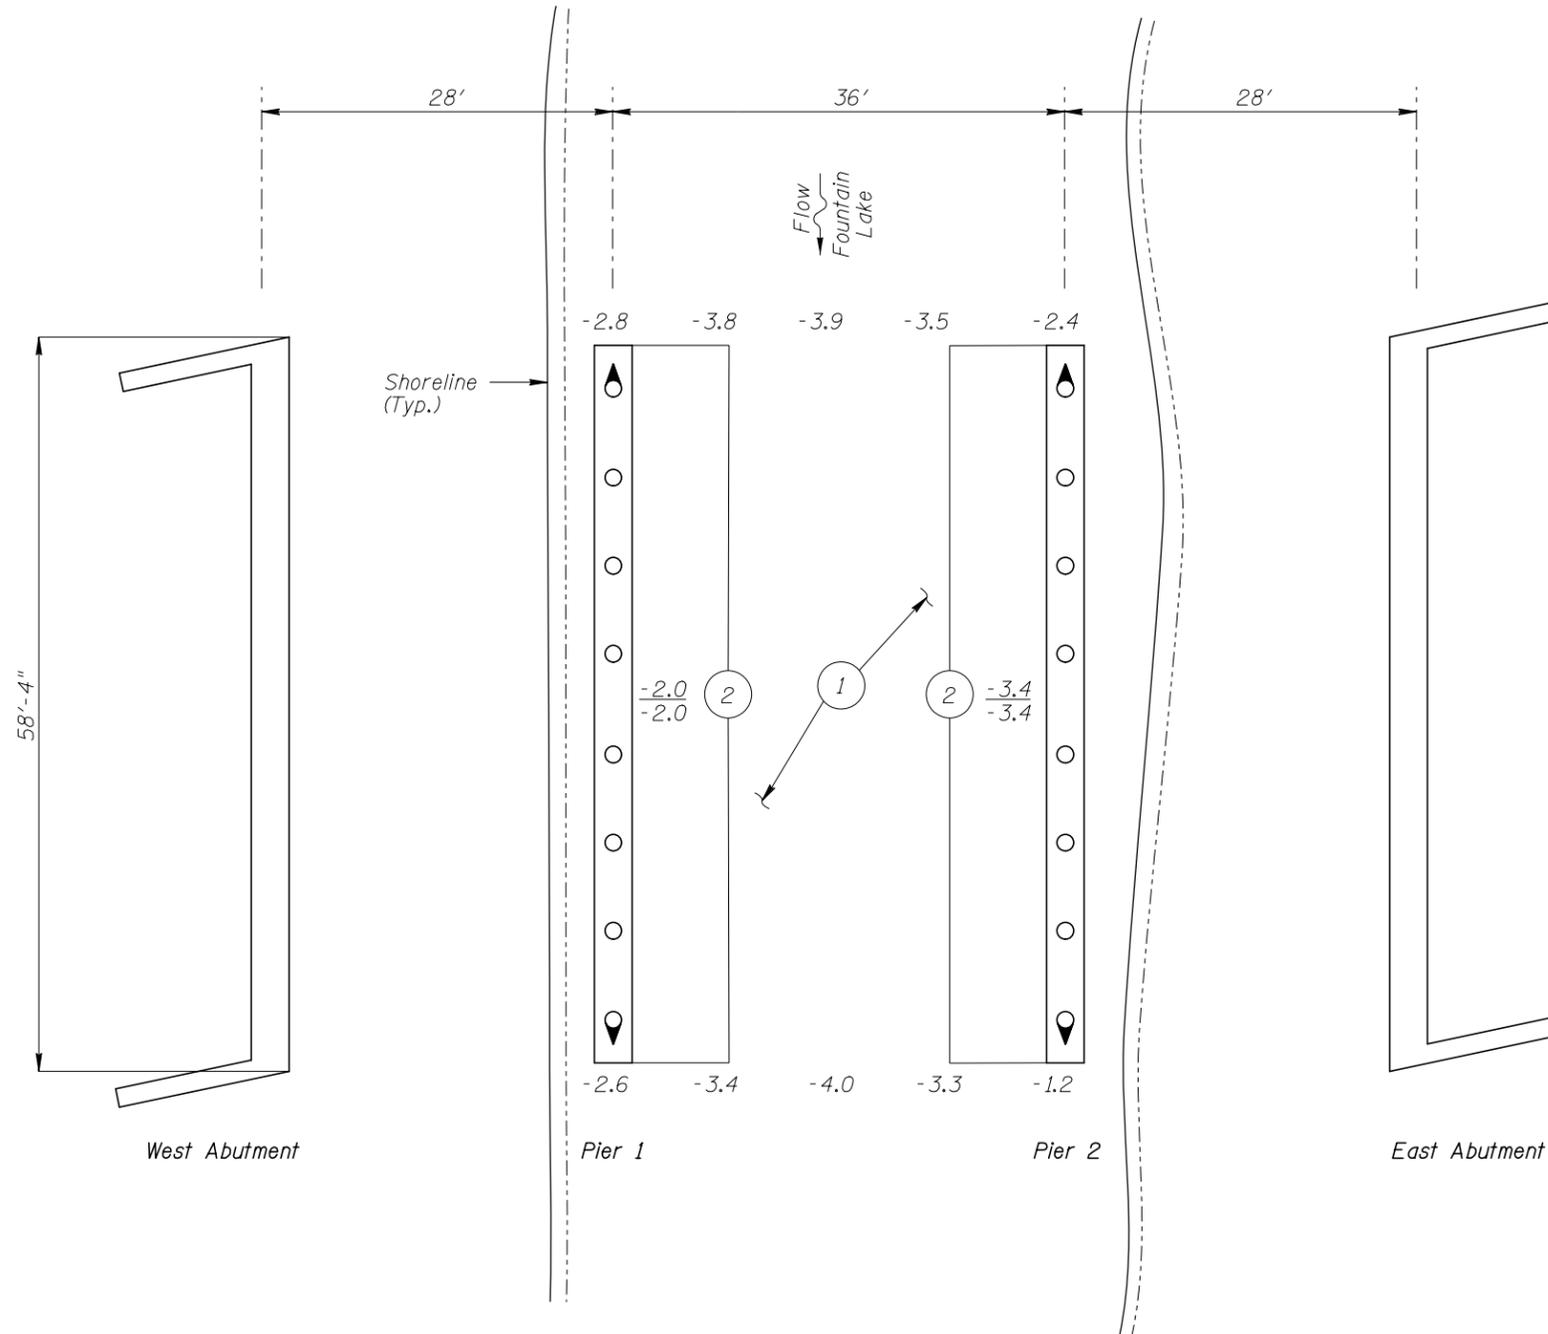
SOUNDING PLAN

- INSPECTION NOTES:
- 1 The steel pile casings typically exhibited light surface corrosion from 1 foot above the waterline to the channel bottom.
 - 2 Channel bottom material typically consisted of silty sand with 2 inches of probe rod penetration and scattered 6 inch to 24 inch diameter riprap.
