UNDERWATER BRIDGE INSPECTION REPORT

STRUCTURE NO. 25504
CSAH 2
OVER
WELLS CREEK
DISTRICT 6 - GOODHUE COUNTY

OCTOBER 1, 2012

BY
COLLINS ENGINEERS, INC.

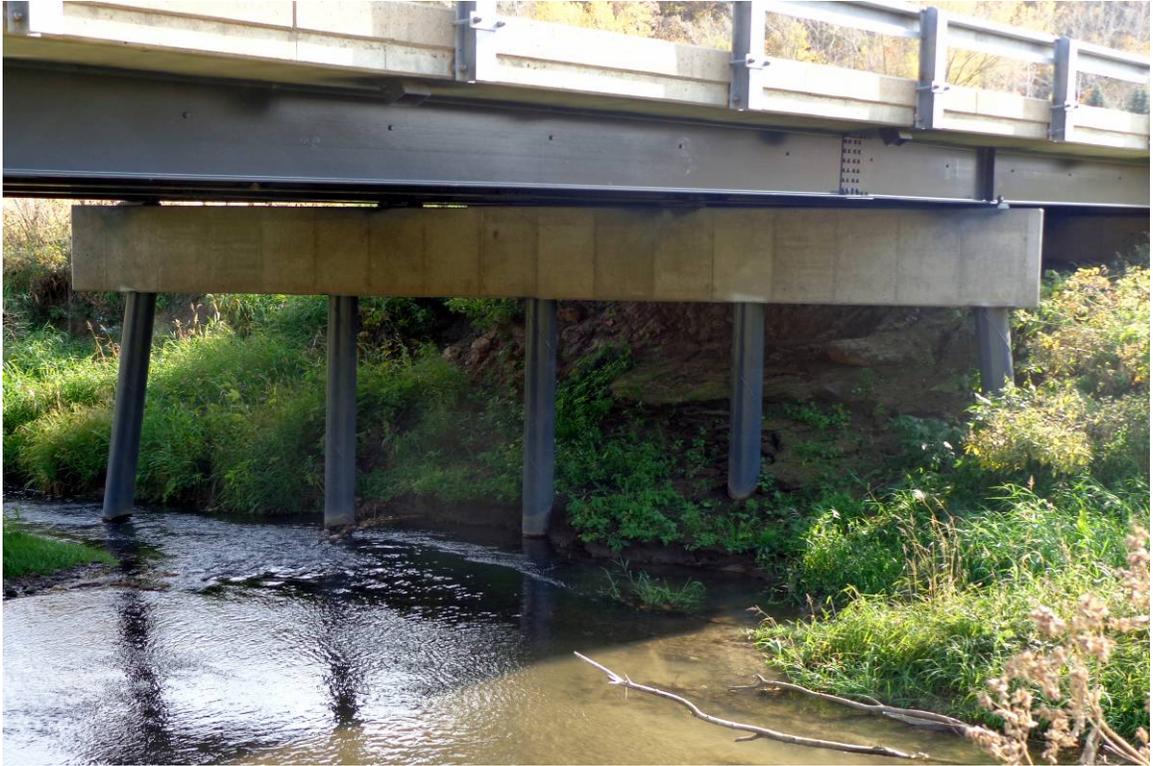
Photograph 3. View of Pier 1, Looking Southeast.

The substructure unit inspected below water at Bridge No. 25504, Pier 1, was found to be in good condition with no defects of structural significance observed. The cast-in-place piles were sound with no notable defects. The channel bottom appeared stable consisting of sand and cobbles and no significant scour.

- (A) The channel bottom material around Pier 1 consisted of sand and cobbles allowing 1 inch of penetration with a standard probe rod.

- (A) The inspection of the submerged substructure units of Structure No. 25504 can most likely be accomplished in the future without the use of a dive team. To perform the underwater inspection, a properly equipped qualified inspector will have to enter the water during a period of low flow. As channel bottom contours and depths of flow can change quickly, it is recommended that lead line soundings of water depth be taken along the upstream and downstream fascias to determine whether wading is possible prior to beginning the inspection. If conditions are unsafe for inspection by wading, then an underwater inspection with the use of a dive team will be required.
- (B) Reinspect the submerged substructure units at the normal maximum recommended (NBIS) interval of sixty (60) months.

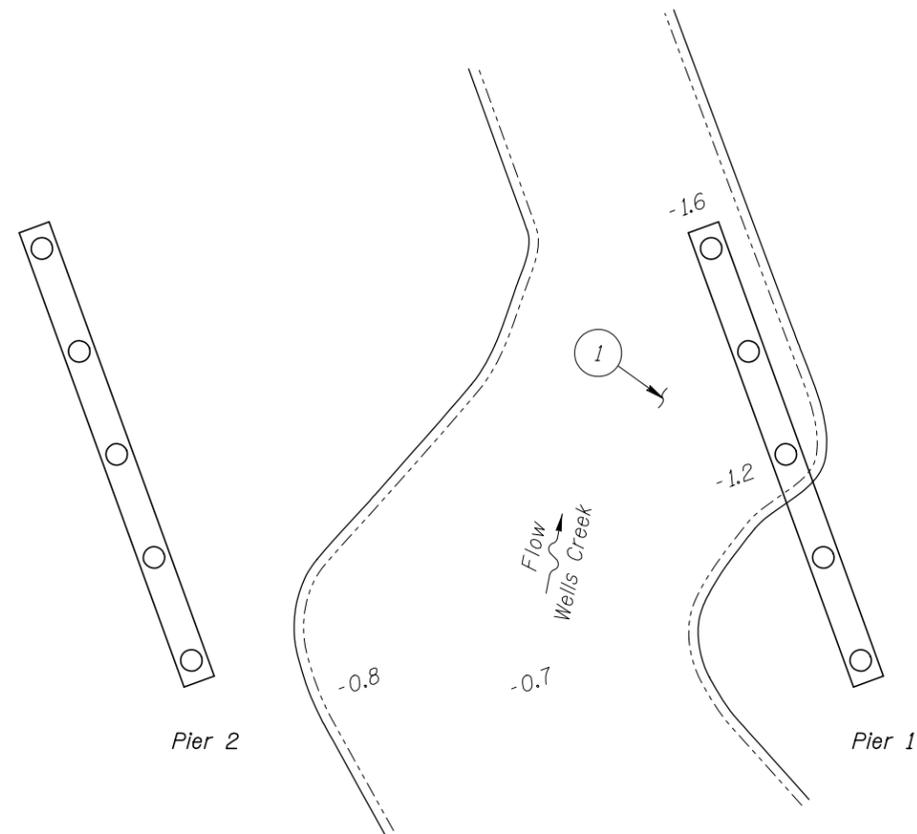
- 1 The channel bottom material around Pier 1 consisted of sand and cobbles allowing 1 inch of penetration with a standard probe rod.
