UNDERWATER BRIDGE INSPECTION REPORT

STRUCTURE NO. 25541
CSAH NO. 9
OVER THE
LITTLE CANNON RIVER
GOODHUE COUNTY

MAY 24, 2012

BY
COLLINS ENGINEERS, INC.

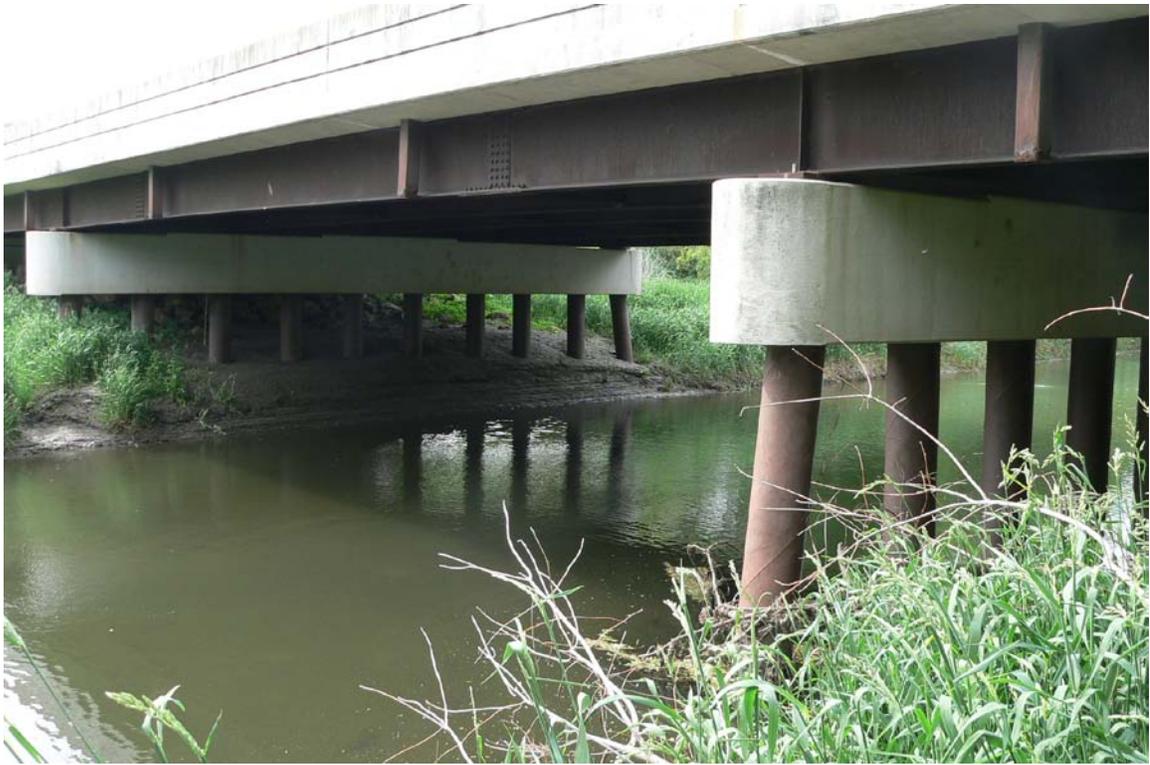
Photograph 1. Overall View of Structure, Looking Northwest.

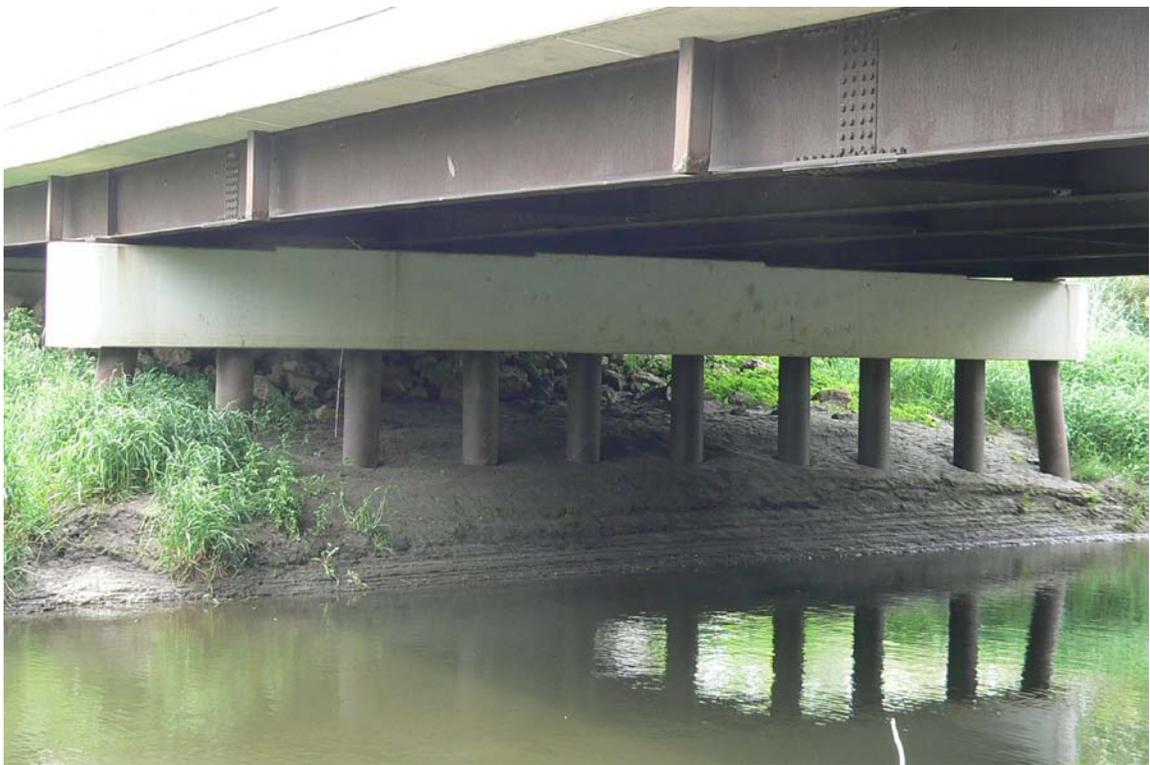
Photograph 2. View of Bent 1, Looking Northwest.

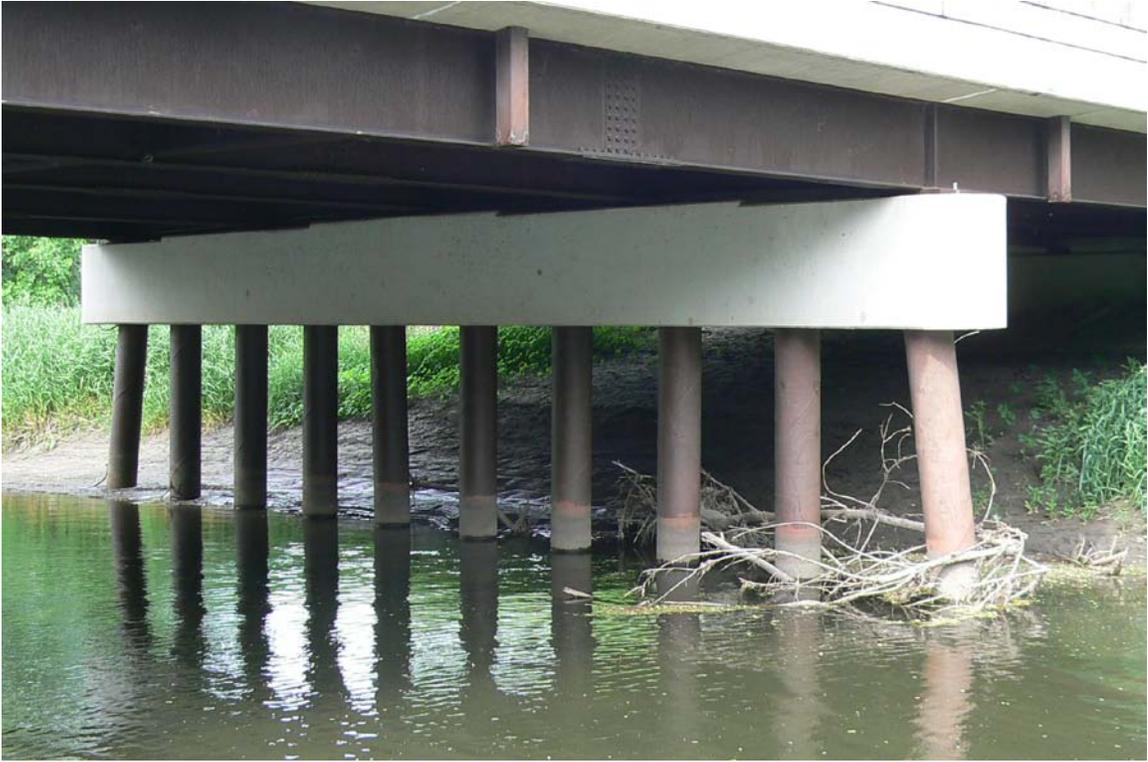
The substructure unit inspected at Bridge No. 25541, Bent 2, was found to be in good condition. There was a light accumulation of timber debris around the upstream nose of Bent 2. The channel bottom appeared to be stable with no evidence of significant scour.

Photograph 3. View of Bent 2, Looking Northeast.

- (A) Reinspect the submerged substructure at the normal maximum recommended (NBIS) interval of sixty (60) months.

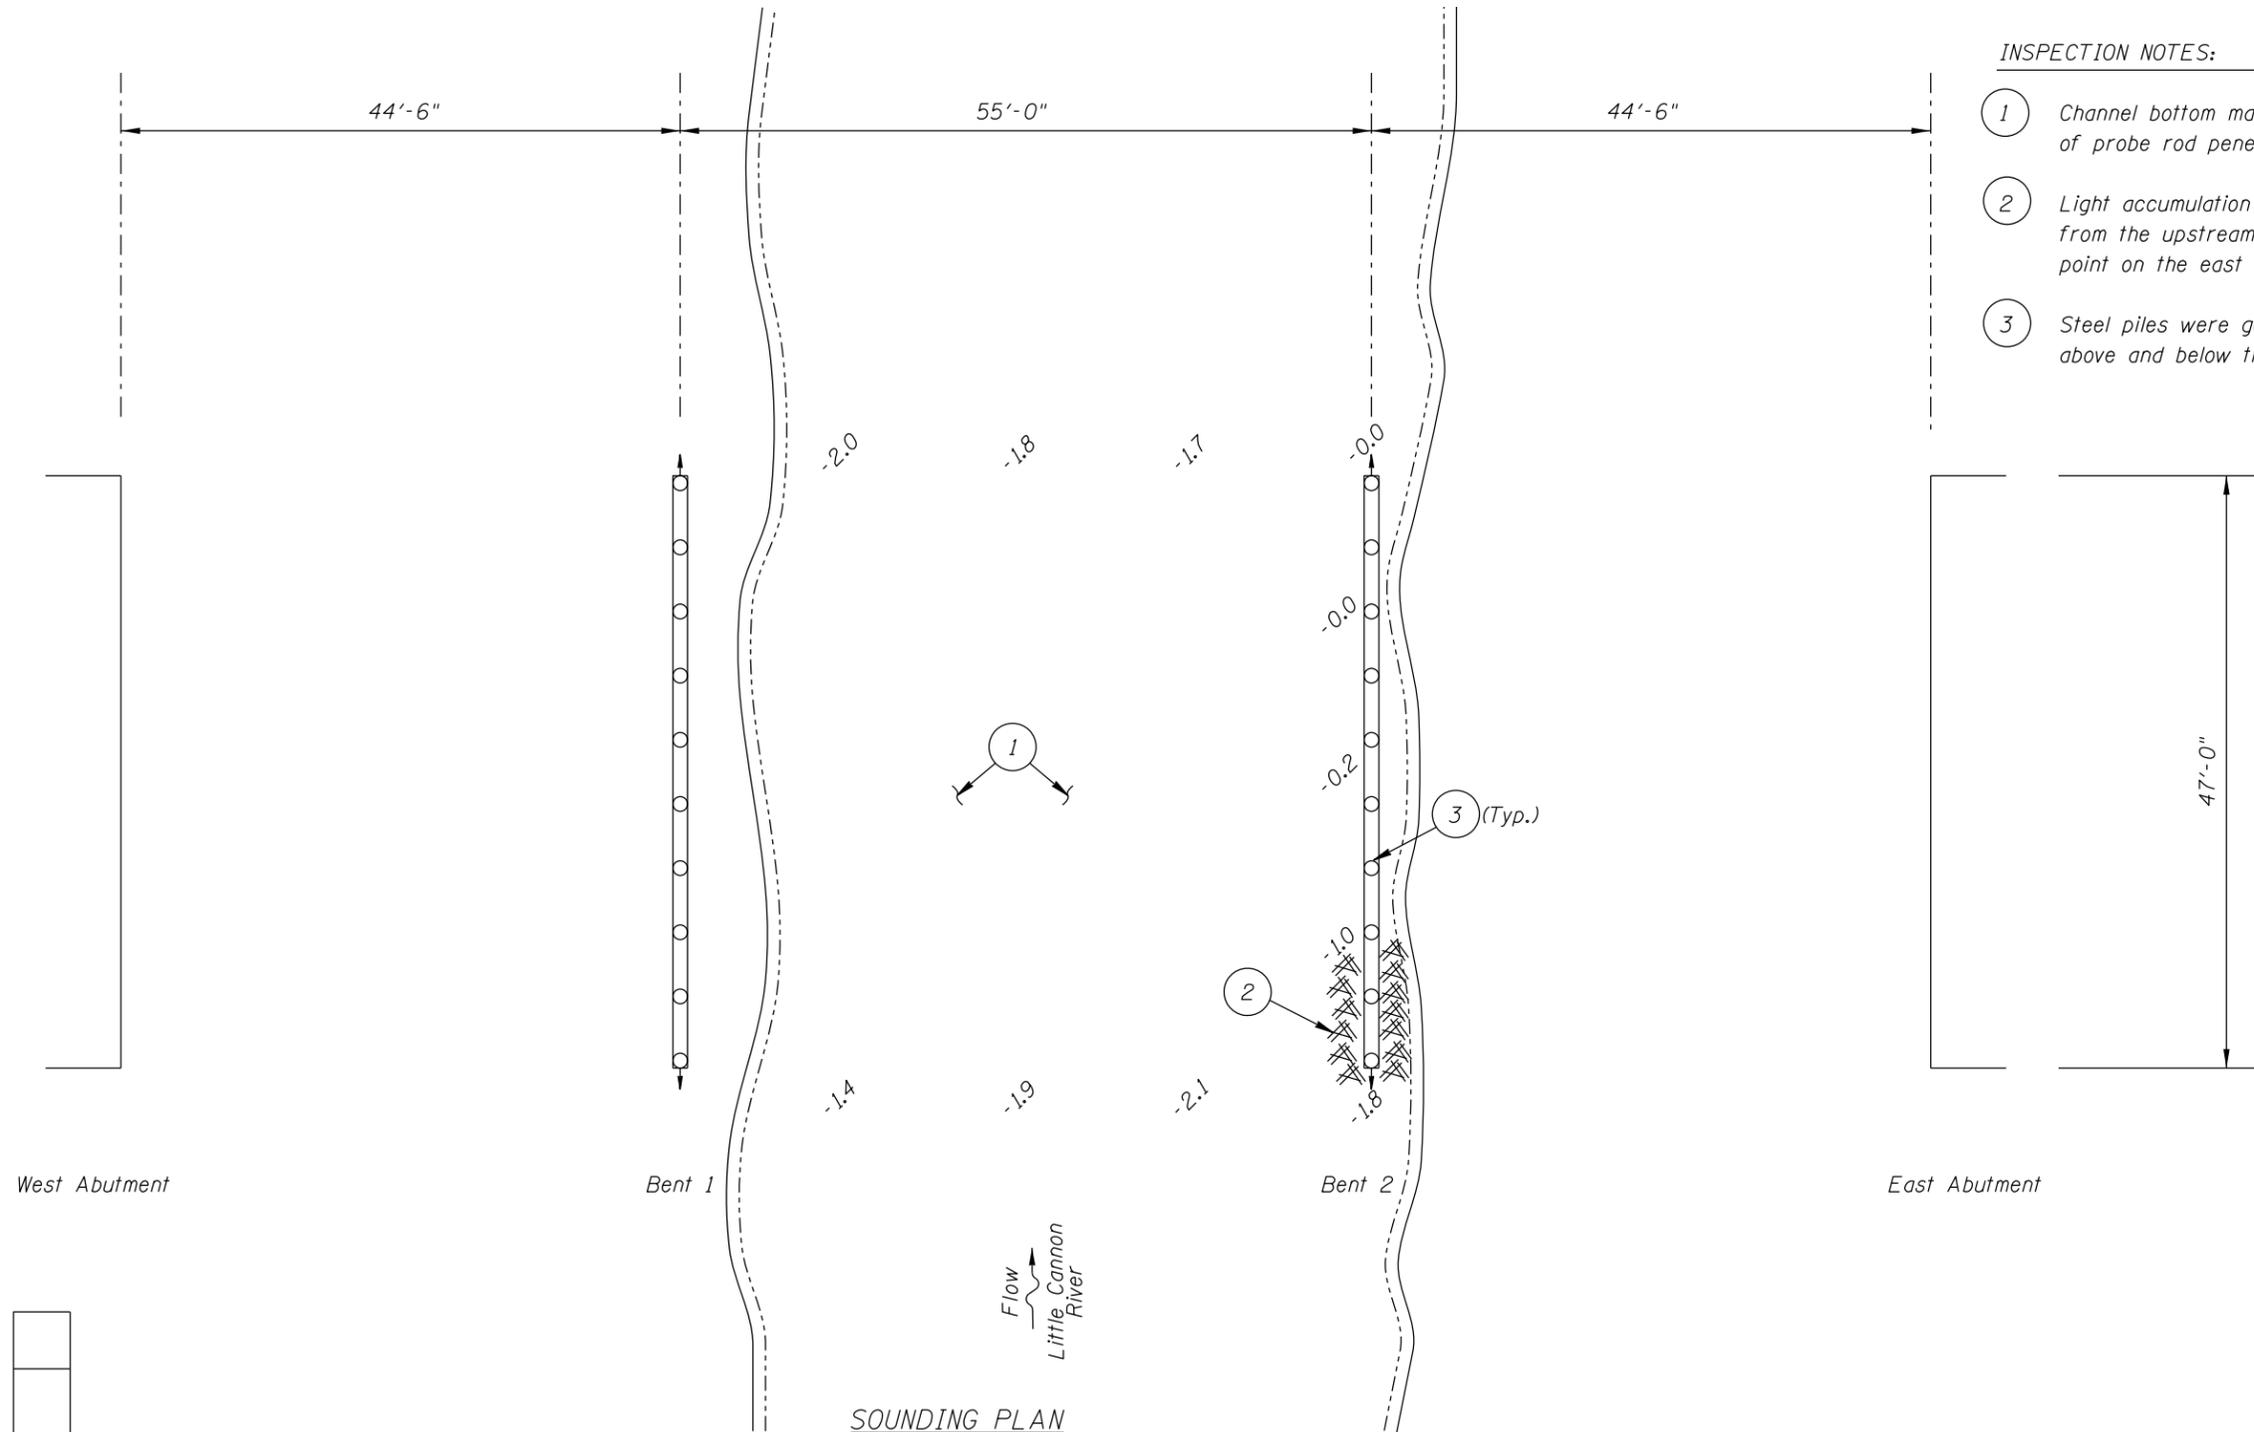
SOUNDING PLAN

- INSPECTION NOTES:**
- ① Channel bottom material consisted of silty clay with up to 3 feet of probe rod penetration.
 - ② Light accumulation of timber debris up to 6 inches in diameter, from the upstream nose of Bent 2 to the upstream quarter point on the east and west faces.
 - ③ Steel piles were generally sound, and the coating was intact above and below the waterline.
