UNDERWATER BRIDGE INSPECTION REPORT

STRUCTURE NO. 25572  
TWP 475 (KOHAN LANE)  
OVER  
WELLS CREEK  
DISTRICT 6 - GOODHUE COUNTY

OCTOBER 1, 2012

BY  
COLLINS ENGINEERS, INC.

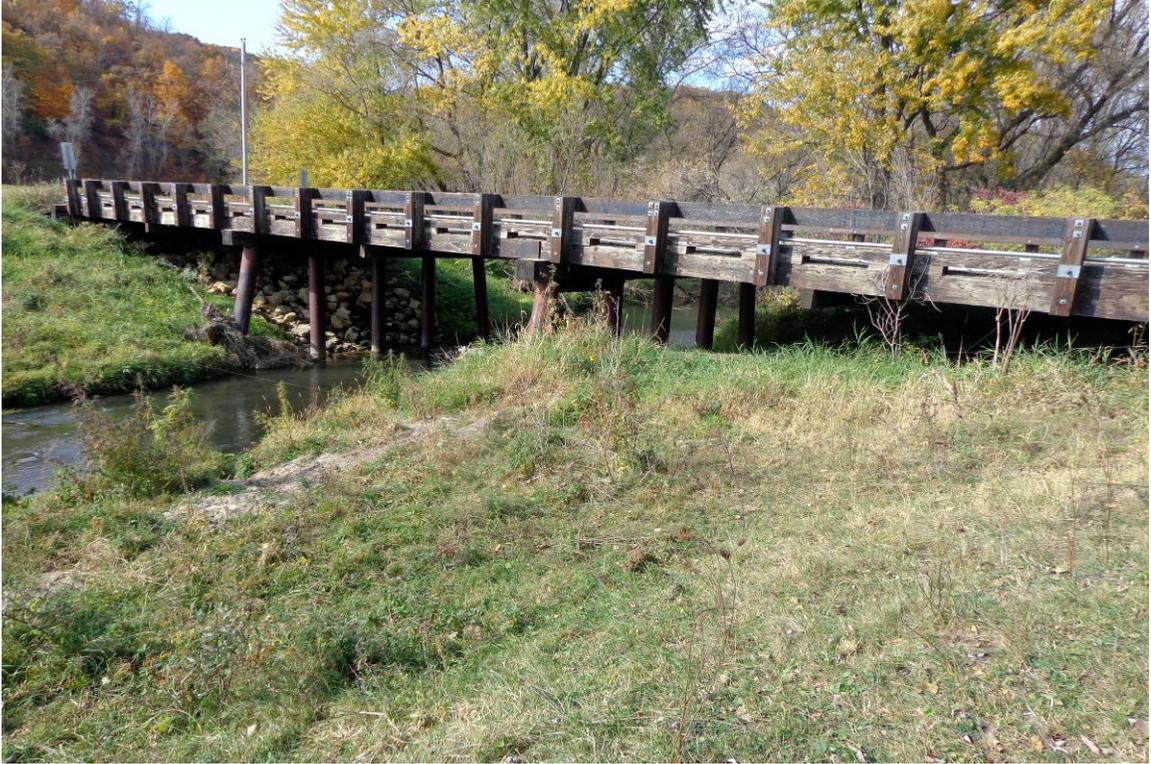
Photograph 1. Overall View of Bridge, Looking Northwest.

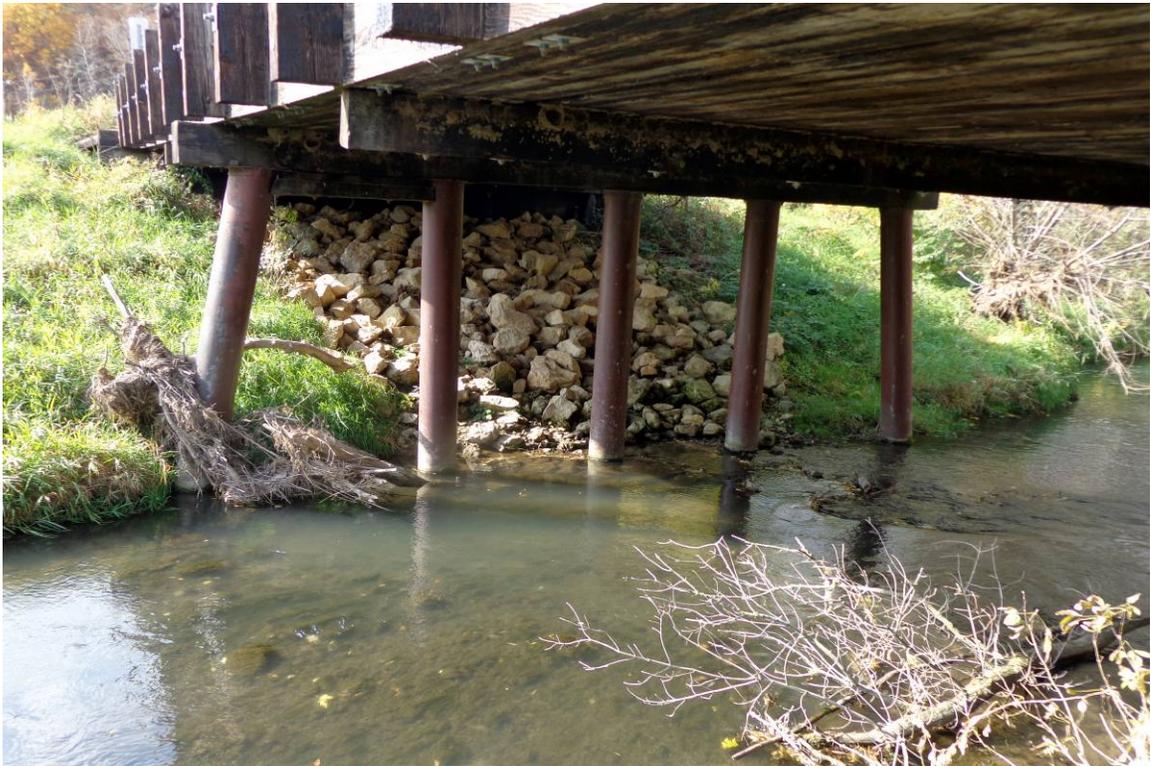
The substructure unit inspected below water at Bridge No. 25572, Bent 1, was found to be in good condition with no defects of structural significance observed. The channel bottom appeared stable consisting of silty sand and riprap with no significant scour present. Timber debris was observed at the upstream nose of Bent 1 along with associated loss of coating on the adjacent pile due to abrasion.

Photograph 2. View of Bent 1, Looking West.

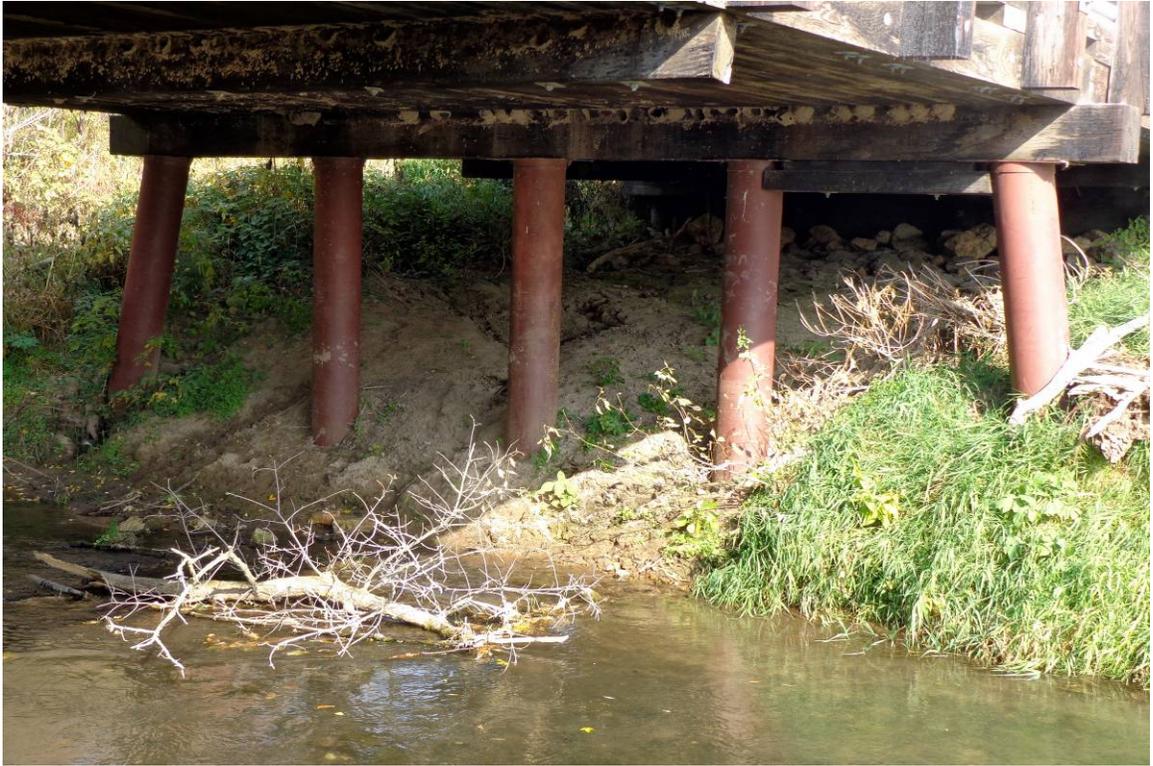
Photograph 3. View of Bent 2, Looking Northeast.

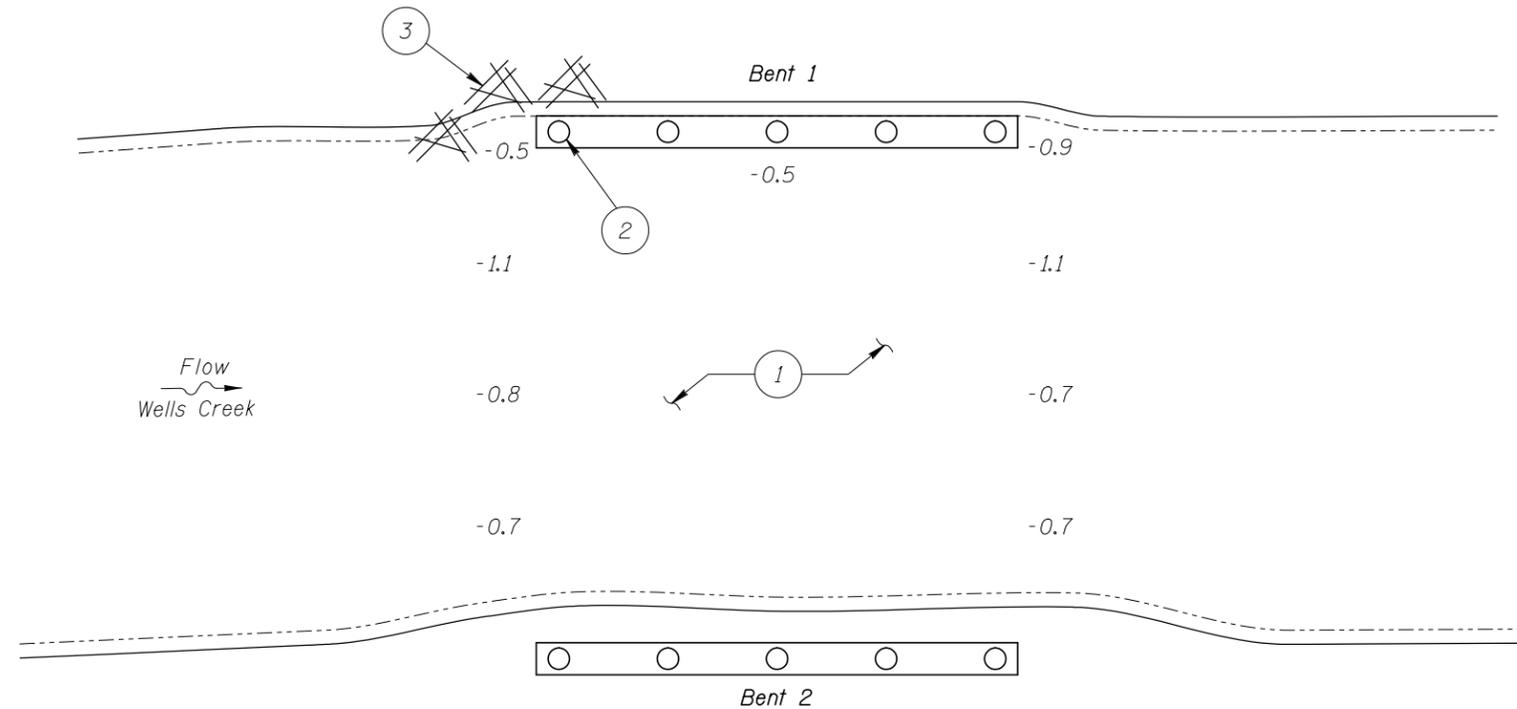
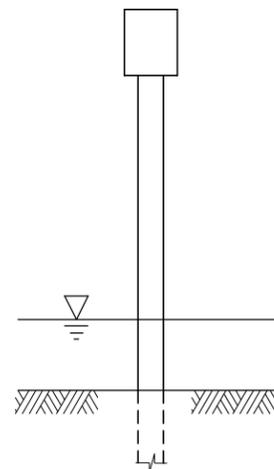
- 1 The channel bottom material in the vicinity of the bridge consisted of silty sand allowing 3 inches of penetration and scattered 12 inch diameter riprap.
- 2 The upstream pile of Bent 1 exhibited 50 percent loss of coating due to abrasion.
- 3 A light to moderate timber debris accumulation was observed at the upstream nose of Bent 1, consisting of 12 inch diameter and smaller logs and branches, extending from the channel bottom up 5 feet.
