UNDERWATER BRIDGE INSPECTION REPORT

STRUCTURE NO. 28528

ROOT RIVER

MINNESOTA DEPARTMENT OF TRANSPORTATION
UNDERWATER BRIDGE INSPECTION

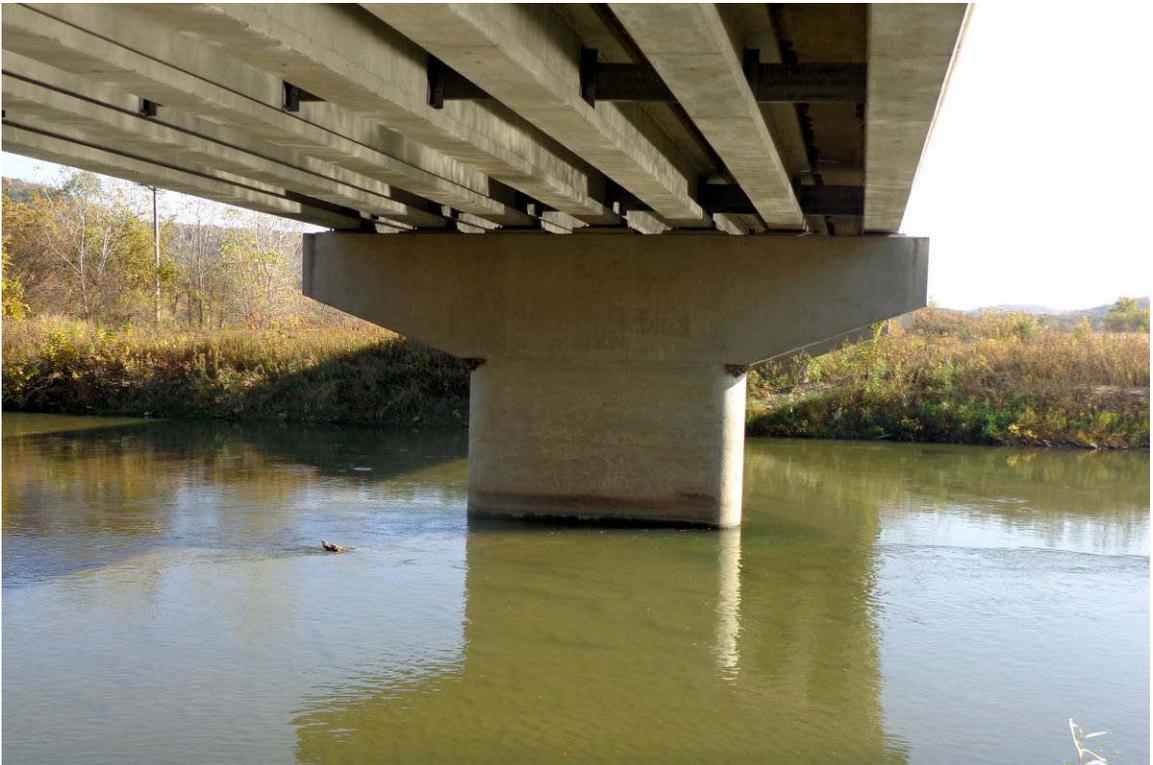
The substructure unit inspected at Bridge No. 28528, Pier 2, was found to be in good condition. The concrete of the pier shaft was sound and exhibited no appreciable deficiencies. The channel bottom appeared stable with a minor scour depression along the south face of the pier.

Photograph 2. View of Pier 2, Looking South.

- (A) Reinspect the submerged substructure units at the normal maximum recommended (NBIS) interval of sixty (60) months.

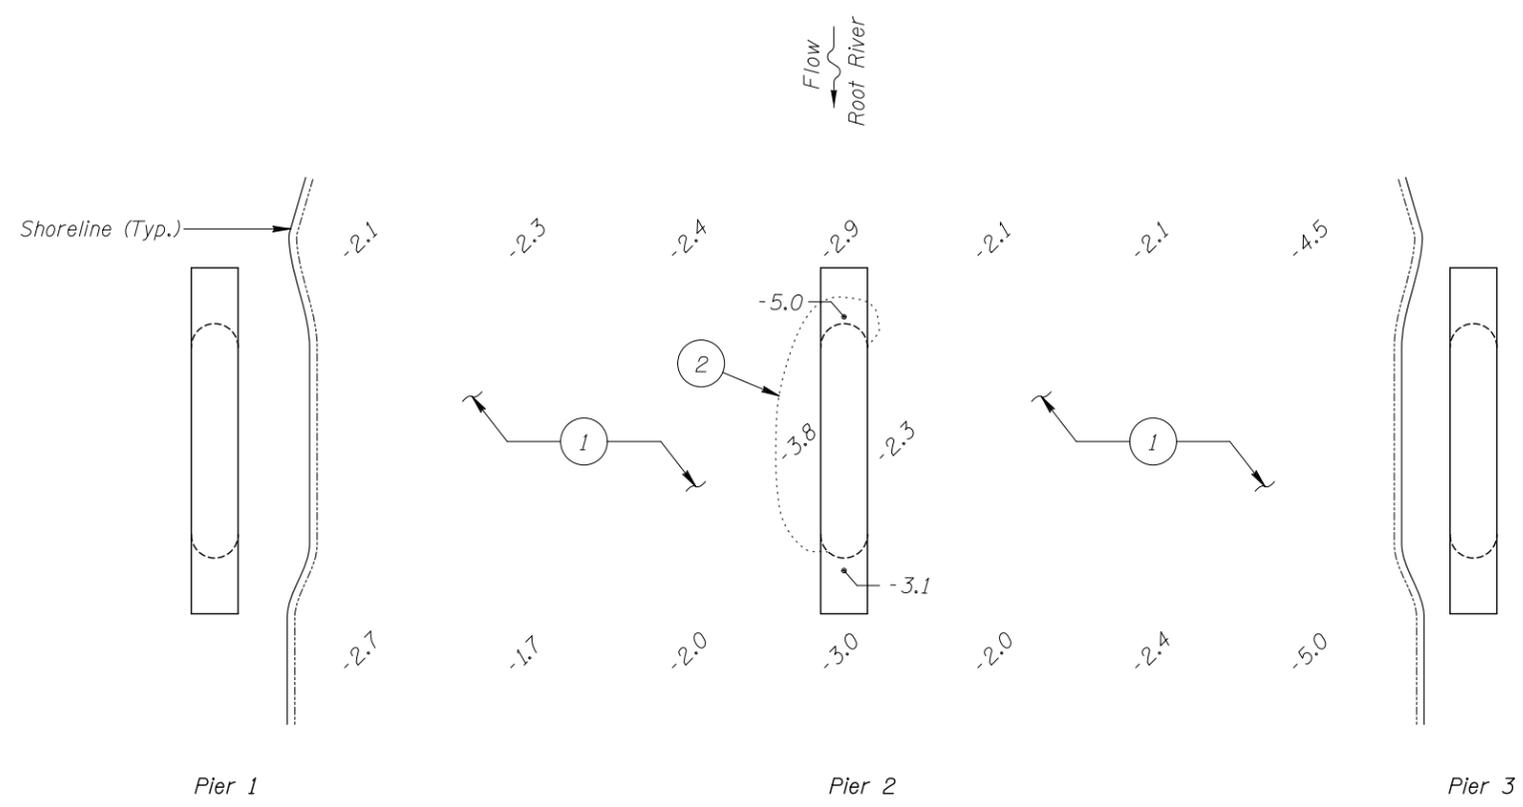
SOUNDING PLAN

- ① The channel bottom material consisted of sand allowing 2 inches of standard probe rod penetration.
- ② A scour depression was observed at the upstream nose and south face of Pier 2, measuring 5 feet wide and 2 feet deep relative to the adjacent channel bottom.

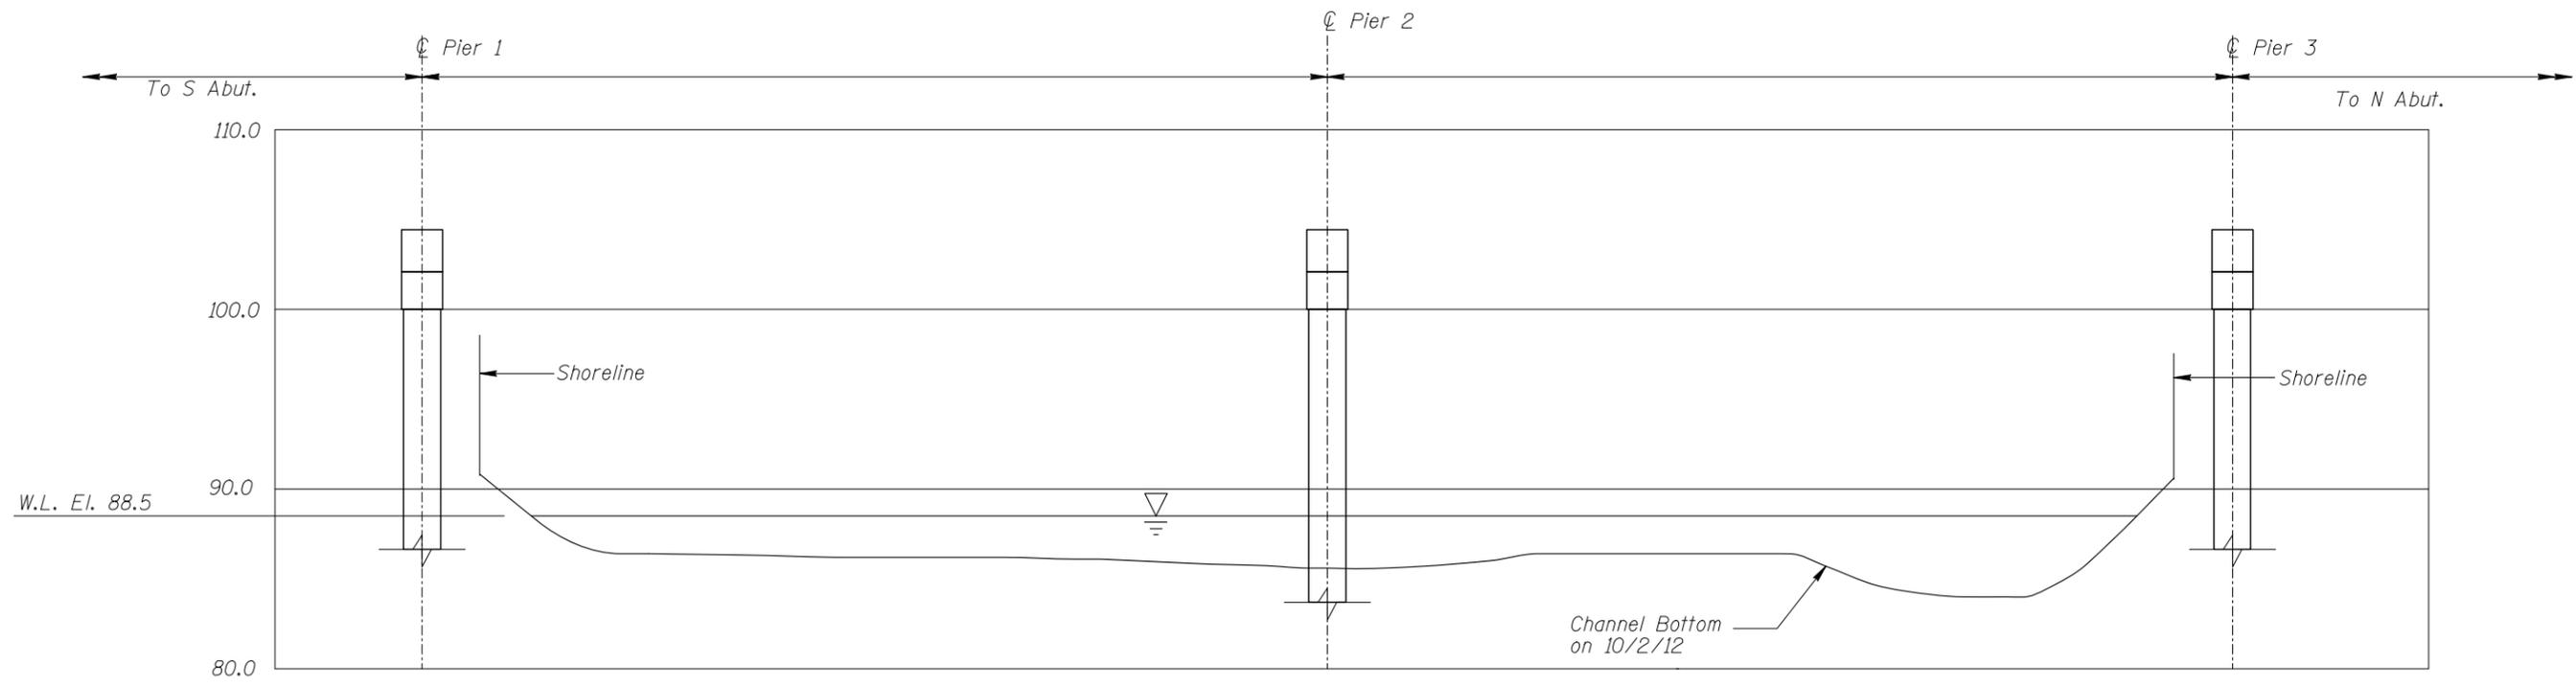
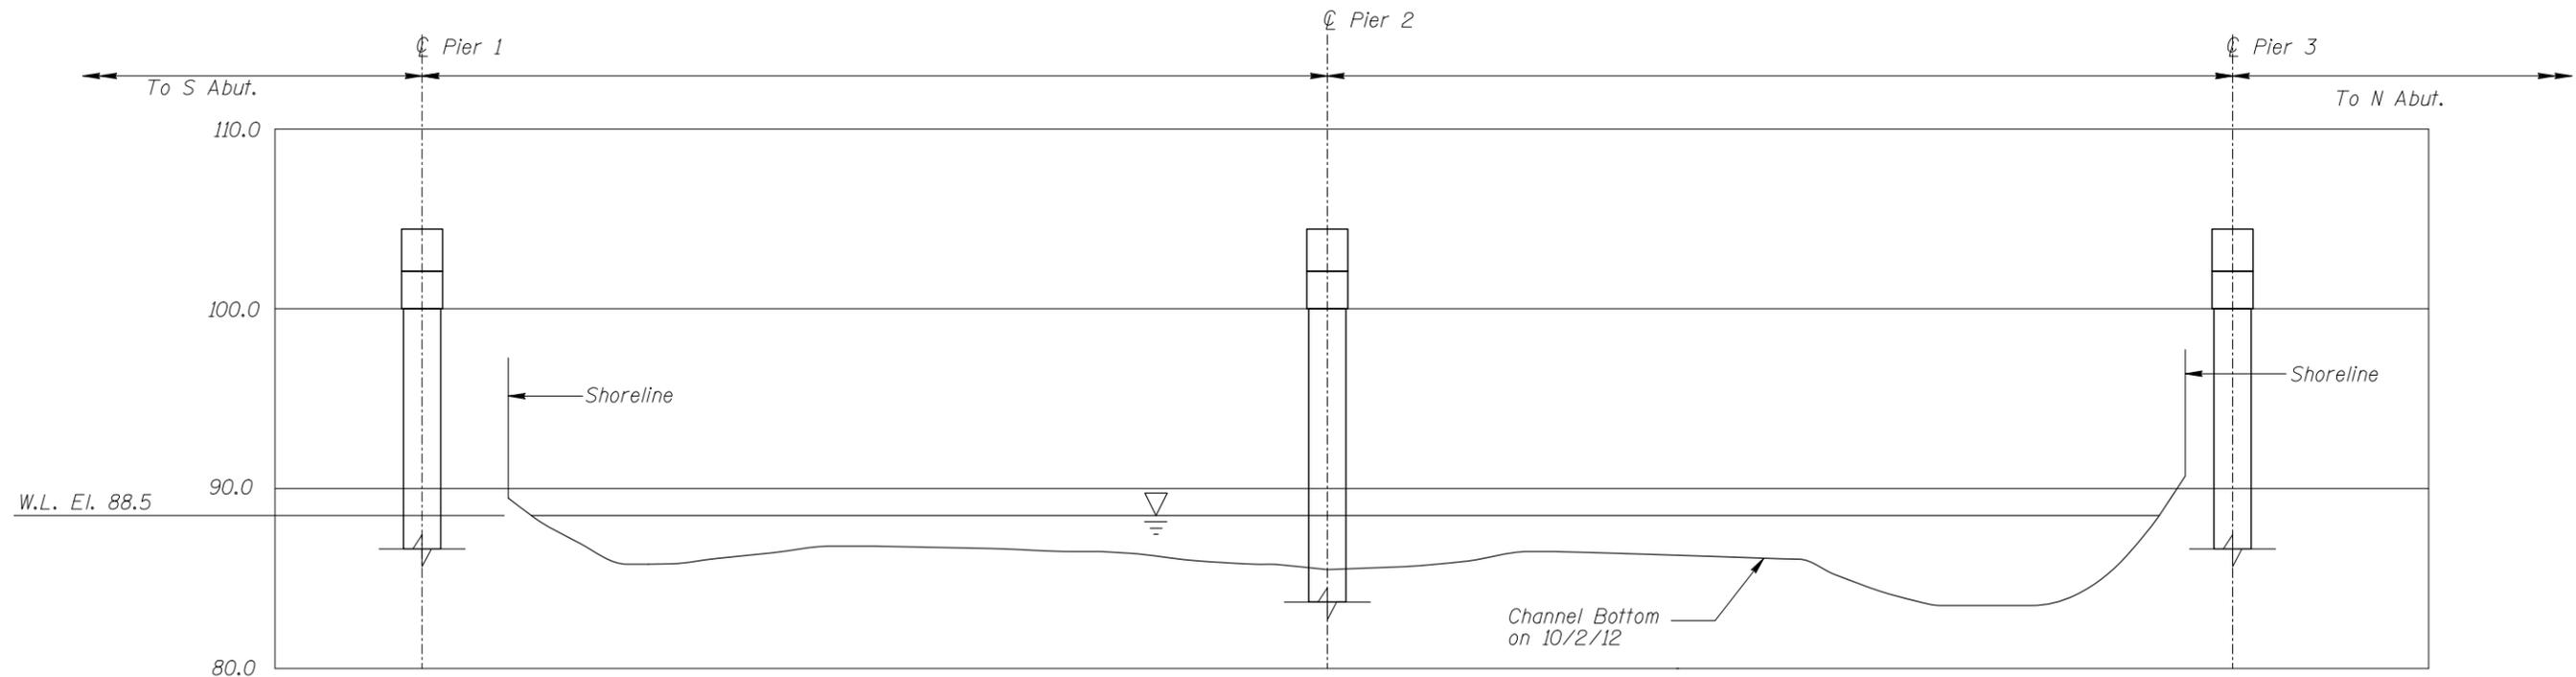
- (A) The channel bottom material consisted of sand with 2 inches of standard probe rod penetration.
- (B) A scour depression was observed at the upstream nose and south face of Pier 2 measuring 5 feet wide and 2 feet deep relative to the adjacent channel bottom.
