UNDERWATER BRIDGE INSPECTION REPORT

STRUCTURE NO. 4260

NORTH CHANNEL OF THE MISSISSIPPI

AUGUST 16, 2012

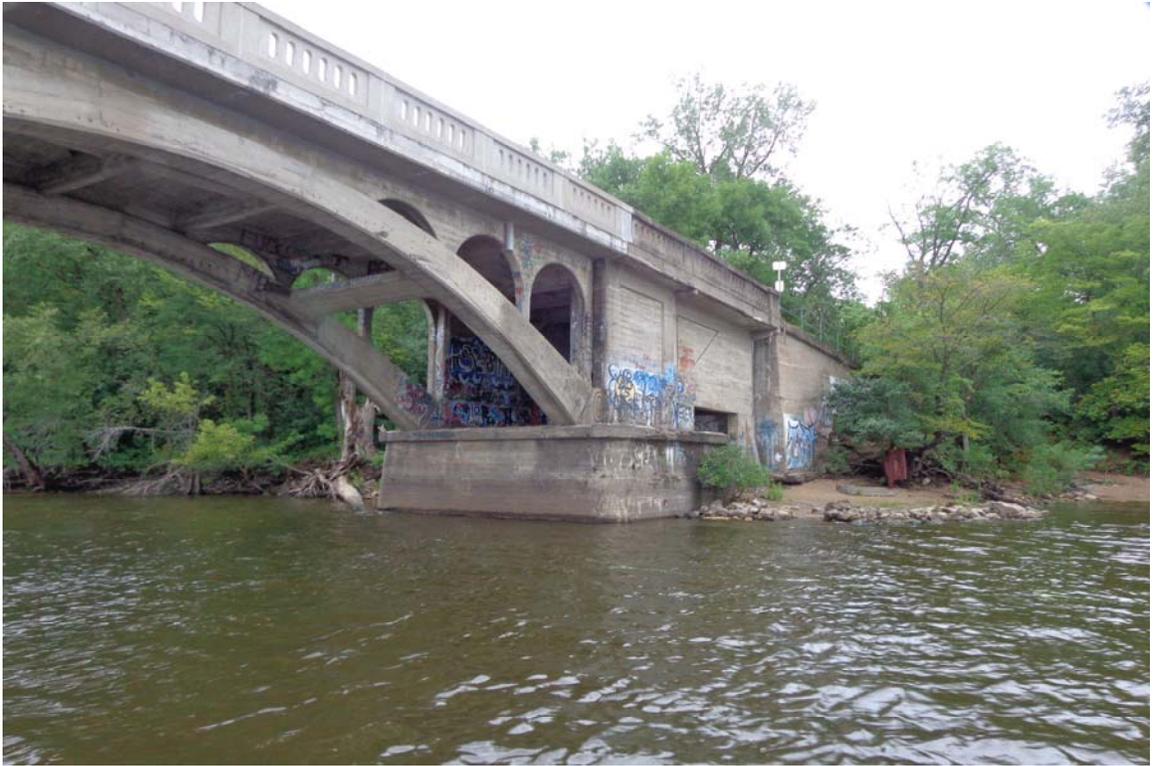
Photograph 1. View of Pier 1, Looking north.

- (C) The footing at Pier 1 was exposed along the southwest face from nose to nose of the pier with a maximum vertical face exposure of 2 feet.
- (D) The submerged concrete was typically in satisfactory to fair condition with moderate scaling from 1 foot above to 1 foot below the waterline with typical penetrations of 1 inch and maximum penetrations of up to 6 inches. Random vertical and horizontal hairline cracks were also observed on the concrete shaft surfaces widespread throughout all piers. Cracking often had efflorescence associated with it.

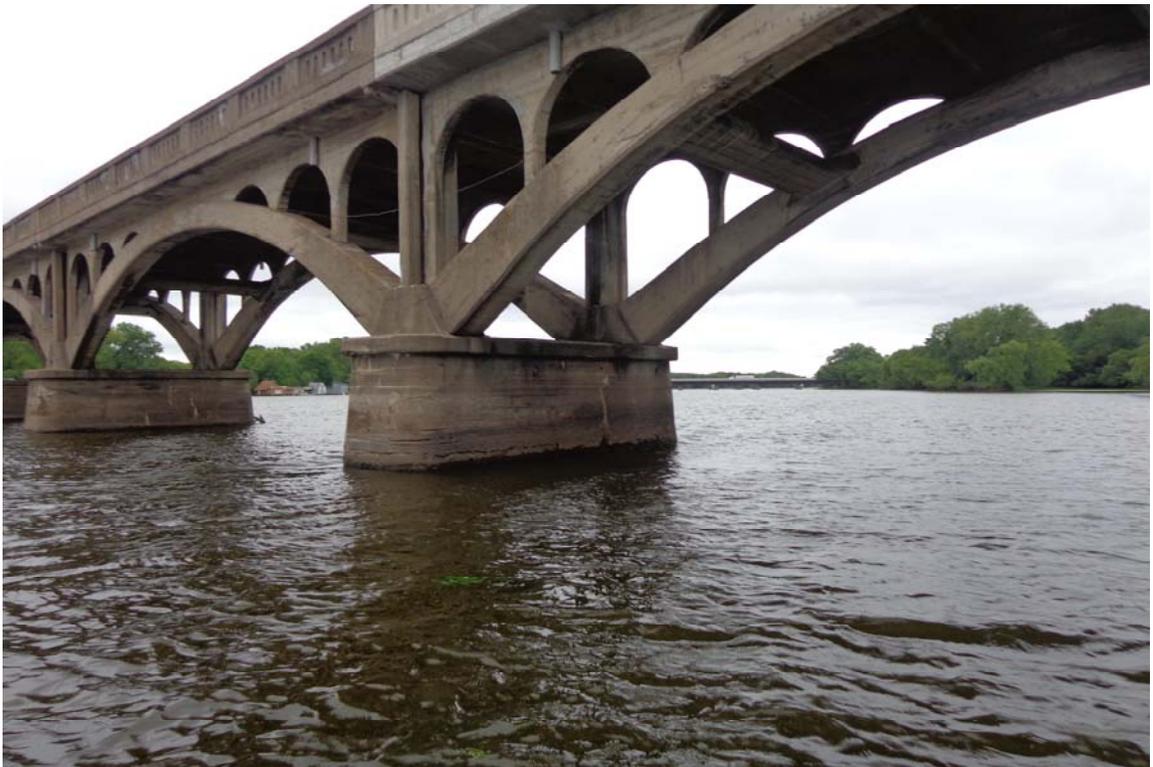
Photograph 2. View of Pier 2, Looking West.

- (E) The footing at Pier 2 was exposed at the upstream nose and tapered off to midpoint where it was covered by riprap. The footing was exposed a maximum of 3 feet vertically.
- (F) Pier 9 exhibited an area of section loss on the downstream south corner from 2 feet above to 6 inches below the waterline with up to 3 inches of penetration.
- (G) The upstream nose and west face of Pier 3 had moderate timber debris accumulation from channel bottom up to 2 feet above waterline, consisting of 2 foot diameter and smaller logs.

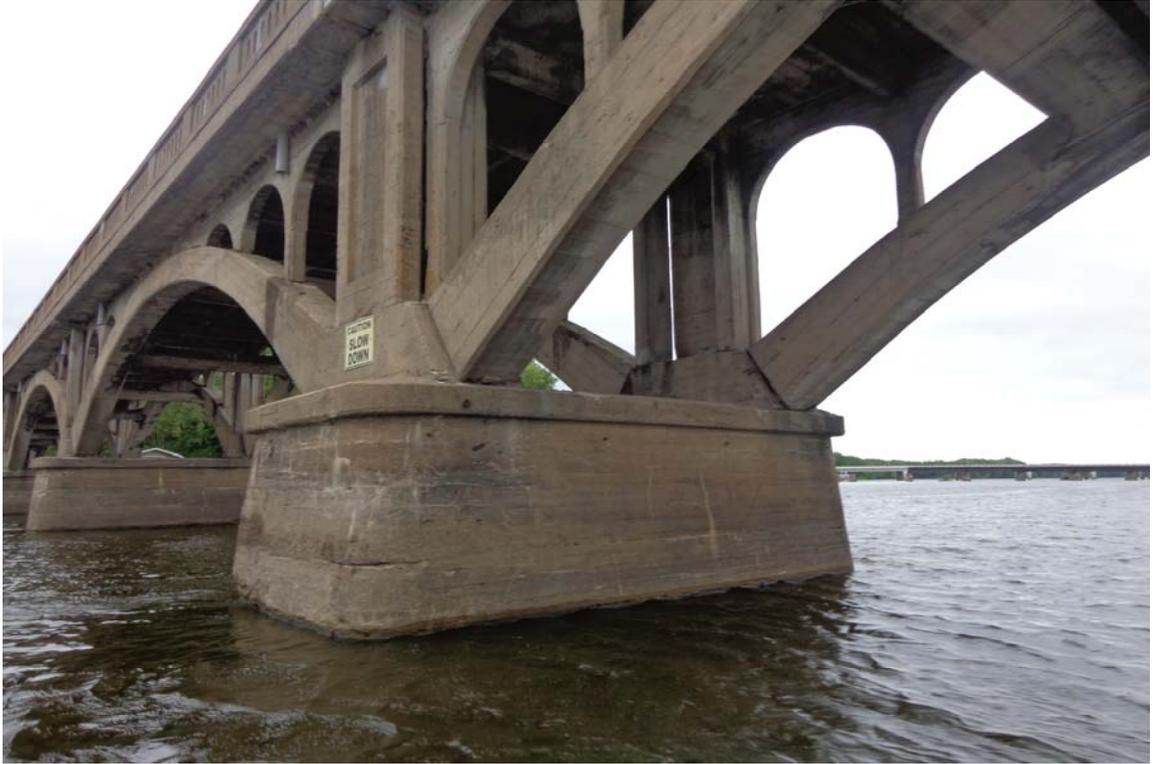
Photograph 9. View of Pier 9, Looking West.

- ④ Pier 9 exhibited an area of section loss on the downstream south corner from 2 feet above to 6 inches below the waterline with up to 3 inches of penetration.

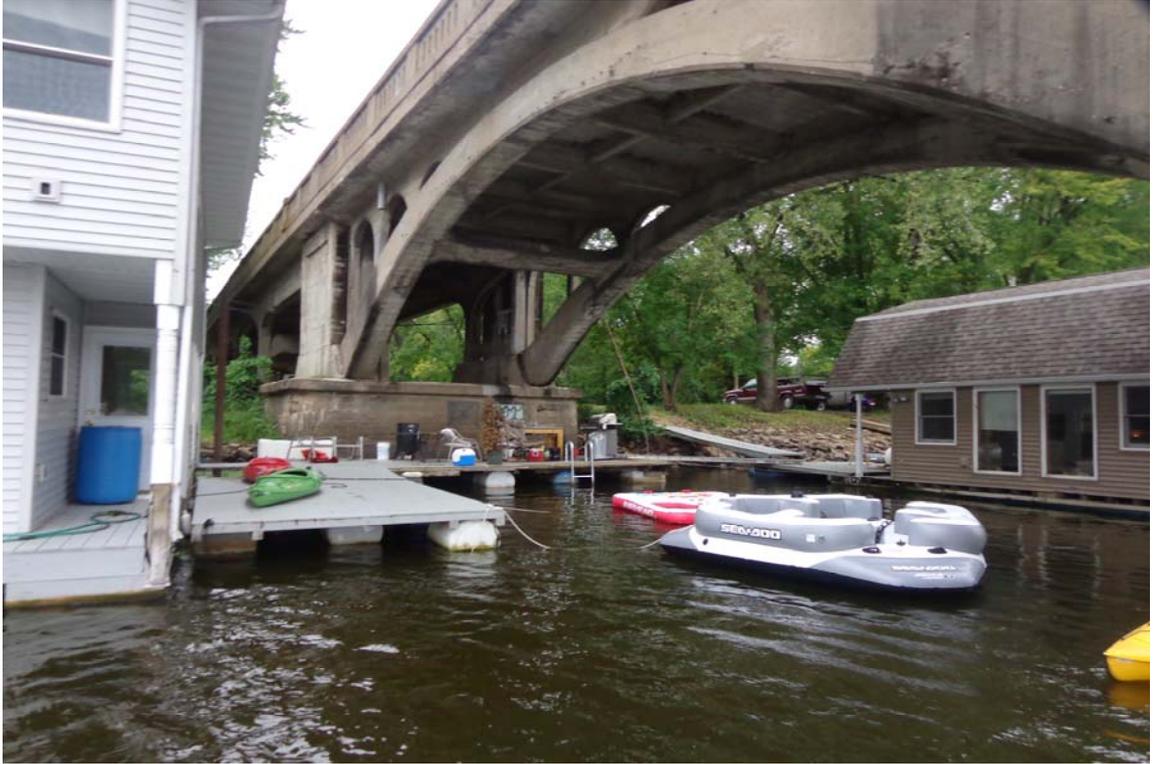
Photograph 13. View of Pier 13, Looking West.

- (B) The channel bottom of Pier 13 consisted of silt with small stones and no riprap. Stones and rubble were observed at the upstream and downstream ends.

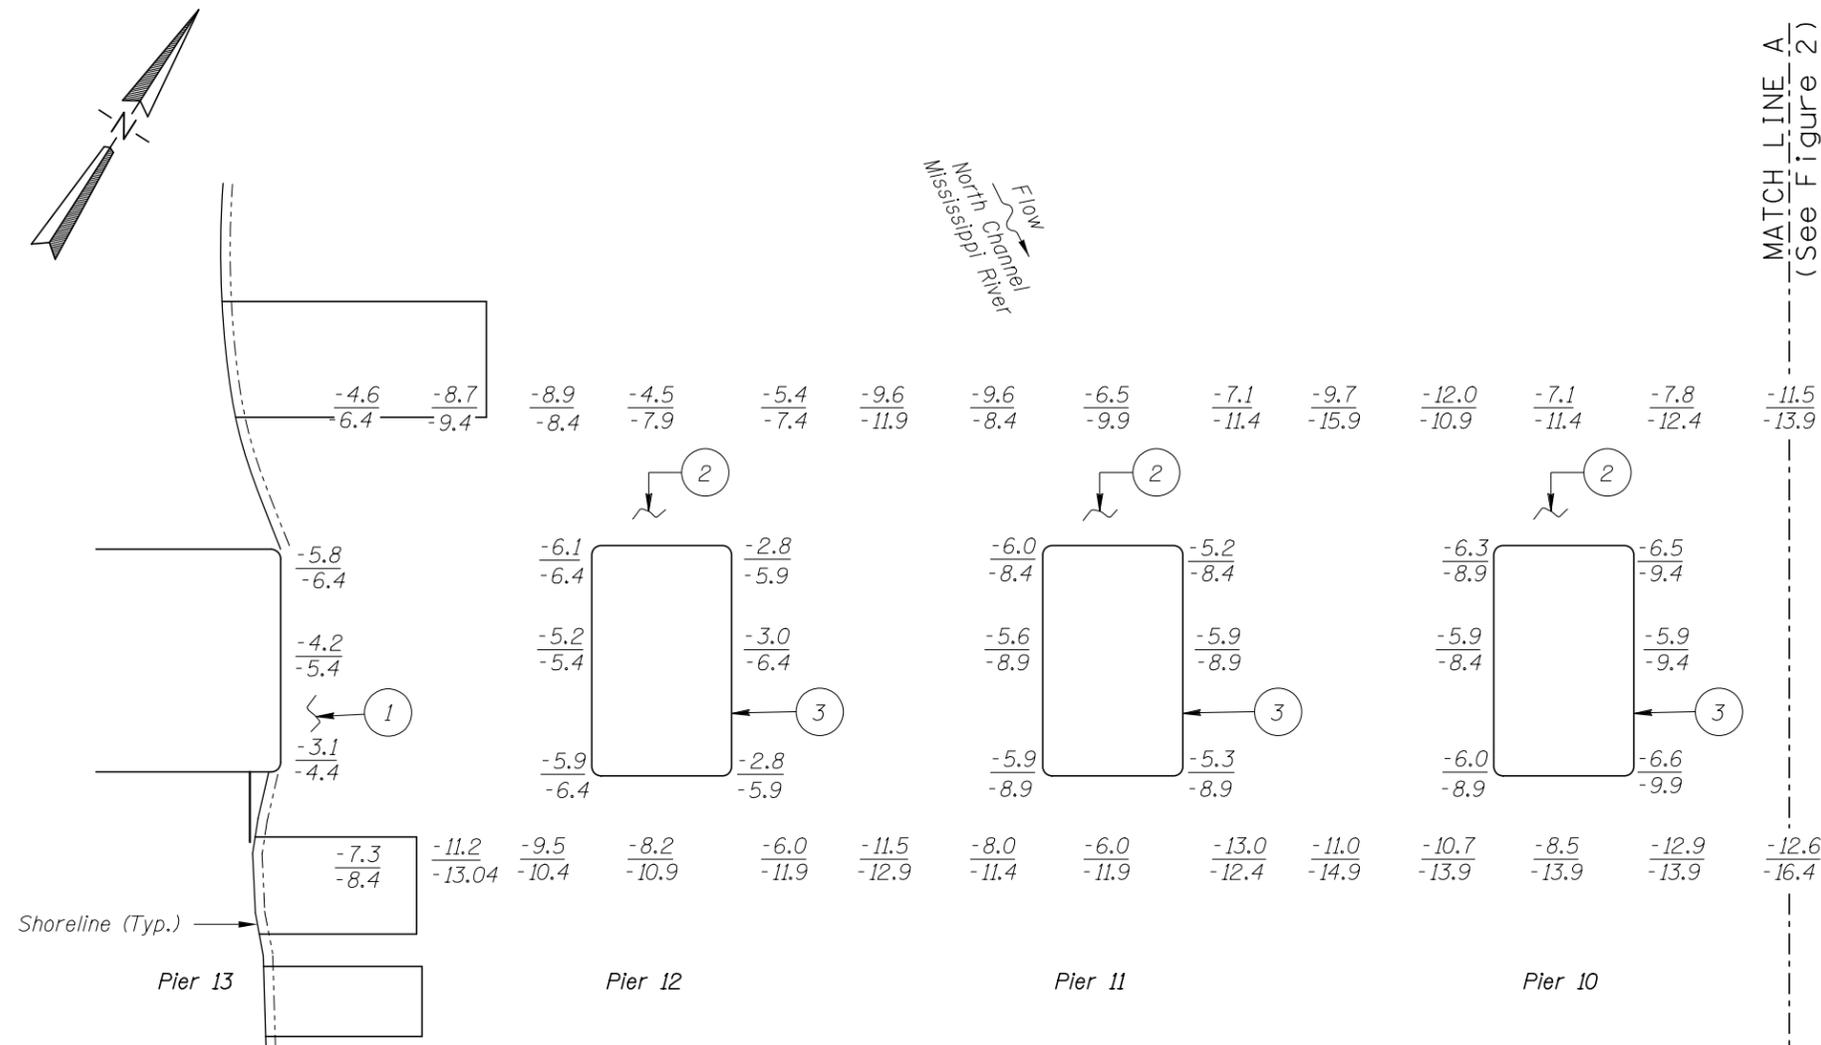
- 1 The channel bottom at Pier 13 consisted of silt with small stones and no riprap. Stone and rubble was observed at the upstream and downstream ends.

- 2 The channel bottom at Piers 1 through 12 consisted of riprap typically 1 to 2 feet in diameter with a maximum diameter of up to 3 feet. It was observed around the entire perimeter of all piers typically extending to top of footing or to no lower than 3 feet below top of footing.

- 3 The submerged concrete was typically in satisfactory condition with moderate scaling from 1 foot above the waterline to 1 foot below the waterline with typical penetrations of 1 inch and maximum penetrations of up to 6 inch. Random vertical and horizontal hairline cracks were also observed on the concrete shaft surfaces widespread throughout all piers. Cracking often had efflorescence associated with it. The concrete footing (where exposed) typically exhibited rough surfaces with up to 3 inch maximum penetration.

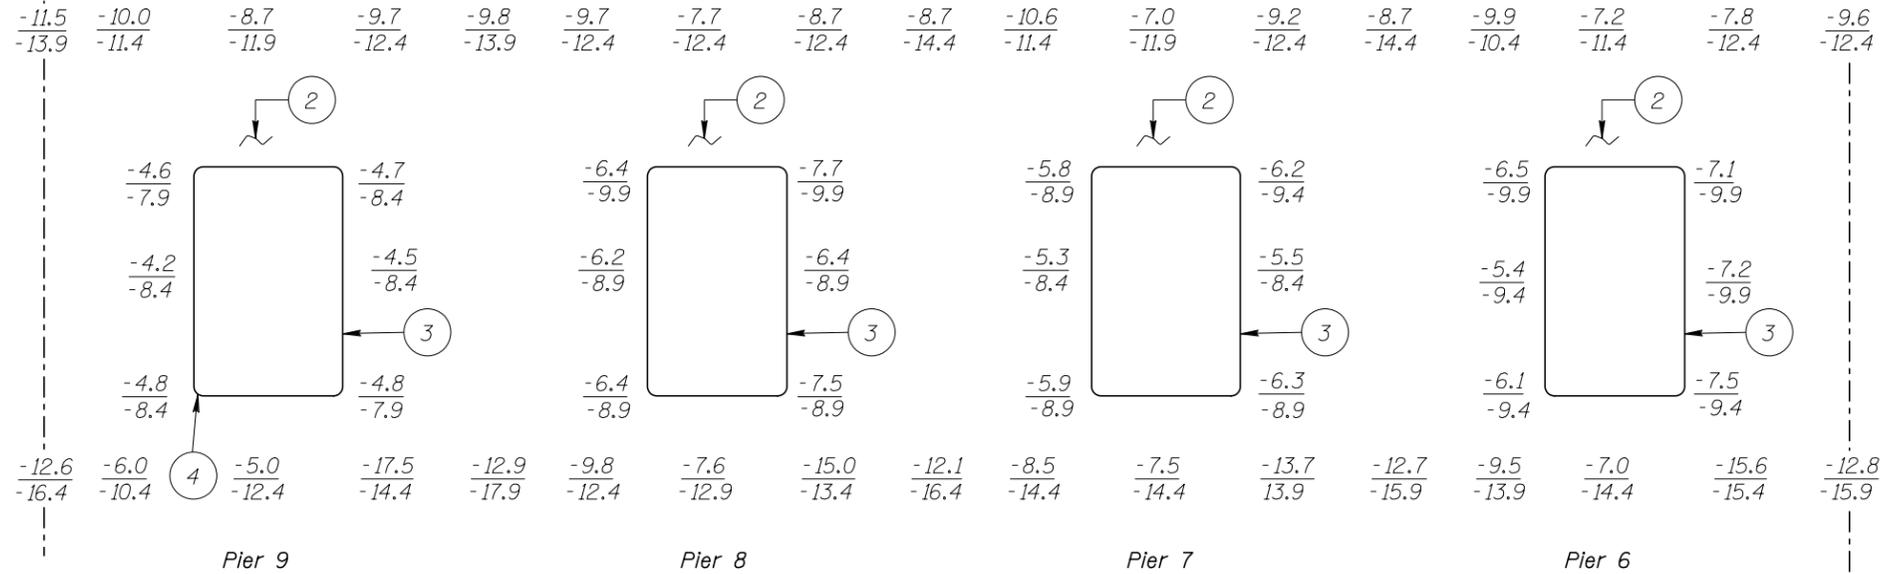
- ② The channel bottom at Piers 1 through 12 consisted of riprap typically 1 to 2 feet in diameter with a maximum diameter of up to 3 feet. It was observed around the entire perimeter of all piers typically extending to top of footing or to no lower than 3 feet below top of footing.

- ③ The submerged concrete was typically in satisfactory condition with moderate scaling from 1 foot above the waterline to 1 foot below the waterline with typical penetrations of 1 inch and maximum penetrations of up to 6 inch. Random vertical and horizontal hairline cracks were also observed on the concrete shaft surfaces widespread throughout all piers. Cracking often had efflorescence associated with it. The concrete footing (where exposed) typically exhibited rough surfaces with up to 3 inch maximum penetration.

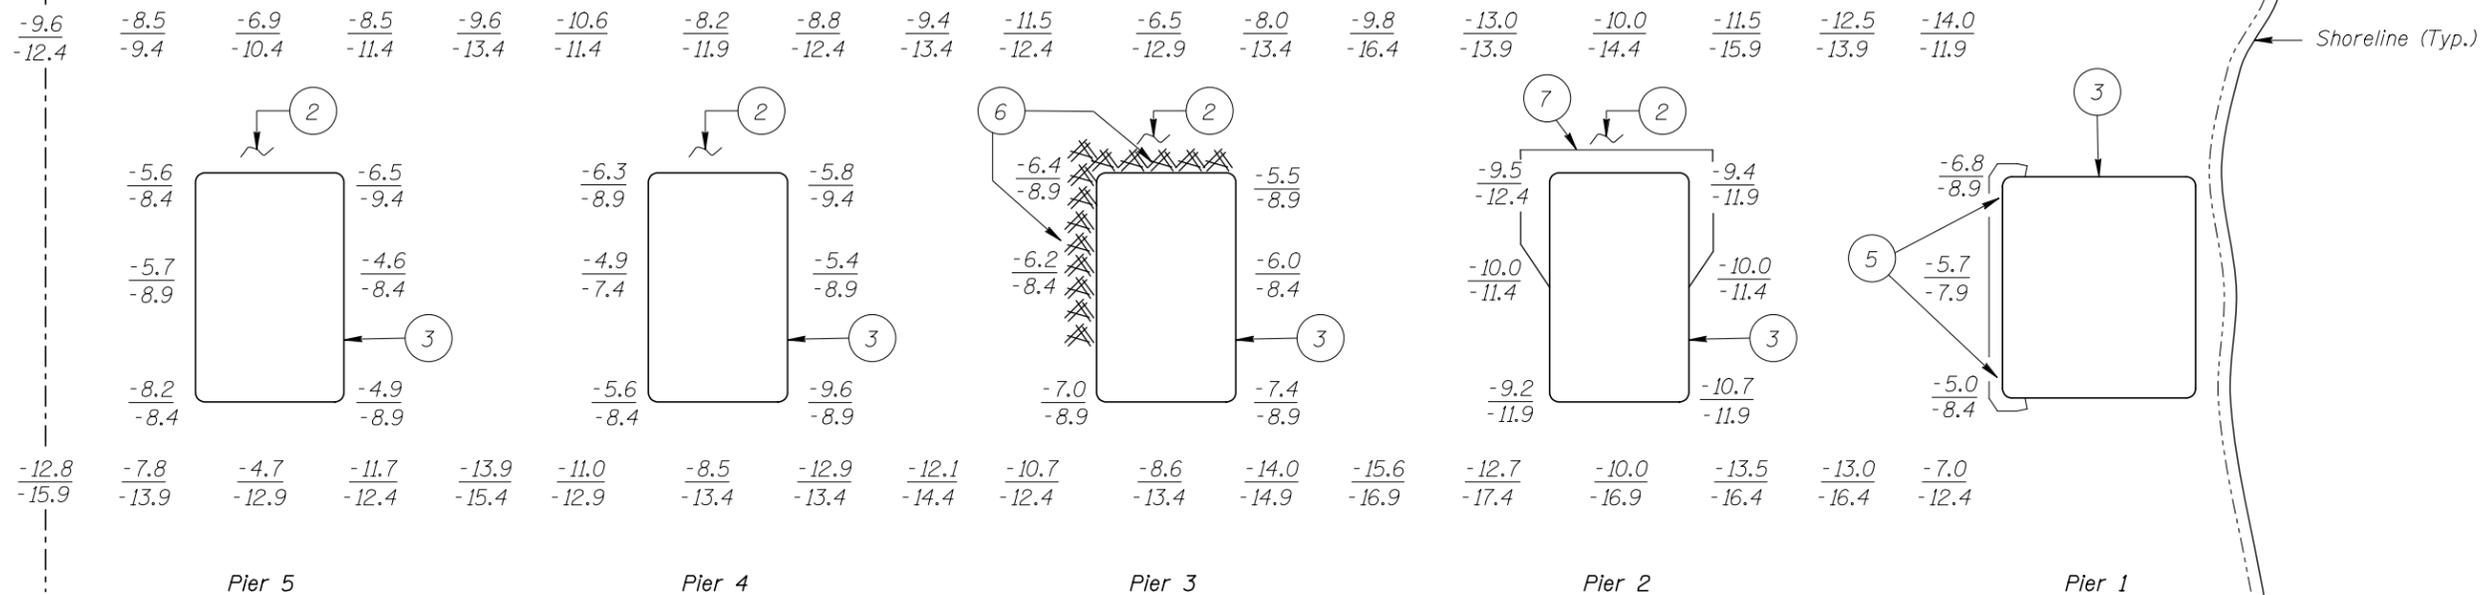
- ② The channel bottom at Piers 1 through 12 consisted of riprap typically 1 to 2 feet in diameter with a maximum diameter of up to 3 feet. It was observed around the entire perimeter of all piers typically extending to top of footing or to no lower than 3 feet below top of footing.

- ③ The submerged concrete was typically in satisfactory condition with moderate scaling from 1 foot above the waterline to 1 foot below the waterline with typical penetrations of 1 inch and maximum penetrations of up to 6 inch. Random vertical and horizontal hairline cracks were also observed on the concrete shaft surfaces widespread throughout all piers. Cracking often had efflorescence associated with it. The concrete footing (where exposed) typically exhibited rough surfaces with up to 3 inch maximum penetration.

- ⑤ The footing at Pier 1 was exposed along the southwest face from nose to nose of the pier with a maximum vertical face exposure of 2 feet.
- ⑥ The upstream nose and west face of Pier 3 had moderate timber debris consisting of 2 foot diameter and smaller logs, extending from channel bottom up to 2 feet above waterline.

- ⑦ The footing at Pier 2 was exposed around the upstream half of the pier. The footing was exposed a maximum of 3 feet vertically.
