UNDERWATER BRIDGE INSPECTION REPORT

STRUCTURE NO. 55031

SOUTH BRANCH, MIDDLE FORK, ZUMBRO RIVER

SEPTEMBER 12, 2012

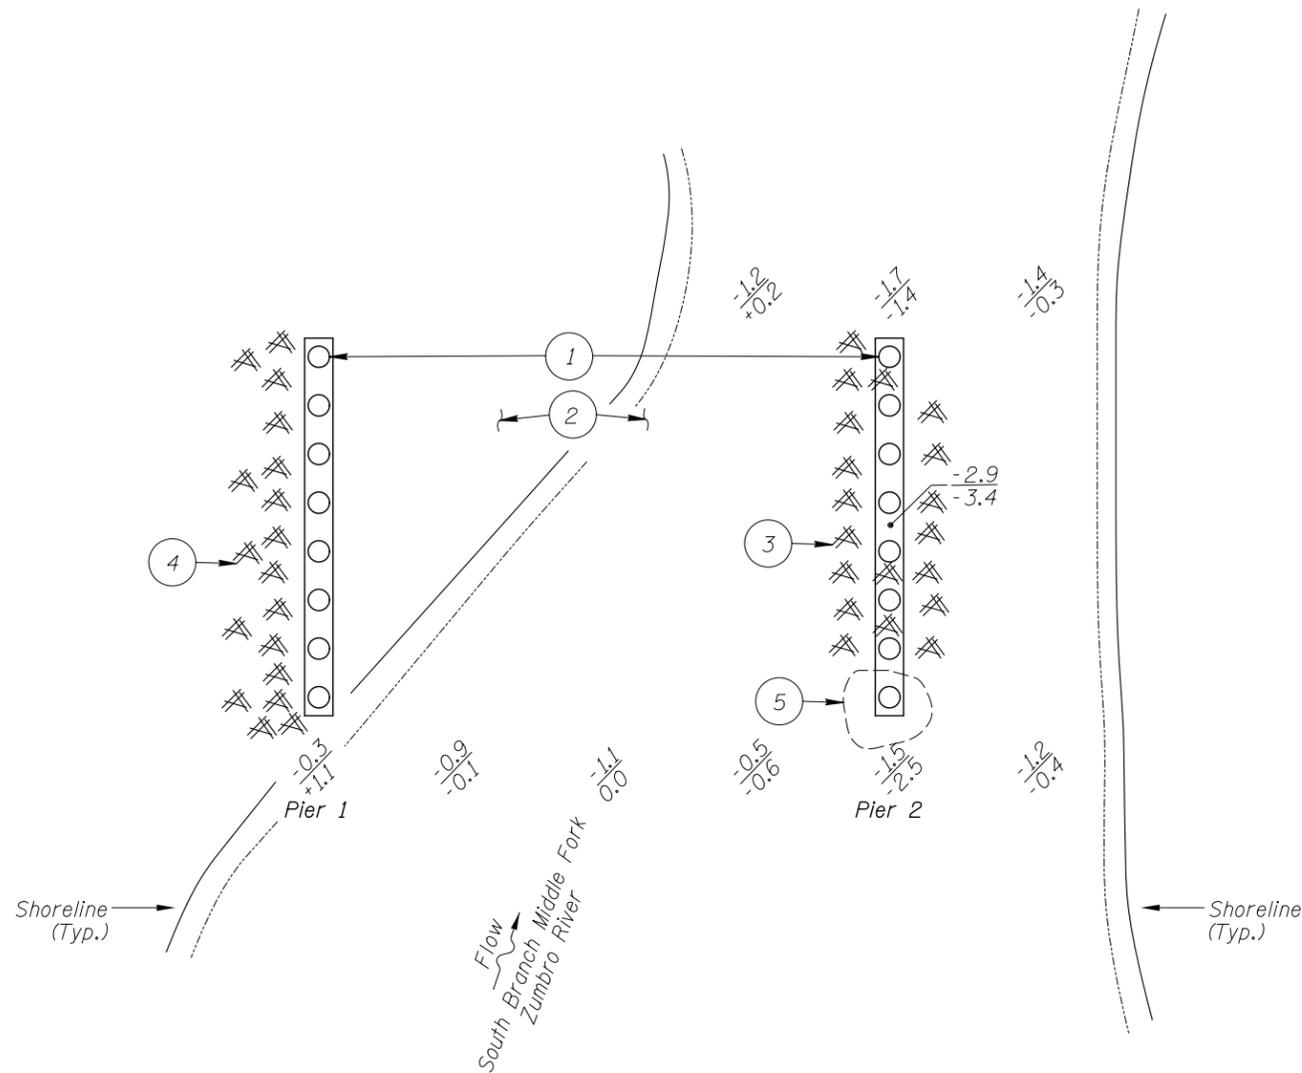
| <b>INSPECTION AND SOUNDING PLAN</b> | | |

- ① Steel piles exhibited coating failure with light surface corrosion over 100 percent of the surface area from channel bottom to 10 feet above the waterline.
- ② The channel bottom material consisted of silty sand allowing 1 foot of maximum probe rod penetration.
- ③ A heavy accumulation of timber debris, consisting of 1.5 foot diameter and smaller logs and branches, was observed around the perimeter of Pier 2 extending from the channel bottom up 5 feet.
- ④ A heavy accumulation of timber debris, consisting of 2 feet diameter and smaller logs and branches, was observed along the north side of Pier 1 extending from the channel bottom to 8 feet above the waterline.
- ⑤ A scour depression measuring 4 feet radially by 1 foot deep was observed at the upstream pile at Pier 2.

- (A) Monitor accumulations of timber debris during future inspections and consider removal operations in order to reduce channel obstruction, additional lateral loads on the substructure, as well as scour susceptibility at the bridge site.
