UNDERWATER BRIDGE INSPECTION REPORT

STRUCTURE NO. 55033
5th STREET NW
OVER THE
MIDDLE FORK, ZUMBRO RIVER
OLMSTED COUNTY

SEPTEMBER 12, 2012
PREPARED FOR THE
MINNESOTA DEPARTMENT OF TRANSPORTATION
BY
COLLINS ENGINEERS, INC.
JOB NO. 7423

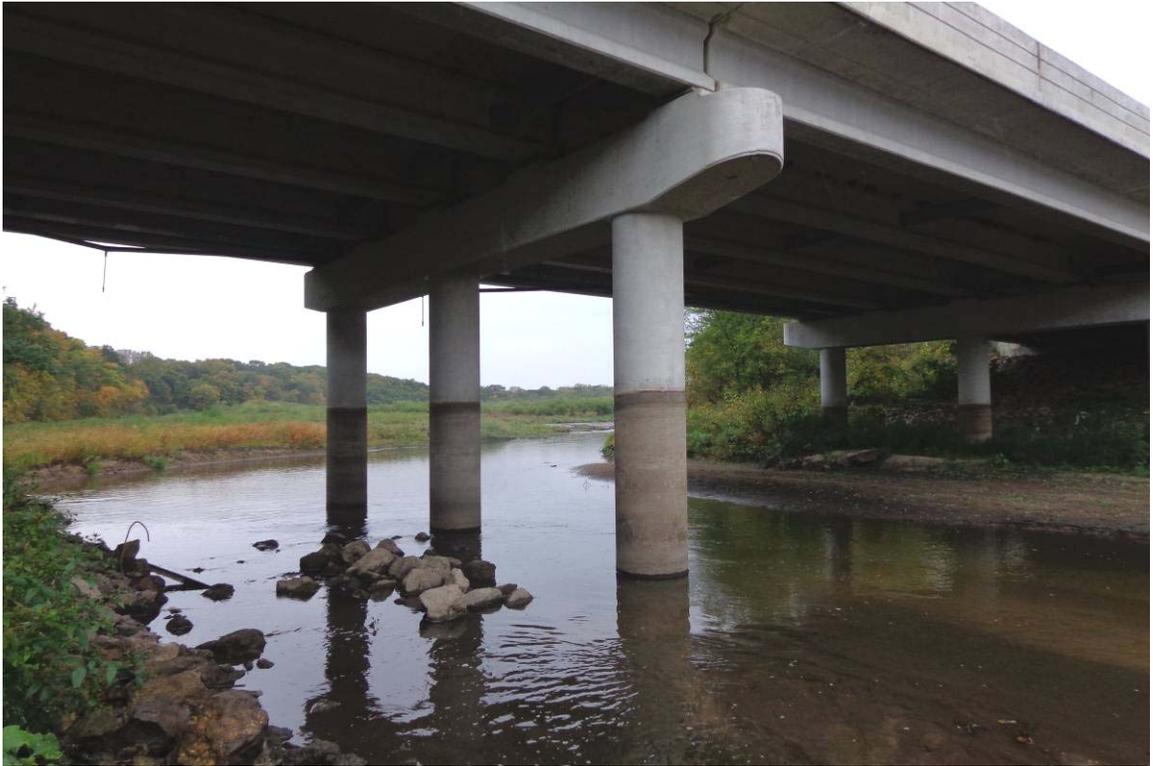
Photograph 2. View of Pier 2, Looking Northwest.

The substructure unit inspected at Bridge No. 55033, Pier 2, was found to be generally in good condition with no defects of structural significance observed. The concrete of the pier was smooth and sound throughout. Comparison of the current water depth soundings with the soundings recorded in 2008 indicates significant channel bottom infill as well as a significant reduction in the extent of foundation exposure at Pier 2. No foundation undermining was detected and the maximum vertical face footing exposure at Pier 2 measured only several inches. The channel bottom material consisted of random 12 inch diameter riprap with silty sand and gravel.

- (A) Monitor the minor scour depressions and footing exposure at Pier 2 during future underwater inspections and after (or during) periods of high water and high flows.
- (B) Reinspect the submerged substructure units at the normal maximum recommended (NBIS) interval of sixty (60) months.

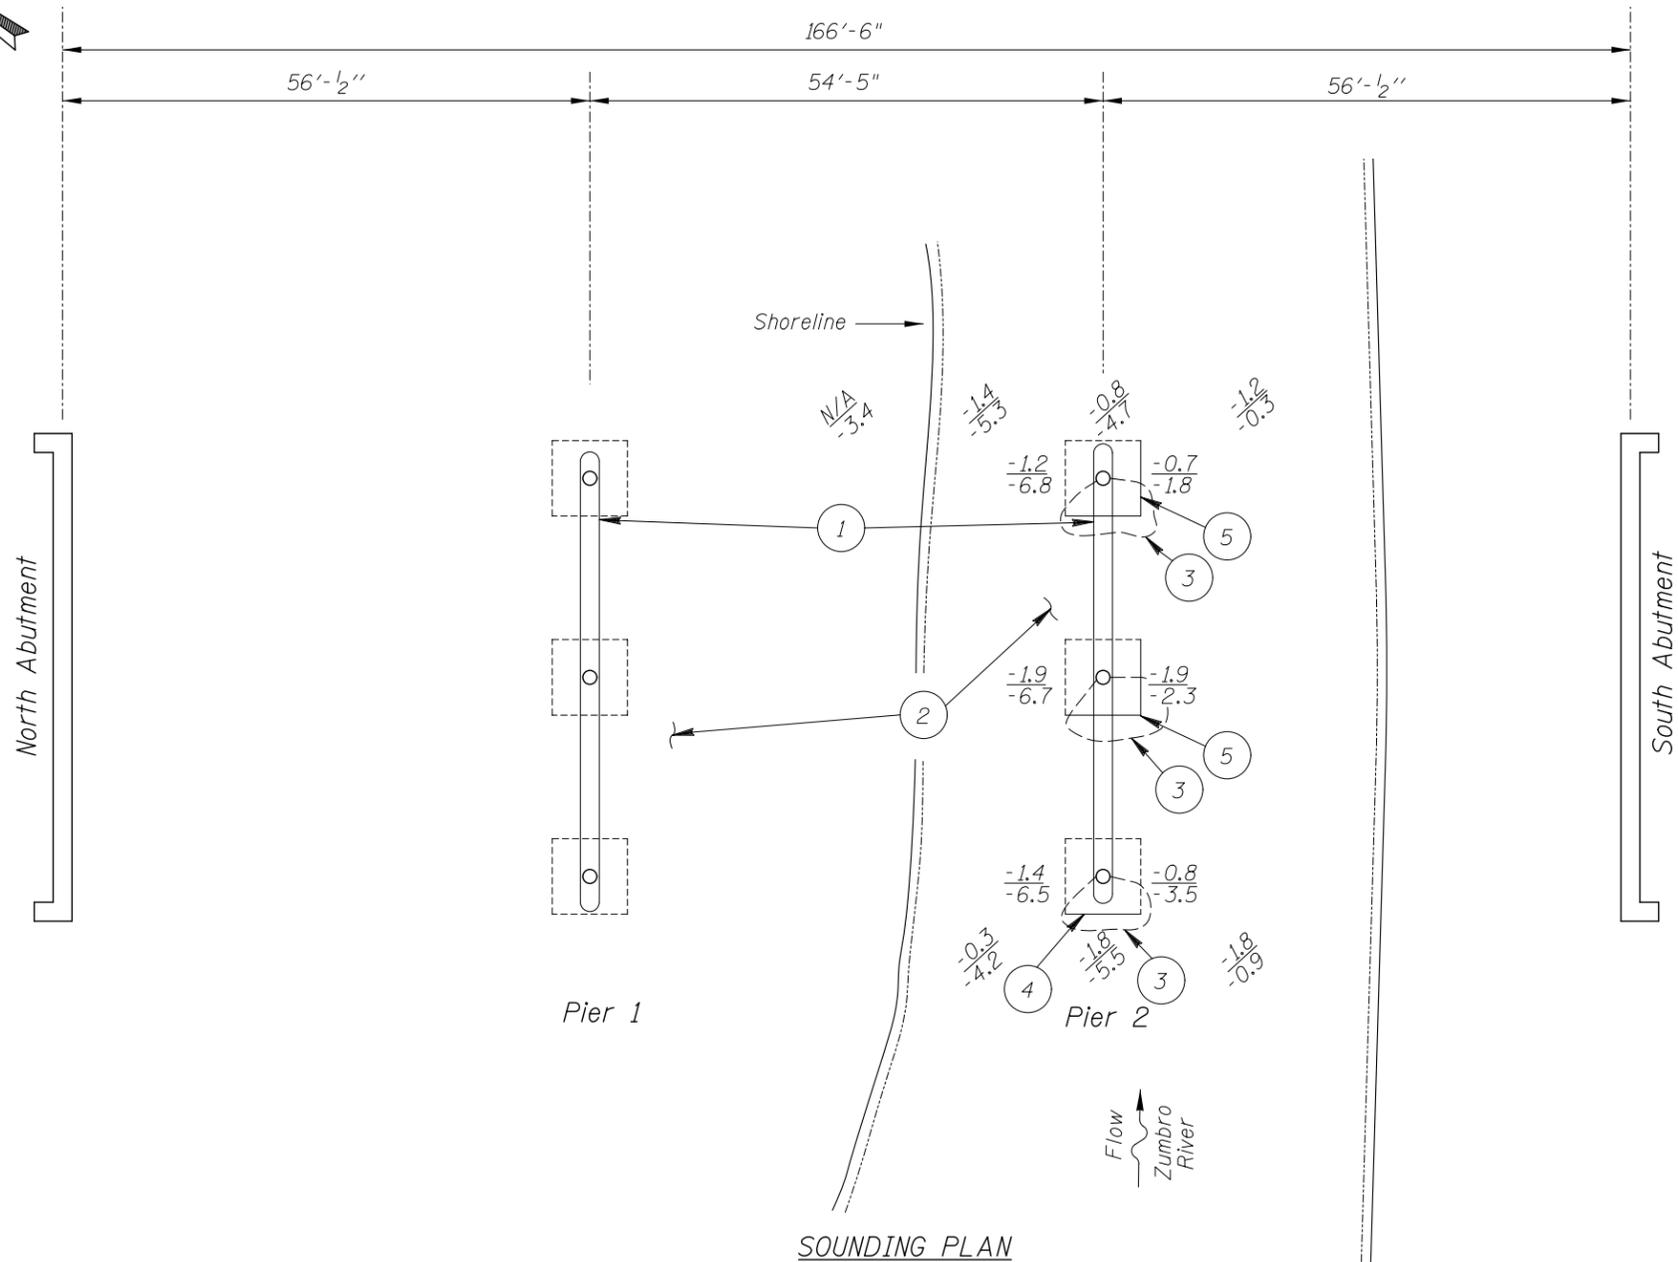
- ① The concrete was typically smooth and sound with no notable deterioration.
- ② The channel bottom material consisted of silty sand and gravel with up to 3 inches of probe rod penetration and random 12 inch diameter riprap.
- ③ A minor 2-foot-diameter by 0.5-foot-deep scour depression was observed at the upstream side of all Pier 2 columns.
- ④ The top of footing was partially exposed on the upstream side of the upstream column of Pier 2.
- ⑤ A 2-foot-radius area of the top of footing was exposed on the upstream side of the middle and downstream columns of Pier 2 with up to 3 inches of the vertical face exposure along the upstream side of the columns.
