UNDERWATER BRIDGE INSPECTION REPORT

STRUCTURE NO. 55517
EAST CENTER STREET (MSAS 105)
OVER THE
ZUMBRO RIVER
CITY OF ROCHESTER

OCTOBER 2, 2012
PREPARED FOR THE
MINNESOTA DEPARTMENT OF TRANSPORTATION
BY
COLLINS ENGINEERS, INC.
JOB NO.7423

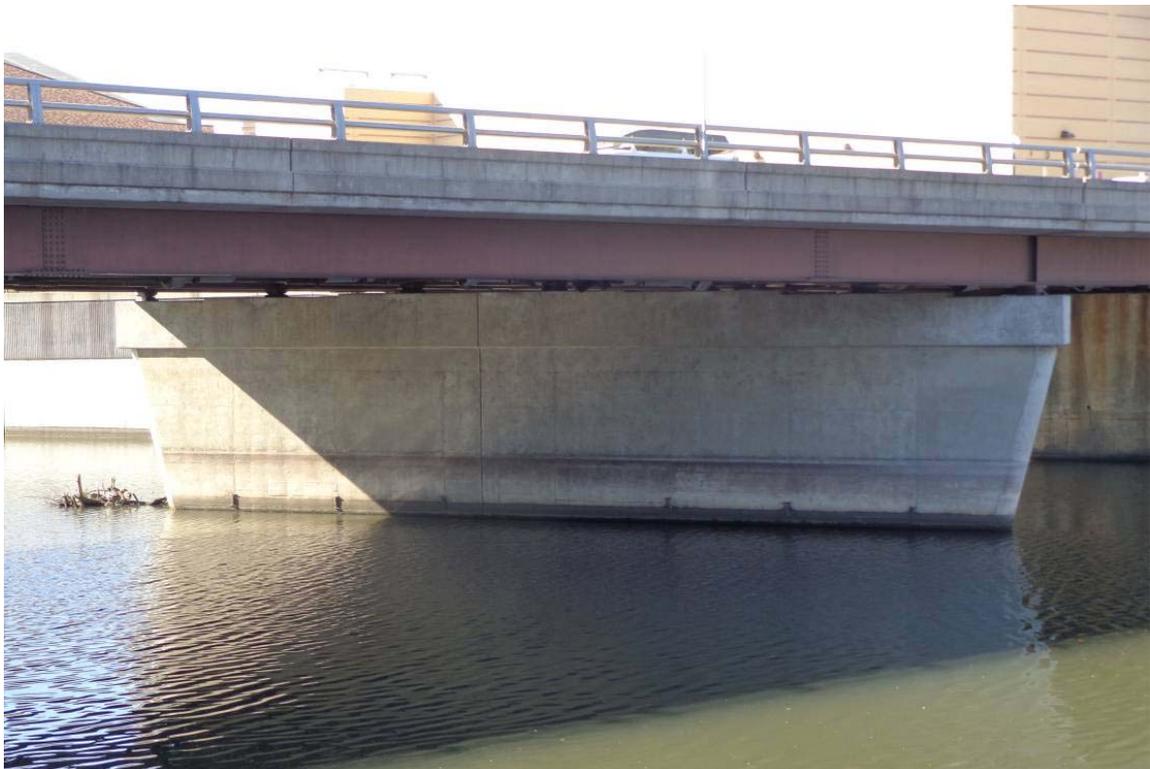
Photograph 2. View of Pier 1, Looking Southwest.

- (D) The channel bottom material consisted of sandy silt with up to 6 inches of probe rod penetration.
- (E) A light accumulation of 6-inch-diameter and smaller timber debris was observed at the upstream end of Pier 1 extending from the channel bottom to 2 feet above the waterline.

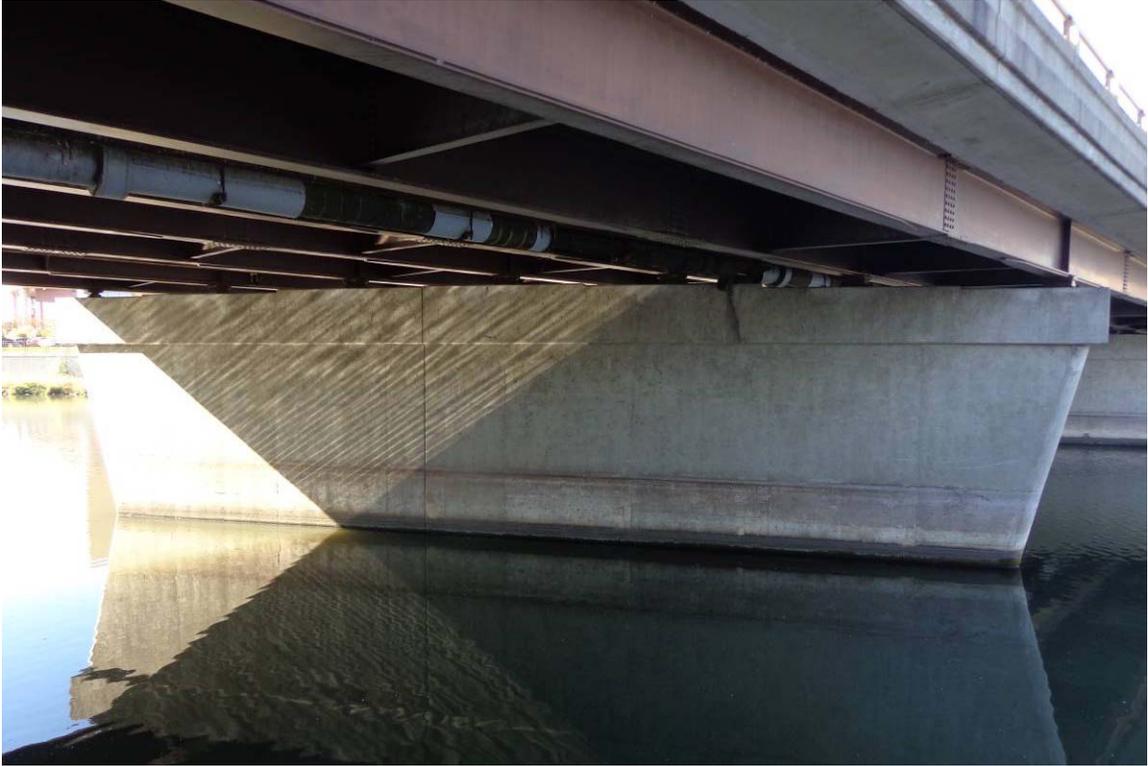
Photograph 3. View of Pier 2, Looking West.

- (F) A vertical hairline crack extended from the bottom of the pier cap to the channel bottom at the downstream west quarter-point of Pier 2.

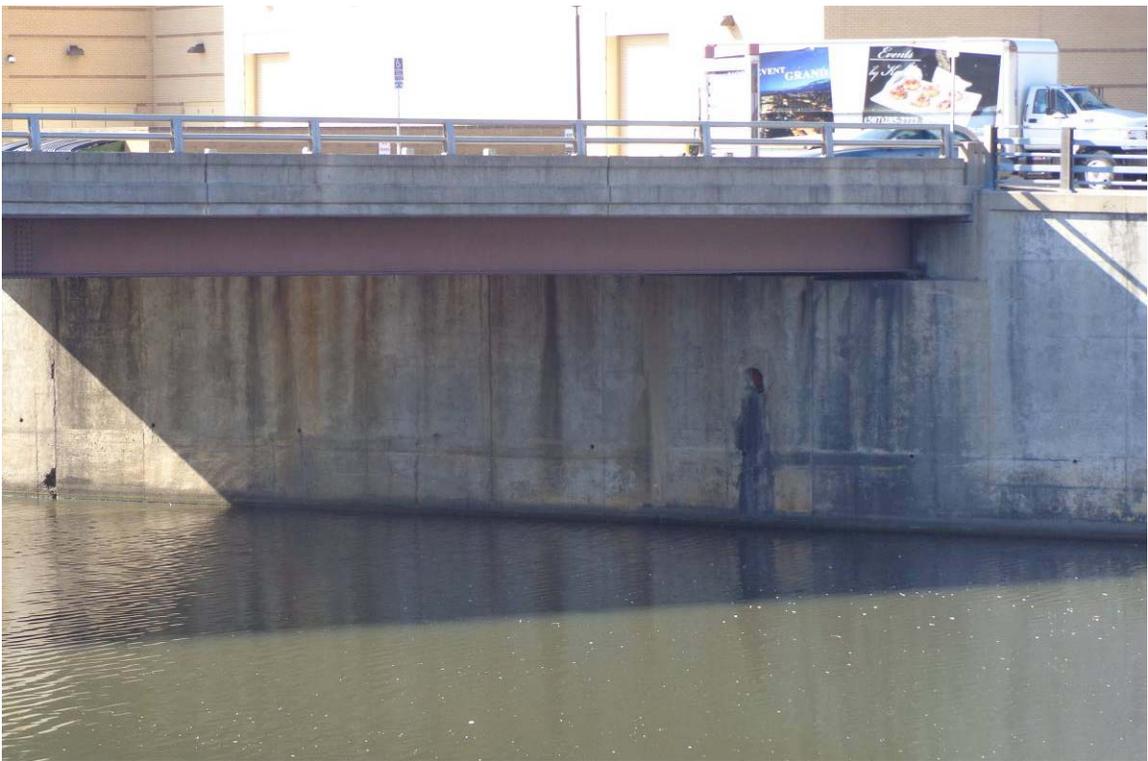
Photograph 4. View of the West Abutment, Looking Southwest.

- (A) An area of poor consolidation was located 1 foot above the waterline along a joint at the upstream end of the West Abutment that measured 1 foot in diameter with up to 6 inches of penetration.

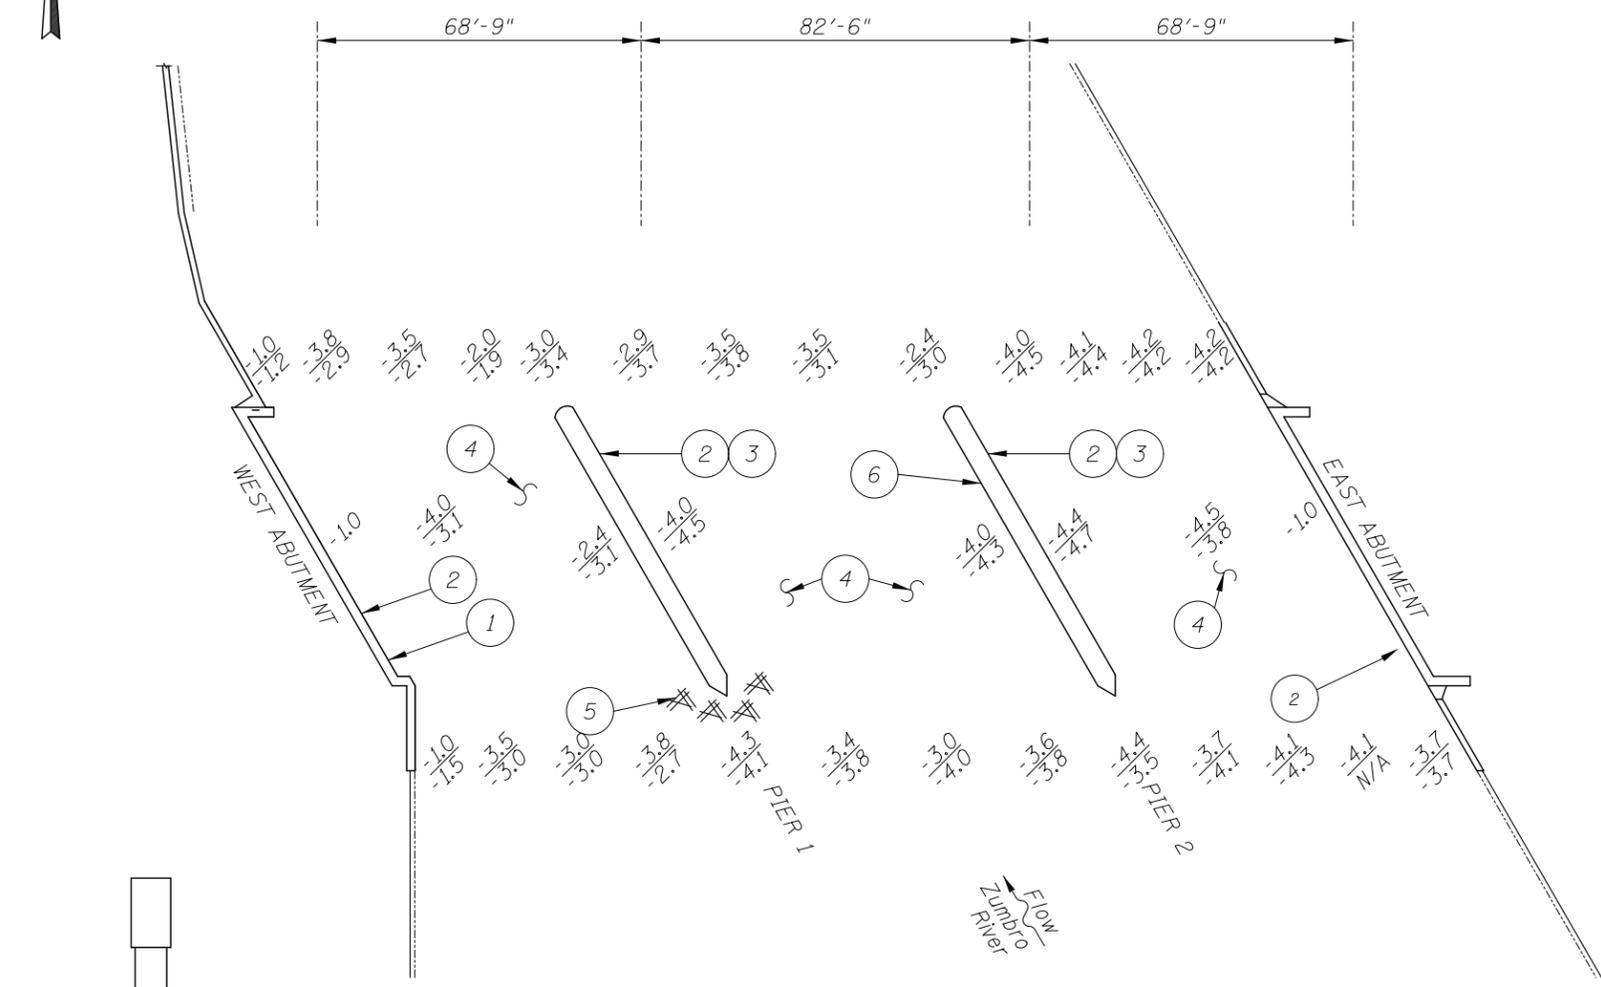
- 1 An area of poor consolidation was located 1 foot above the waterline along a joint at the upstream end of the West Abutment that measured 1 foot in diameter with up to 6 inches of penetration.

- 2 The concrete was typically smooth and sound with random minor areas of poor consolidation with up to 1 inch of penetration. A sloped concrete scour protection encased both piers from 1 ft below the waterline to the channel bottom, and was typically in good condition.

- 3 Three steel beams on 6-foot centers were embedded in the concrete pier shafts near the waterline at both the upstream and downstream ends of Piers 1 and 2.

- 4 The channel bottom consisted of sandy silt with up to 6 inches of probe rod penetration.
- 5 A light accumulation of 6-inch-diameter and smaller timber debris was observed at the upstream end of Pier 1 extending from channel bottom to 2 feet above the waterline.

- 6 A vertical hairline crack extended from the bottom of the pier cap to the channel bottom at the downstream west 1/4-point of Pier 2.
