UNDERWATER BRIDGE INSPECTION REPORT

STRUCTURE NO. 55520
CSAH NO. 12
OVER THE
ZUMBRO RIVER
DISTRICT 6 - OLMSTED COUNTY

SEPTEMBER 14, 2012
PREPARED FOR THE
MINNESOTA DEPARTMENT OF TRANSPORTATION
BY
COLLINS ENGINEERS, INC.
JOB NO. 7423

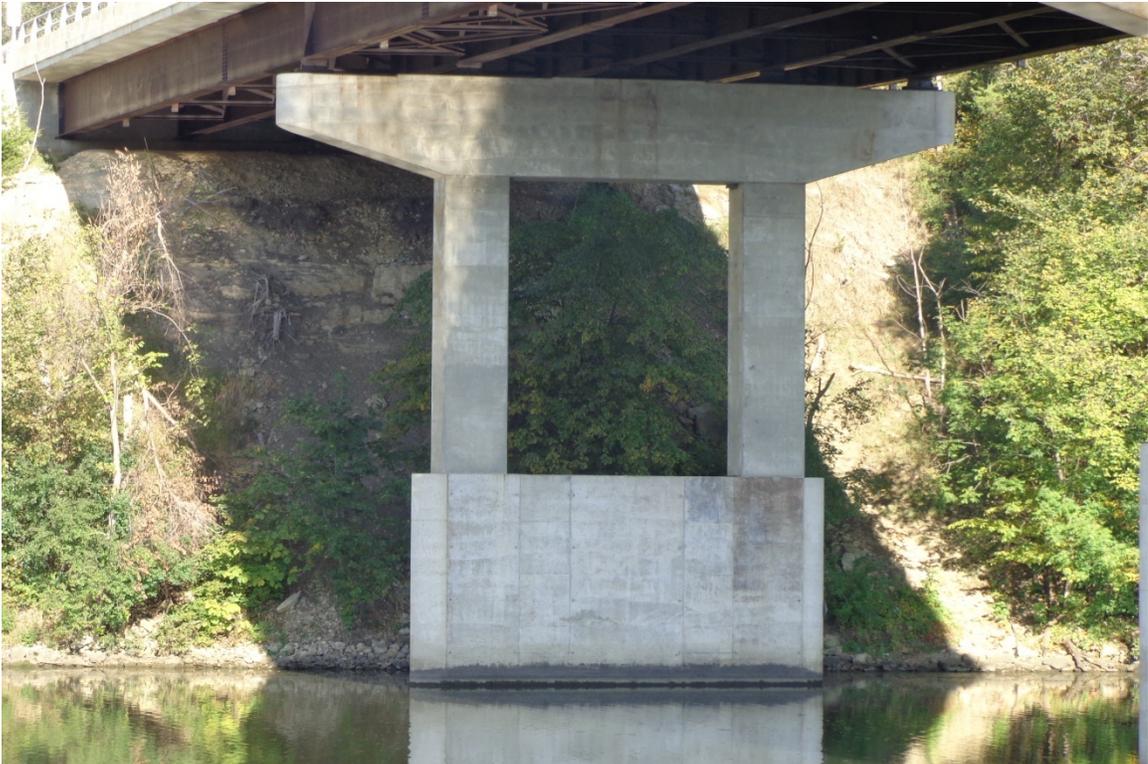
- (A) The channel bottom material around Piers 2 and 3 consisted of fine silty organics with greater than 2 feet of probe rod penetration.
- (B) The channel bottom material around Pier 1 consisted of 6 to 12 inch layer of soft silt over firm clay.
- (C) Minor voids due to poor consolidation of the concrete were observed at various locations along the piers, typically up to 1 inch in diameter with up to 1/2 inch of penetration.
- (D) The footing was partially exposed along the east face of Pier 1 with a maximum vertical face exposure of 1 foot. The surface of the footing was rough with 6 to 12 inch diameter irregularities.
- (E) The upstream nose of Pier 2 stops at 6 feet below water and cuts back 1.5 feet.

Photograph 2. View of Pier 1, Looking Northwest.

- (A) Monitor the extent of footing exposure at Pier 1 during future underwater inspections.
- (B) Reinspect the submerged substructure units at the normal maximum recommended (NBIS) interval of sixty (60) months.

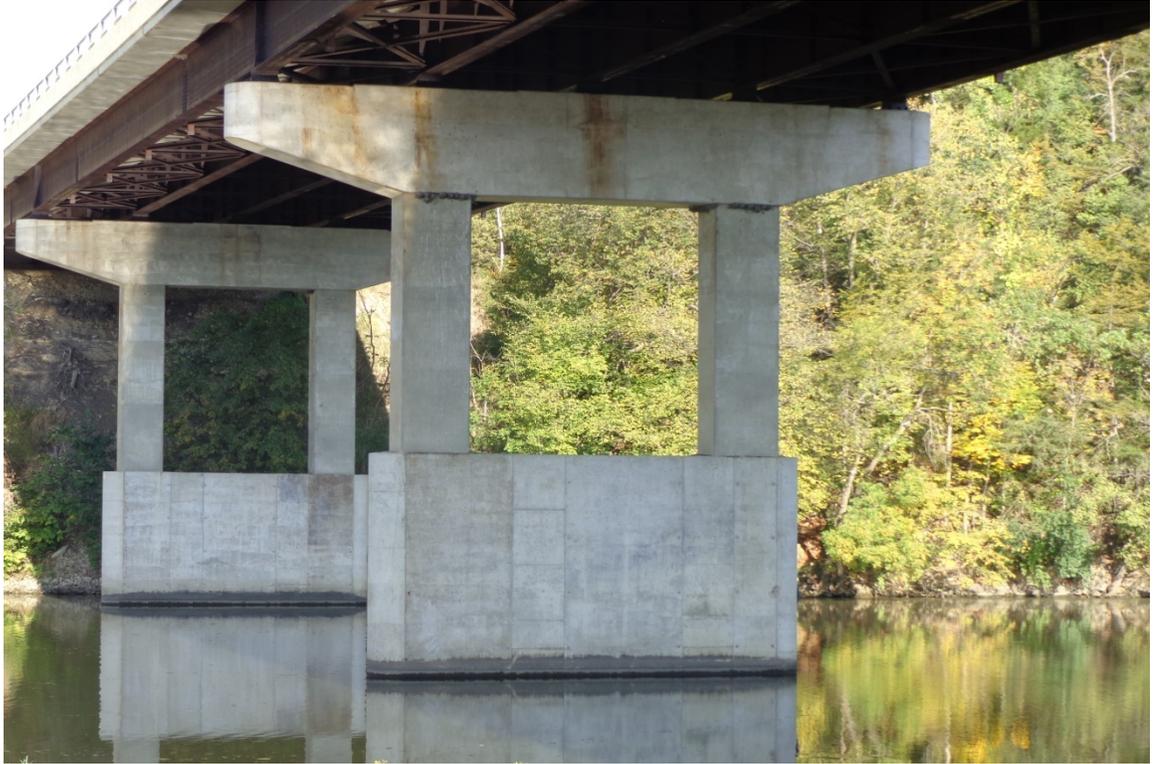
Photograph 3. View of Pier 2, Looking Northwest.

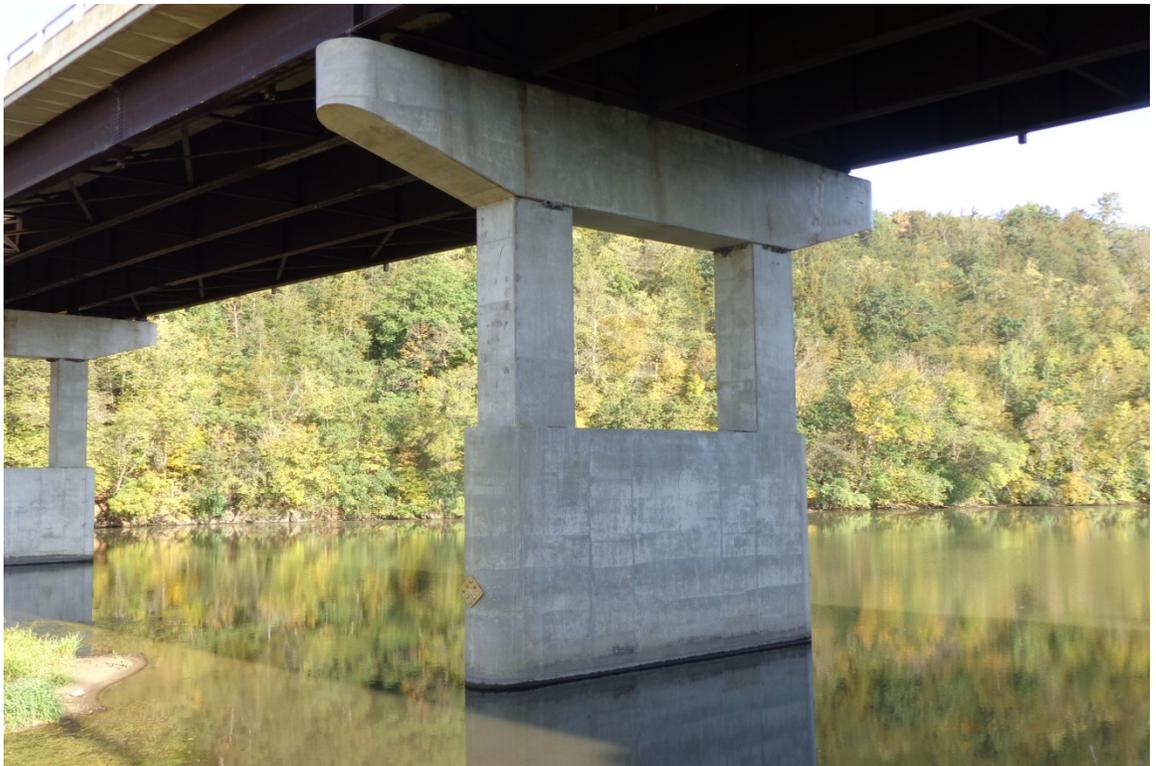
Photograph 4. View of Pier 3, Looking East.

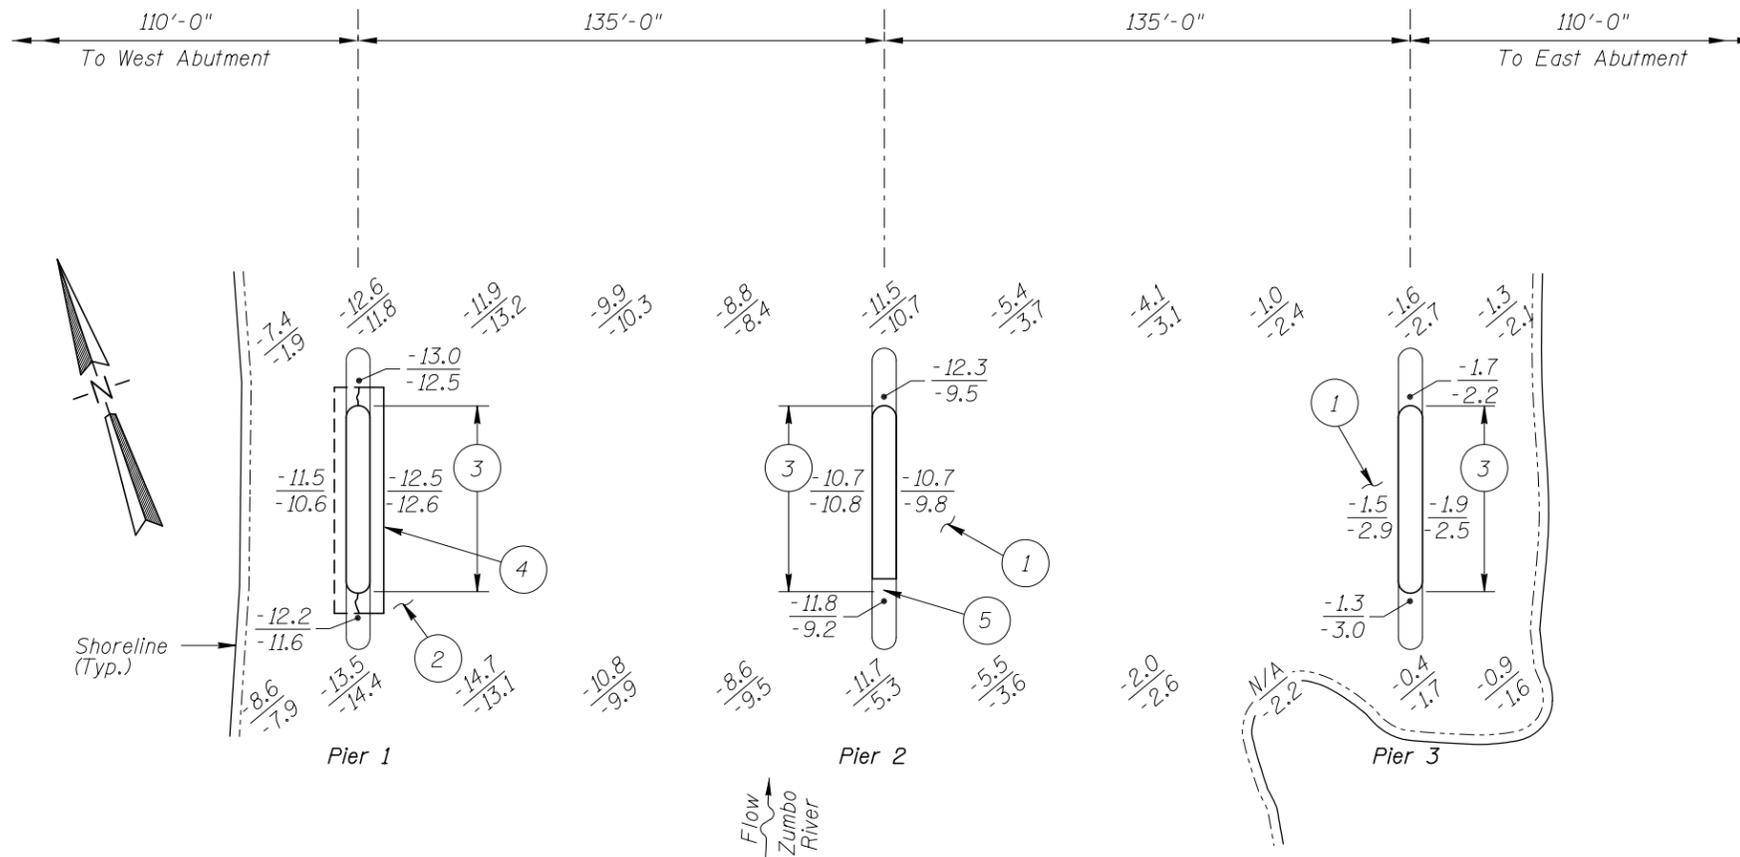
- 1 The channel bottom material around Piers 2 and 3 consisted of fine silty organics with greater than 2 feet of probe rod penetration.
- 2 The channel bottom material around Pier 1 consisted of 6 to 12 inch layer of soft silt infill over firm clay.
- 3 Minor voids due to poor consolidation of the concrete were observed at various locations along the piers, typically up to 1 inch in diameter with up to 1/2 inch of penetration.
- 4 The footing was exposed along the east face of Pier 1 with a maximum of vertical face exposure of 1 foot. The surface of the footing was rough and irregular.
- 5 The upstream nose of Pier 2 stops at 6 feet below water and cuts back 1.5 feet.

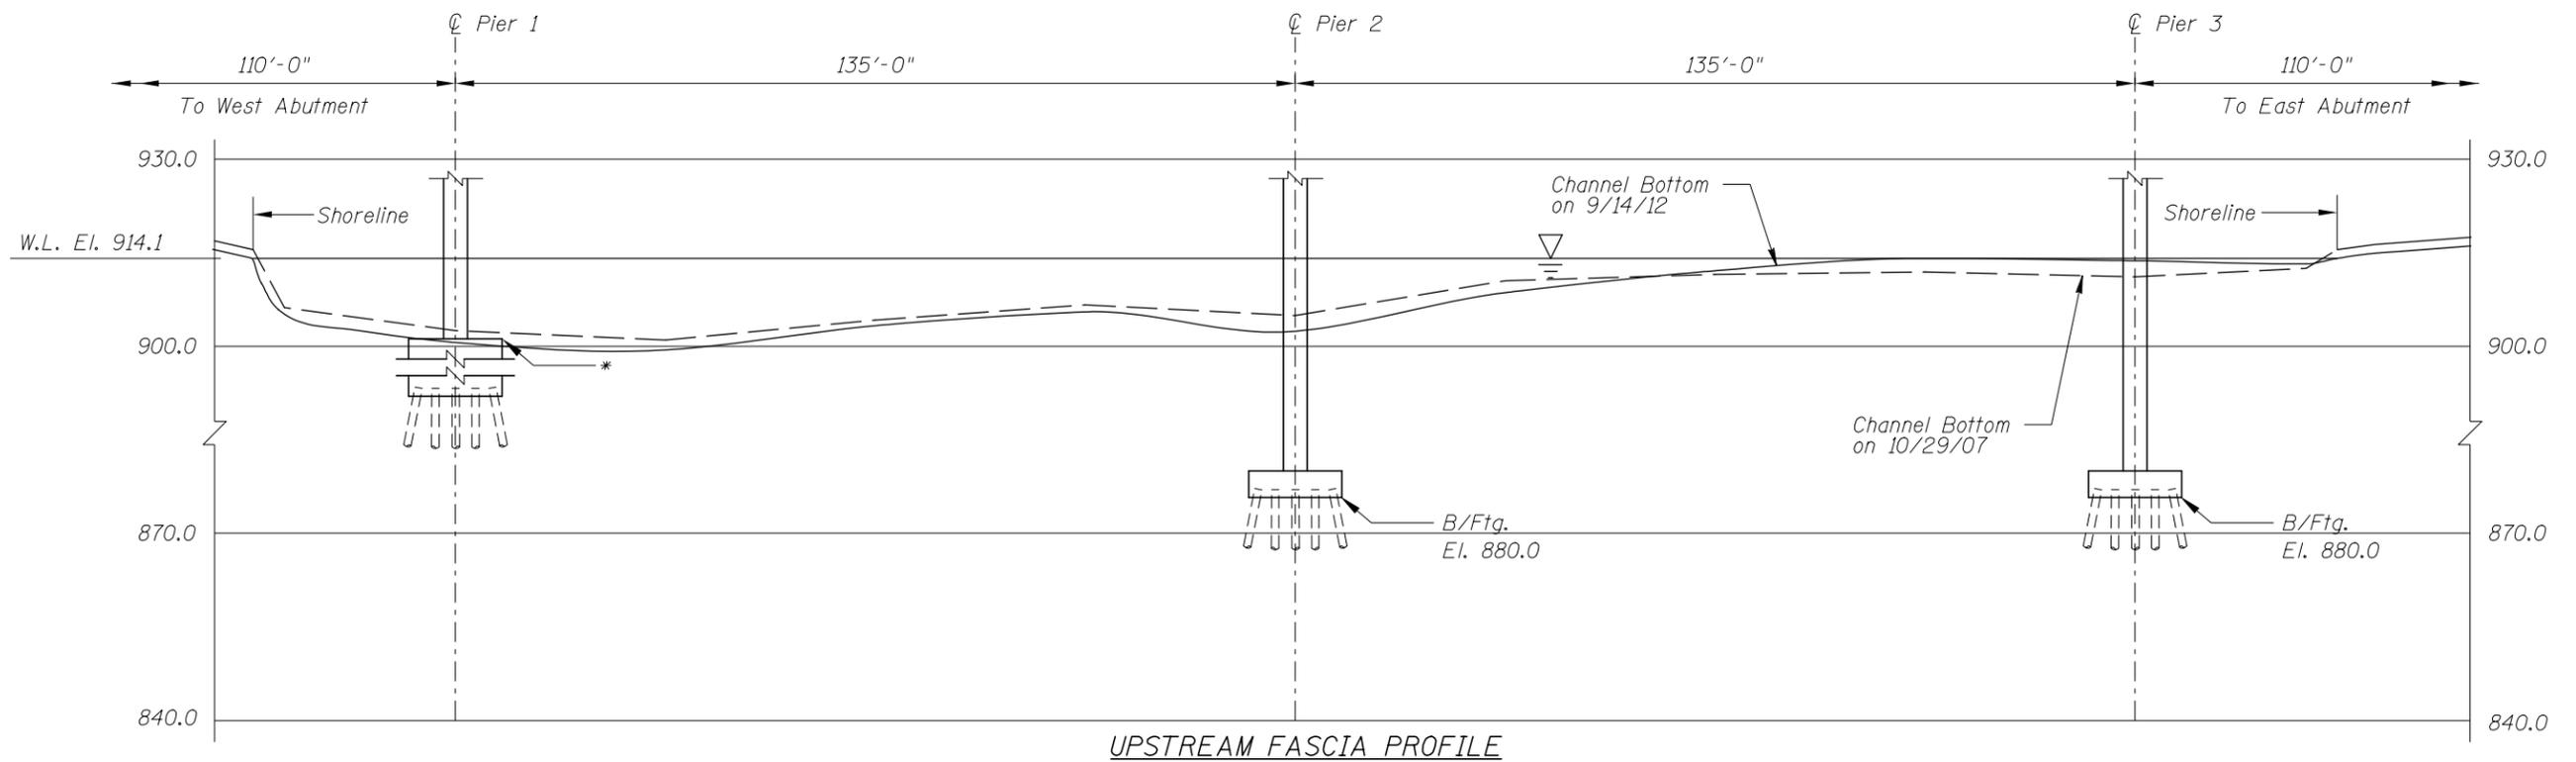
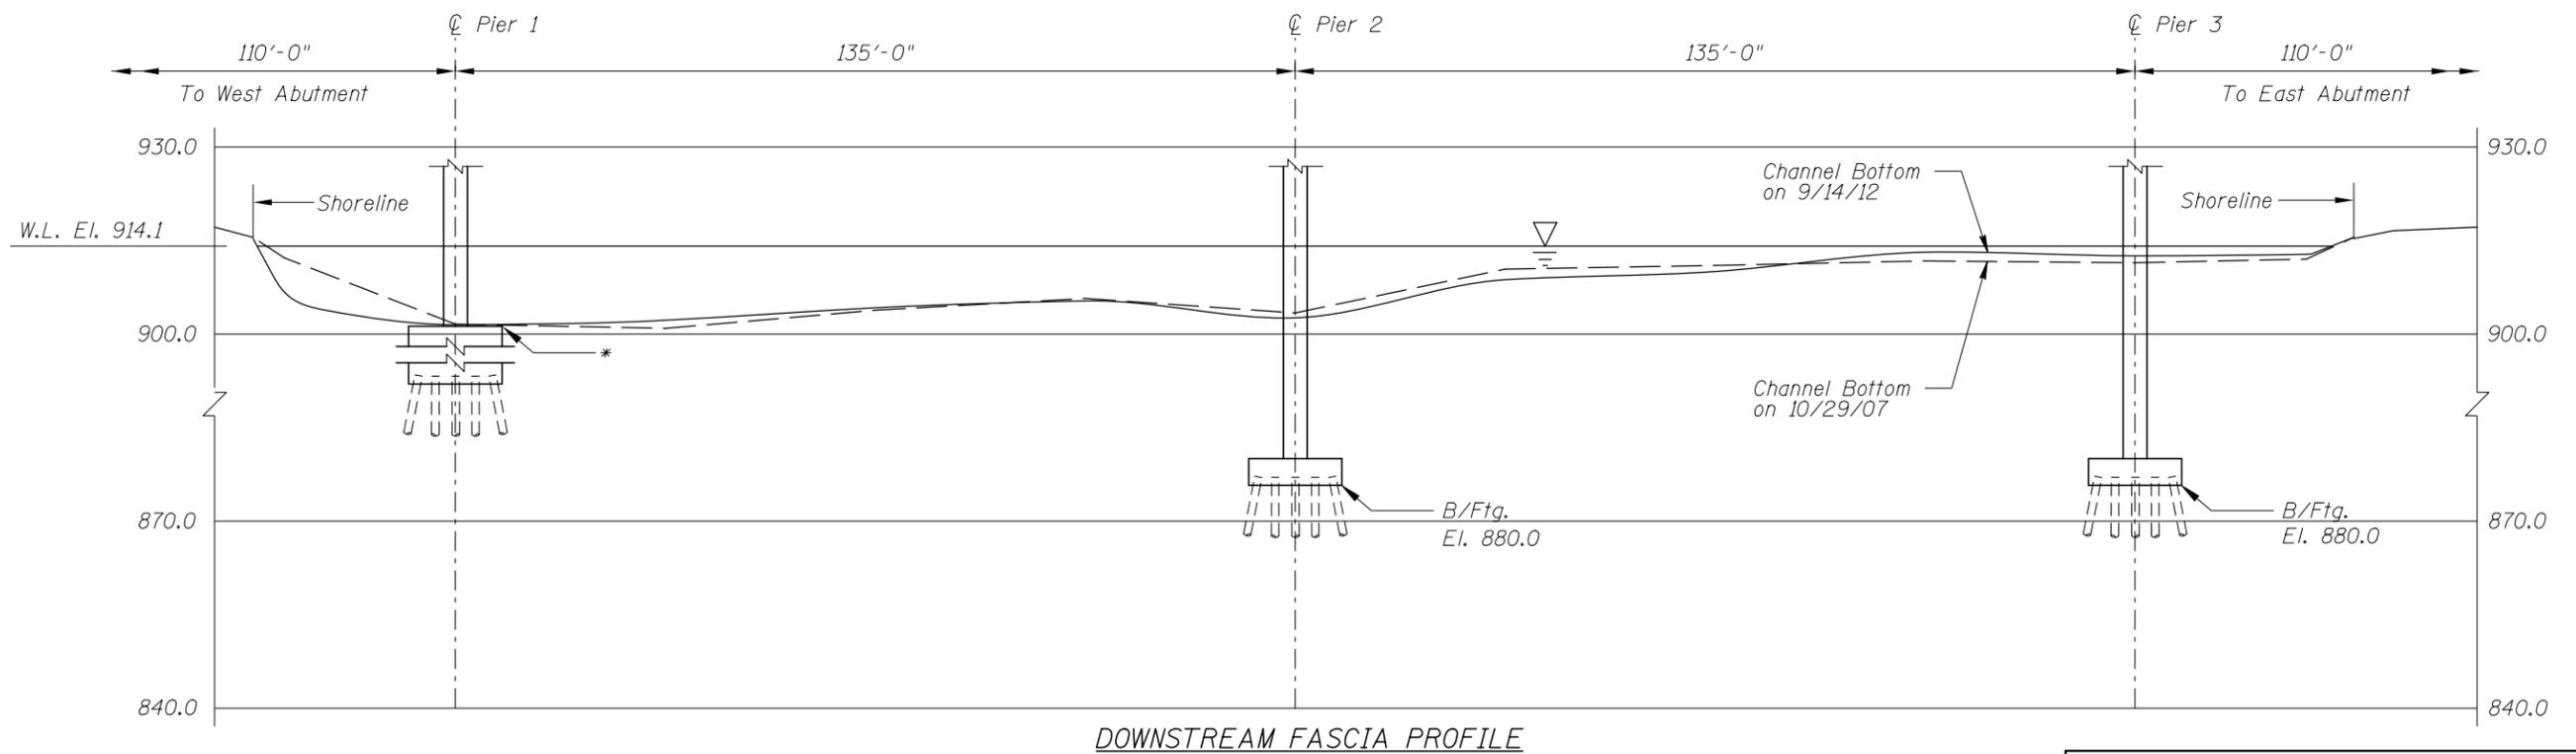
General Shape: The piers consist of a rectangular concrete shaft with rounded ends, supported by a rectangular footing founded on steel piles. The top of footing location of Pier 1 as observed during the filed inspection conducted on 9/14/2012 was found to be inconsistent with the bridge plans dated 11/20/1974. The observed top of footing was found to be approximately 4 to 5 feet higher than indicated in the plans.

* T/Footing configuration shown as per field observations on 9/14/12 is inconsistent with the bridge plans dated 11/20/74.
