UNDERWATER BRIDGE INSPECTION REPORT

STRUCTURE NO. 55J11

TWP 197 (70TH AVE NW)

MINNESOTA DEPARTMENT OF TRANSPORTATION
UNDERWATER BRIDGE INSPECTION

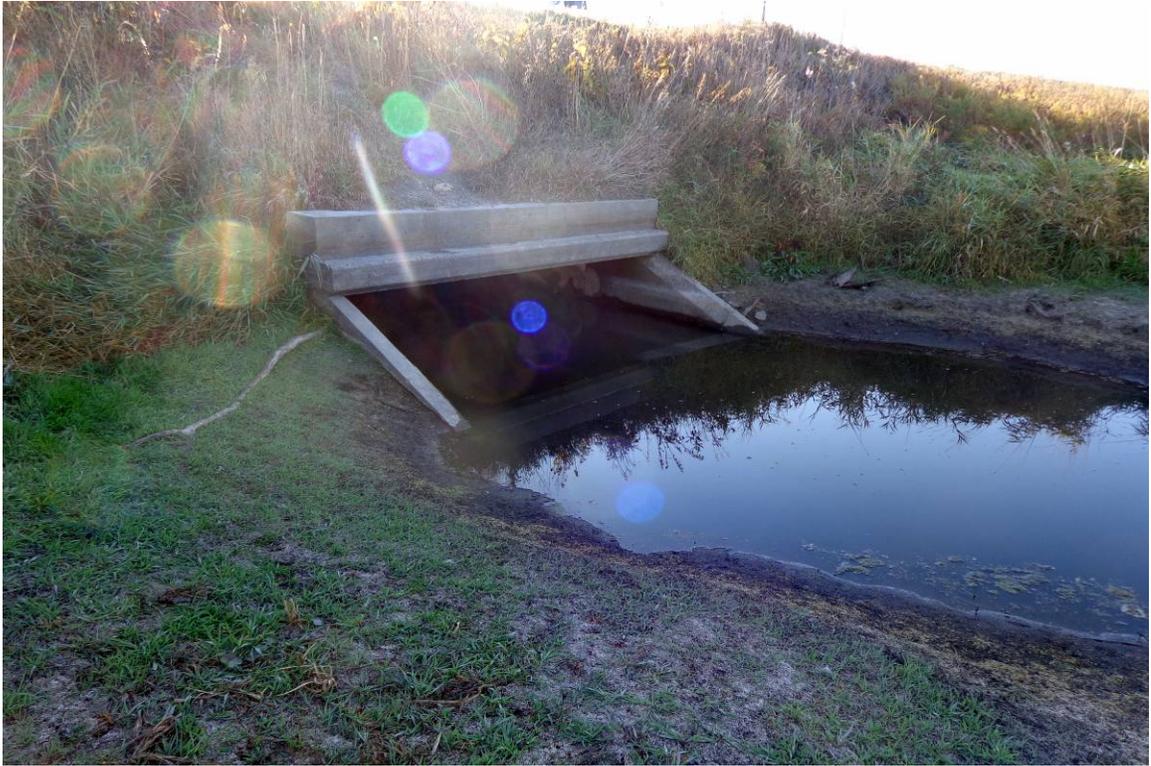
Photograph 1. Overall View of the West Opening, Looking Southeast.

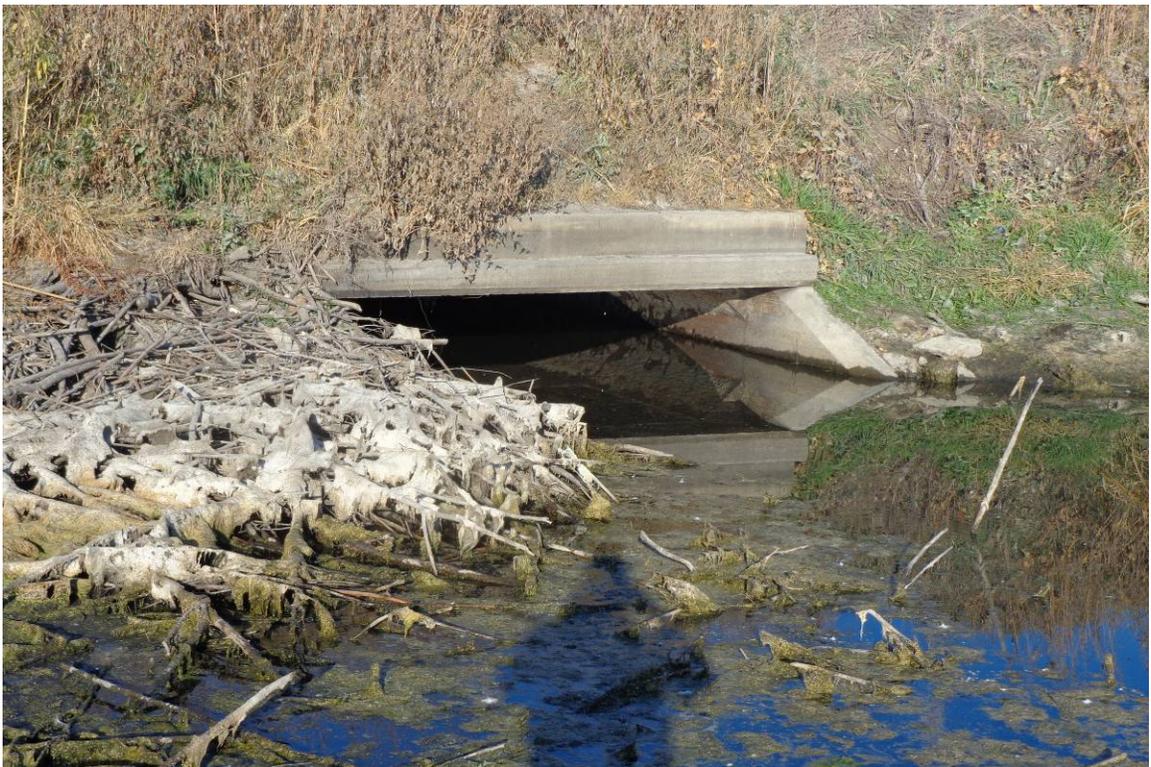
Photograph 2. Overall View of the East Opening, Looking West.

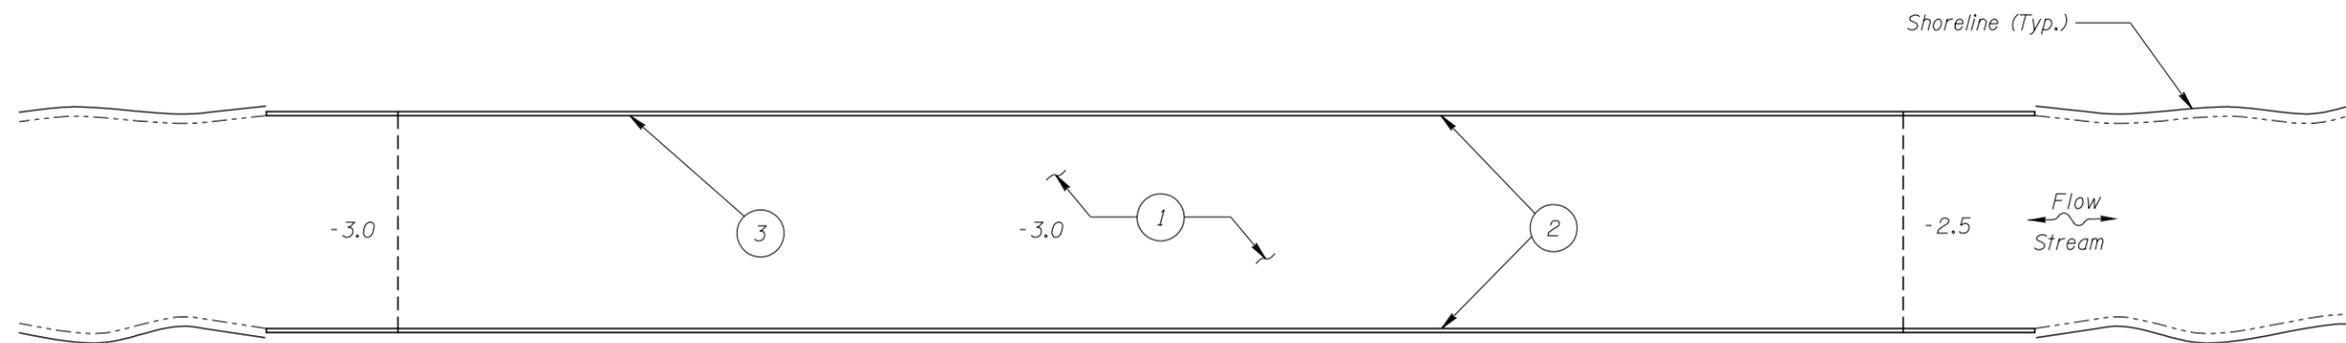
INSPECTION AND SOUNDING PLAN
NTS

- ① The channel bottom material consisted of a 1 foot thick layer of soft silt infill.
- ② The concrete was typically smooth and sound.
- ③ The culvert joints were bell and spigot type with 1/2 to 1 inch typical gaps and no loss of fill material.
