UNDERWATER BRIDGE INSPECTION REPORT

STRUCTURE NO. 6564

ZUMBRO RIVER

WABASHA COUNTY

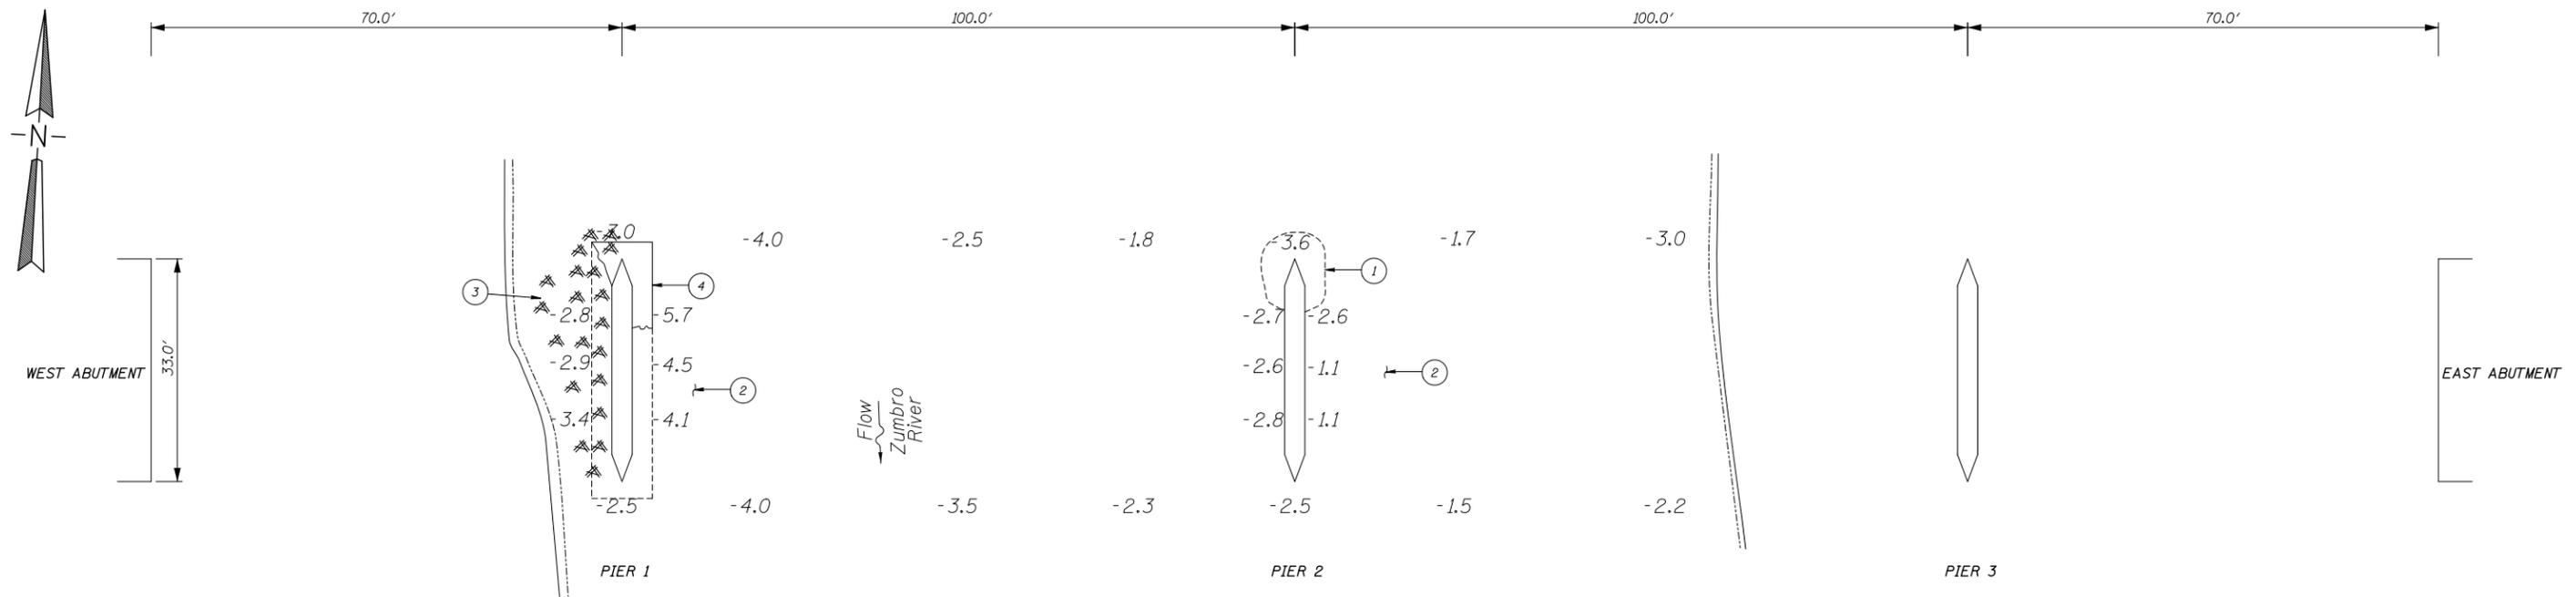
- ① There was a 3 foot radius by 2 foot deep scour depression at the upstream nose of Pier 2.
- ② The channel bottom material consisted of silty sand and gravel allowing 2 inches of probe rod penetration.
- ③ Moderate accumulation of timber debris, consisting of 1 foot diameter and smaller drift pieces, was observed from the channel bottom to 5 feet above waterline between the shore and the west face of Pier 1.
- ④ The footing was partially exposed from the northwest corner of Pier 1 around the upstream nose to the upstream 1/4-point along the east face of the pier with a maximum vertical face exposure of 1.5 feet. The top of the footing was located at approximately 5.5 feet below the water surface.
