UNDERWATER BRIDGE INSPECTION REPORT

STRUCTURE NO. 66505

5<sup>th</sup> STREET

MAY 23, 2012

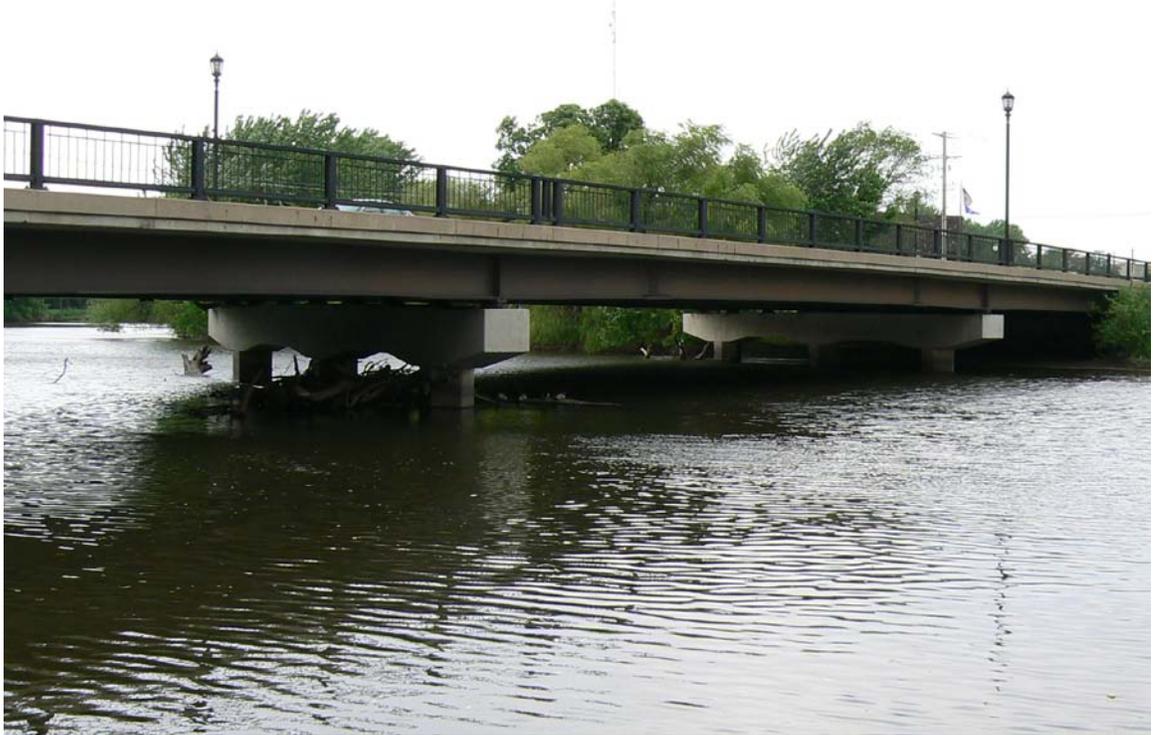
The substructure units inspected below water at Bridge No. 66505, Piers 1 and 2, were found to be in good condition with no defects of structural significance observed. The channel bottom exhibited minor degradation since the 2007 underwater inspection. Refer to Figure No. 2 for the upstream and downstream fascia profiles.

Photograph 1. Overall View of Bridge, Looking Southwest.

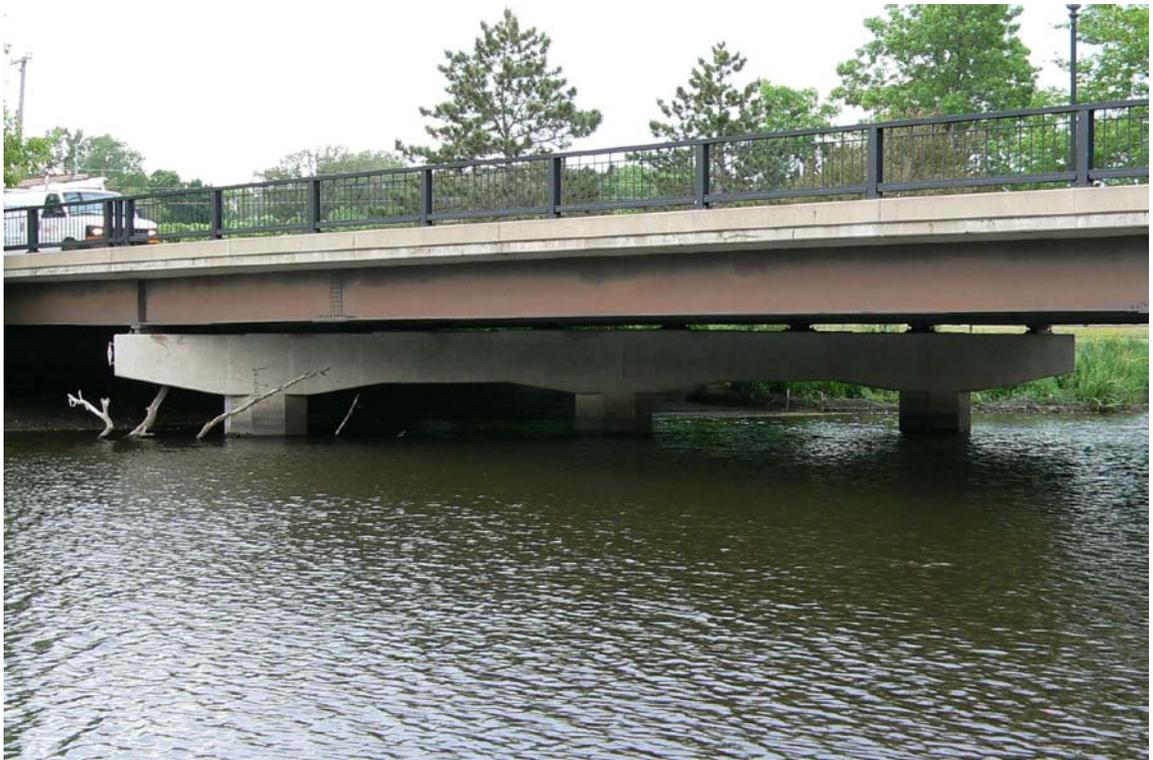
Photograph 2. View of Pier 1, Looking Northwest.

REMARKS: The concrete was typically smooth and sound. A light accumulation of 6-inch-diameter and smaller timber debris was observed on the channel bottom near the center column of Pier 1 and moderate to heavy accumulation of 2-foot-diameter and smaller timber debris was observed along the east face of Pier 2.

- (A) Ideally, the timber debris accumulation at Pier 2 should be removed to reduce excessive lateral loads on the pier, limit further debris accumulation, and reduce the likelihood of channel bottom degradation resulting from obstructed flow. Until drift removal can be accomplished, the timber debris at Pier 2, as well as Pier 1, should be monitored during future inspections.

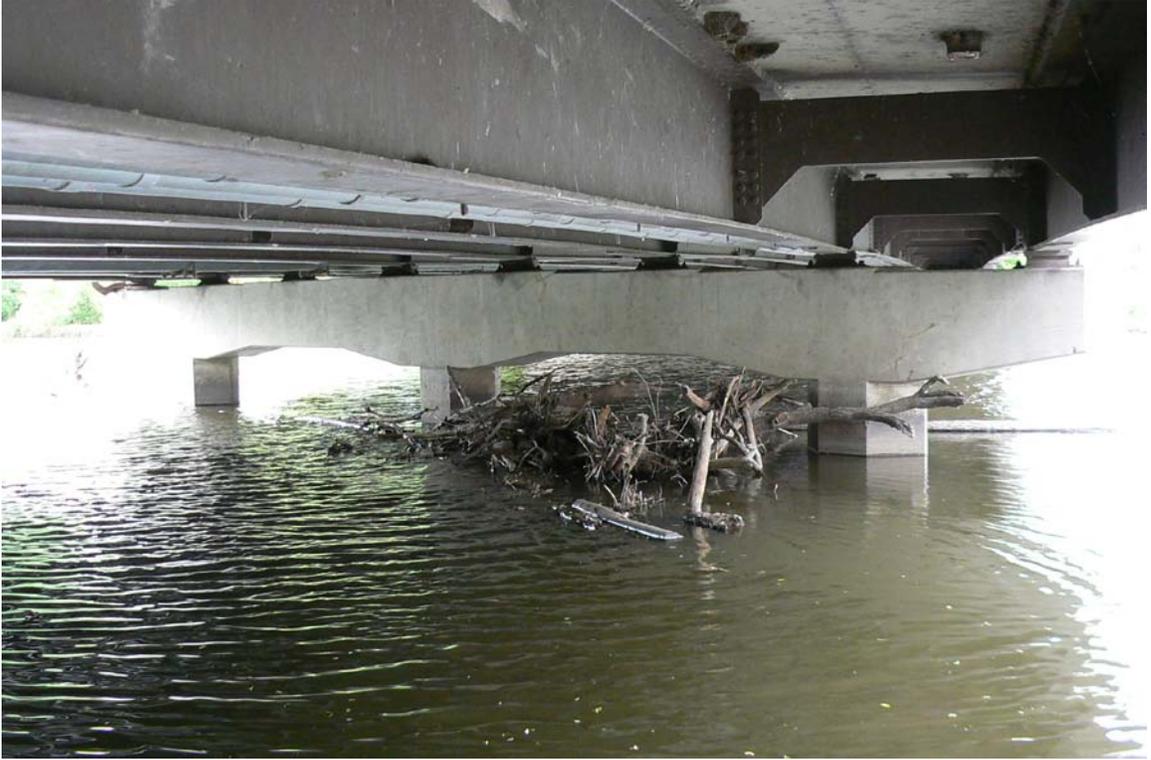
Photograph 3. View of Pier 2, Looking Southwest.

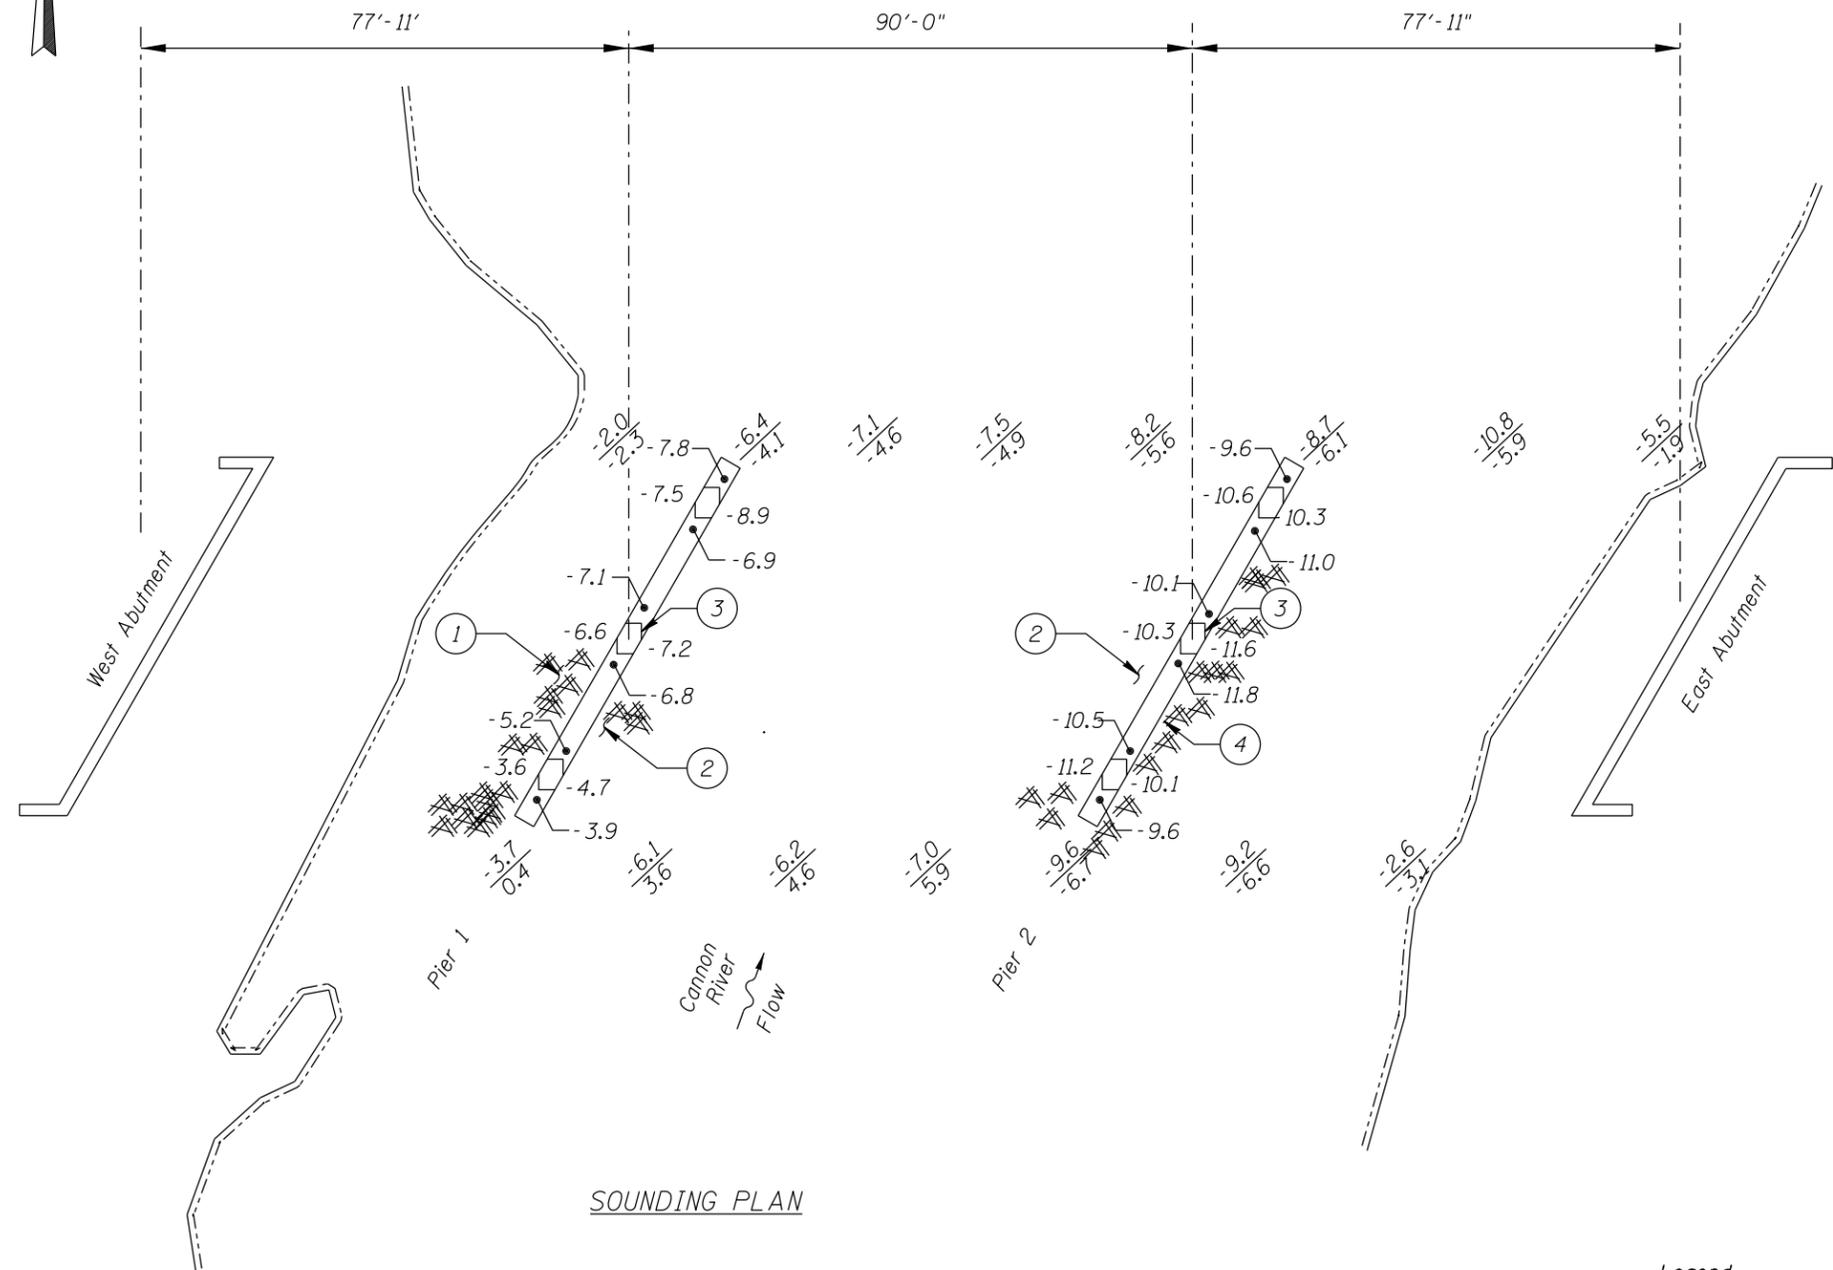
| <b>INSPECTION AND SOUNDING PLAN</b> | | |

- ① A light accumulation of 6-inch-diameter and smaller timber debris was observed on the channel bottom along the center column at Pier 1 and extended to the upstream column.
- ② The channel bottom consisted of silty clay and sand with up to 8 inches of probe rod penetration.
- ③ The concrete pier columns were typically smooth and sound.
- ④ A moderate to heavy accumulation of timber debris consisting of up to 1 foot diameter drift pieces, was observed along the east face of Pier 2 and extended from the waterline down 8 feet. A tree 2 feet in diameter extended from downstream nose to upstream nose of the pier.
