UNDERWATER BRIDGE INSPECTION REPORT

STRUCTURE NO. 66506

CANNON RIVER

SEPTEMBER 13, 2012

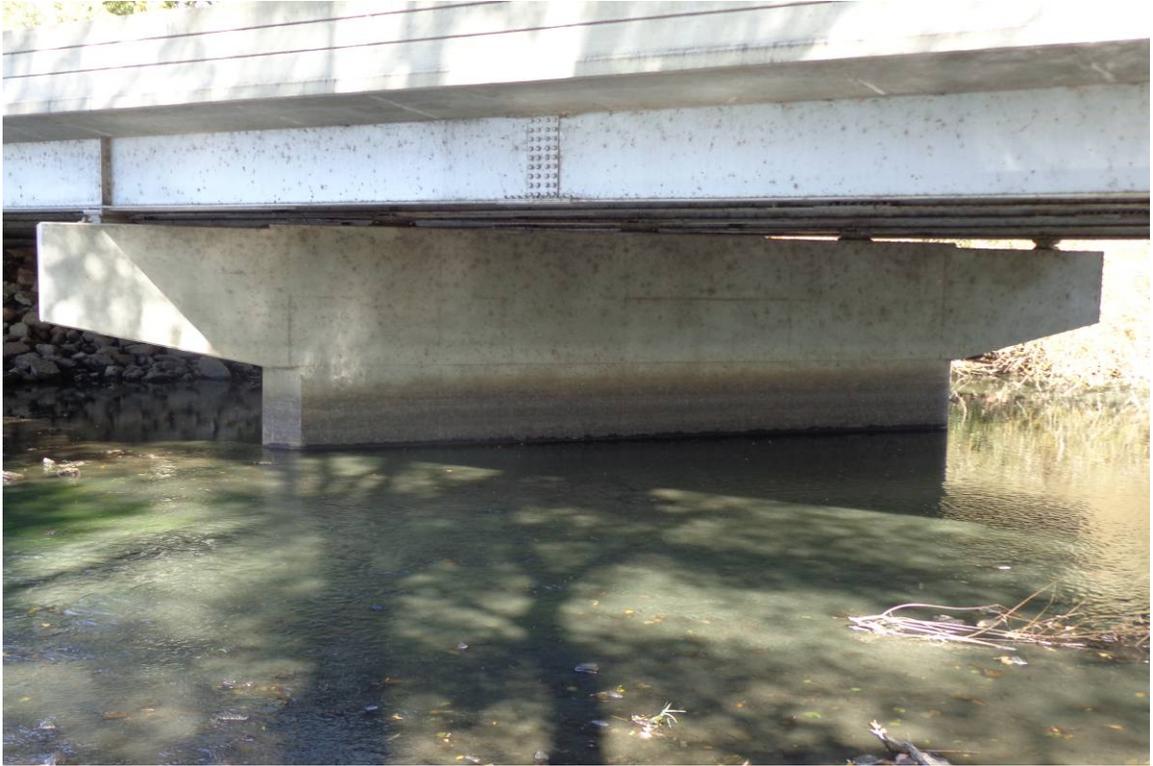
Photograph 1. View of Pier 1, Looking Northwest.

REMARKS: The concrete was smooth and sound and in good condition. The channel bottom appeared stable with no significant signs of degradation / scour since the last inspection.

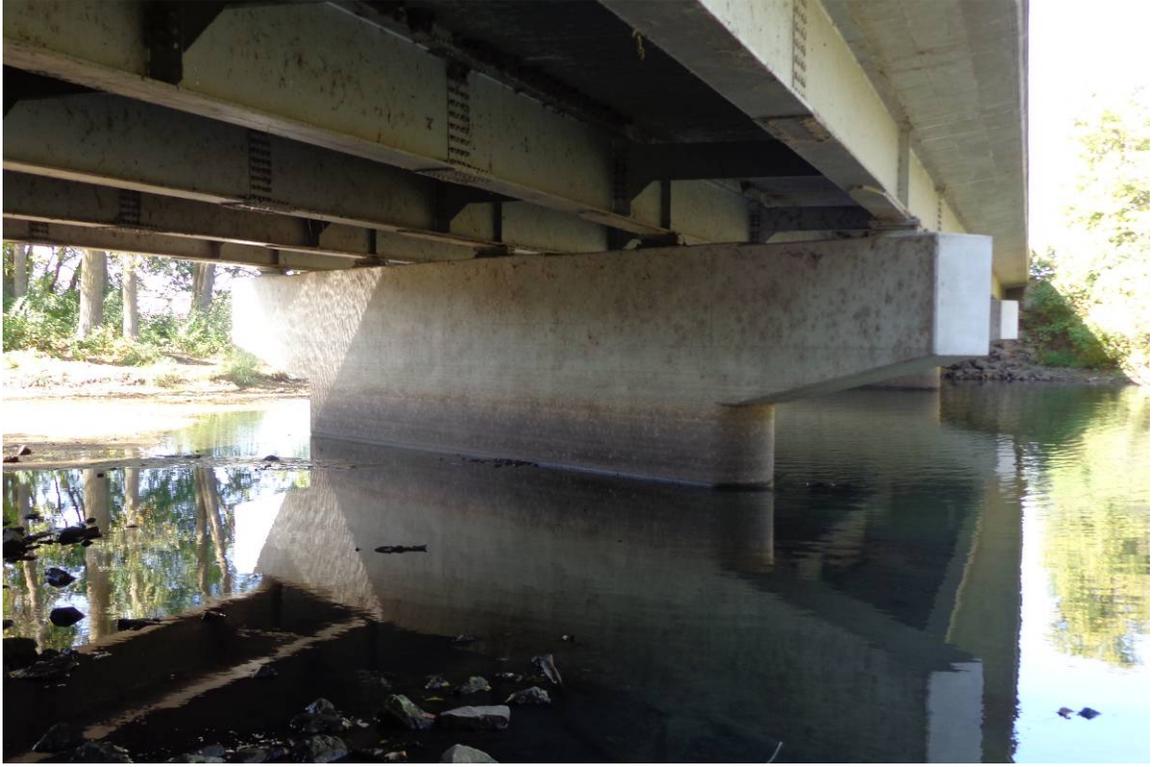
Photograph 2. View of Pier 2, Looking Southwest.

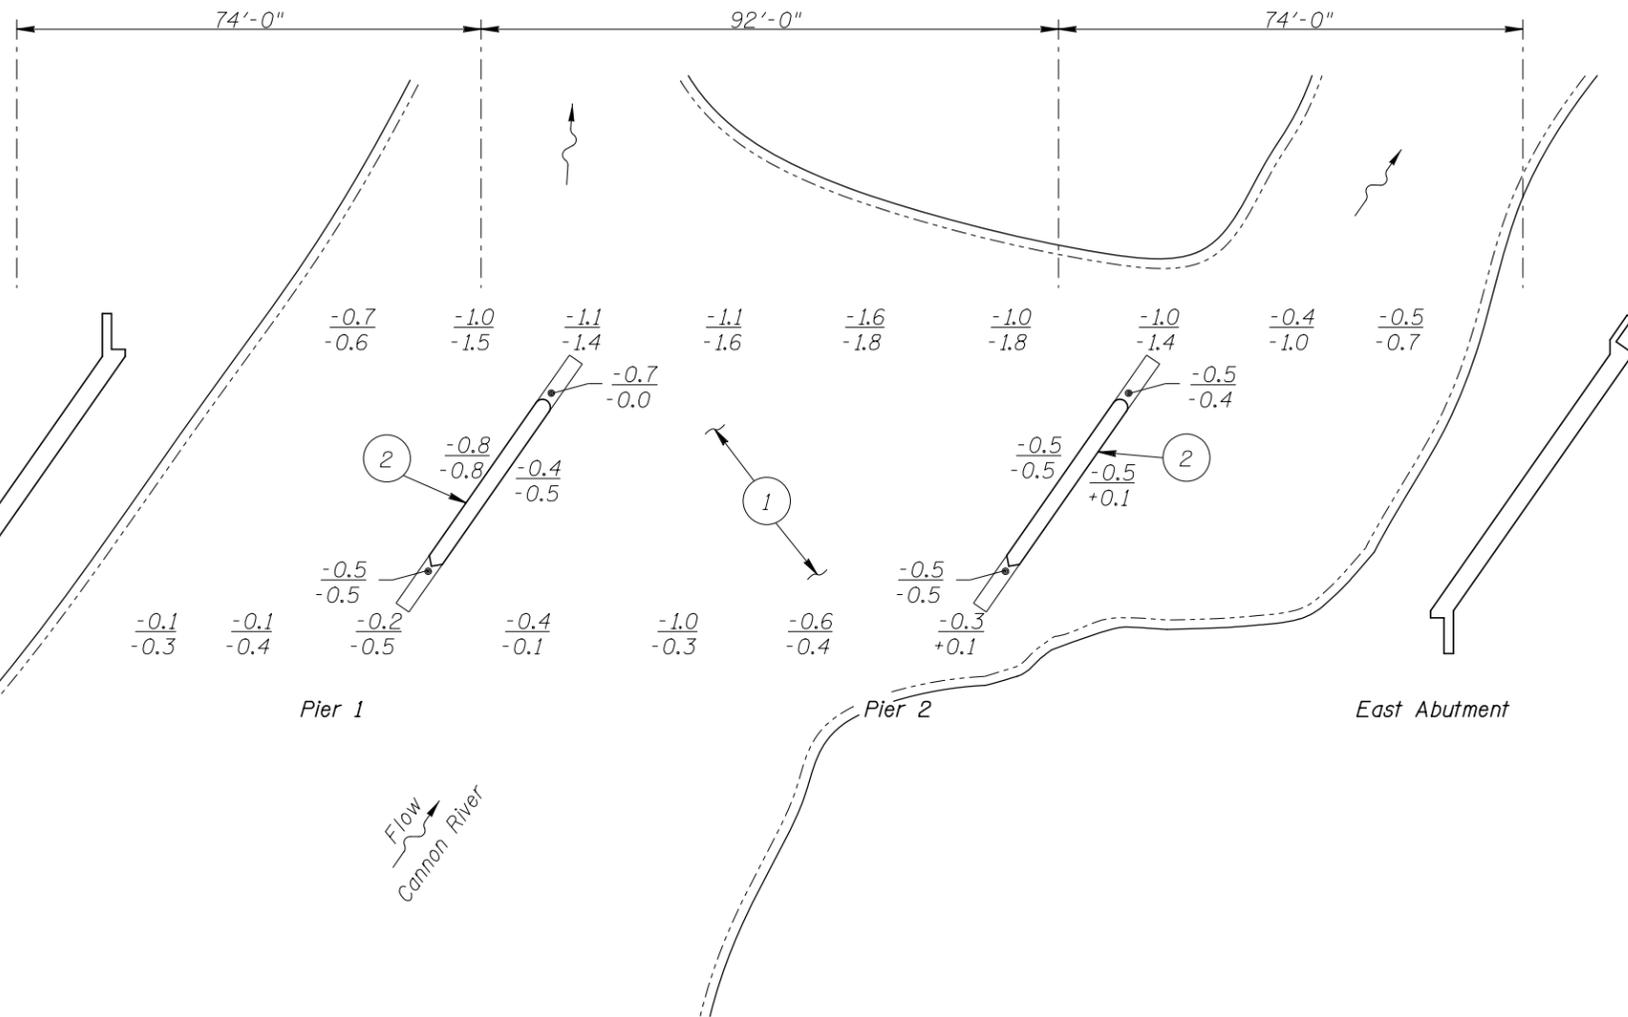
SOUNDING PLAN

- ① The channel bottom material consisted of gravel and 1 foot diameter and smaller cobbles, with no appreciable probe rod penetration.
- ② The concrete was in smooth and sound condition.
