UNDERWATER BRIDGE INSPECTION REPORT

STRUCTURE NO. 66513  
14<sup>th</sup> STREET (MSAS NO. 103)  
OVER THE  
STRAIGHT RIVER  
CITY OF FARIBAULT, RICE COUNTY

SEPTEMBER 14, 2012  
PREPARED FOR THE  
MINNESOTA DEPARTMENT OF TRANSPORTATION  
BY  
COLLINS ENGINEERS, INC.  
JOB NO. 7423

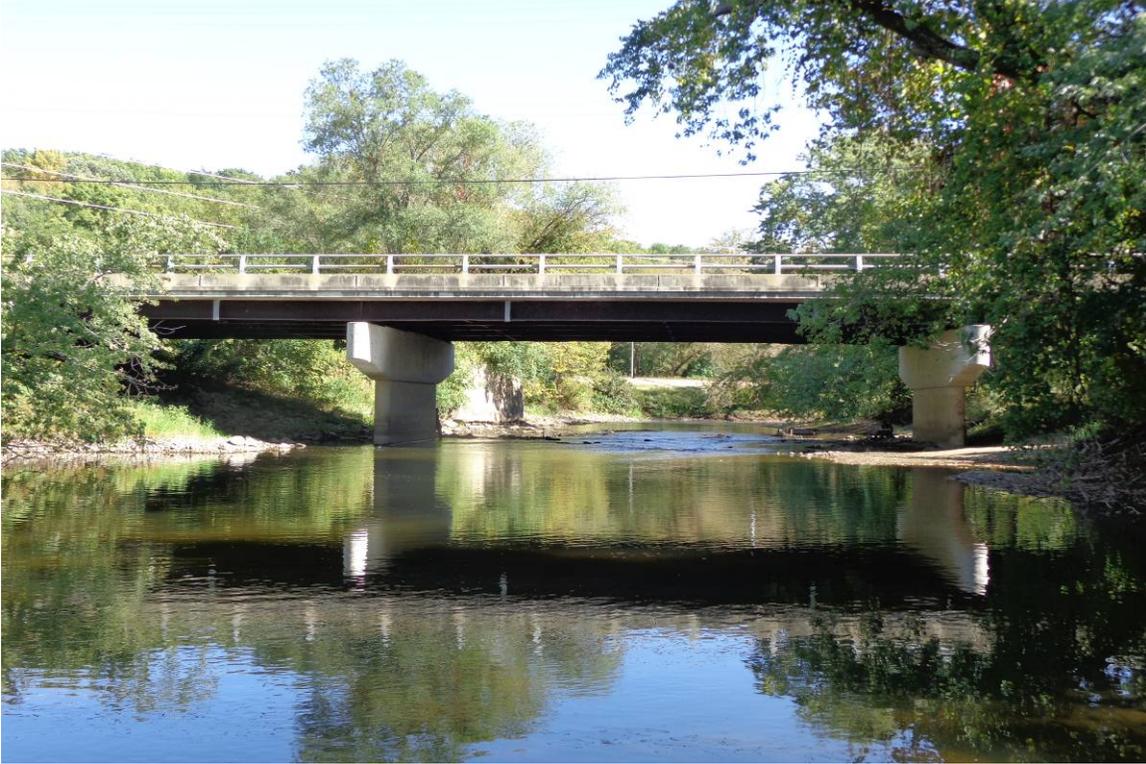
Photograph 1. Overall View of the Structure, Looking South.

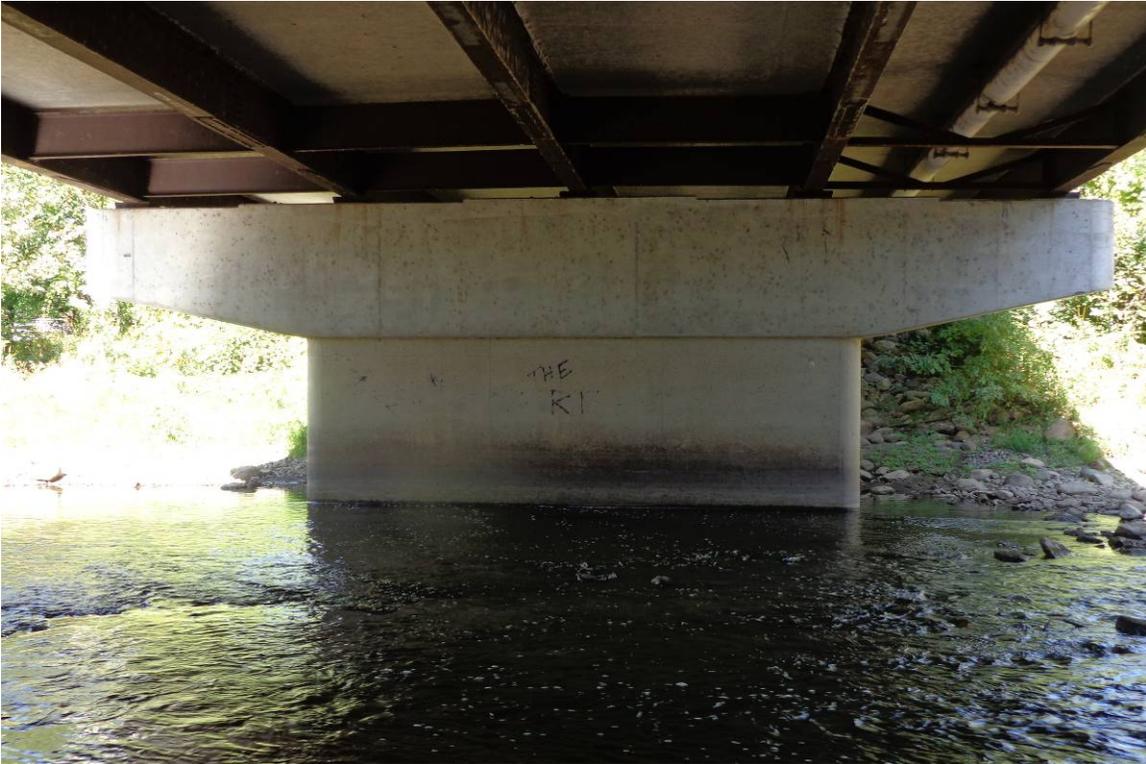
Photograph 2. View of East Pier, Looking East.

- 1 The top of the footing was partially exposed along the west face of the East Pier extending from the upstream 1/4-point to the downstream 1/4-point of the pier. No vertical face/footing edge exposure was present.
- 2 The concrete was in smooth and sound condition with no notable deterioration.
- 3 The channel bottom material consisted of 1 foot and smaller diameter stone.

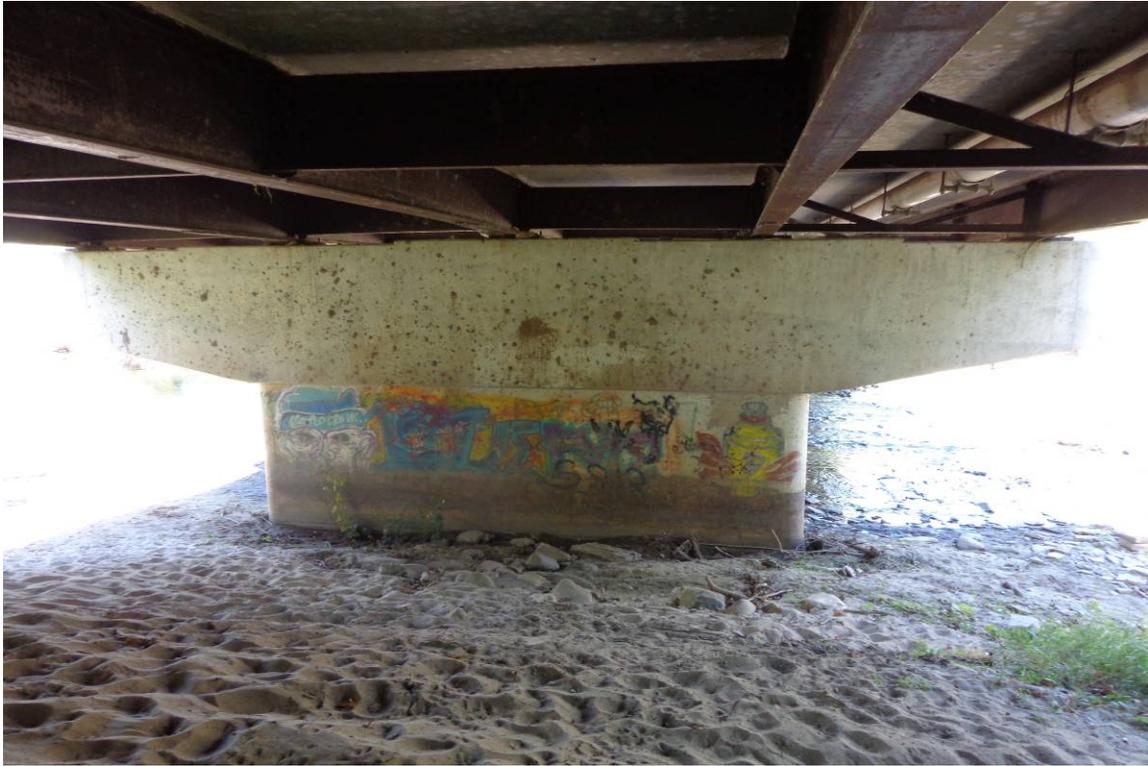
Photograph 3. View of West Pier, Looking East.

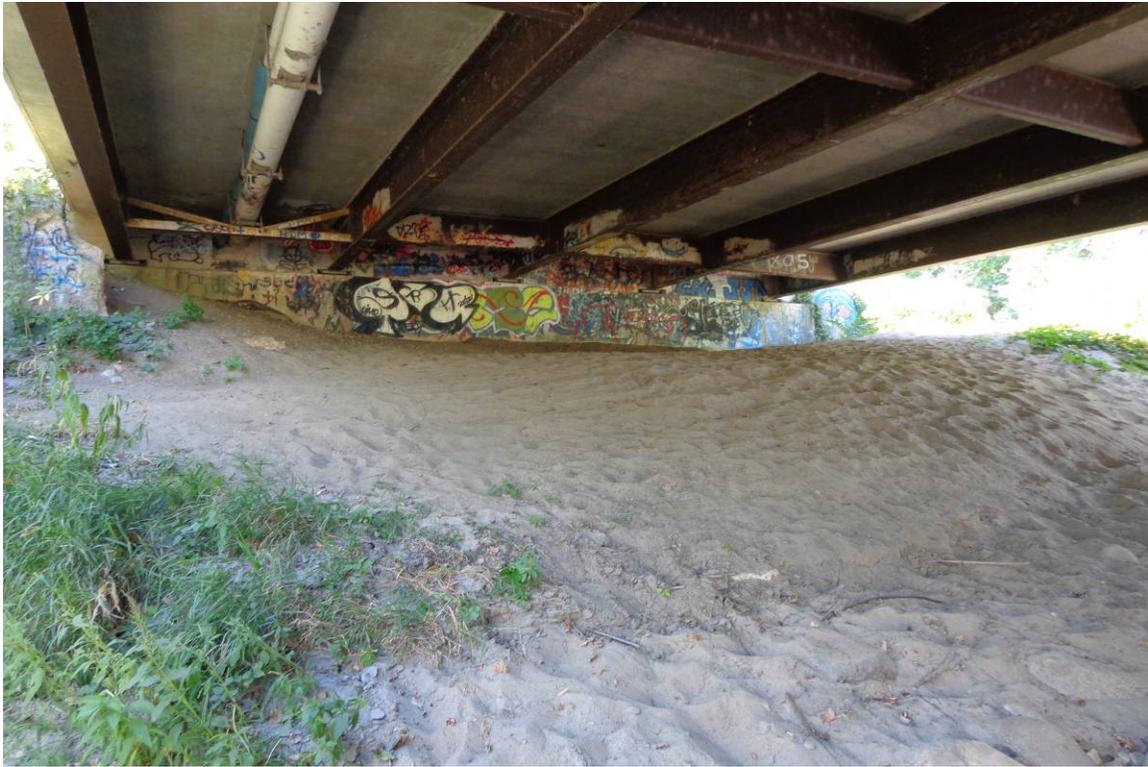
Photograph 4. View of West Abutment, Looking West.

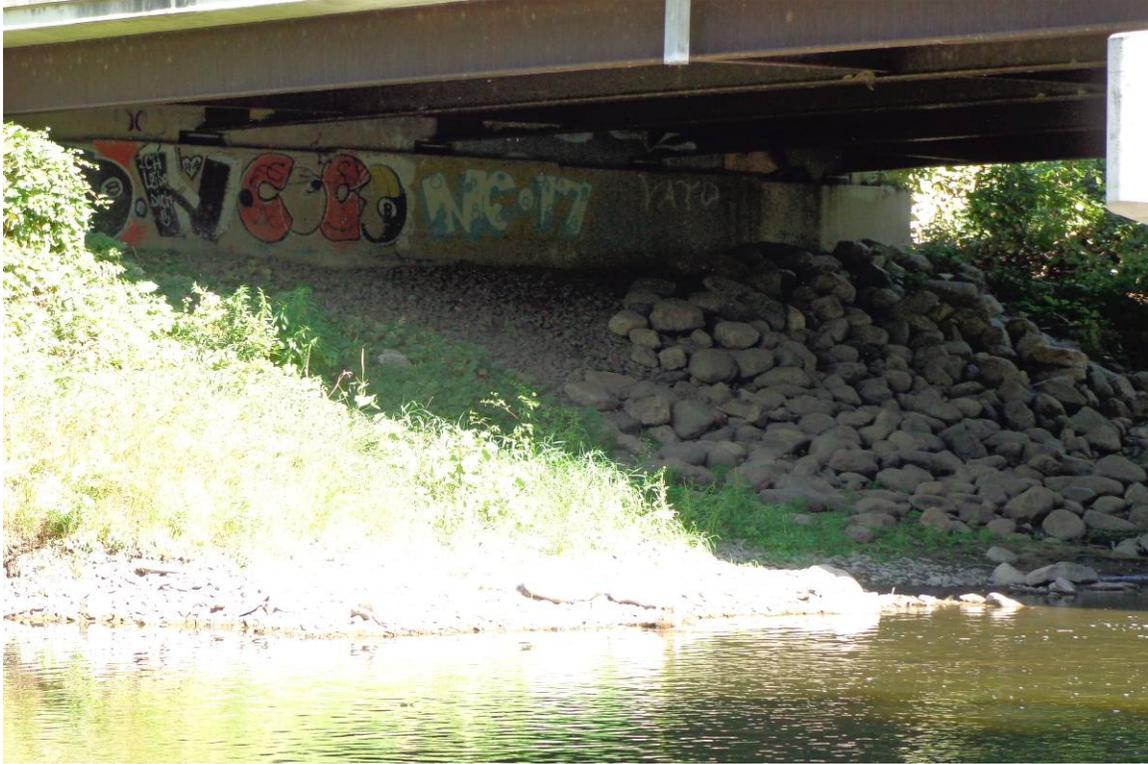
Photograph 5. View of East Abutment, Looking Southeast.
