UNDERWATER BRIDGE INSPECTION REPORT

STRUCTURE NO. 66515

CANNON RIVER

MAY 23, 2012

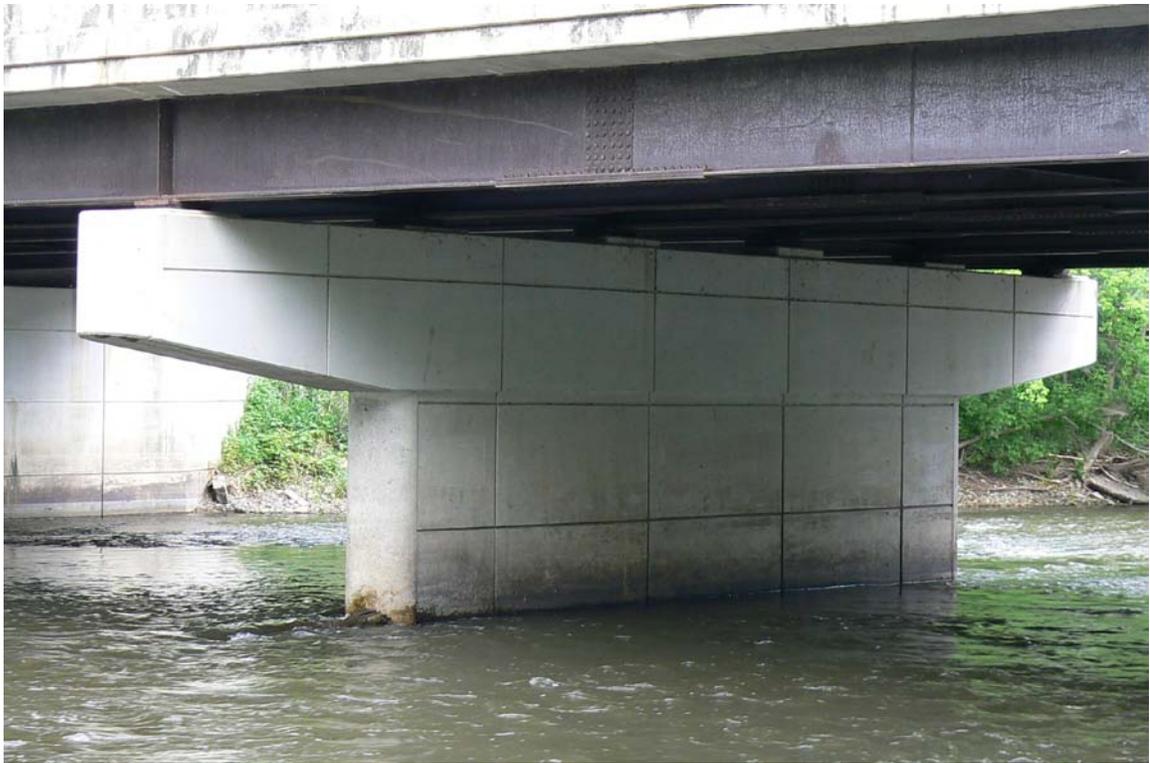
Photograph 1. View of Pier 1, Looking Northwest.

- 9 A 1/32 inch wide vertical crack was observed at Pier 1 extending from the bottom of the pier cap to the channel bottom.
- 10 Light accumulation of timber debris was located at the upstream nose of Pier 1, consisting of logs up to 1 foot in diameter, extending along entire west face the pier.

- 11 A scour depression 8 feet in radius and 2.5 feet deep was observed at upstream nose of Pier 1.

- (A) Monitor accumulations of timber debris and possibly consider removal operations if accumulation continues to increase in the future.
- (B) Reinspect the submerged substructure units at the normal maximum recommended (NBIS) interval of sixty (60) months.

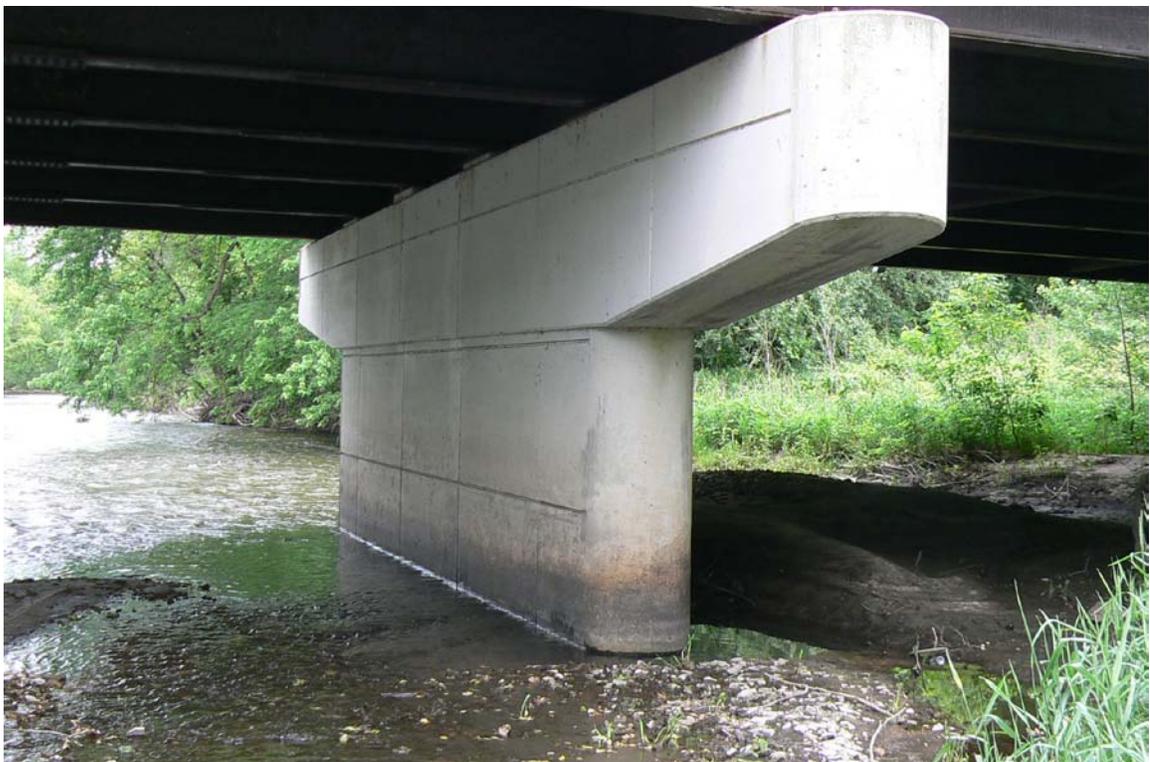
Photograph 2. View of Pier 2, Looking Northeast.

- 5 A 1/16 inch wide vertical crack with light efflorescence was observed on the east face of Pier 2, extending from the bottom of the pier cap to the channel bottom.

- 6 A scour depression 5 feet in radius, 1.5 feet deep was observed at the upstream end and along the west face of Pier 2.
- 7 A vertical crack 1/32 inch wide was observed at the midpoint of the West Abutment, extending from 6 feet above the waterline to the channel bottom.

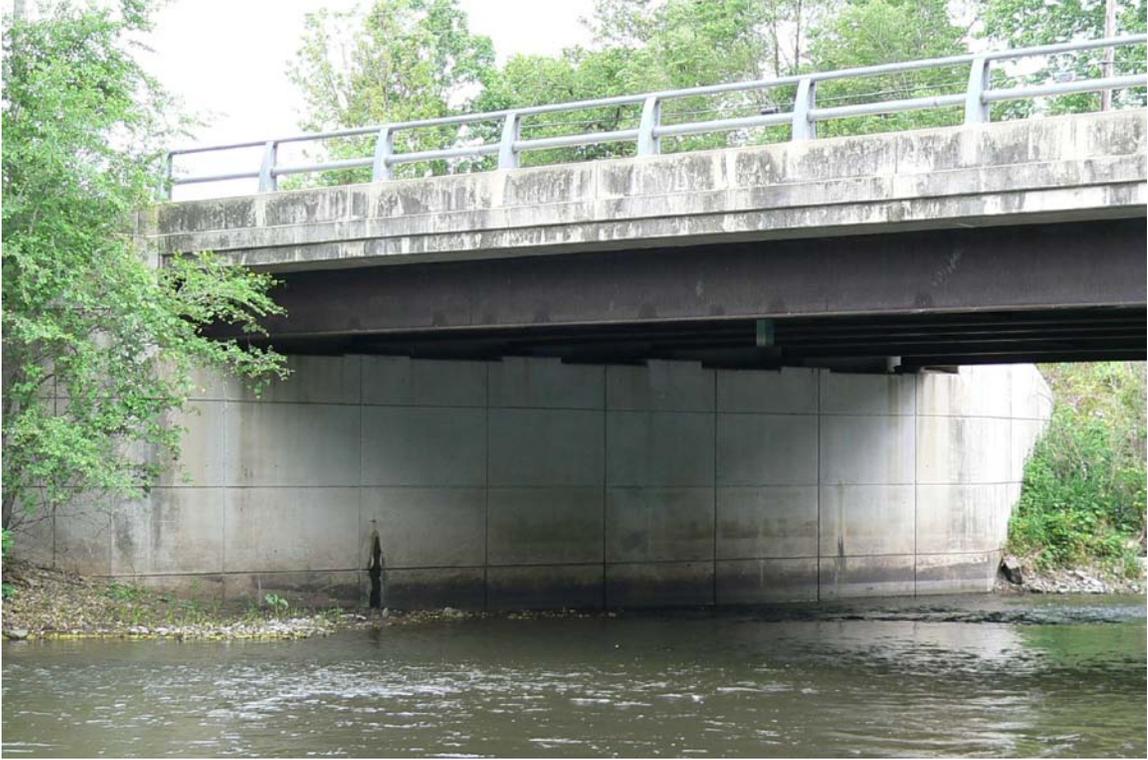
Photograph 3. View of West Abutment, Looking Northwest.

- 8 Vertical cracks with efflorescence and moisture, 1/32 inch wide, were observed extending from bridge seat to channel bottom at 8 feet and 16 feet away from upstream corner of West Abutment.

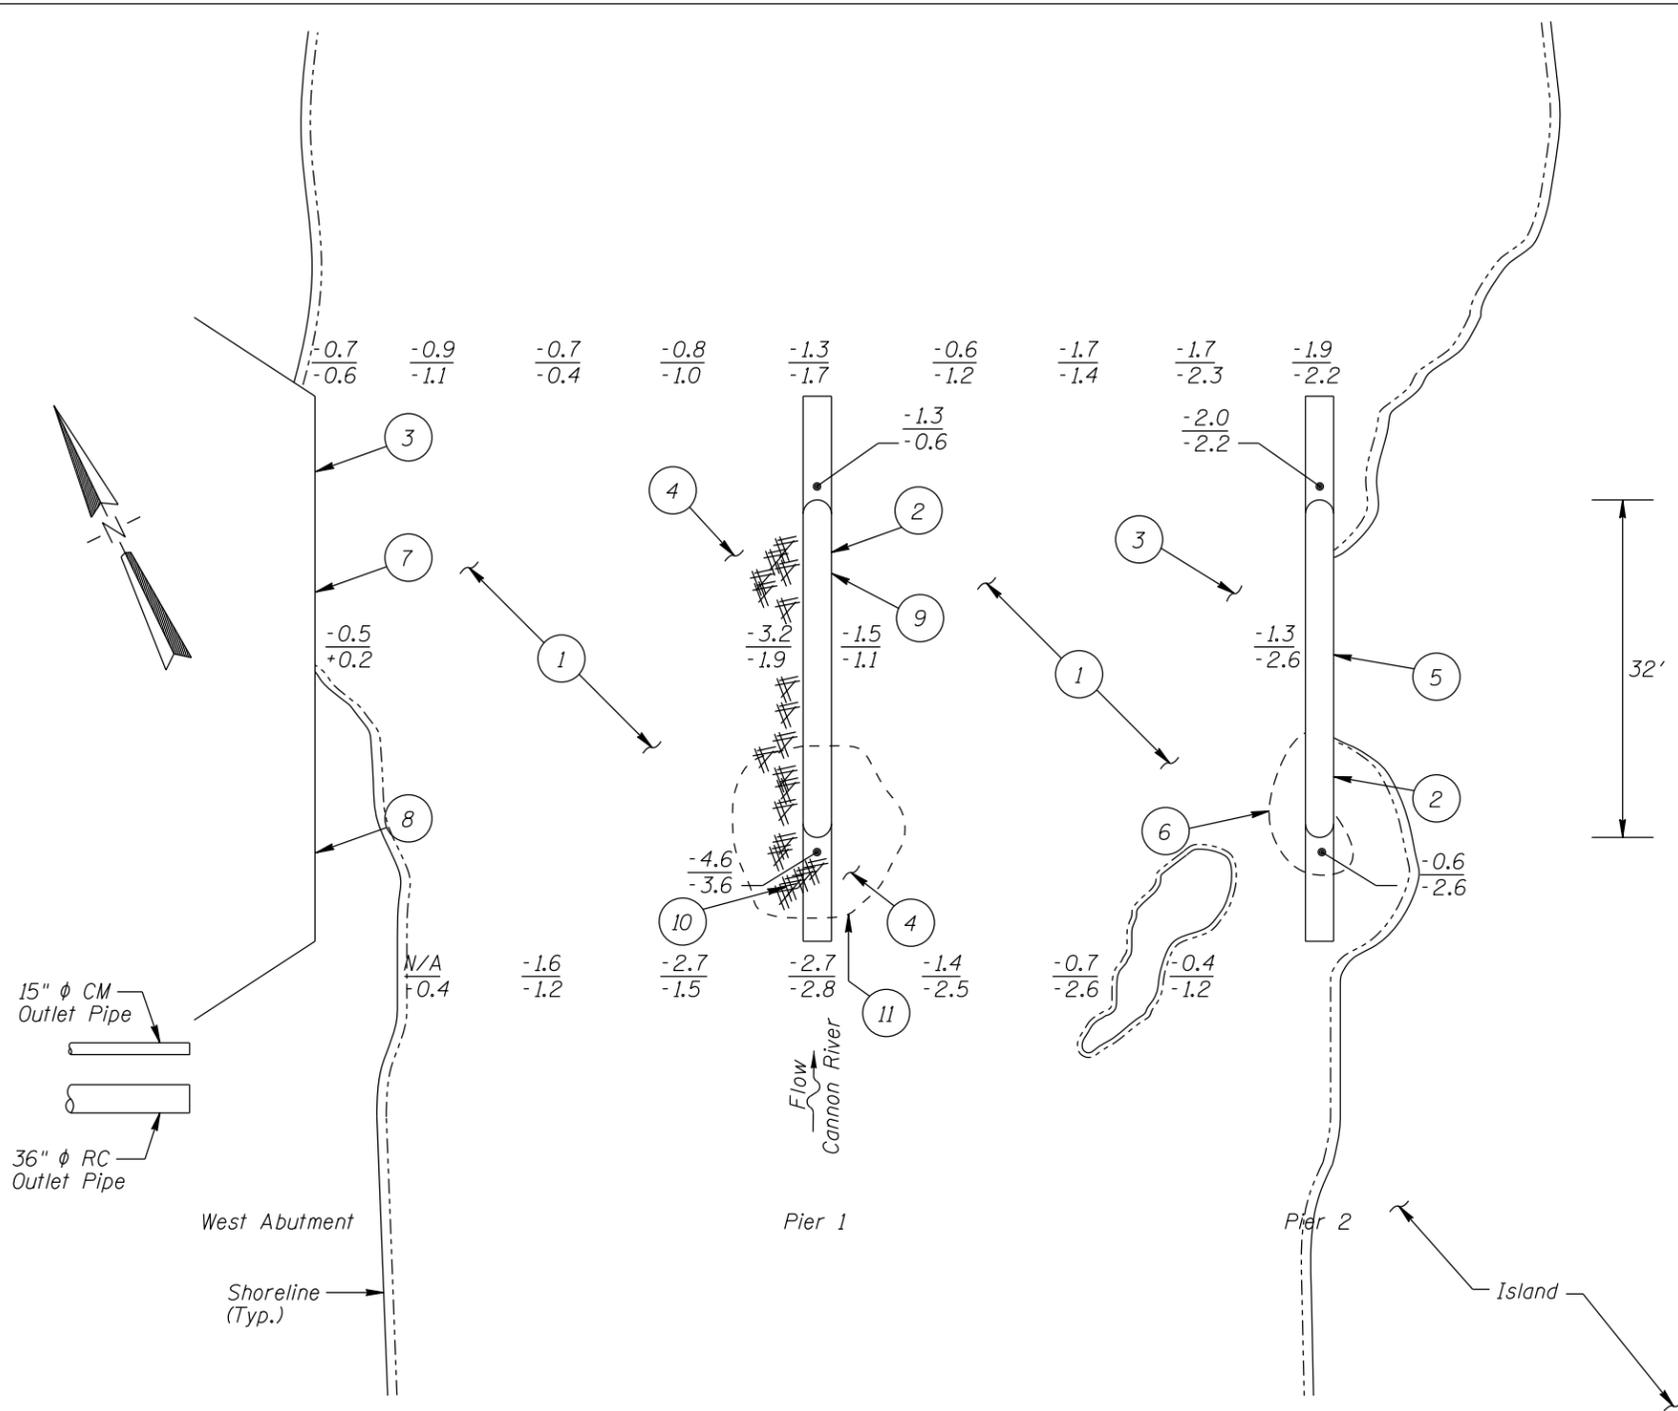
SOUNDING PLAN

- 1 The channel bottom material consisted of soft silt allowing 9 inches of maximum probe rod penetration.
- 2 Light scaling was observed on concrete shaft of both piers, extending from the channel bottom to 1.5 feet above the waterline with a maximum penetration of 1/4 inch.

- 3 The channel bottom along the west face of Pier 2 consisted of 5 to 8 inch diameter cobbles with no appreciable probe rod penetration.
- 4 The channel bottom material around Pier 1 consisted of coarse gravel overlaying 18 inch diameter and smaller riprap with no appreciable probe rod penetration.
