UNDERWATER BRIDGE INSPECTION REPORT

STRUCTURE NO. 66518  
CSAH NO. 1 (HESTER ST.)  
OVER THE  
CANNON RIVER OVERFLOW  
RICE COUNTY

MAY 23, 2012

BY  
COLLINS ENGINEERS, INC.

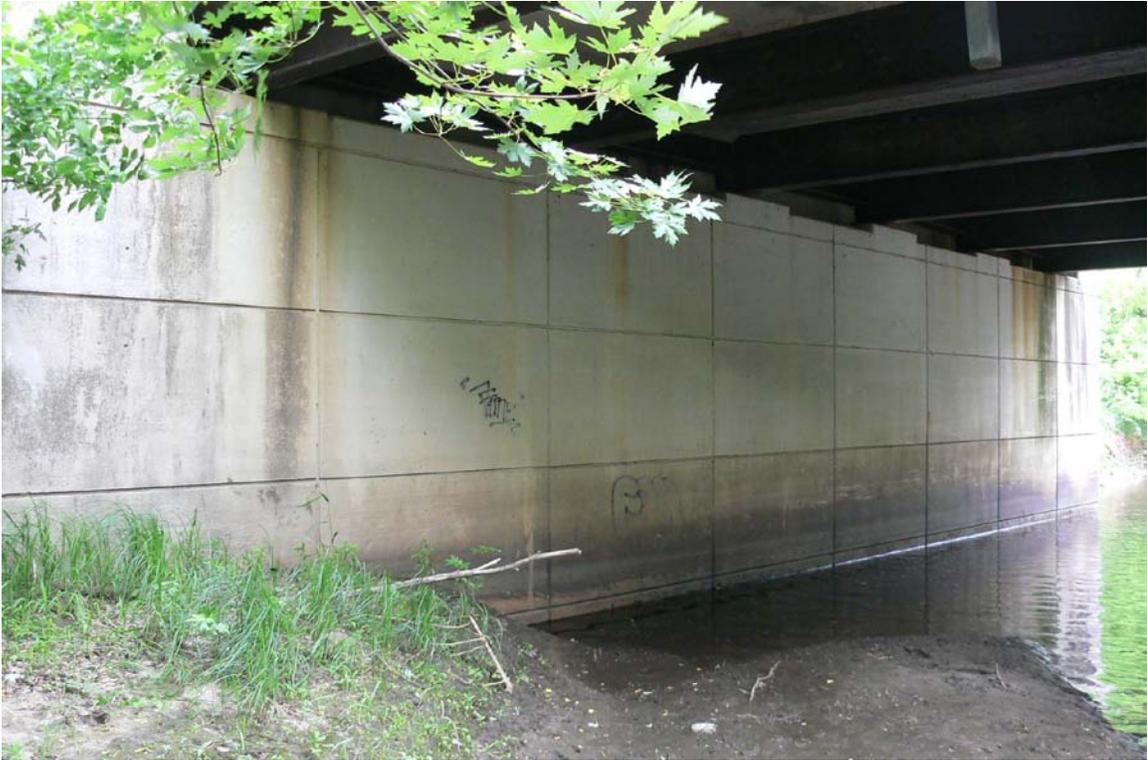
Photograph 1. View of the West Abutment, Looking Northwest.

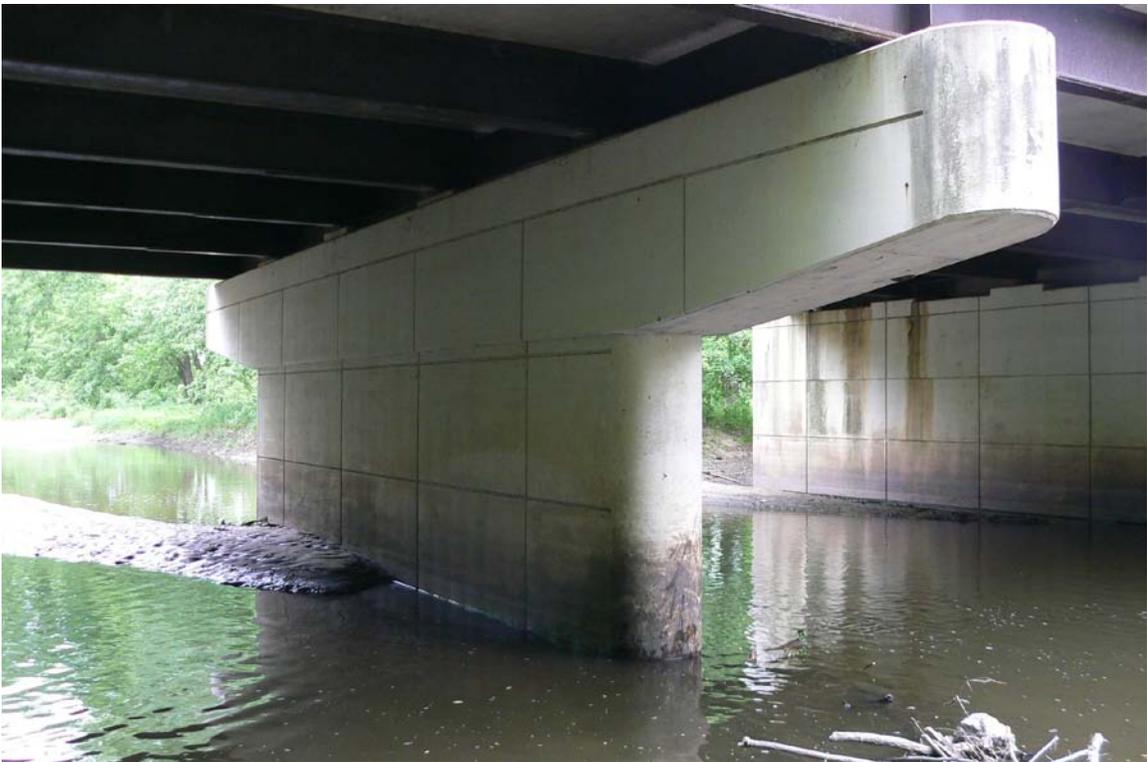
- (A) A localized scour depression, 6 feet in diameter and 1.5 feet deep, was observed at the upstream end of Pier 1.
- (B) 1/32 inch wide vertical cracks were observed in the center and at the upstream quarter point of the East Abutment breast wall, extending from the beam seat to the channel bottom.
- (C) A moderate to heavy accumulation of timber debris, including a 12 inch diameter tree, was observed at the upstream end of Pier 1 extending from the channel bottom to 3 feet above the waterline.

Photograph 2. View of Pier 1, Looking Northeast.

- (A) Remove timber debris at Pier 1.
- (B) Reinspect the submerged substructure units at the normal maximum recommended (NBIS) interval of sixty (60) months.

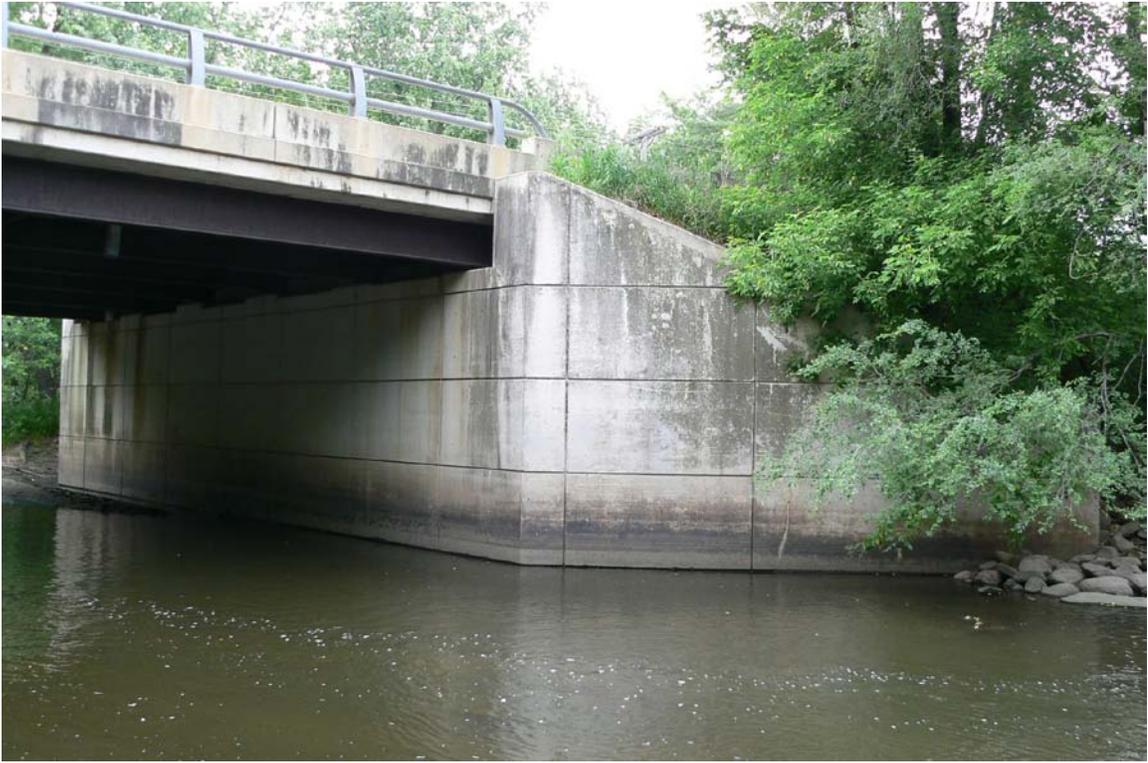
Photograph 3. View of the East Abutment, Looking Northeast.

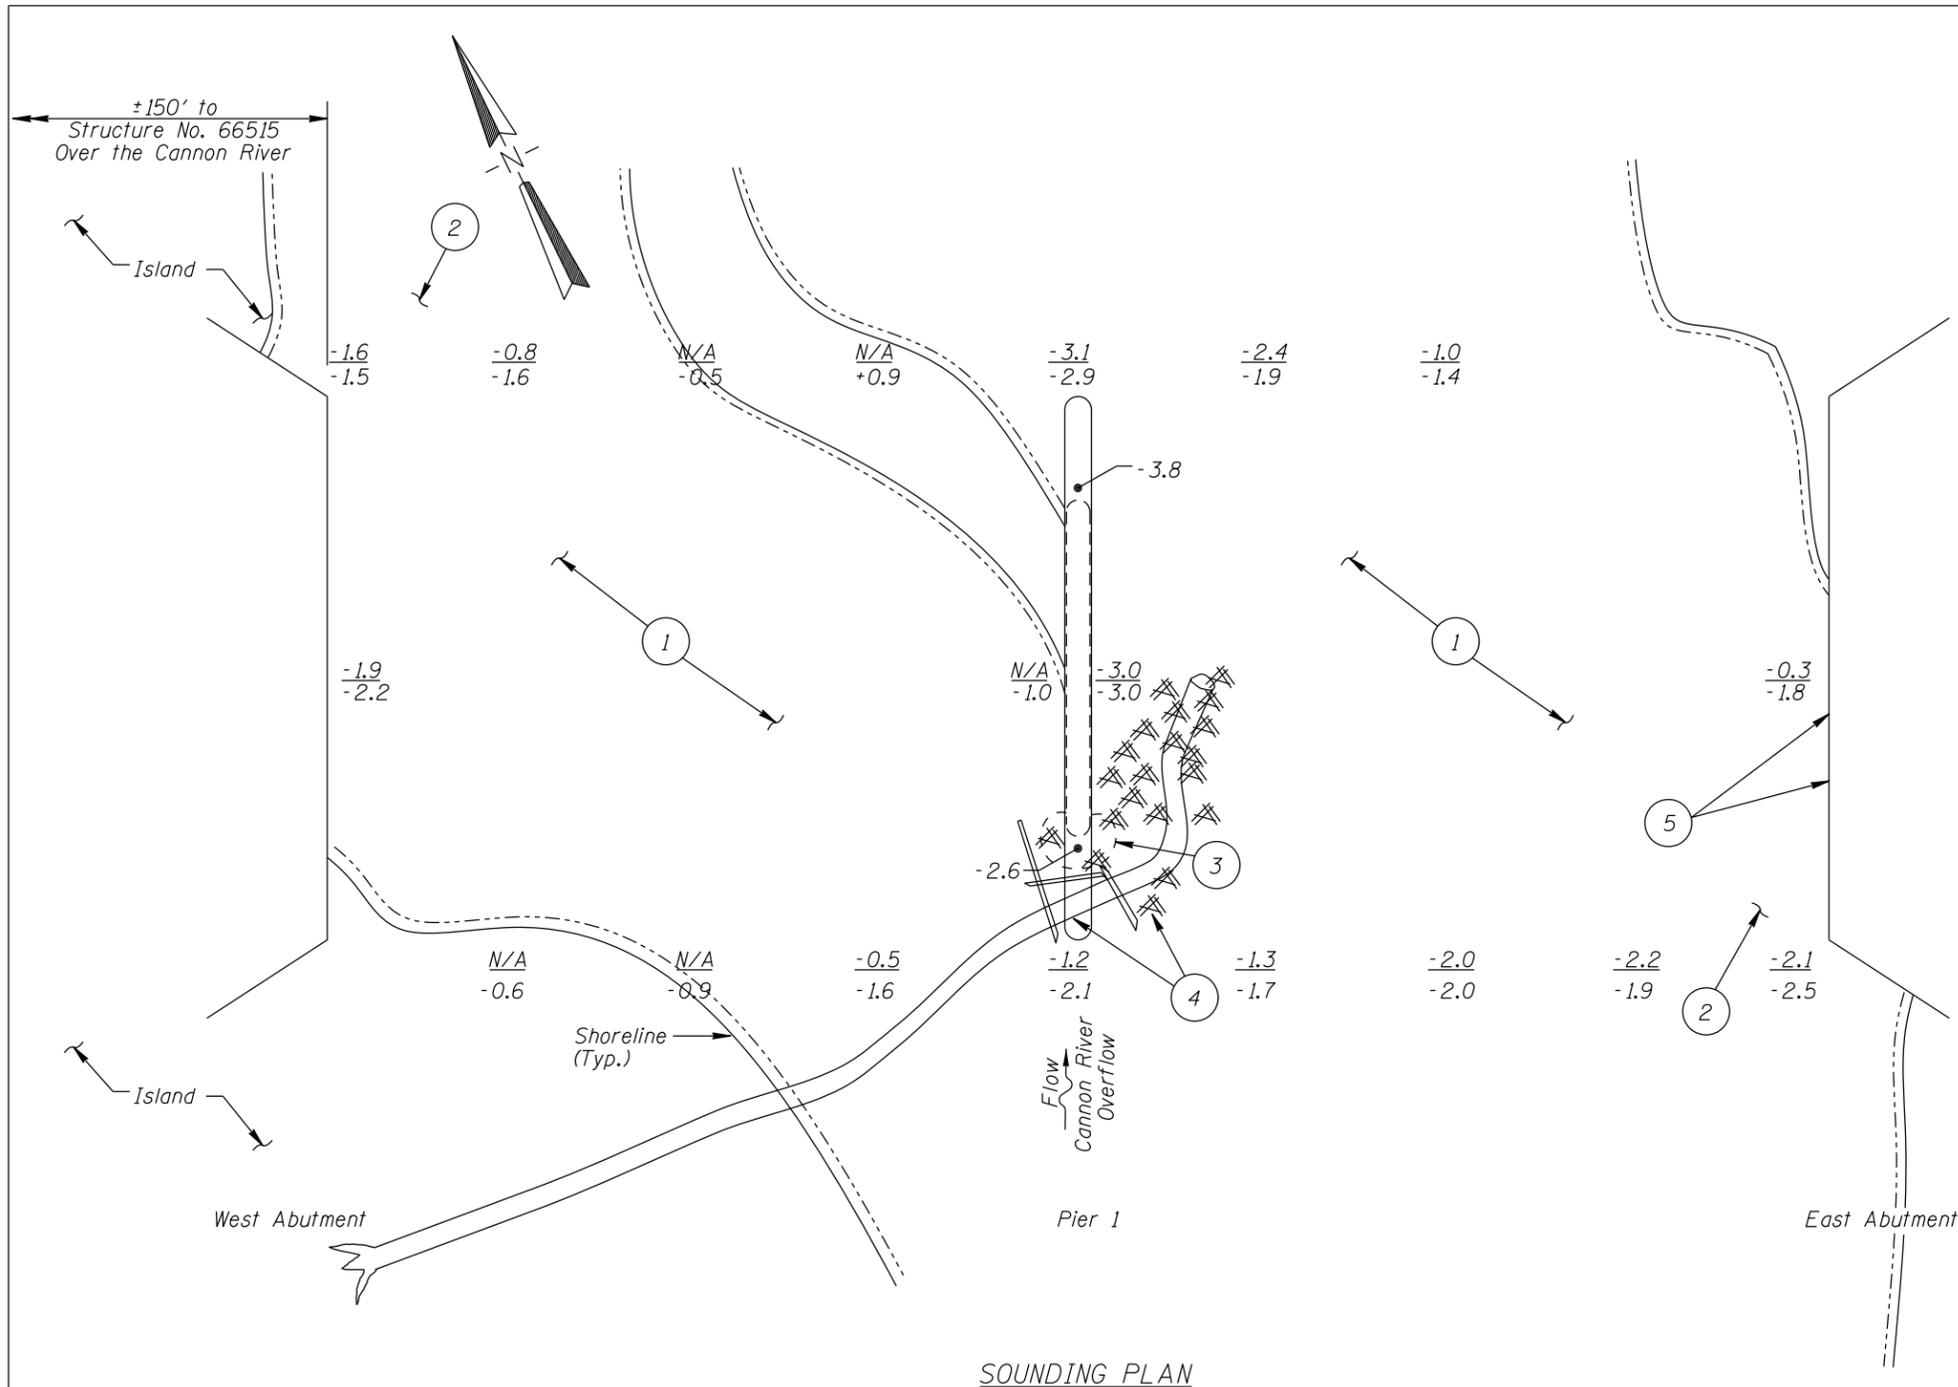
- ① The channel bottom material consisted of silty sand and clay with 6 inches to 1.5 feet of probe rod penetration.
- ② The channel bottom material consisted of cobbles, 6 inch diameter and smaller, with 1 inch of maximum probe rod penetration.
- ③ Scour depression, 6 feet in diameter and 1.5 feet deep, observed at the upstream nose of Pier 1.
- ④ A moderate to heavy accumulation of timber debris was observed at the upstream end of Pier 1, including a 12 inch diameter tree and smaller branches, extending from the channel bottom to 3 feet above the waterline.
- ⑤ Vertical cracks 1/32 inch wide were observed on the face of the East Abutment extending from bridge seat to channel bottom.
