UNDERWATER BRIDGE INSPECTION REPORT

STRUCTURE NO. 66520  
TWP NO. 51 (220<sup>th</sup> STREET)  
OVER THE  
STRAIGHT RIVER  
DISTRICT 6 - RICE COUNTY

SEPTEMBER 12, 2012  
PREPARED FOR THE  
MINNESOTA DEPARTMENT OF TRANSPORTATION  
BY  
COLLINS ENGINEERS, INC.  
JOB NO. 7423

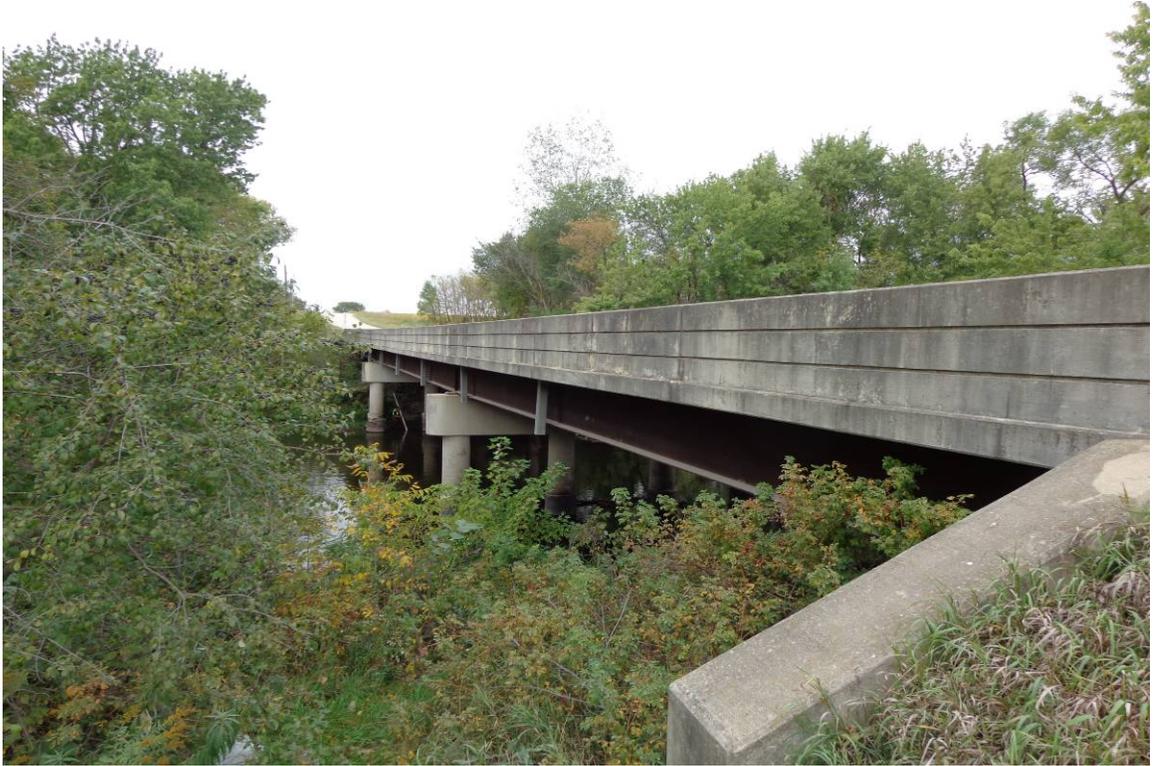
Photograph 1. Overall view of the Bridge, Looking Northwest.

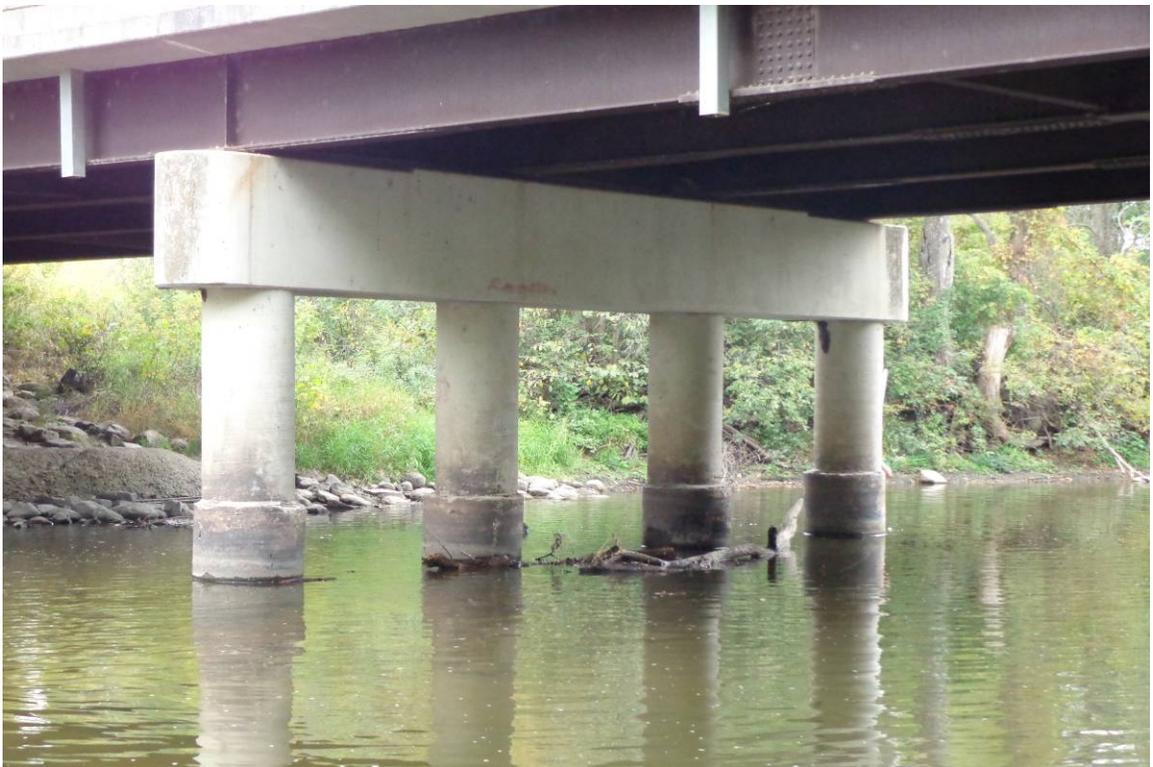
- (A) Timber debris was observed along the west face of Pier 1 that consisted of 6 inch diameter and smaller branches and extended from the channel bottom to 1 foot above the waterline.

Photograph 2. View of Pier 1, Looking Southeast.

- 1 Timber debris was observed along the west face of Pier 1 that consisted of 6 inch diameter and smaller branches and extended from the channel bottom to 1 foot above the waterline.

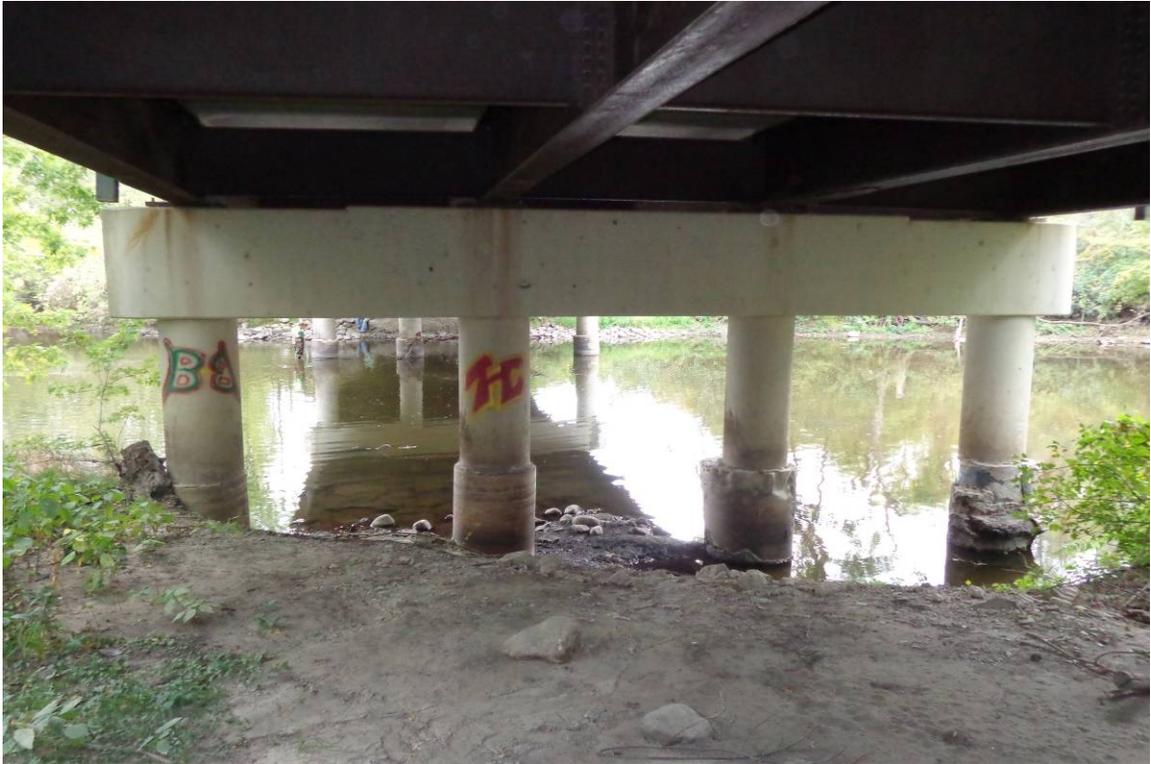
Photograph 3. View of Pier 2, Looking East.

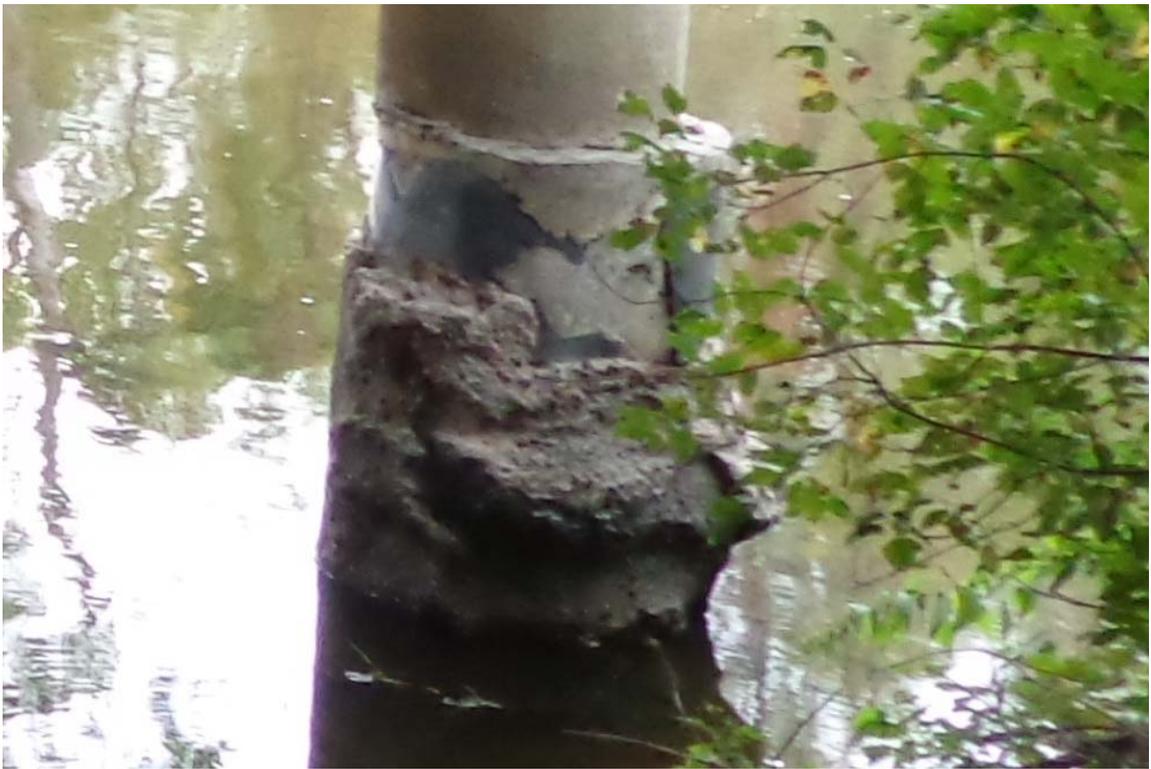
- (C) The columns of Pier 1 were encased in up to 6 inches of additional concrete from the channel bottom to 4.0 feet above the waterline. The encasements exhibited form irregularities (embedded form boards) and spalling with up to 6 inches of penetration.

Photograph 4. View of the Irregular Concrete Encasement at the Upstream Column of Pier 2, Looking East.

- 3 The columns of Pier 1 were encased in up to 6 inches of additional concrete from the channel bottom to 4.0 feet above the waterline. The encasements exhibited form irregularities (embedded form boards) and spalling with up to 6 inches of penetration.

- (A) Monitor concrete deterioration at the concrete column encasements during future underwater inspections.
- (B) Reinspect the submerged substructure units at the normal maximum recommended (NBIS) interval of sixty (60) months.

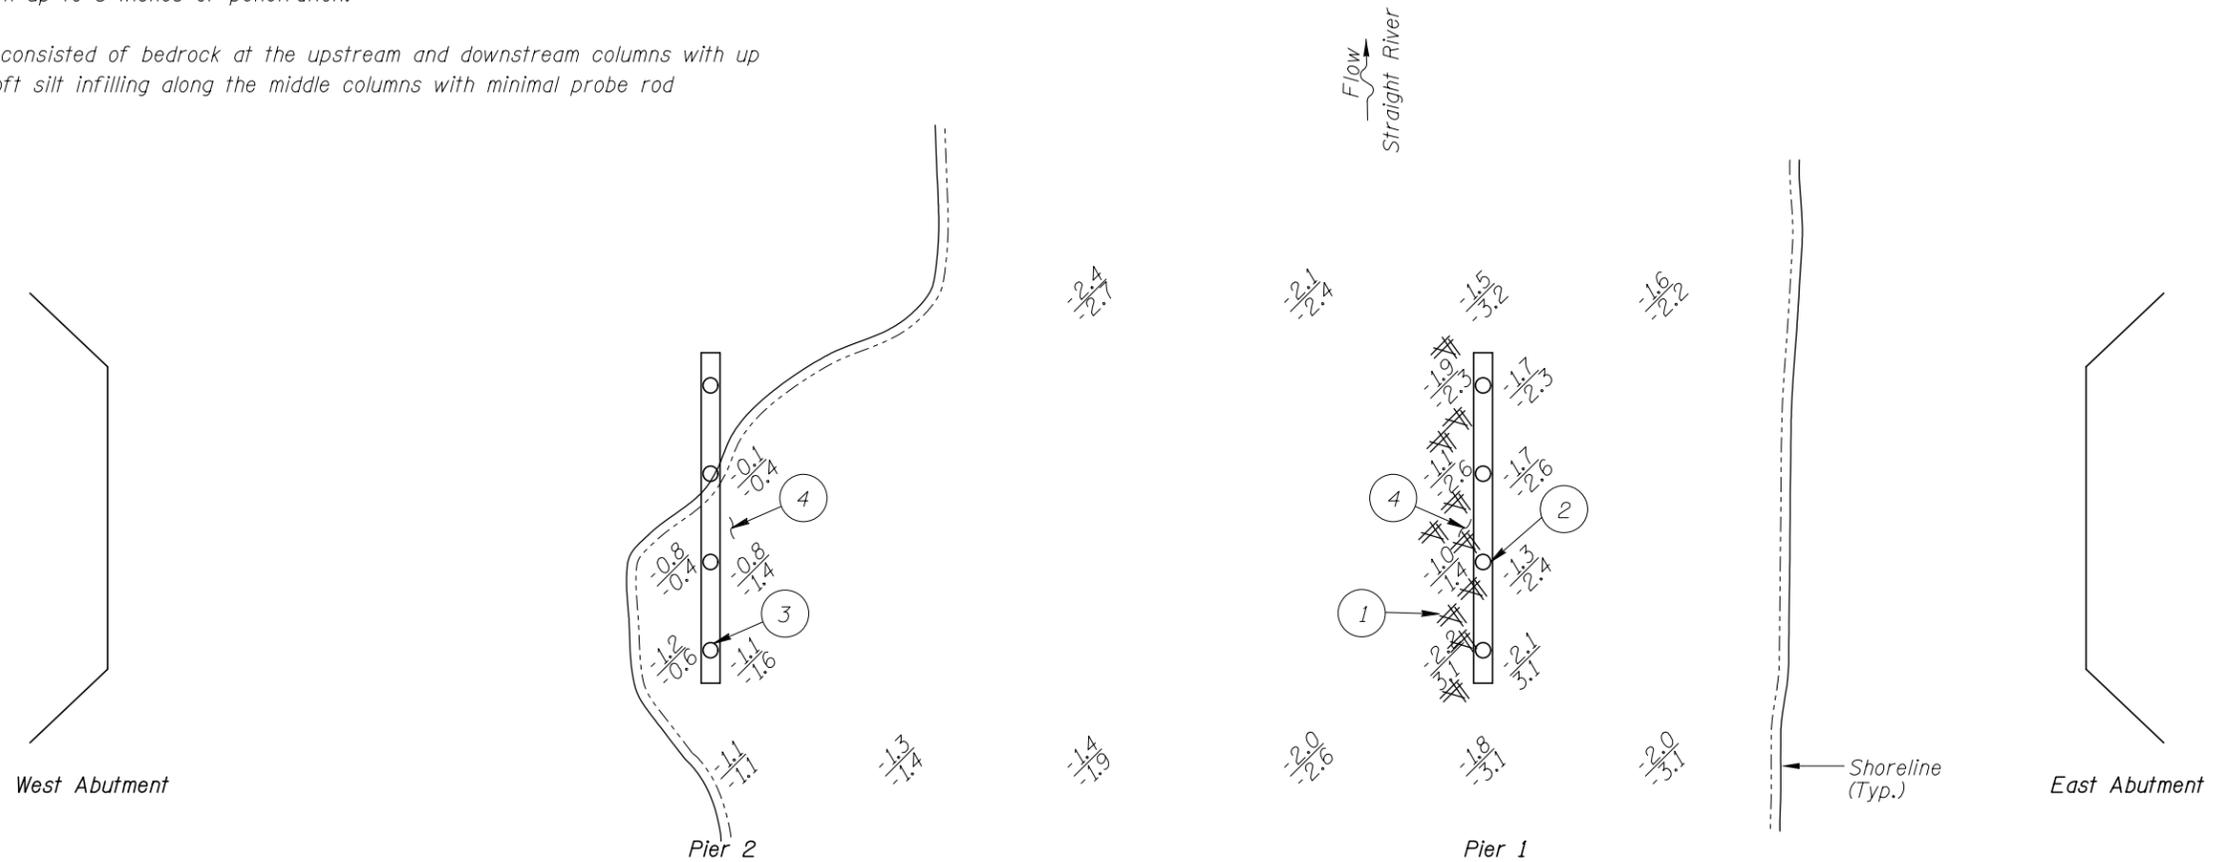
SOUNDING PLAN

- 2 The columns of Pier 1 were encased in up to 6 inches of additional concrete from the channel bottom to 2.3 feet above the waterline. The encasements exhibited form irregularities (embedded form boards) and spalling with up to 3 inches of penetration.

- 4 The channel bottom material consisted of bedrock at the upstream and downstream columns with up to 2 inches of gravel and soft silt infilling along the middle columns with minimal probe rod penetrations.
