UNDERWATER BRIDGE INSPECTION REPORT

STRUCTURE NO. 66523
MSAS 125 (HULET AVENUE)
OVER THE
CANNON RIVER
CITY OF FARBAULT, RICE COUNTY

SEPTEMBER 13, 2012
PREPARED FOR THE
MINNESOTA DEPARTMENT OF TRANSPORTATION
BY
COLLINS ENGINEERS, INC.
JOB NO. 7423

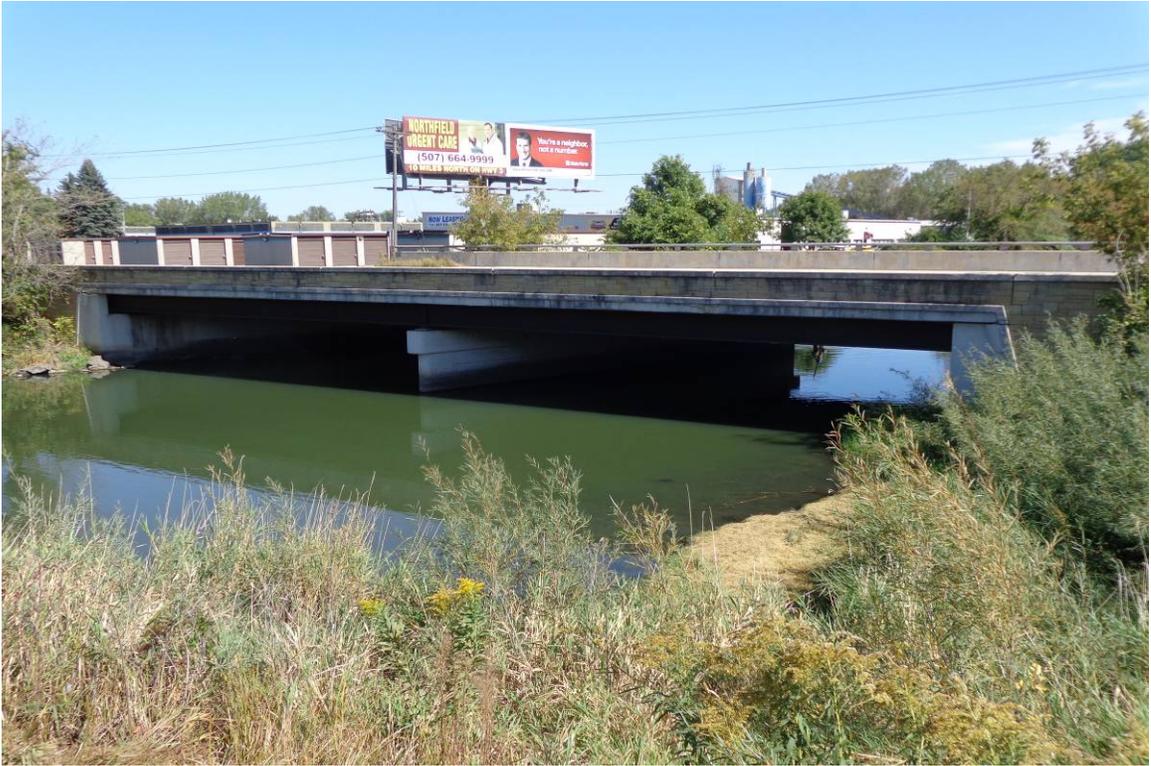
Photograph 1. Overall View of Bridge, Looking Northeast.

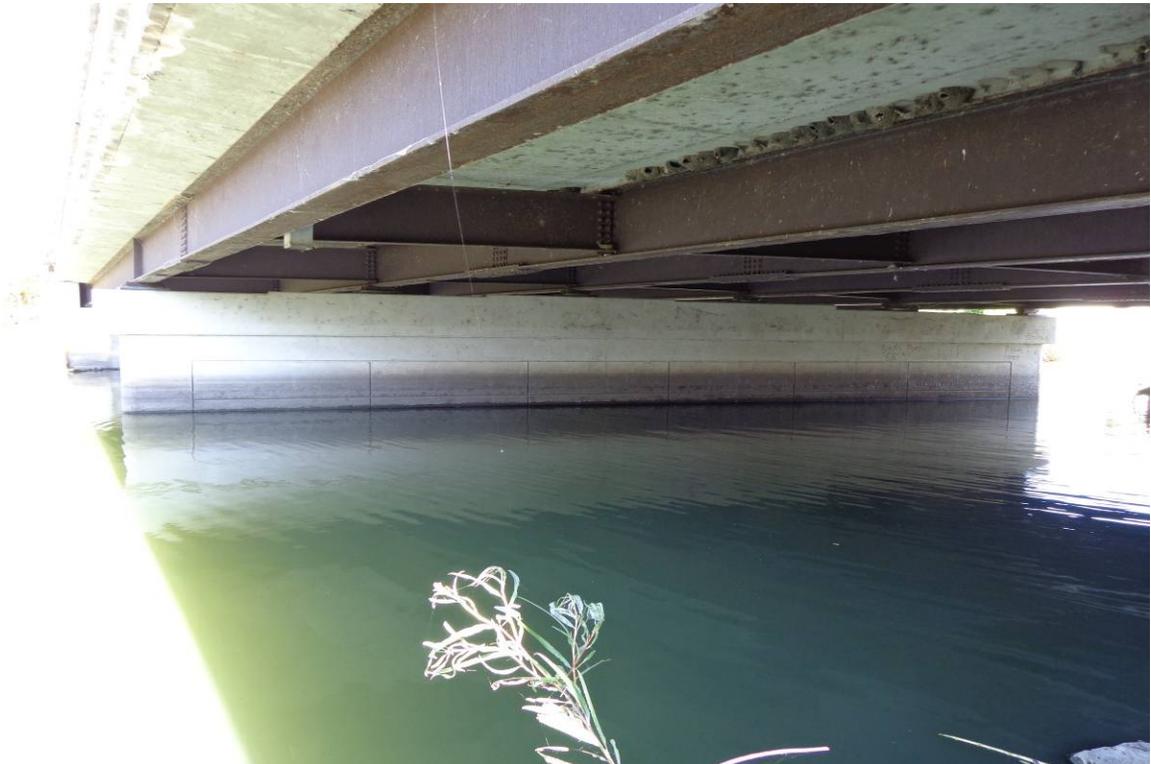
Photograph 2. View of Pier 1, Looking Northeast.

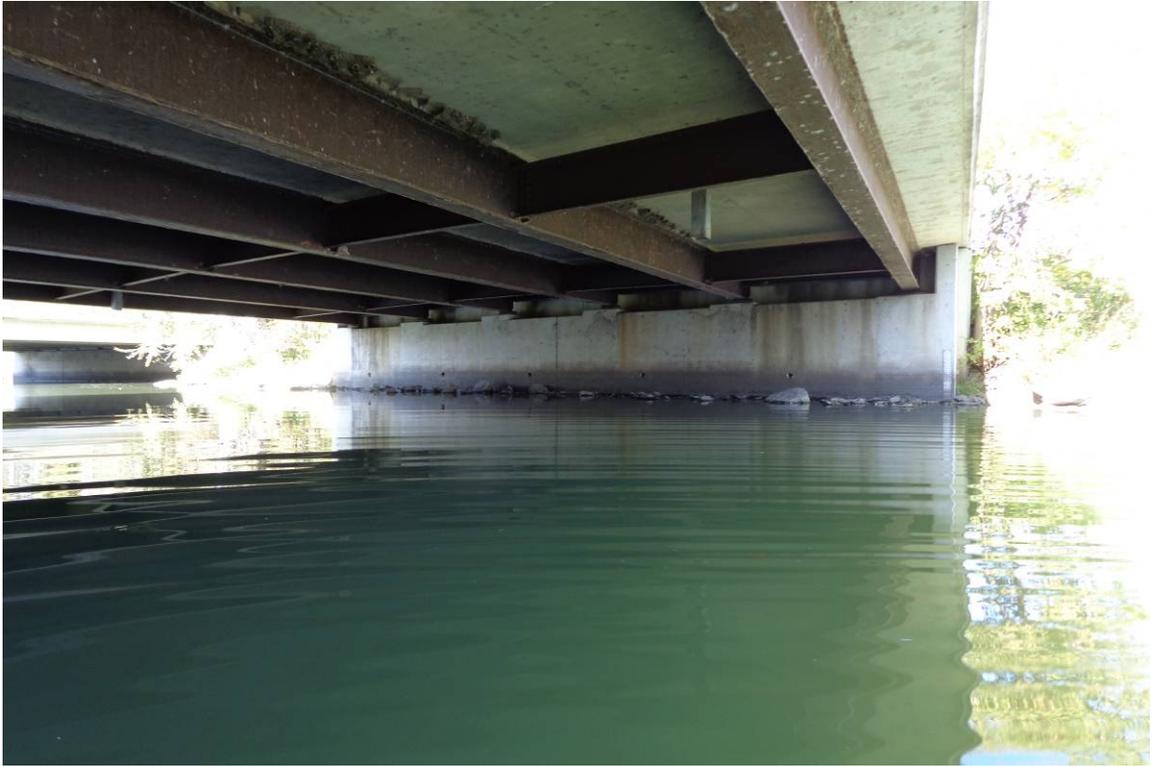
Photograph 3. View of the North Abutment, Looking Northwest.

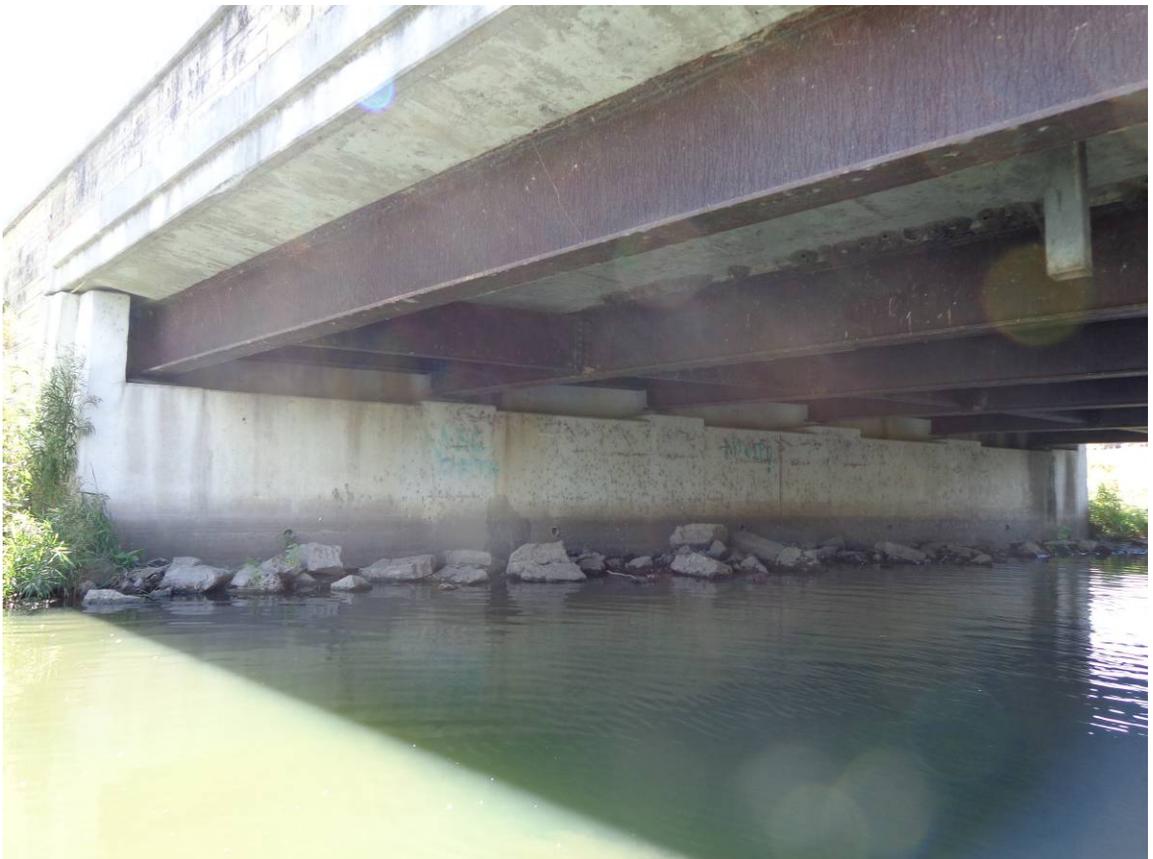
Photograph 4 View of the South Abutment, Looking Southwest.

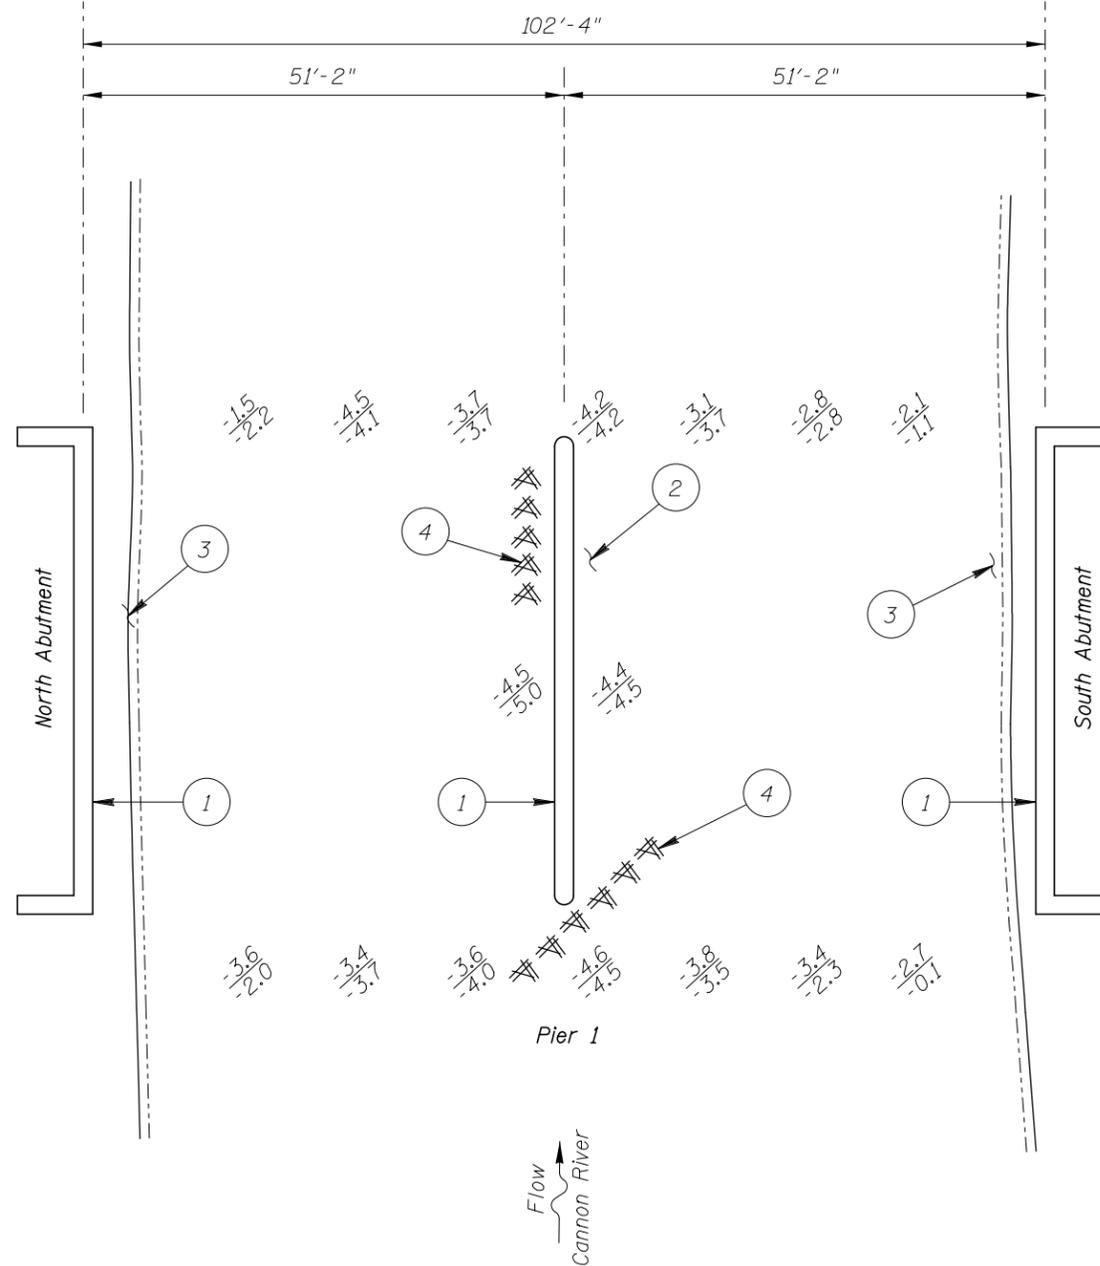
SOUNDING PLAN

- ① The concrete was in smooth and sound condition with no notable deterioration.
- ② The channel bottom at Pier 1 consisted of silty sand with scattered rock and up to 2 inches of probe rod penetration.
- ③ The channel bottom along the North and South Abutments consisted of 2-foot-diameter and smaller riprap.
- ④ A light accumulation of timber debris consisting of 1-foot-diameter and smaller logs and branches was observed from the channel bottom up 1 foot at the upstream nose and along the northern downstream half of Pier 1.
