UNDERWATER BRIDGE INSPECTION REPORT

STRUCTURE NO. 66532
227th STREET (TWP 45)
OVER THE
STRAIGHT RIVER
DISTRICT 6 - RICE COUNTY

SEPTEMBER 12, 2012
PREPARED FOR THE
MINNESOTA DEPARTMENT OF TRANSPORTATION
BY
COLLINS ENGINEERS, INC.
JOB NO. 7423

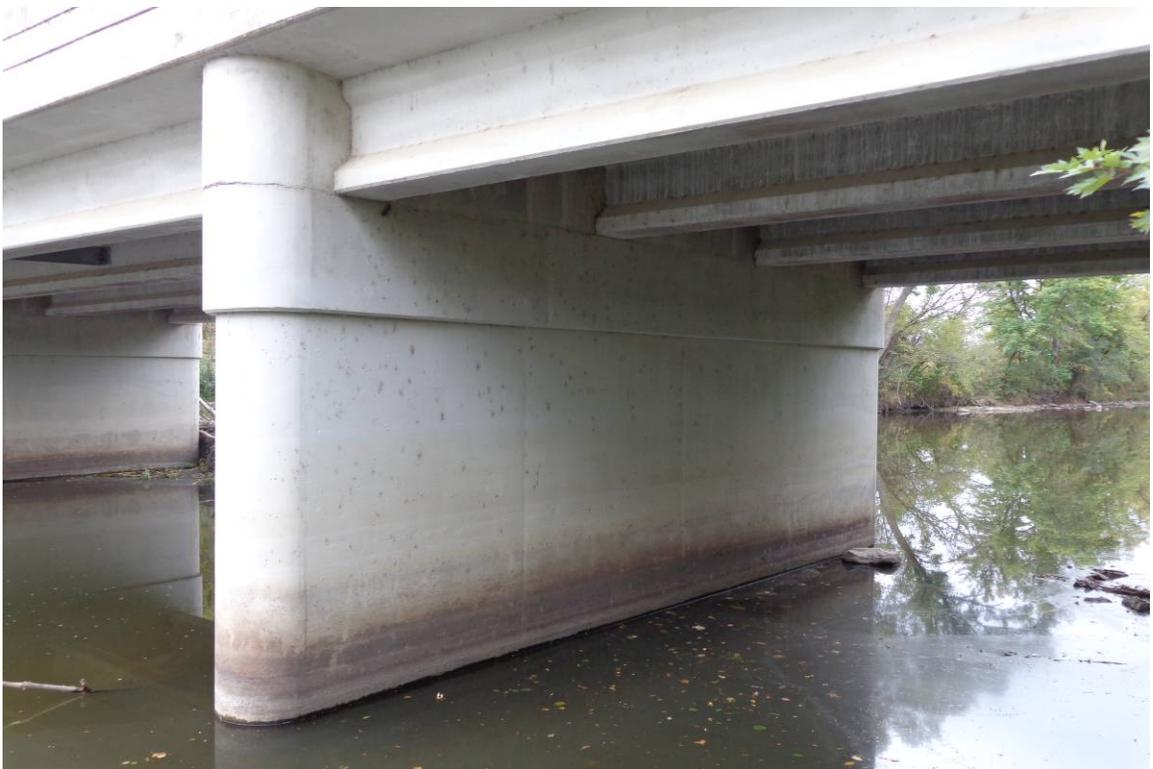
Photograph 2. View of Pier 1, Looking Southeast.

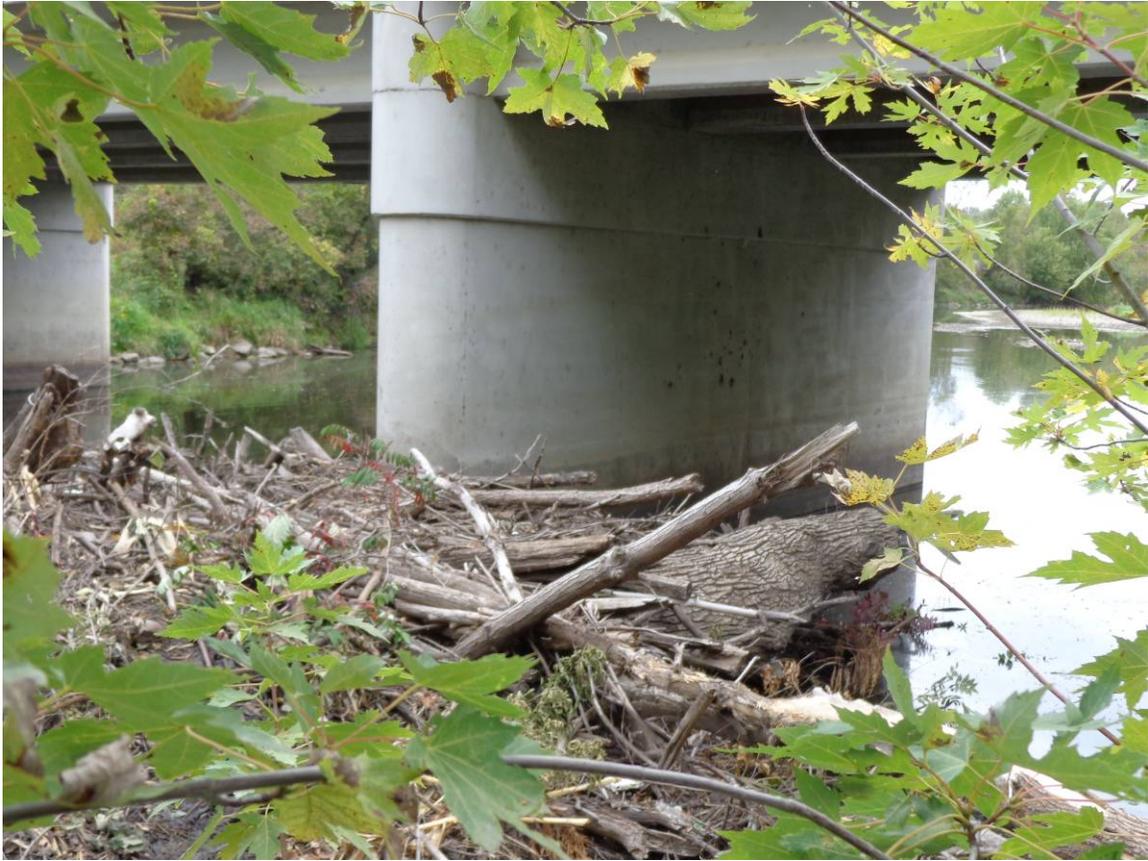
- (A) The channel bottom material at Pier 2 consisted of soft silty infilling and organics with 6 inches of probe rod penetration. Firm rock was at times encountered at Pier 2 under a 1 to 1.5 foot thick layer of soft channel bottom material.
- (B) A heavy timber debris accumulation consisting of 2 feet diameter and smaller logs and branches was observed on the upstream side of Pier 2, extending from the channel bottom to 6 feet above the waterline and up to 30 feet south of the upstream nose.
- (C) Concrete was smooth and sound on both piers.
- (D) The channel bottom material at Pier 1 consisted of firm rock and gravel with no probe rod penetration around the upstream half of the pier, and sand silty infilling with 3 inches of probe rod penetration around the downstream half of the pier.
- (E) A 1 foot diameter log was observed on the channel bottom along the east face of Pier 1.

Photograph 3. View of Pier 2 and Timber Debris, Looking Northwest.

- (A) Remove accumulations of timber debris at both piers (particularly at Pier 2) to alleviate further accumulation, scour influence, and any excessive lateral force on the piers.

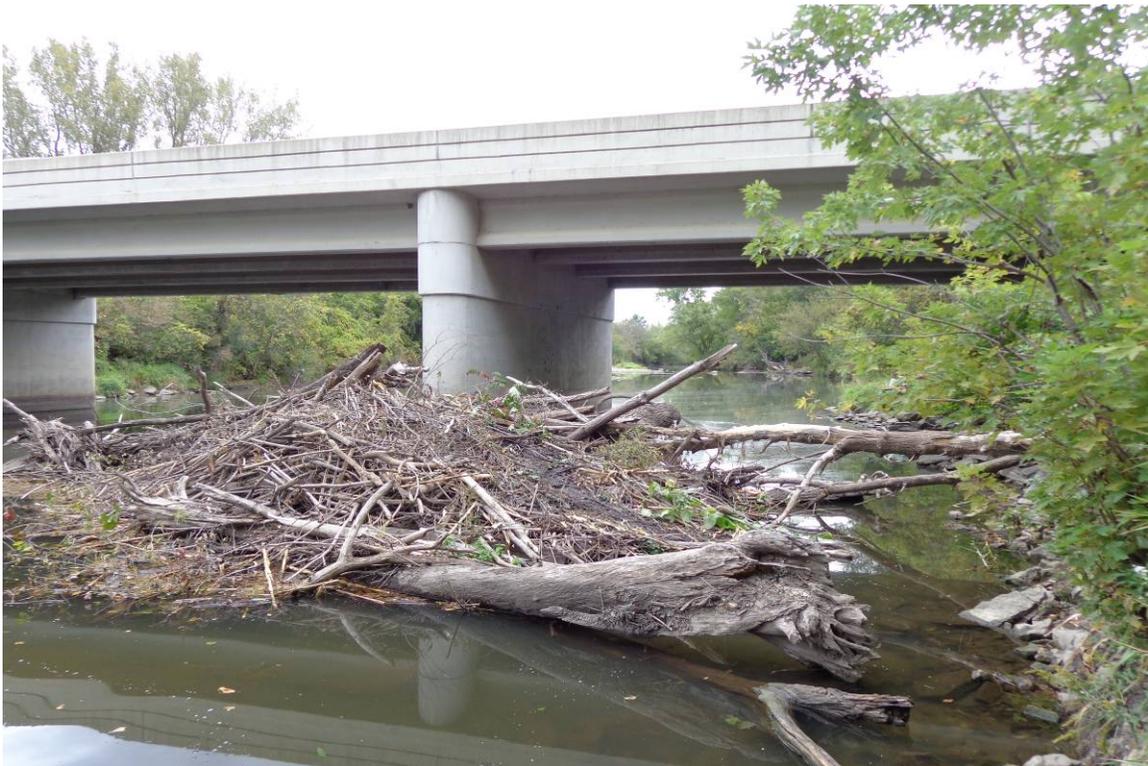
Photograph 4. View of the Upstream End of Pier 2 and Timber Debris, Looking Northwest.
